INVESTIGATING OFFICER'S REPORT

*Nature and Cause Investigation
into a Serious Accident to
s.73 Irrelevant information
at Broadmeadow Underground Mine
on Monday 27th February 2006.*

INVESTIGATING OFFICER: Kevin Clough
District Inspector of Mines
Mackay Central Region

DATE of REPORT: 27th July 2006

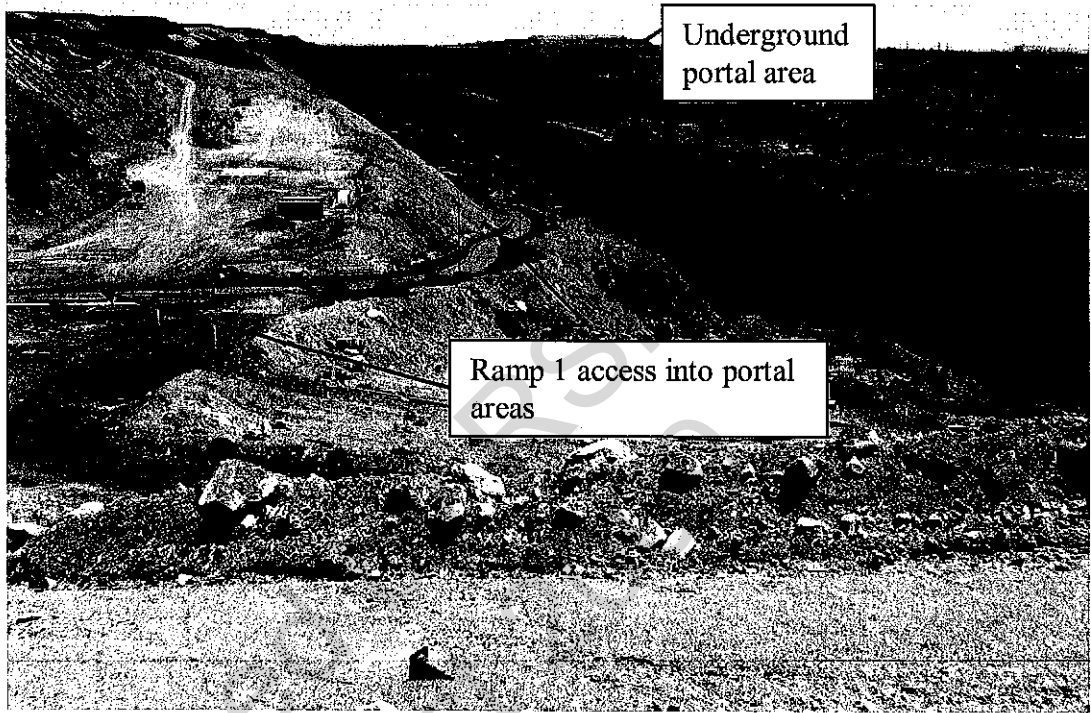
Access to the portal areas of the mine is via a ramp (Ramp 1) approximately 900m long with a gradient of 1:10. **(Photograph 1)** Signs erected at the top and bottom of the ramp limit vehicle speed to 30 km/h with the vehicle in second gear. **(Photograph 2)** The centre portion of the ramp width has been concreted to improve vehicle traction during periods of wet weather and to prevent deterioration of the ramp surface. **(Photograph 3)**

Photograph 1. [return17](#)
Ramp 1 access into Broadmeadow Mine.

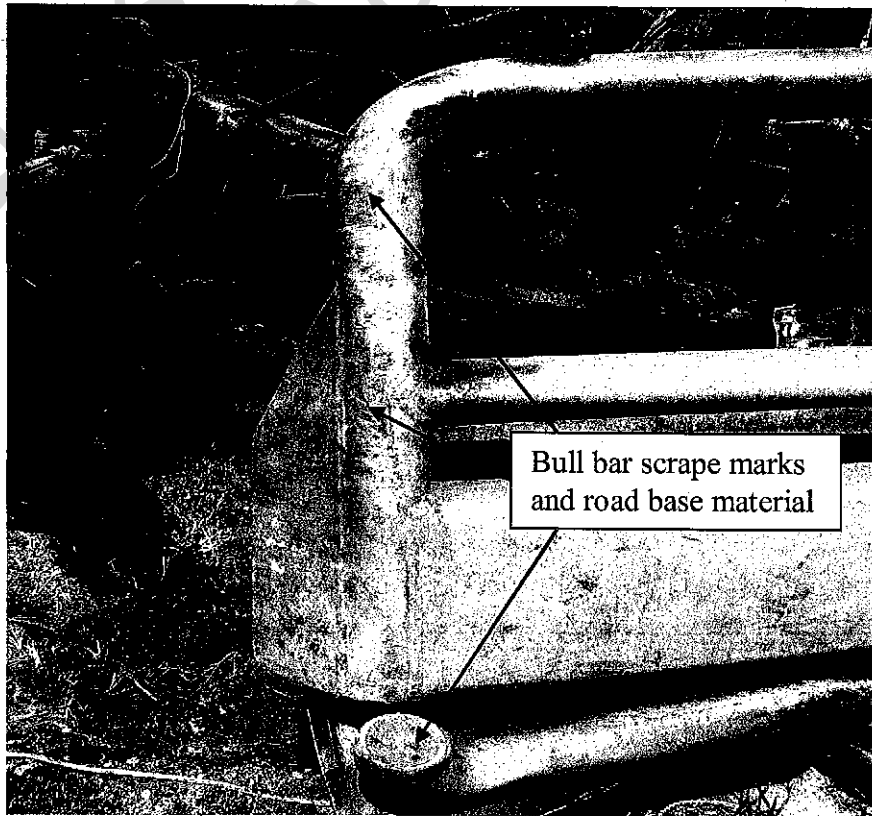
Photograph 16. return33
Right side bull bar indicating scrape marks and damage.

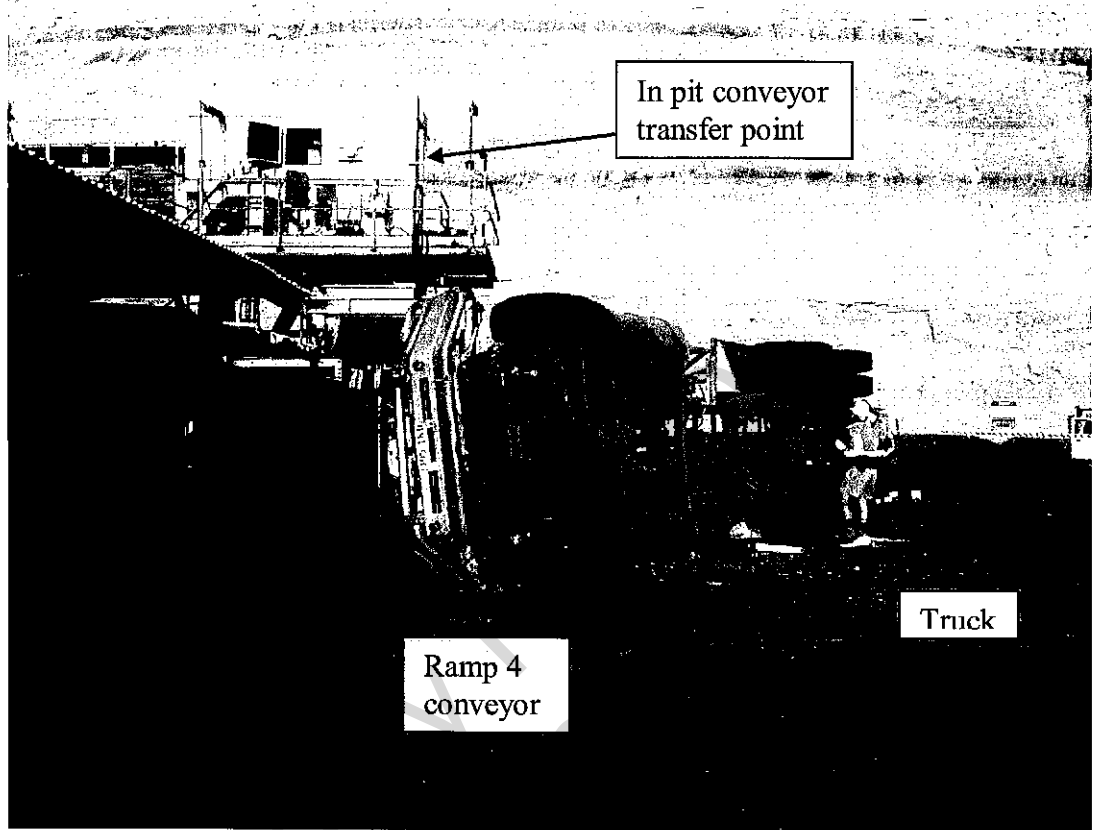
Photograph 17. return34
Position of truck against Ramp 4 conveyor.

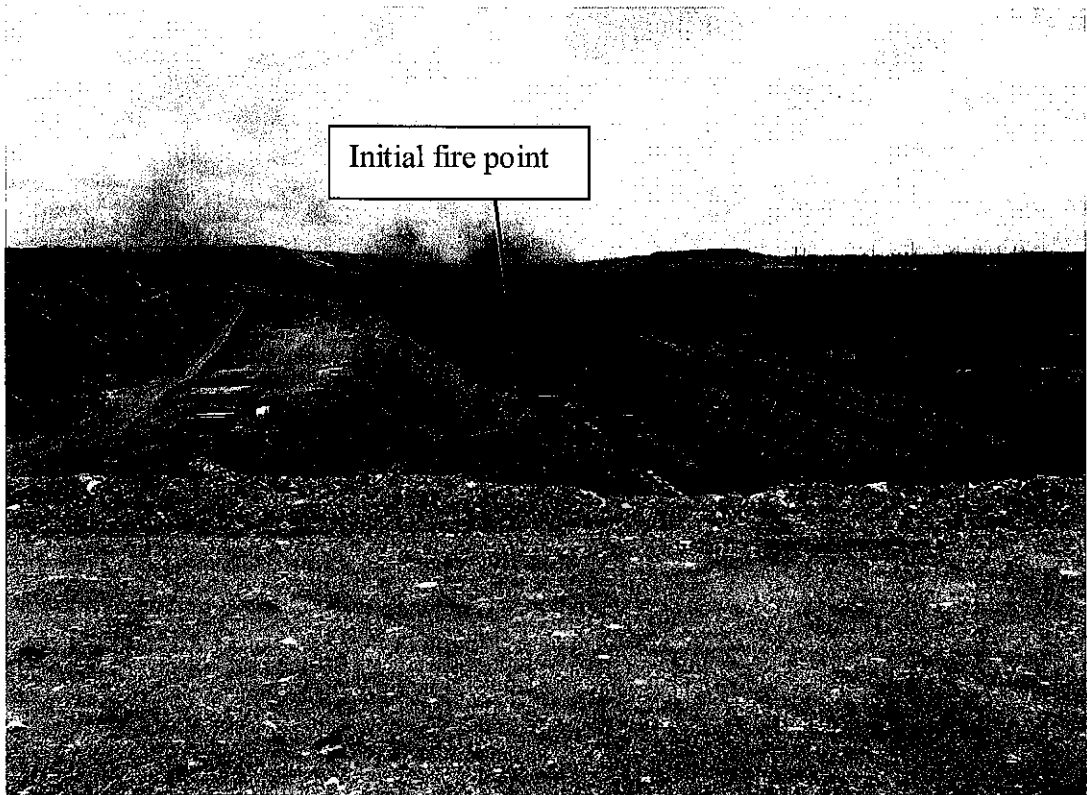
Photograph 23. return40
Initial commencement of fire.

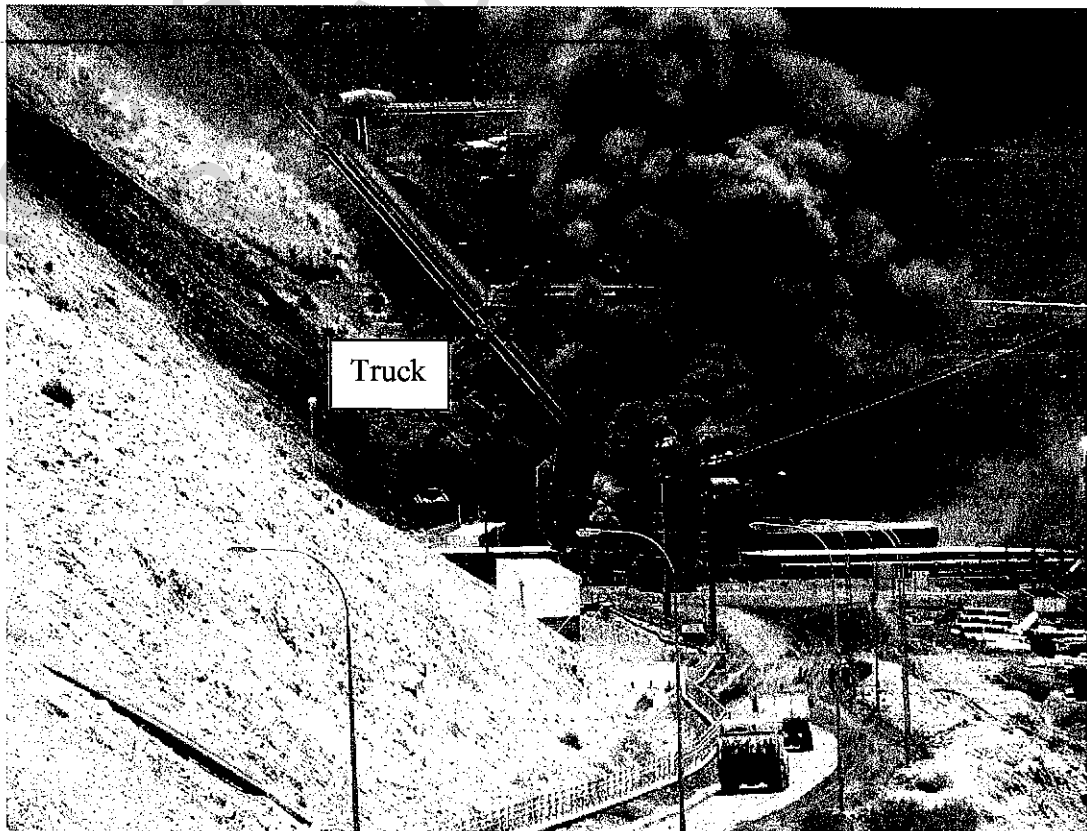
Photograph 24. return41
Truck fully engulfed in flame.

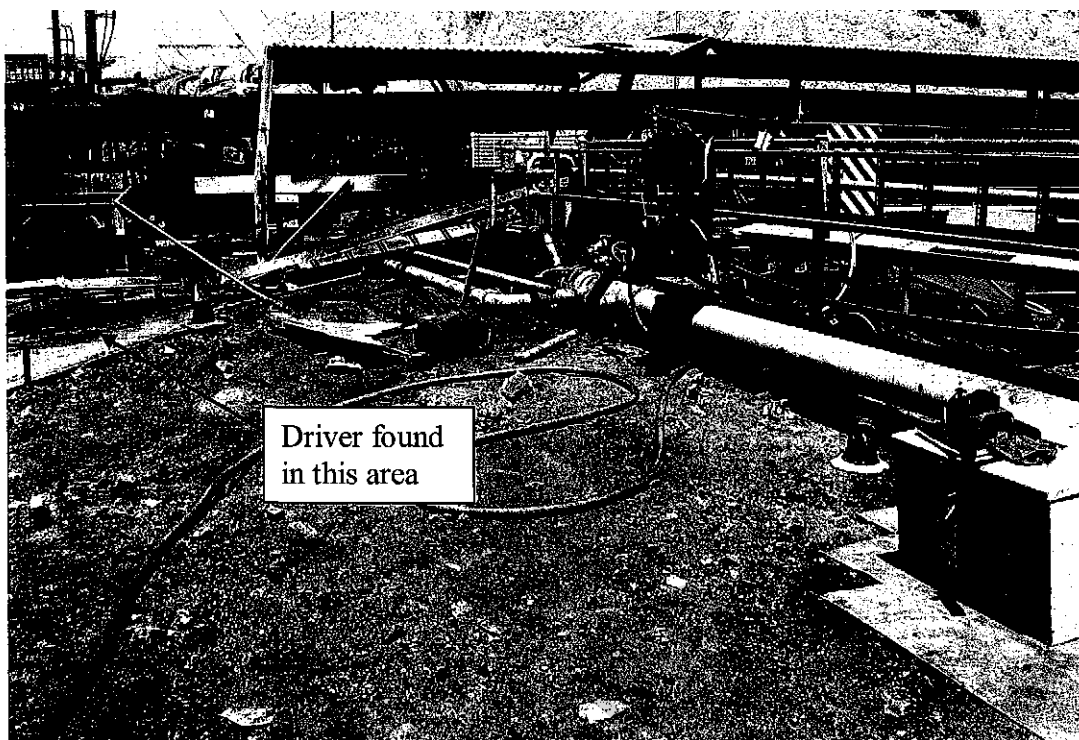
The driver of the truck was found lying on the ground on the opposite side of Ramp 4 conveyor from the burning truck suffering from horrific burns to his upper body. He was able to speak to one witness and has said that the brakes failed and he tried to get the truck into a lower gear, but failed to do so. Refer to witness statement of s.73 Irrelevant information **(Photograph 25)**

Photograph 25. return42
Driver found in this area.

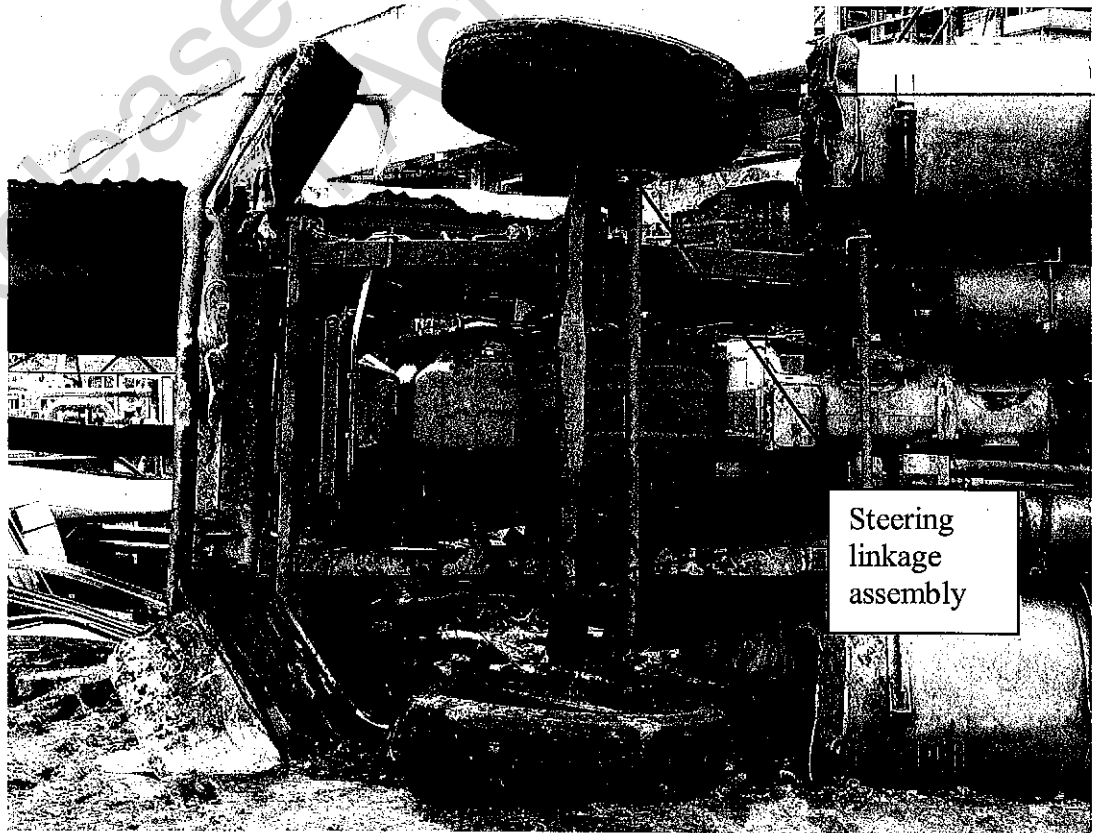
- No excessive wear or movement in any of the ball joints in the steering system tie rods or steering arms. (*Photograph 28*)

Photograph 28. return45
Steering linkages assembly front wheels.
