Mine Safety and Health

Investigation report

Report into a fatality at the Newlands Mine Coal Handling and Preparation Plant, Newlands, Queensland on 30 August 2016

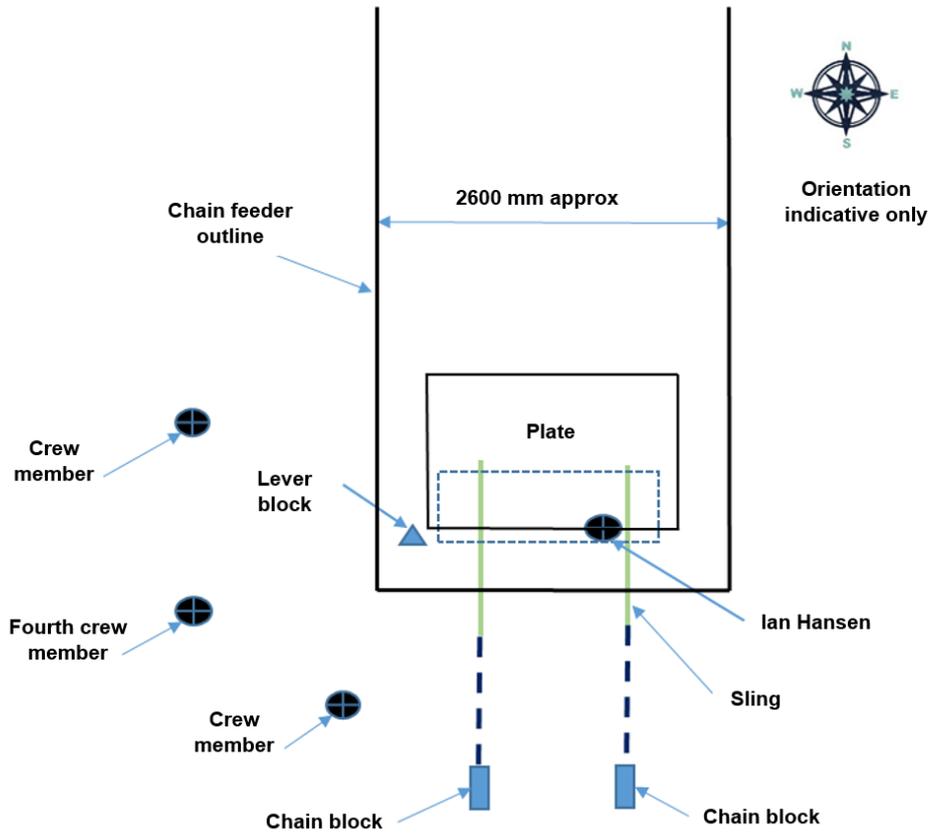
Figure 6 – Plan view of the incident site, based on witness statements

At the time, the fourth crew member was under the deck plates and states that Mr Hansen entered the area below the deck plate to tell him that they were going to remove the bolts and that he should leave the area. That crew member left through the western side railing and saw Mr Hansen bend down, as if to leave through the eastern side railing.

Shortly after exiting through the western side railing the crew member heard the plate fall and impact Mr Hansen.

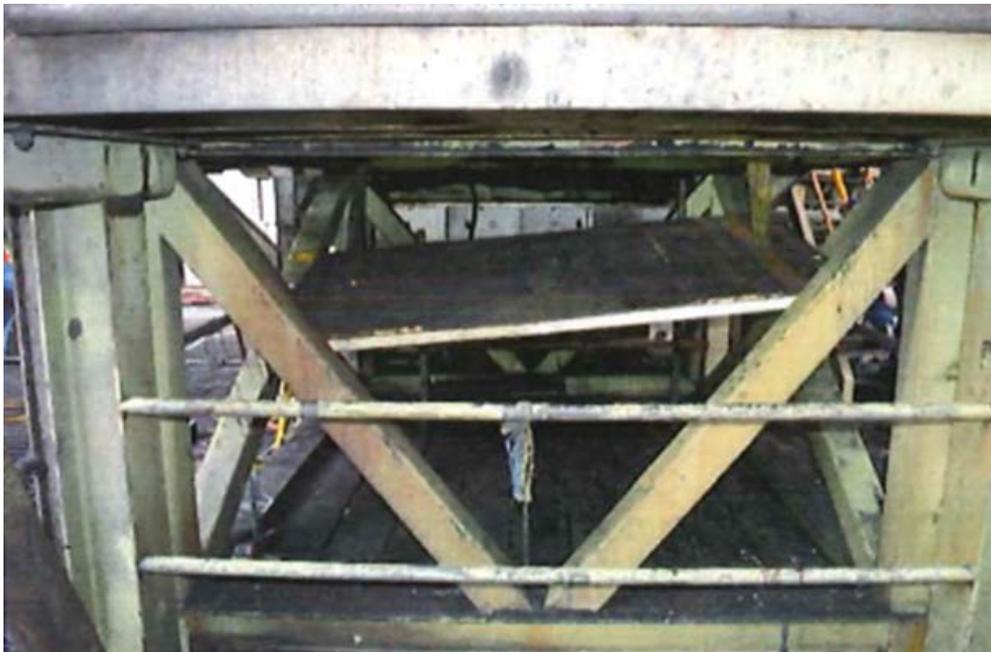
Figure 7 – Incident scene, photographed from south

Inspection of the scene on the day of the incident showed that the work area was clean, with only small pieces of coal and some coal dust present. There was no apparent spillages of oil or grease.

The area under the chain feeder is demarcated by permanent handrails – this effectively demarcates areas around the feeder from falling materials. The area under the feeder had a timber plank floor erected on scaffolding to provide a work platform underneath the feeder. Access to and from the area was restricted by the handrails.

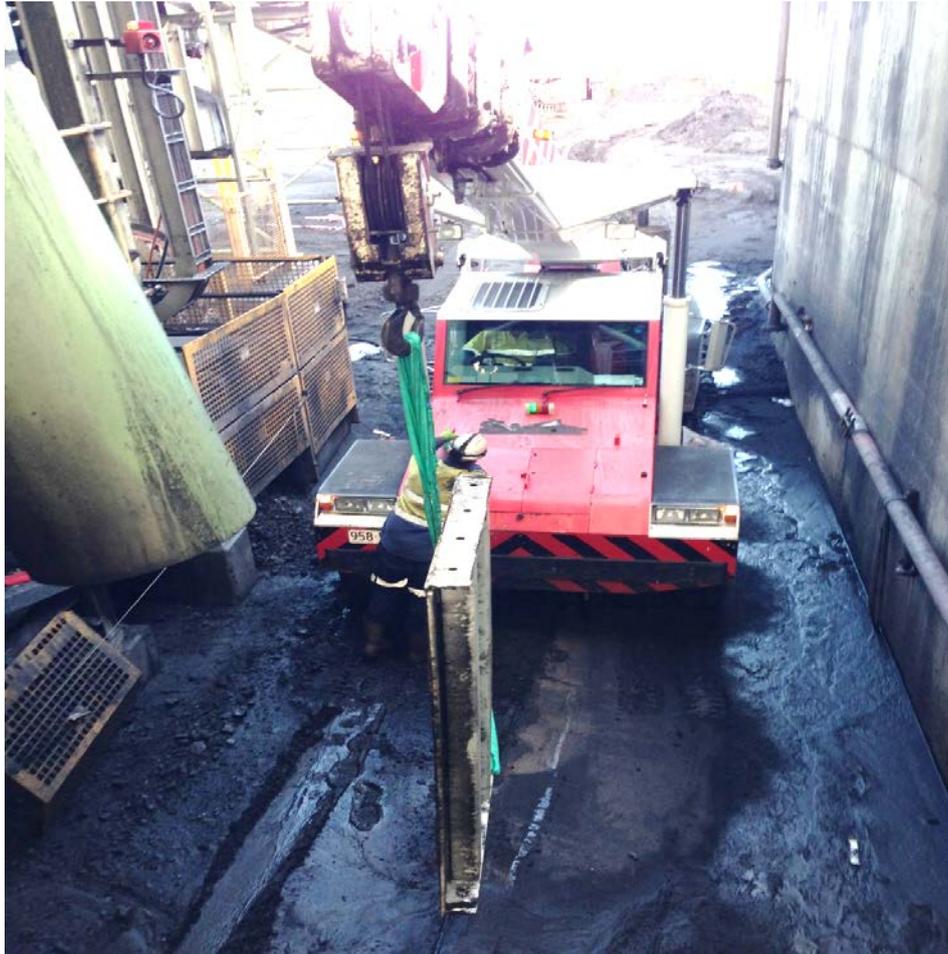
Figure 8 – The recovered second bottom deck plate

The site did not allow for a straight vertical lift of the second bottom deck plate. The plate had been rigged using the same point as the rear bottom deck plate, which had enabled a straight vertical lift. When the rear bottom deck plate dropped from its position it dropped straight down (supported by the rigging). However, utilising the same rigging point for the second bottom deck plate meant that the plate swung in an arc as it dropped. There was also no provision to support the deck plate from underneath.

An issue of risk was the unknown properties of the deck plates. The Original Equipment Manufacturer (OEM) manual did not contain a risk-based methodology for removal and replacement of the deck plates and there was no request made to gain such information. The investigation following the incident found a discrepancy in the mass of the deck plate. The OEM stated the mass to be 890kg but it was actually 390kg. Without a known risk-based methodology and correct information, the planning for the removal of the plates could not have been comprehensive.

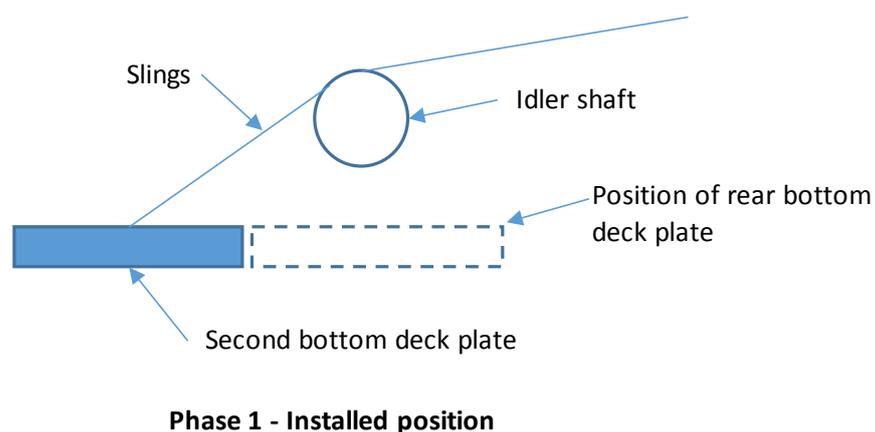
Figure 9a – Phase 1 of the likely sequence of events involving the second bottom deck plate

Mr Hansen was struck by the deck plate as it swung free on its rigging. He was struck in the abdomen and forced back where his head struck a metal cross beam. Mr Hansen's head struck at a force and angle to lose consciousness despite wearing his hard hat.
