Mining safety and health newsflash

Fatal injuries received whilst performing work on bucket

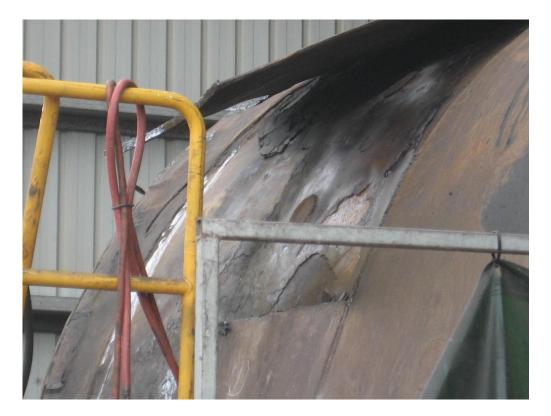
An incident occurred where it appears a wear plate on the bottom of the digger bucket has sprung up and hit a coal mine worker in the forehead causing fatal injuries. The wear plate was in the process of being removed by either air arc gouging or grinding.

All mines should immediately review their processes for removal and replacement of liner and wear plates on earthmoving equipment buckets.
