EXPLOSION AT SIX BELLS COLLIERY  
MONMOUTHSHIRE

# EXPLOSION AT SIX BELLS COLLIERY, MONMOUTHSHIRE

On the causes of, and circumstances  
attending, the explosion which occurred at  
Six Bells Colliery, Monmouthshire,  
on 28th June, 1960

T. A. ROGERS, C.B.E., M.I.Min.E.  
H.M. Chief Inspector of Mines and Quarries

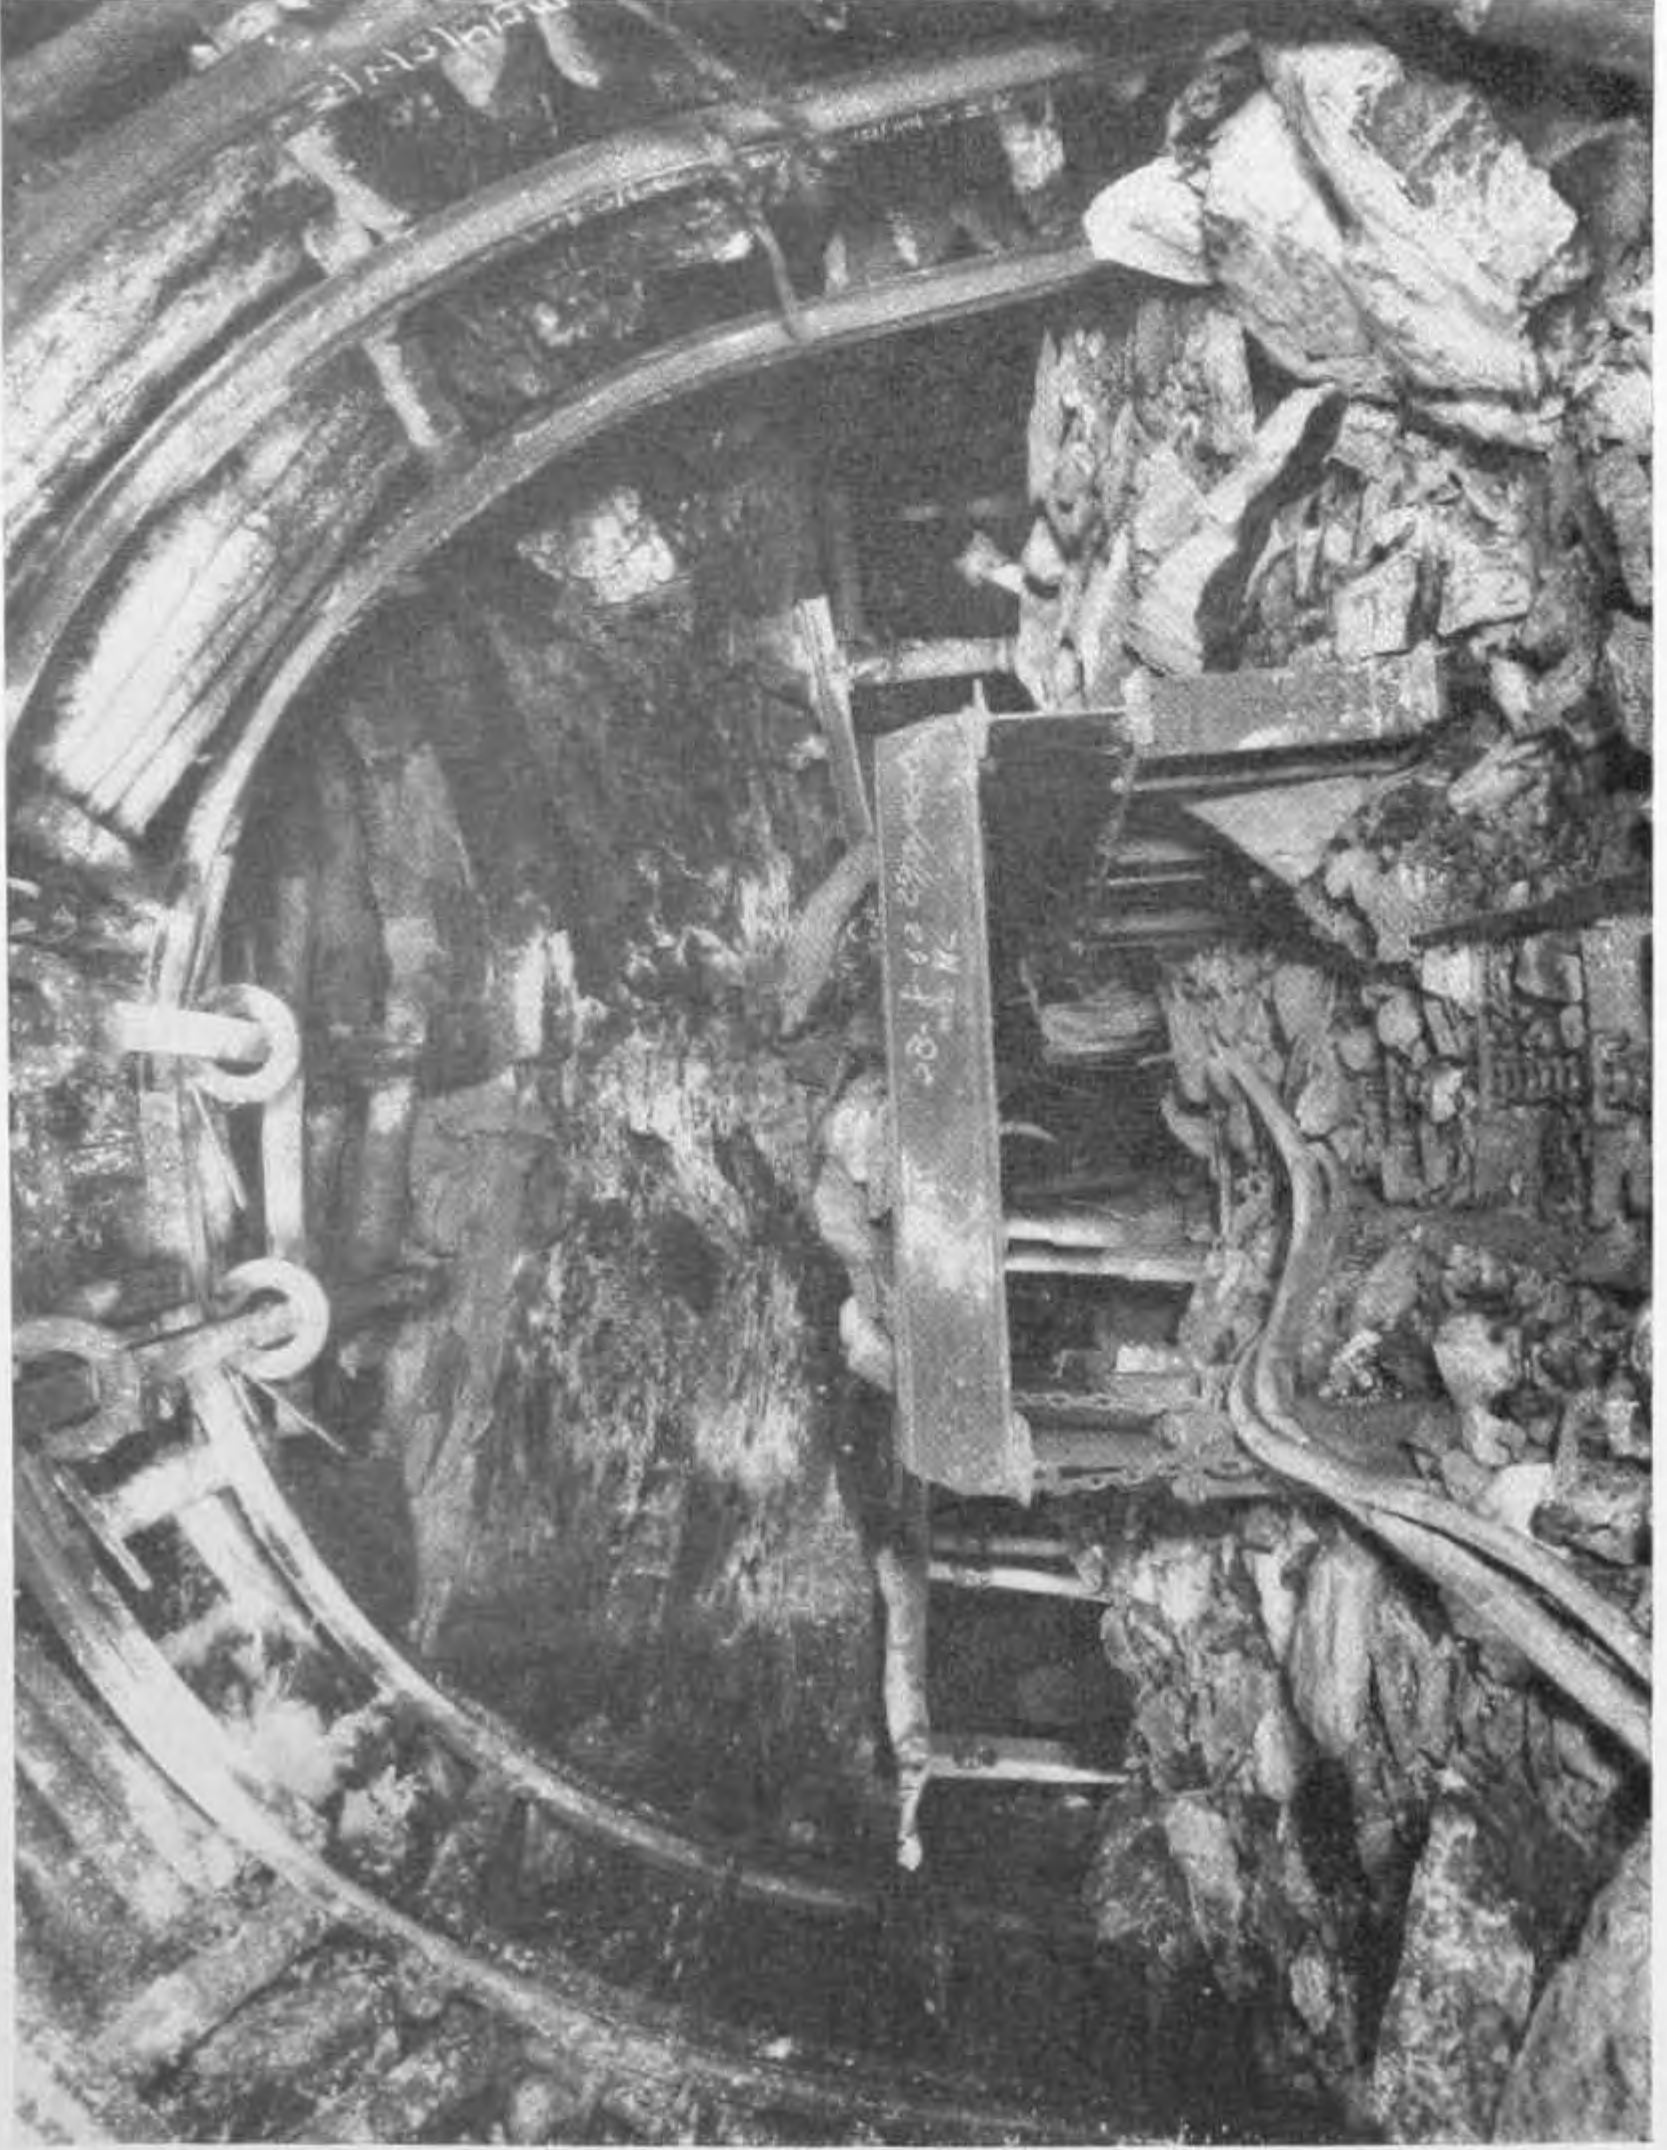
PLATE I. INTAKE (LOADER GATE) ROADHEAD OF O.10 UNIT

condition may result. Hartwell suggested that the impact of the mechanised pick used in the experiments he described would have been about equivalent to that of rock weighing 260 lbs. falling for a distance of three and a half feet onto a steel object. He thought that the most probable cause of the explosion was that there was a fall of rock bringing down with it firedamp that had accumulated at the ripping and that one of the larger pieces of rock struck the canopy in such a way as to produce an incendive condition and so cause inflammation of the surrounding atmosphere. Pieces of quartzitic rock, the largest being estimated to weigh about 240 lbs. were, in fact, found on the ground and on the canopy under O.10 intake ripping (Plate I). Some of it could have fallen a distance of six feet.

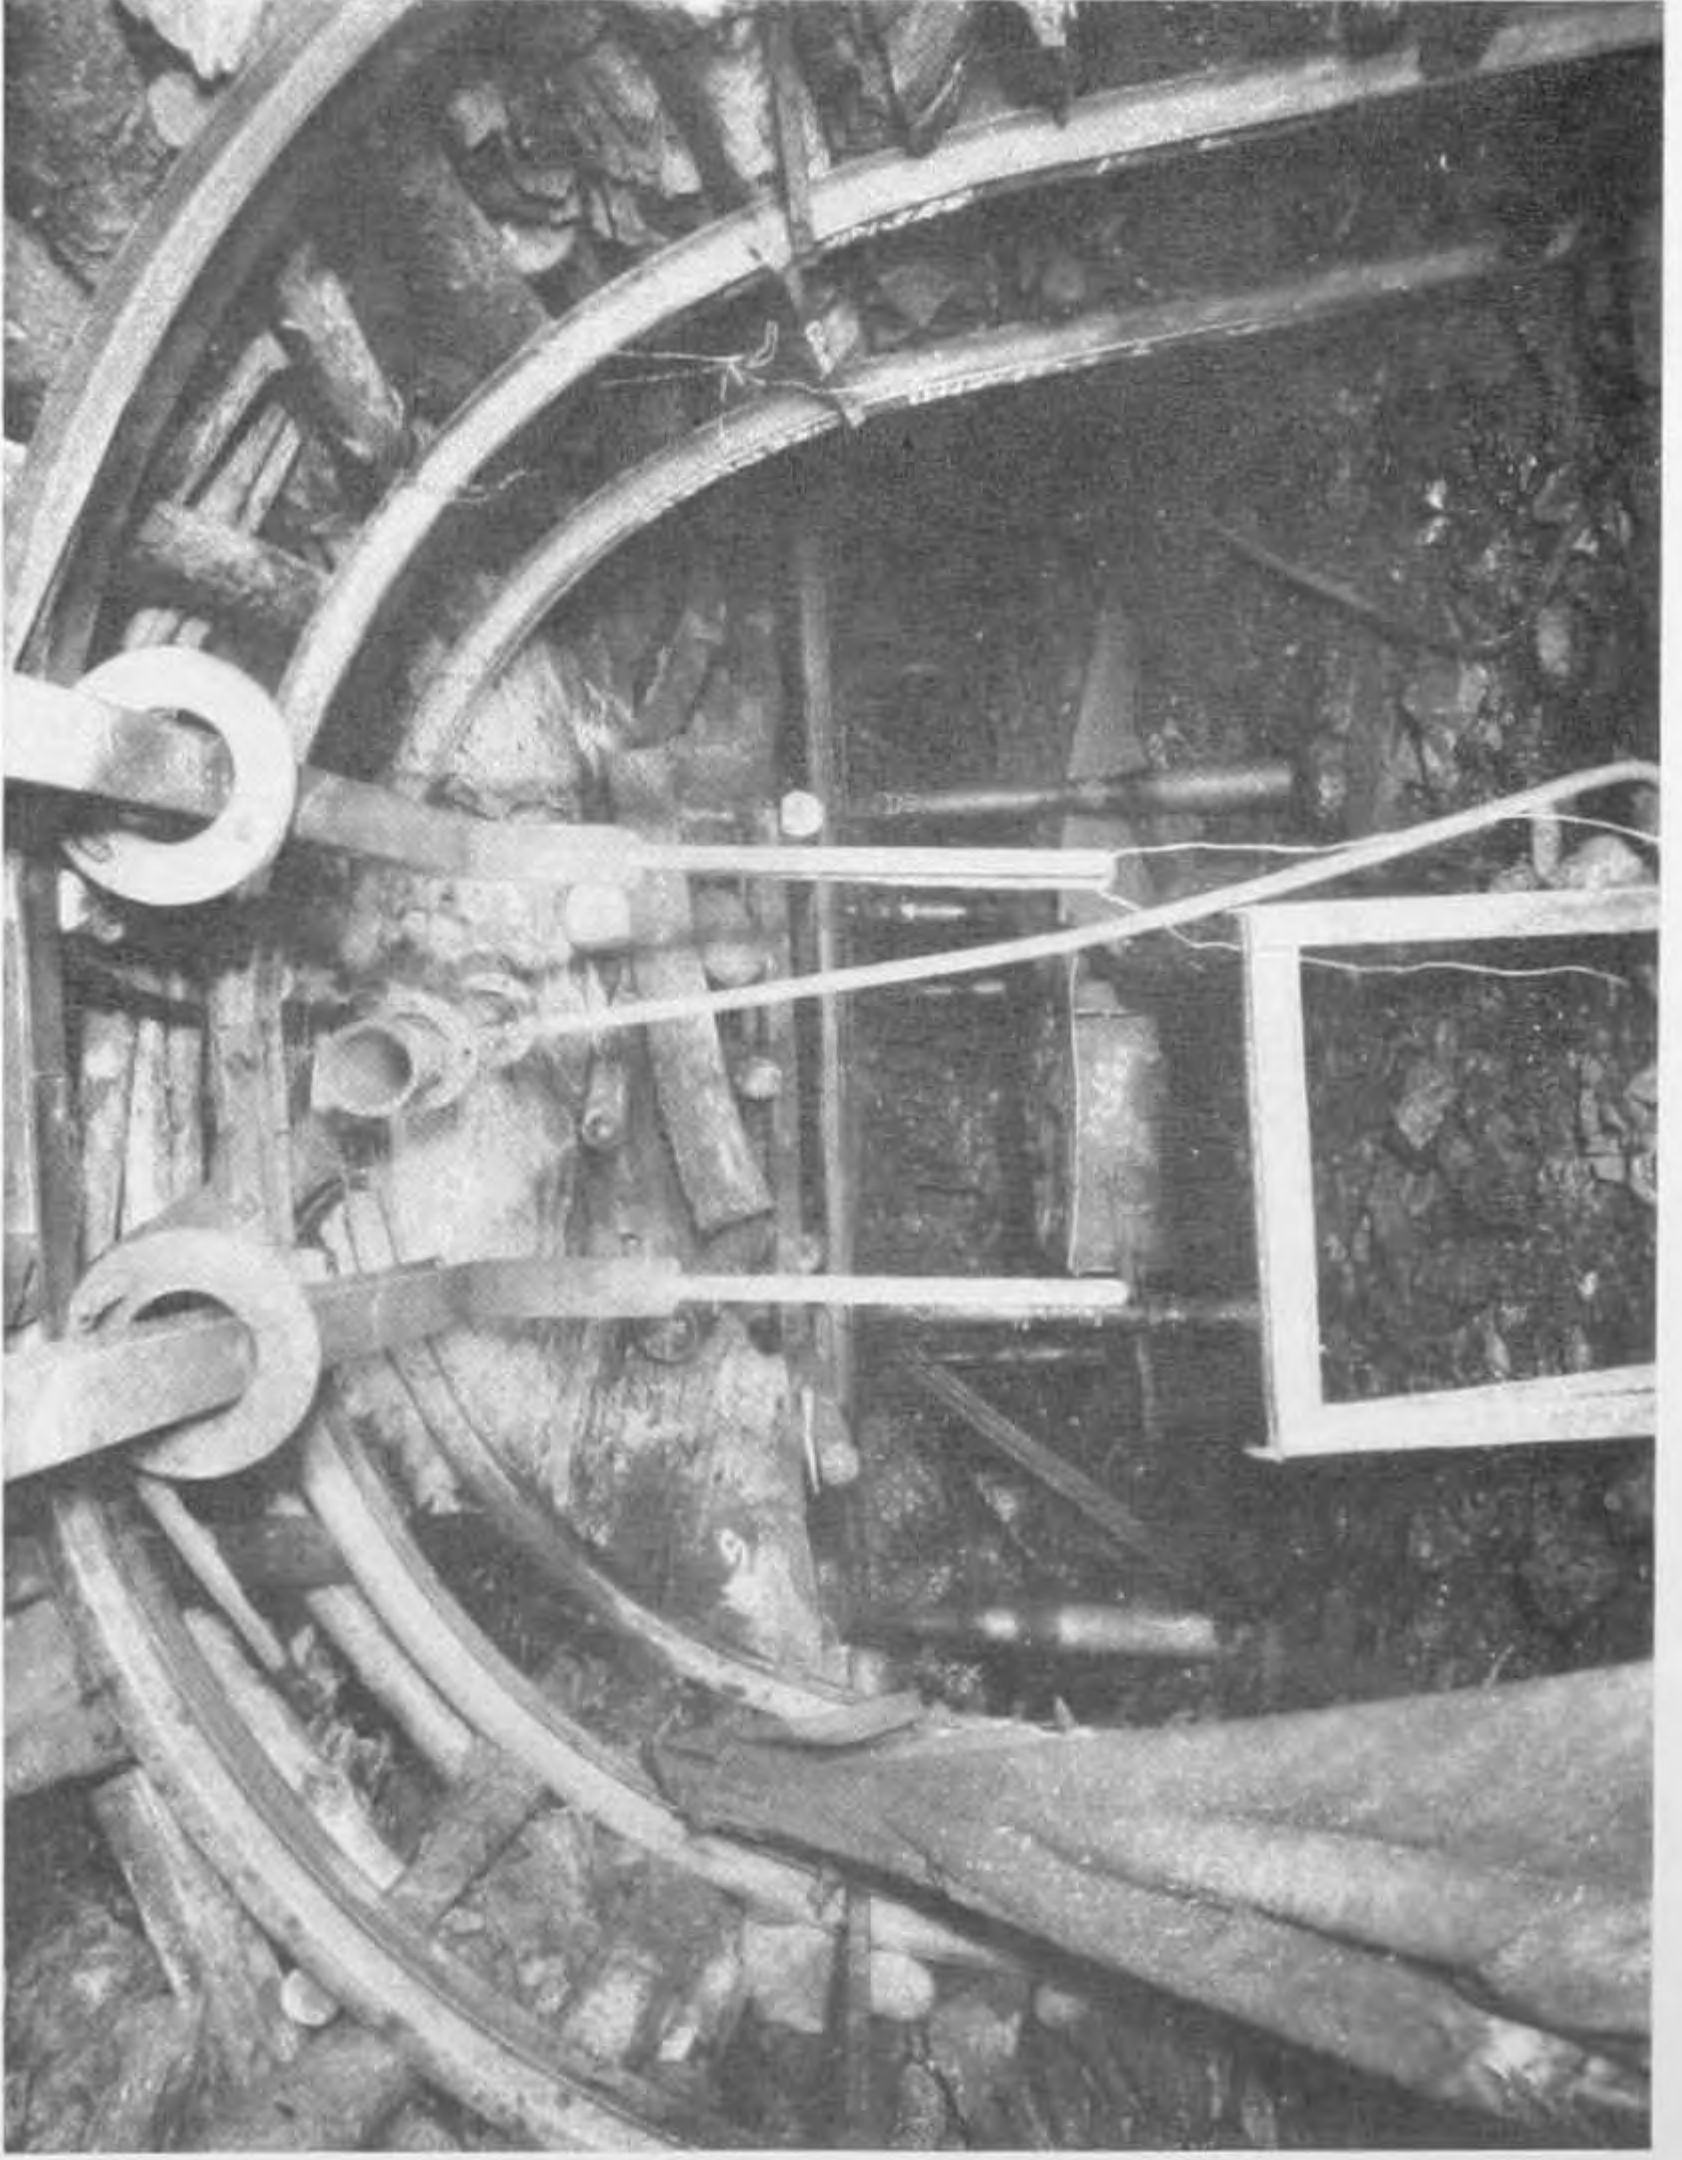
PLATE II. RETURN ROADHEAD OF O.18 UNIT

died out on the tram haulage section of the main intake and on the main return. The prolonged burning at O.18 return roadhead could only have been due to the inflammation of firedamp from open breaks, together with some from the adjacent waste. The signs of extra violence found near O.10 supply roadhead might have been due to firedamp forced out of the waste by the explosion in the intake.

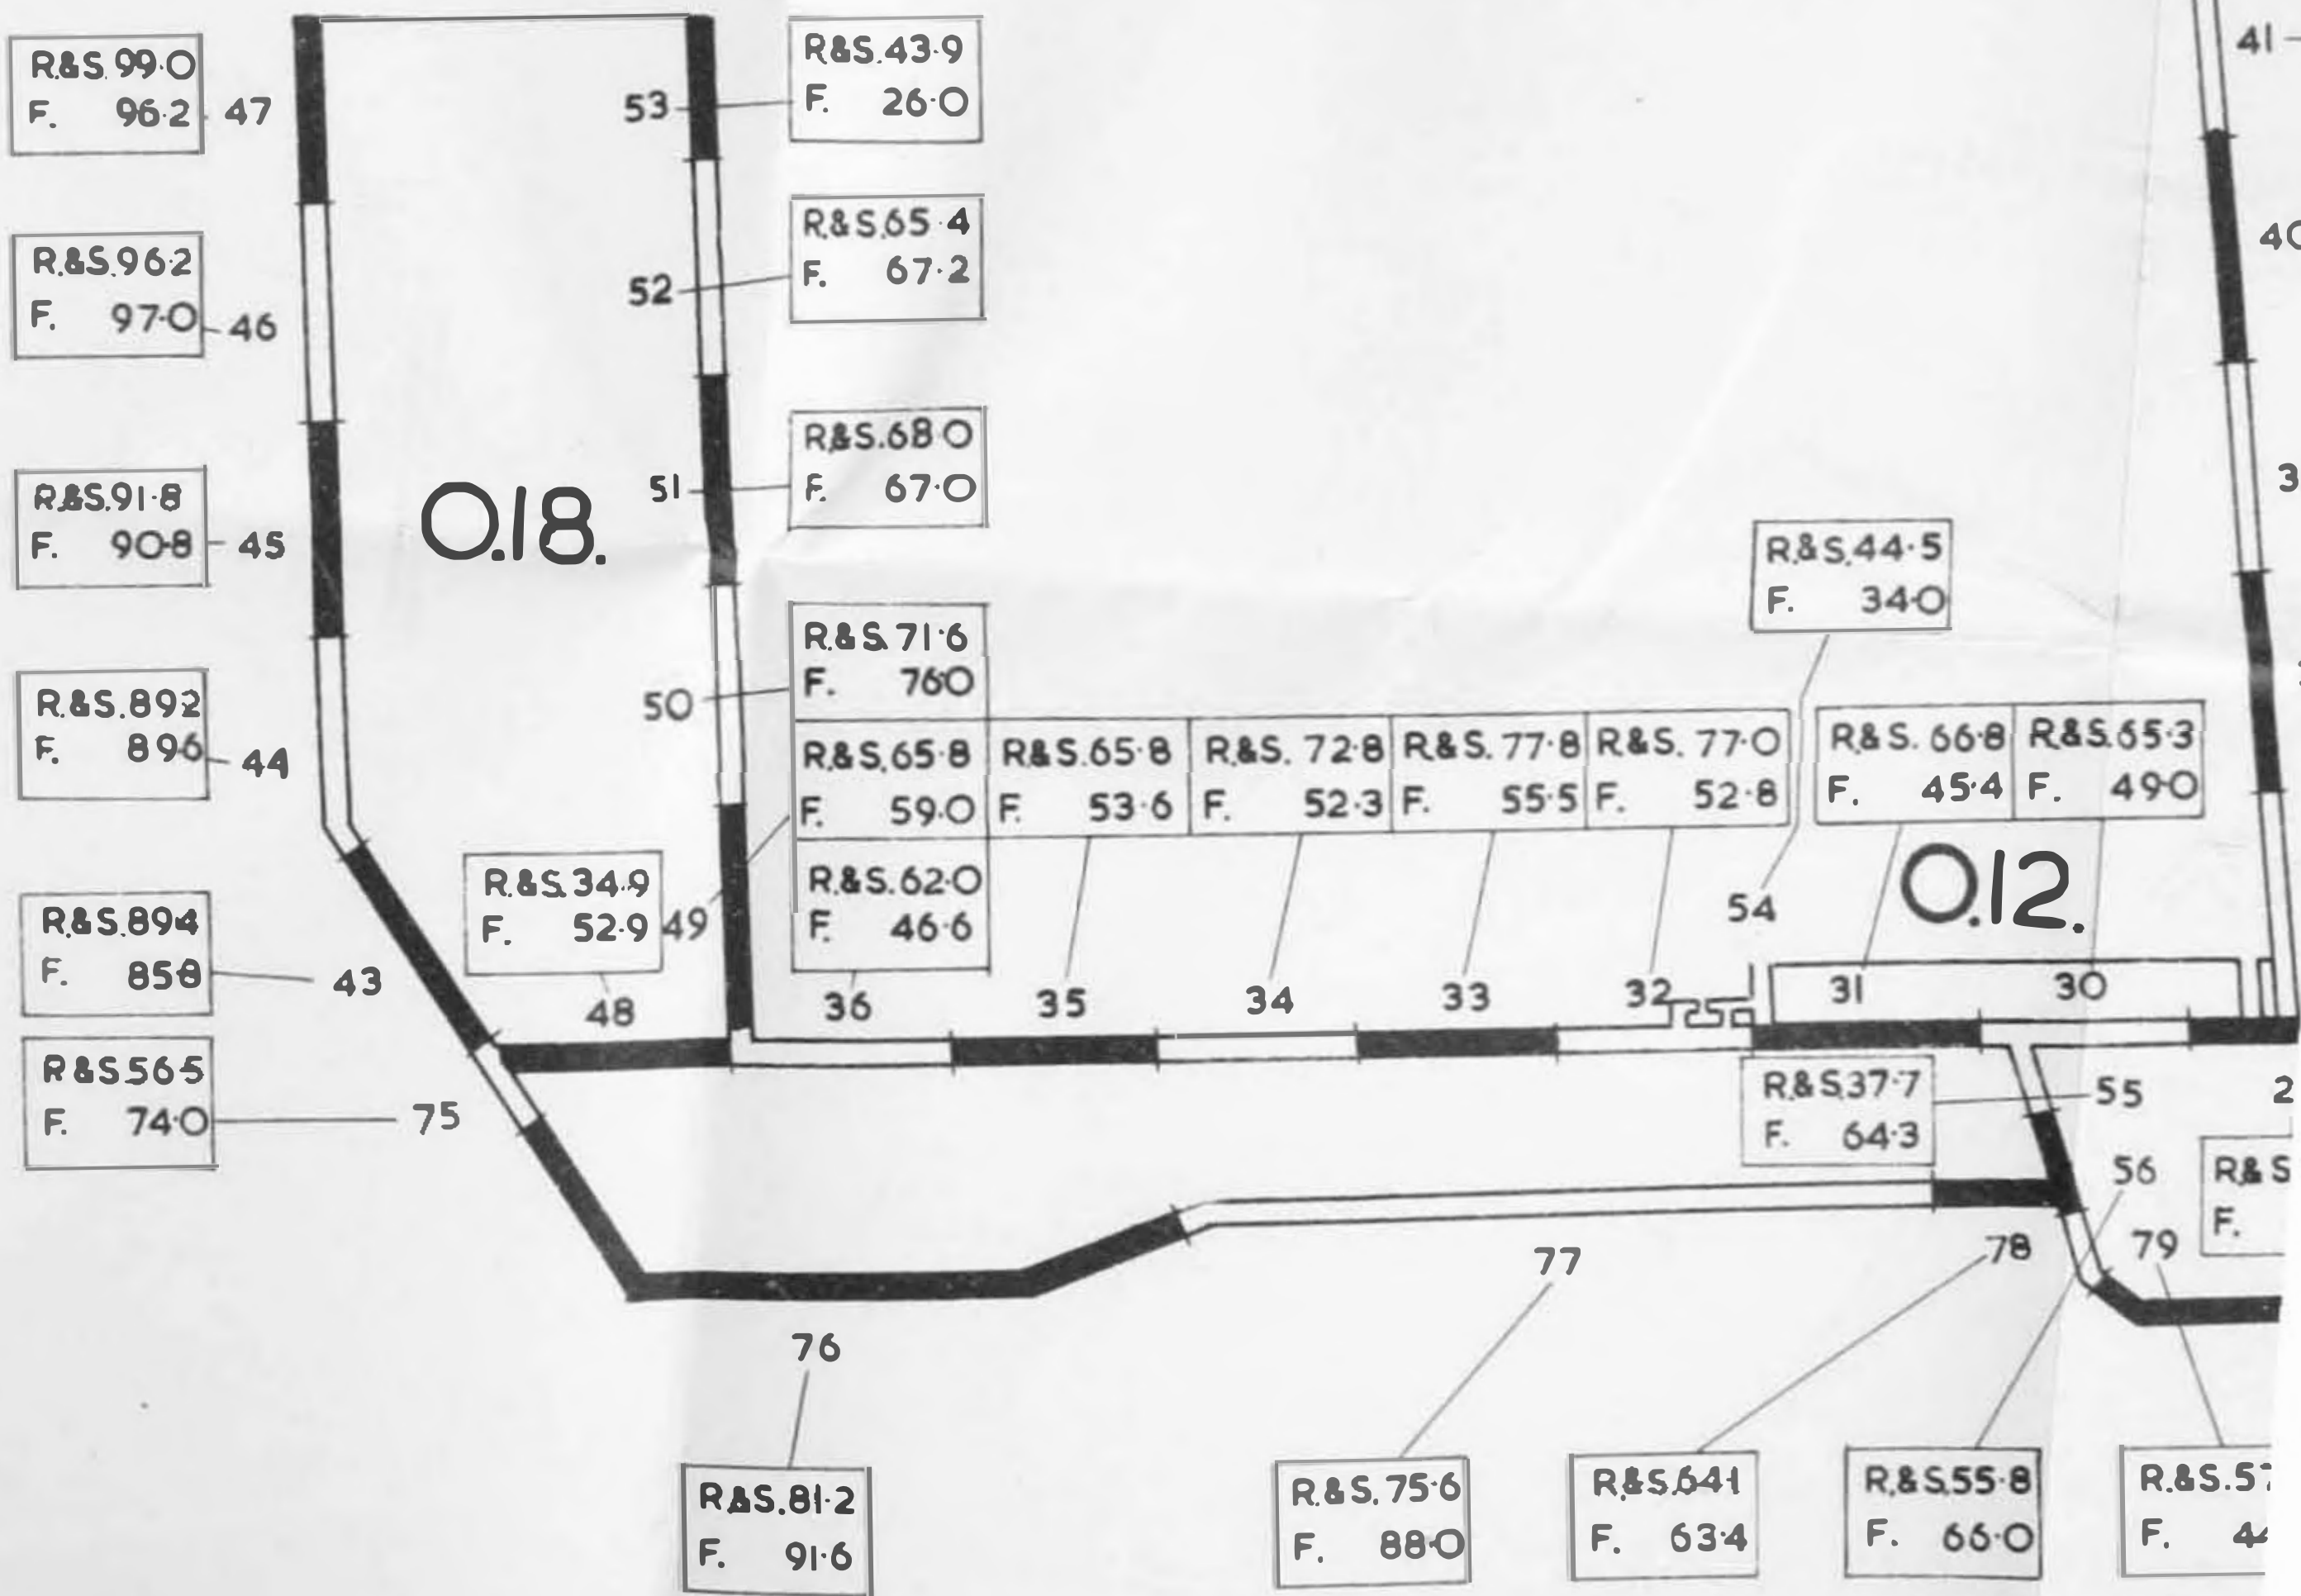
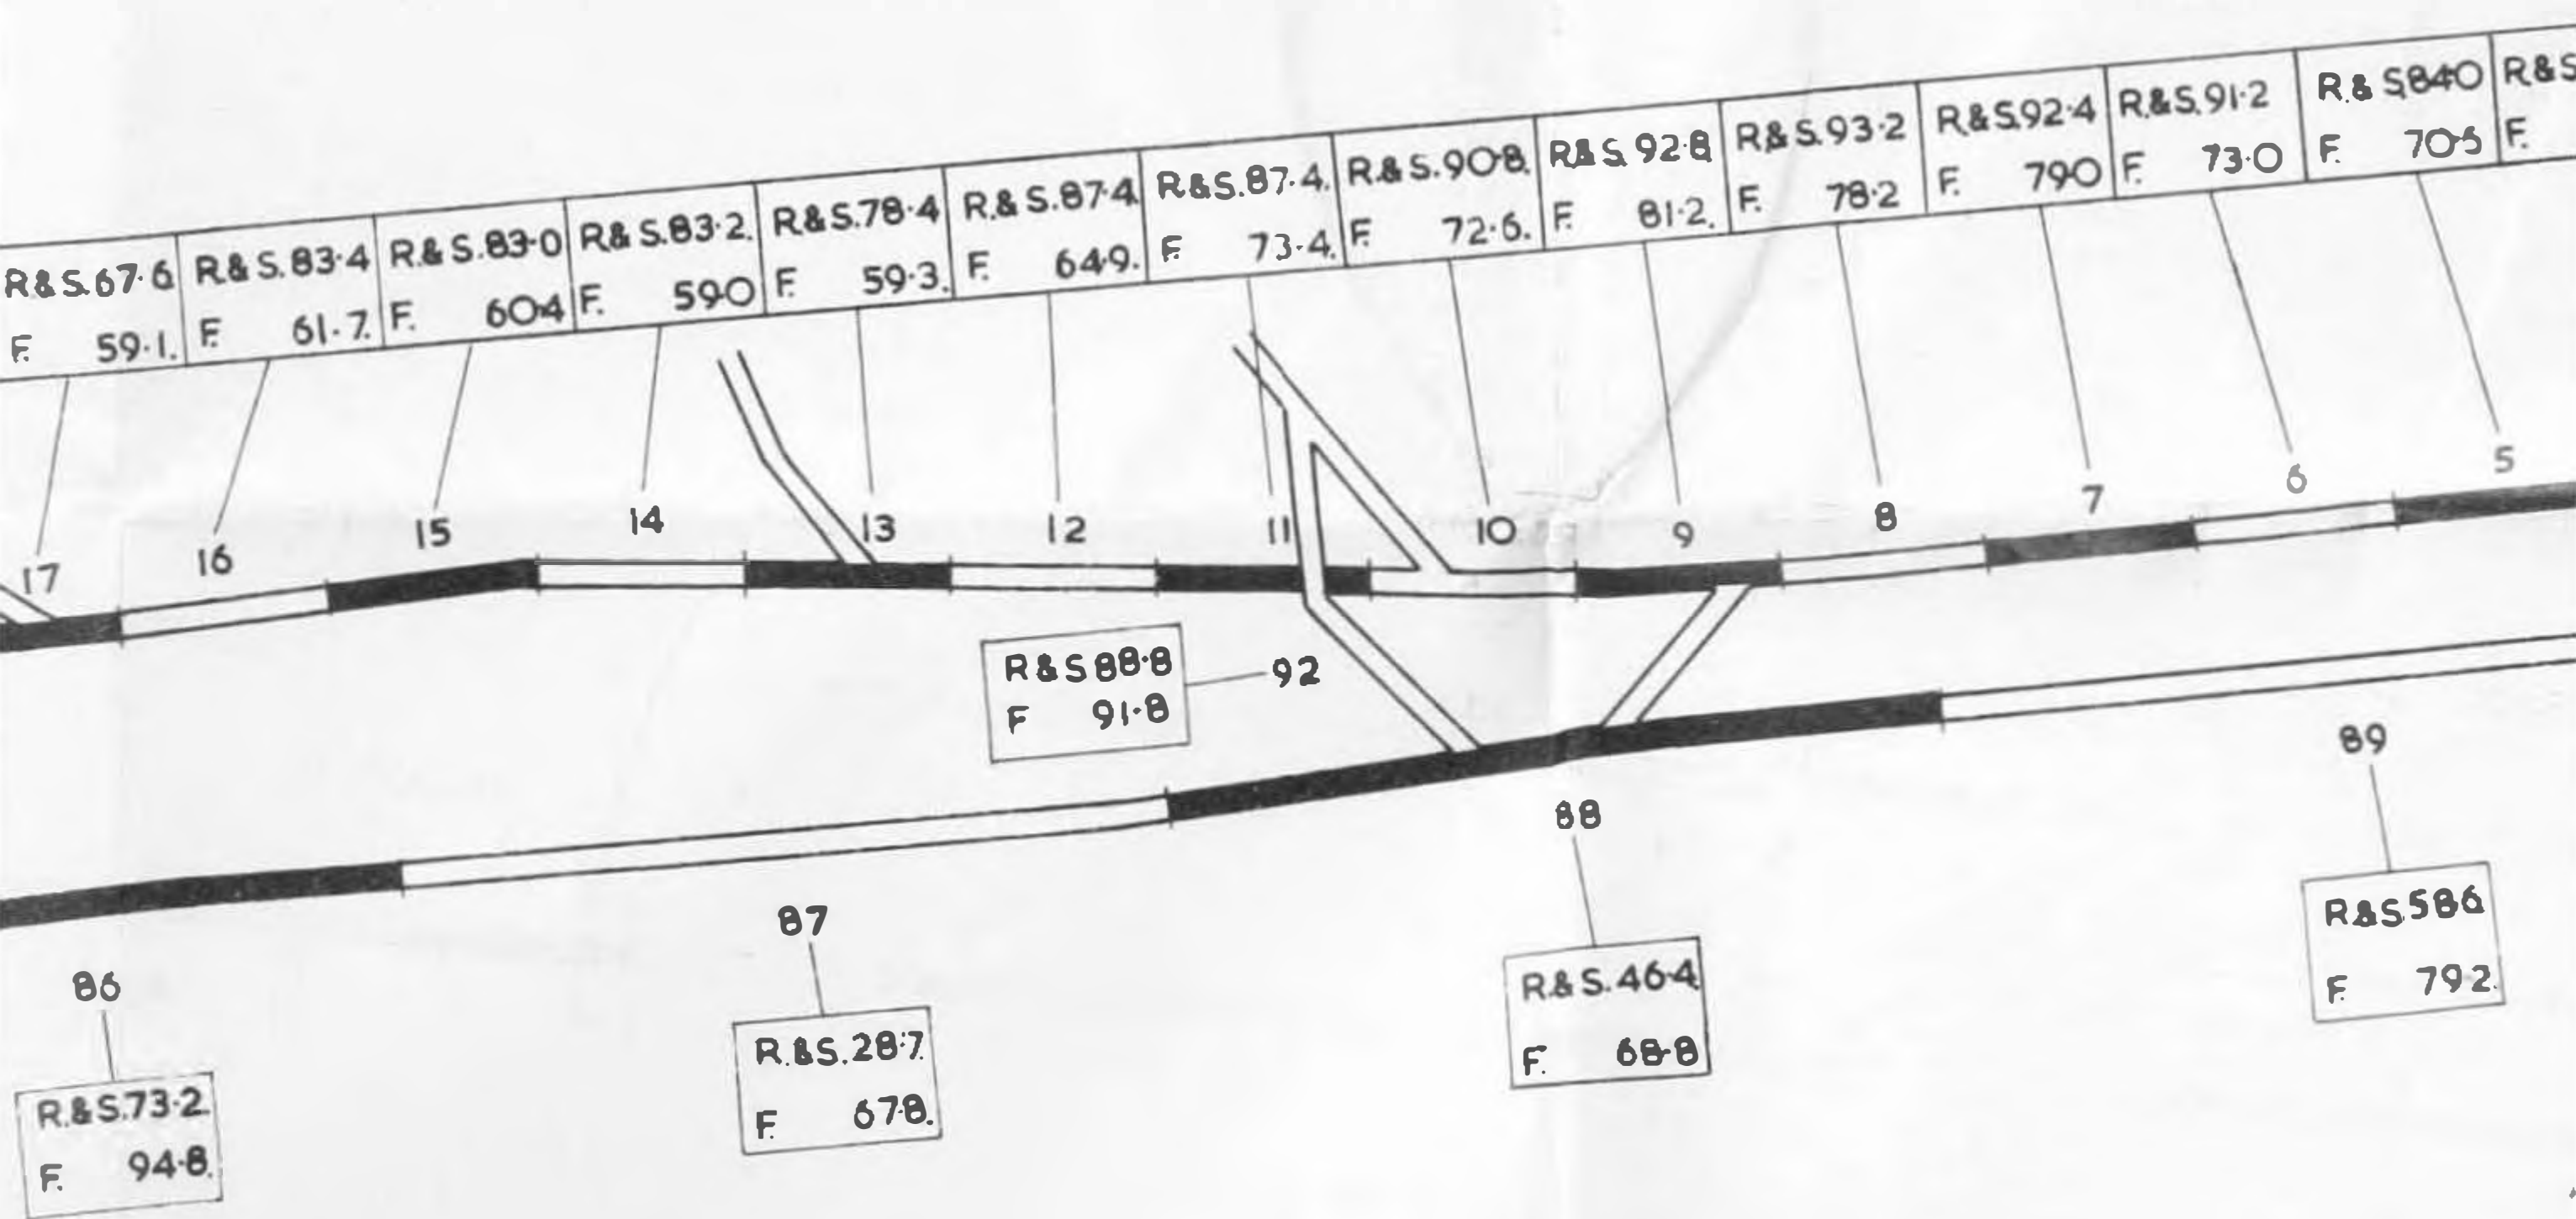
# PLAN No. 4

46. Forty-four samples were collected on 21st June, one week before the explosion, and 41 of these were found to contain over 80 per cent. of incombustible matter. The other three, all taken in the vicinity of the main loading point, contained, respectively, 57, 70 and 75.6 per cent. of incombustible matter. The volatile matter of the coal worked was less than 25 per cent. so that the management could, had they notified H.M. Inspectorate to that effect, have established 60 as the minimum percentage of incombustible matter required to be maintained. They had not done so and thus, by regulation, a minimum percentage of 75 automatically applied.
