EXPLOSION AT SIX BELLS COLLIERY  
MONMOUTHSHIRE

# EXPLOSION AT SIX BELLS COLLIERY, MONMOUTHSHIRE

On the causes of, and circumstances  
attending, the explosion which occurred at  
Six Bells Colliery, Monmouthshire,  
on 28th June, 1960

T. A. ROGERS, C.B.E., M.I.Min.E.  
H.M. Chief Inspector of Mines and Quarries

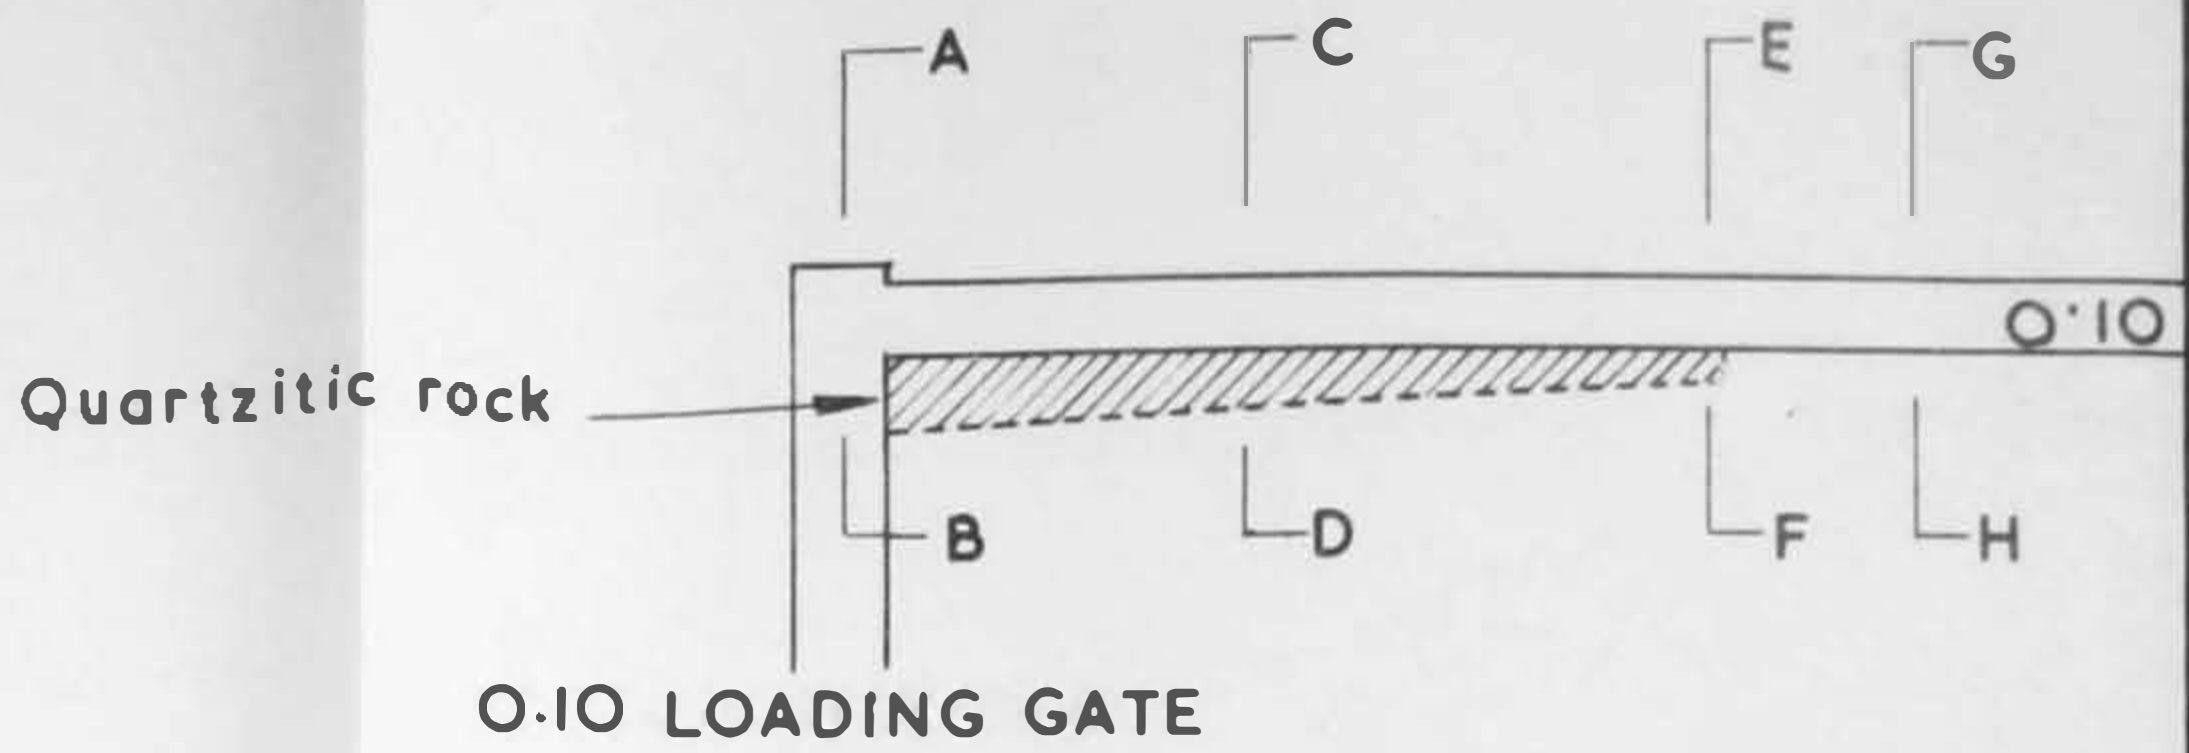
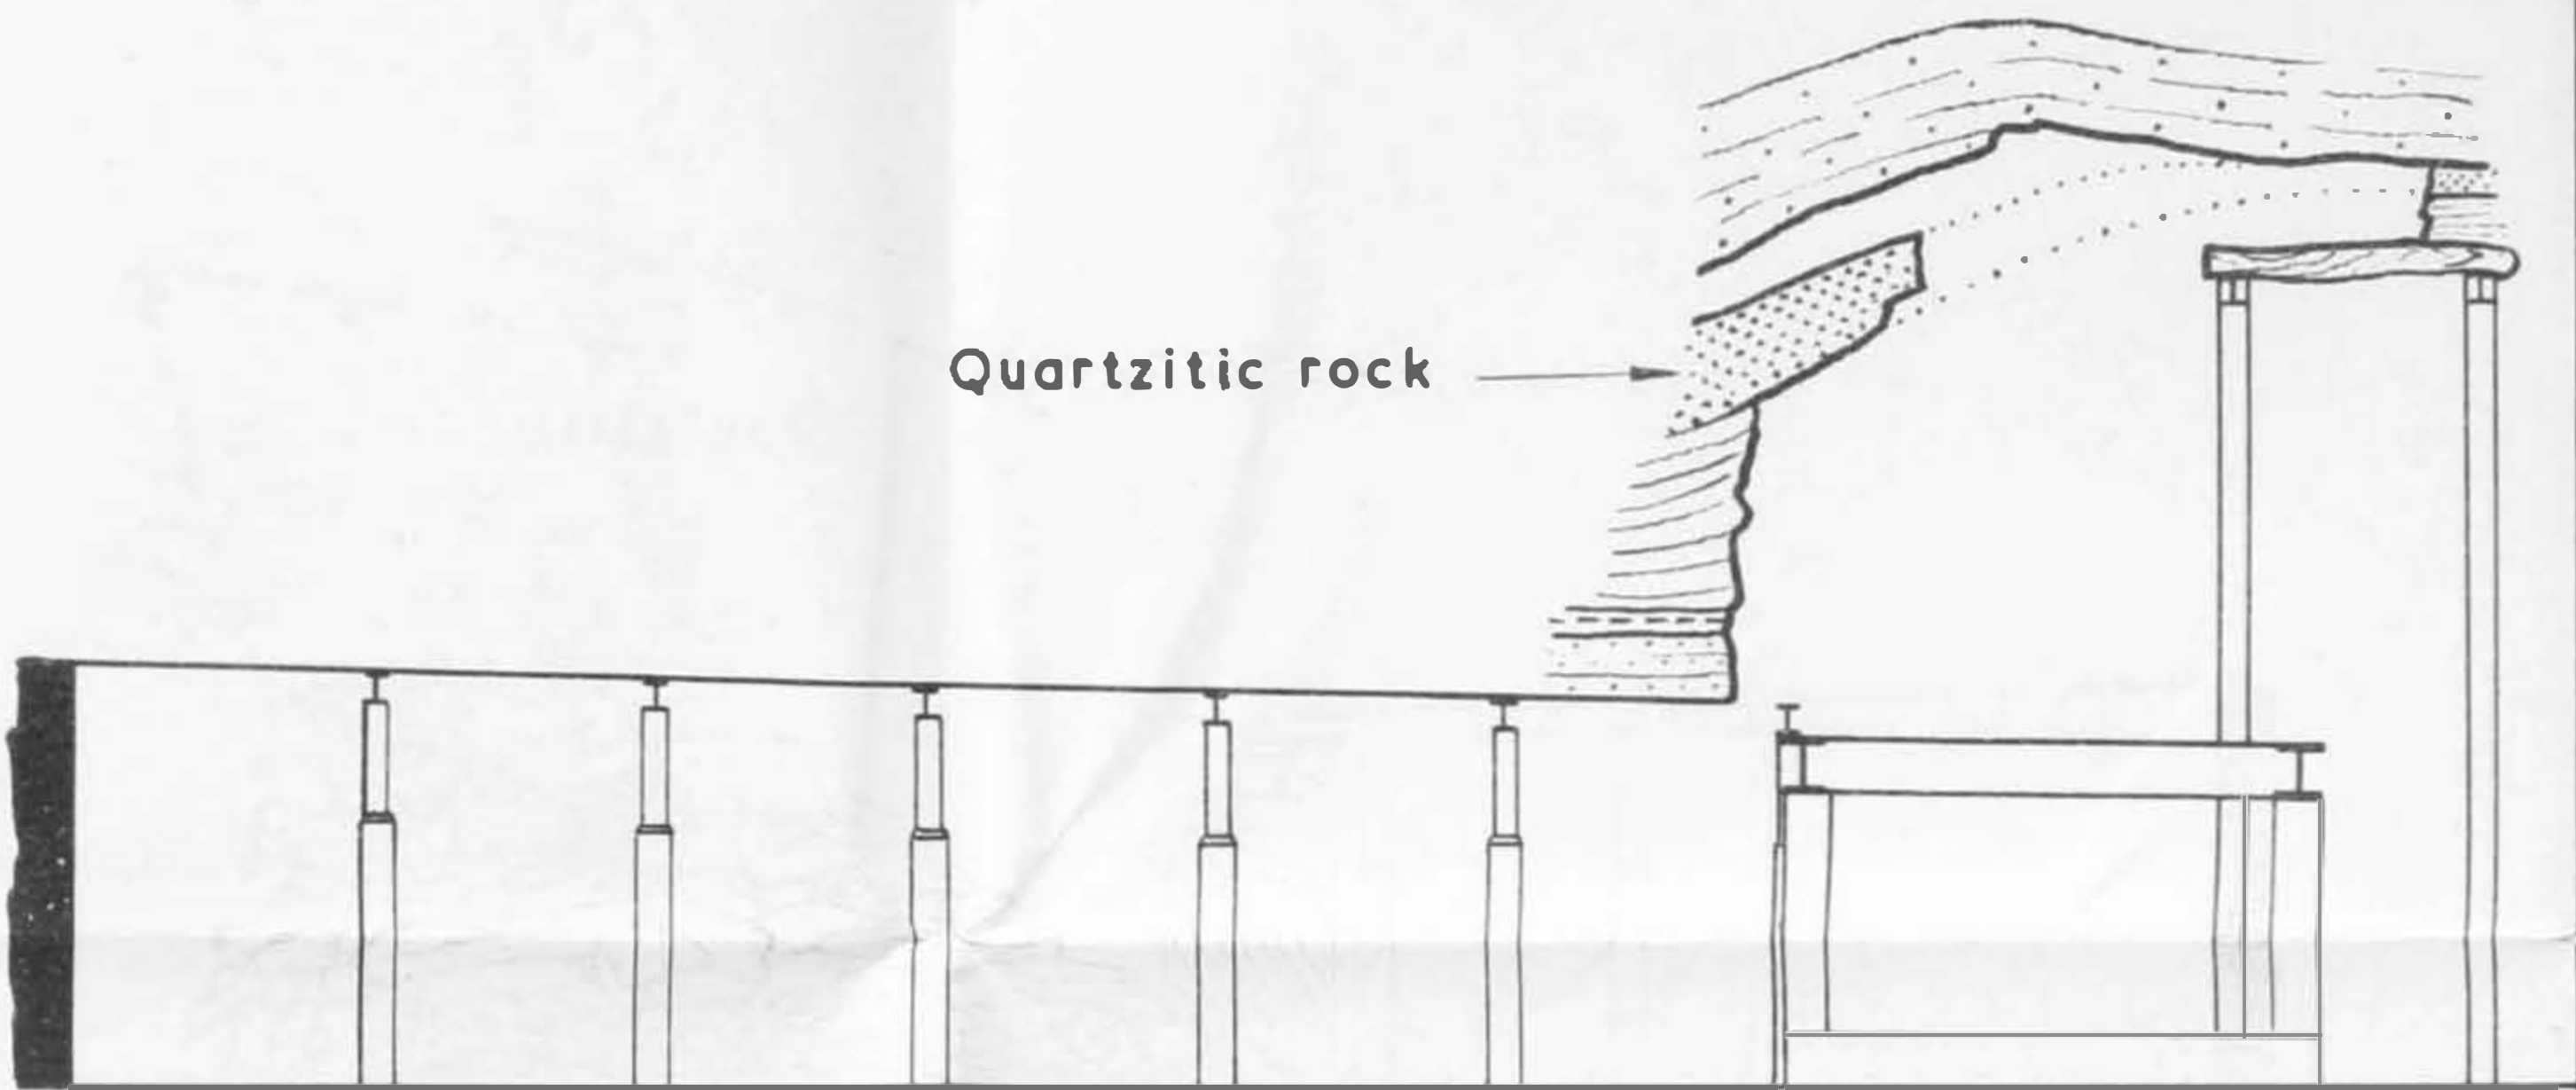
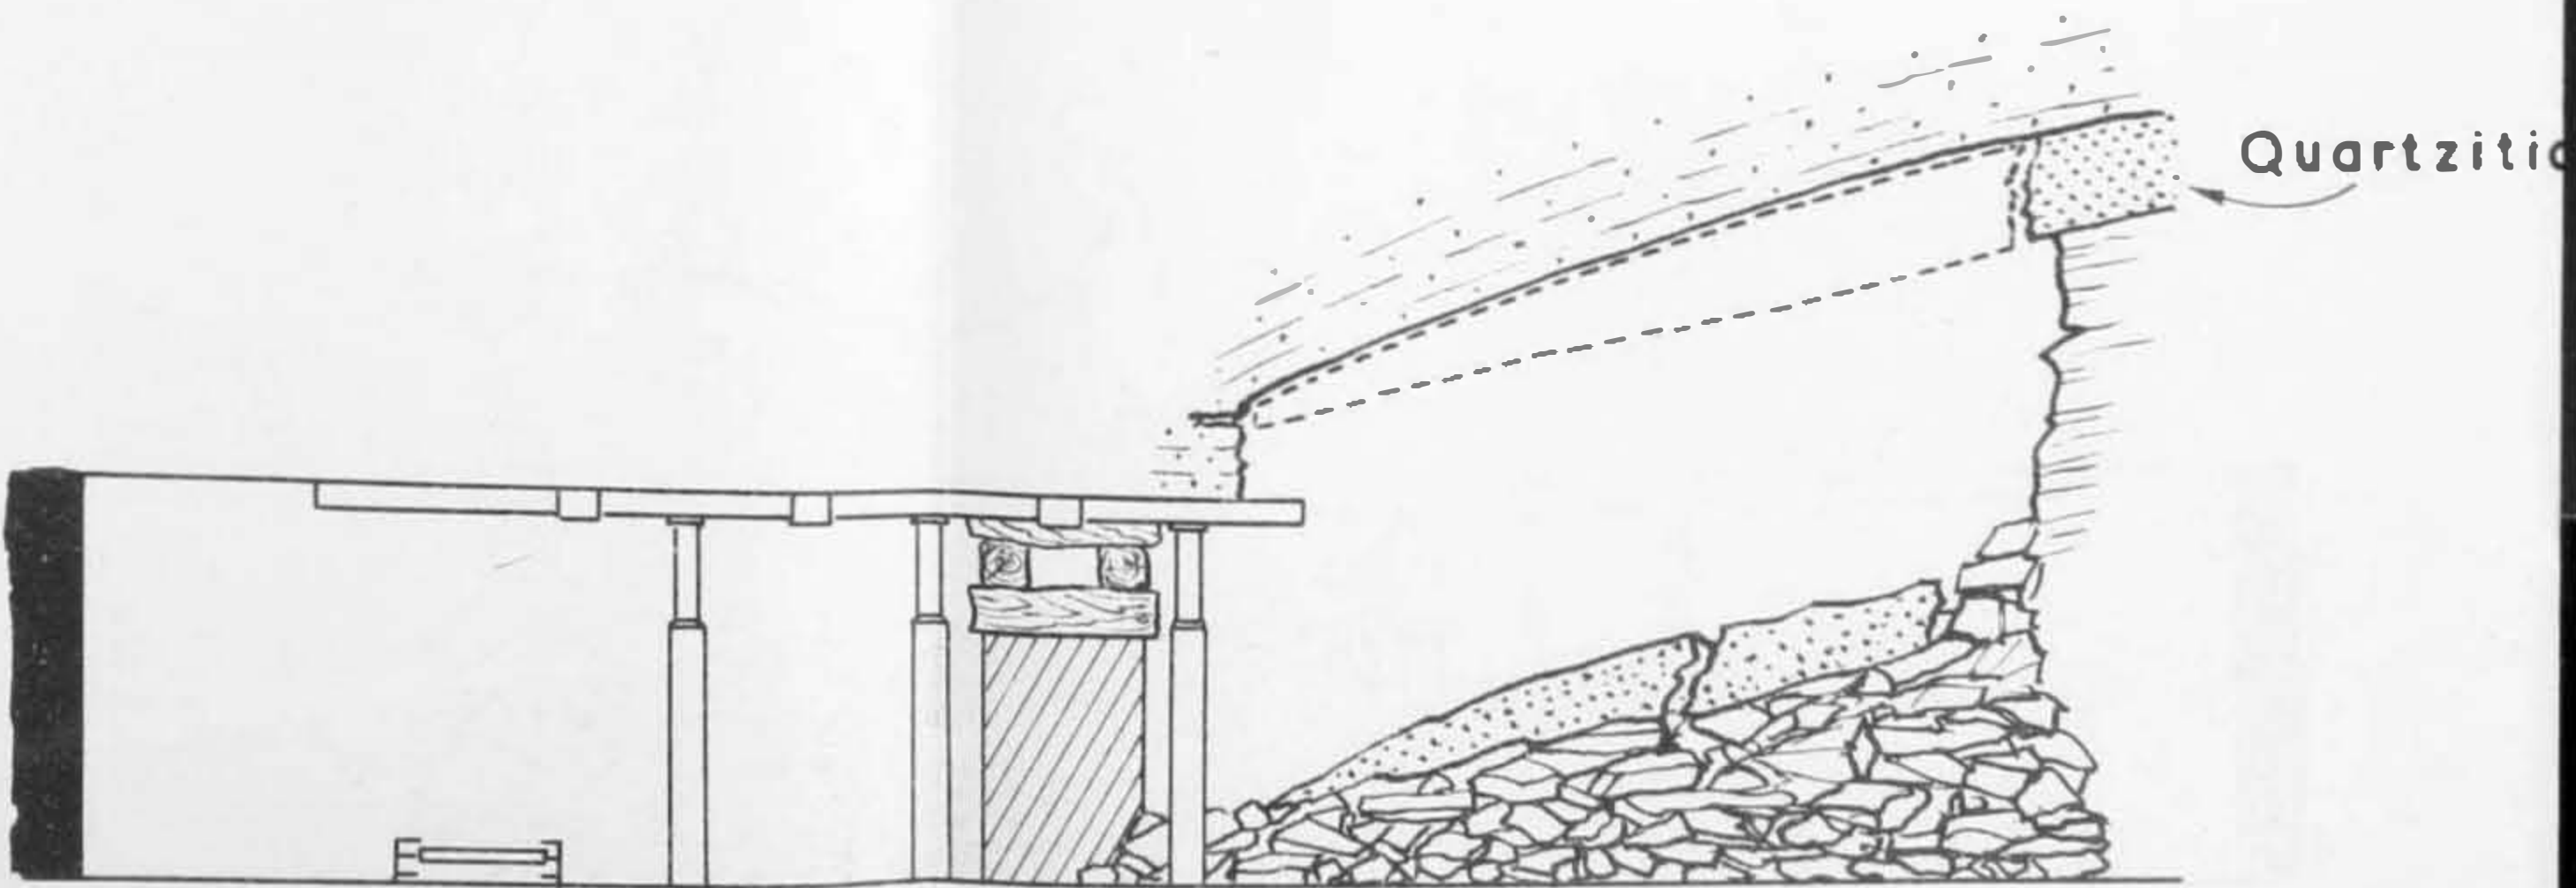
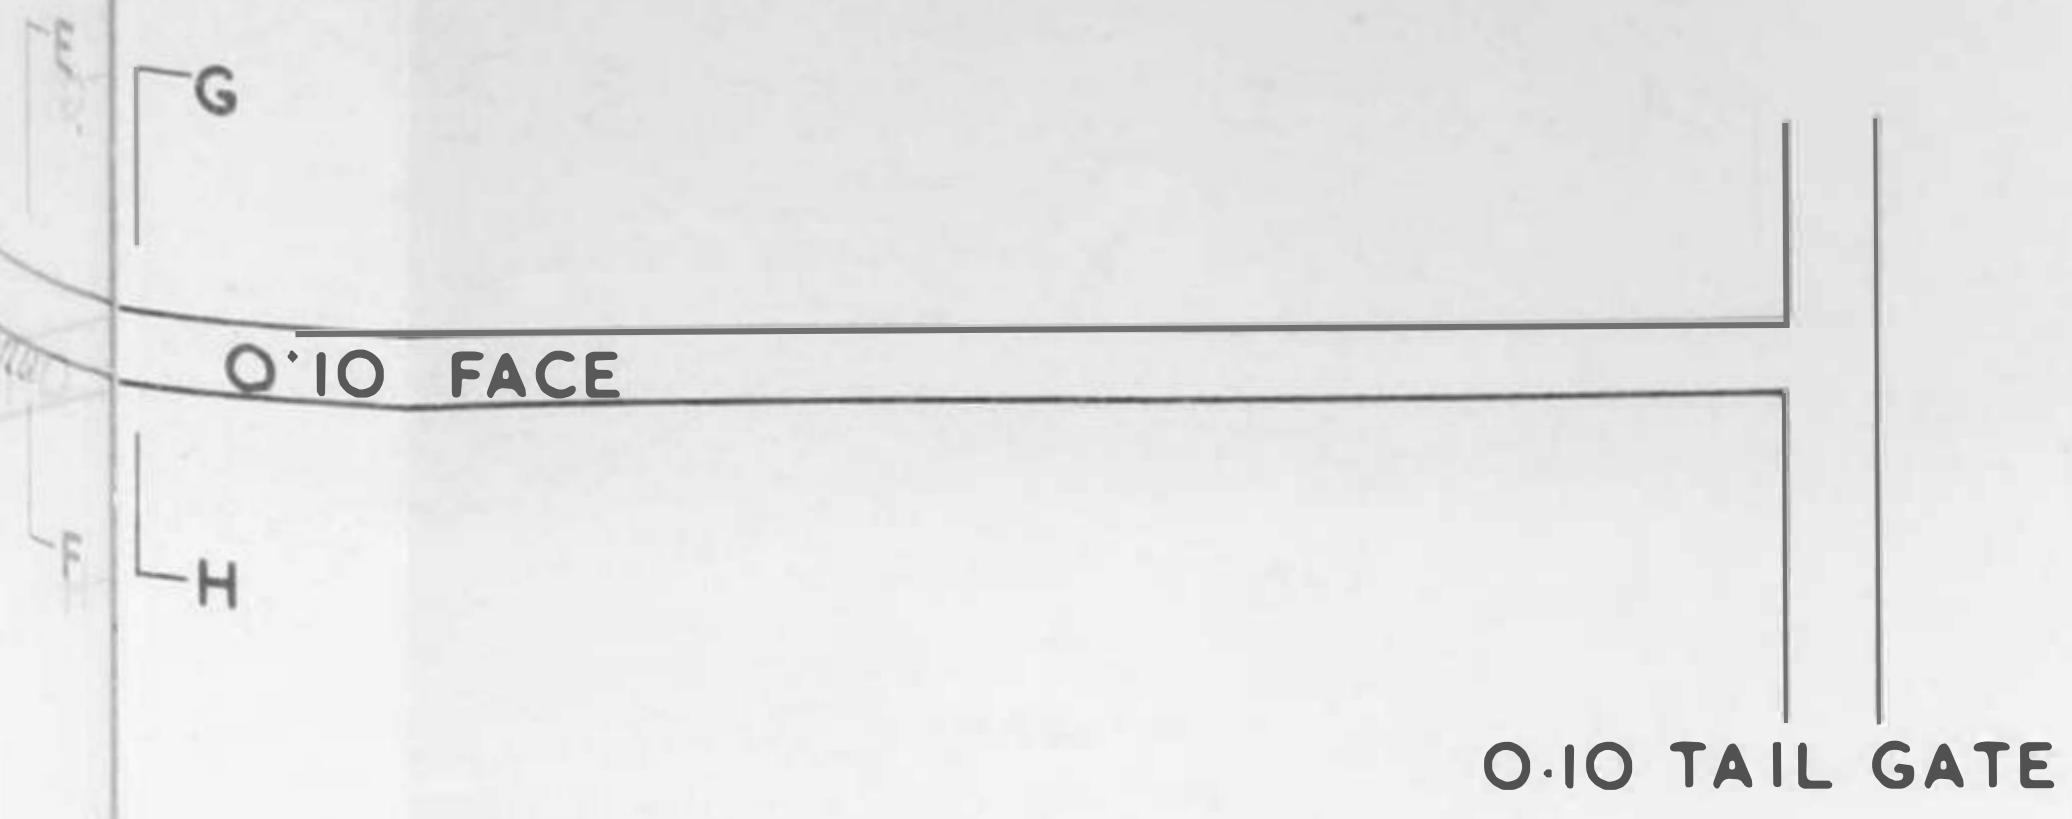
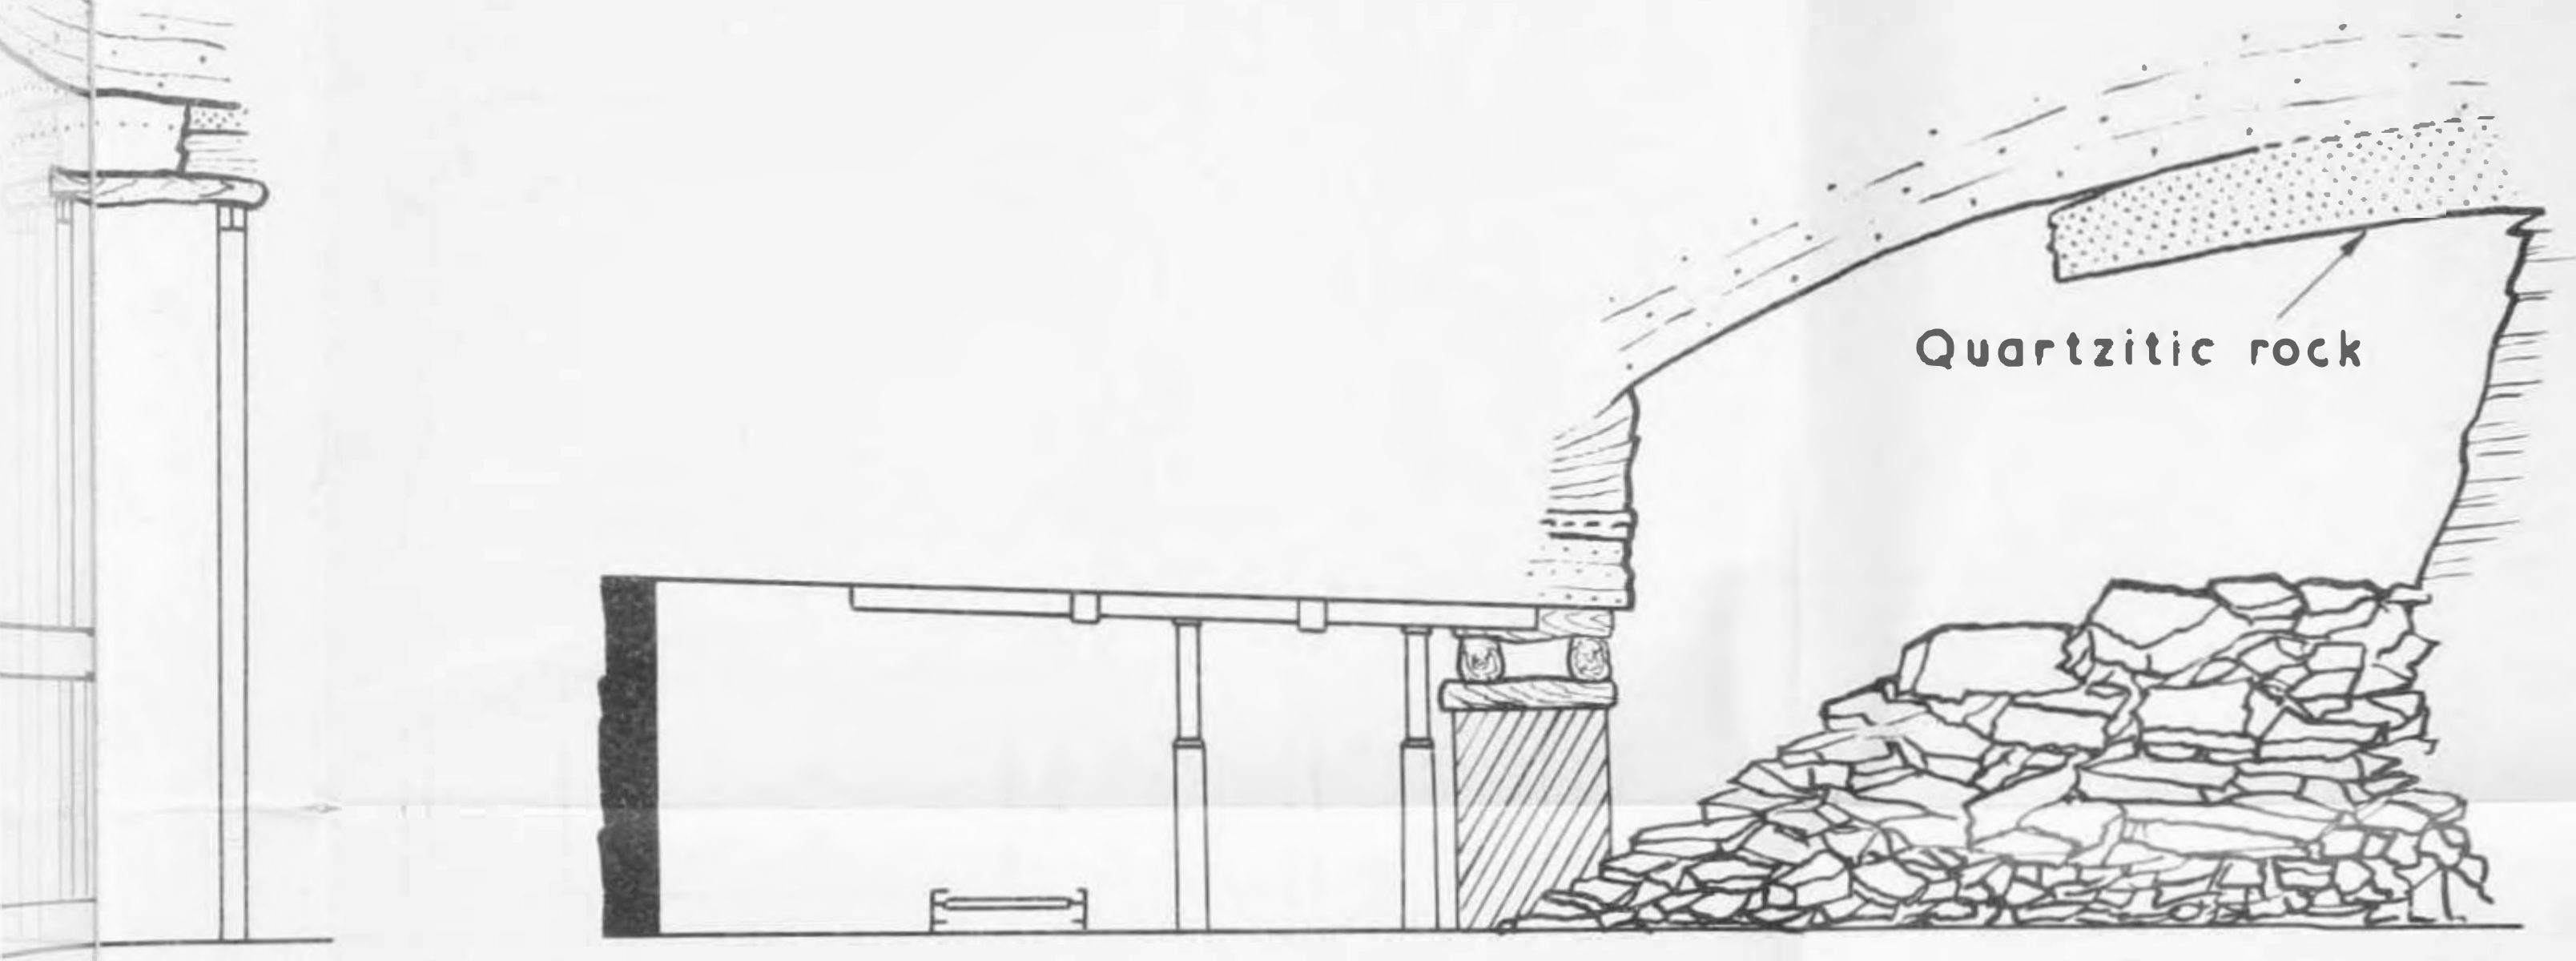
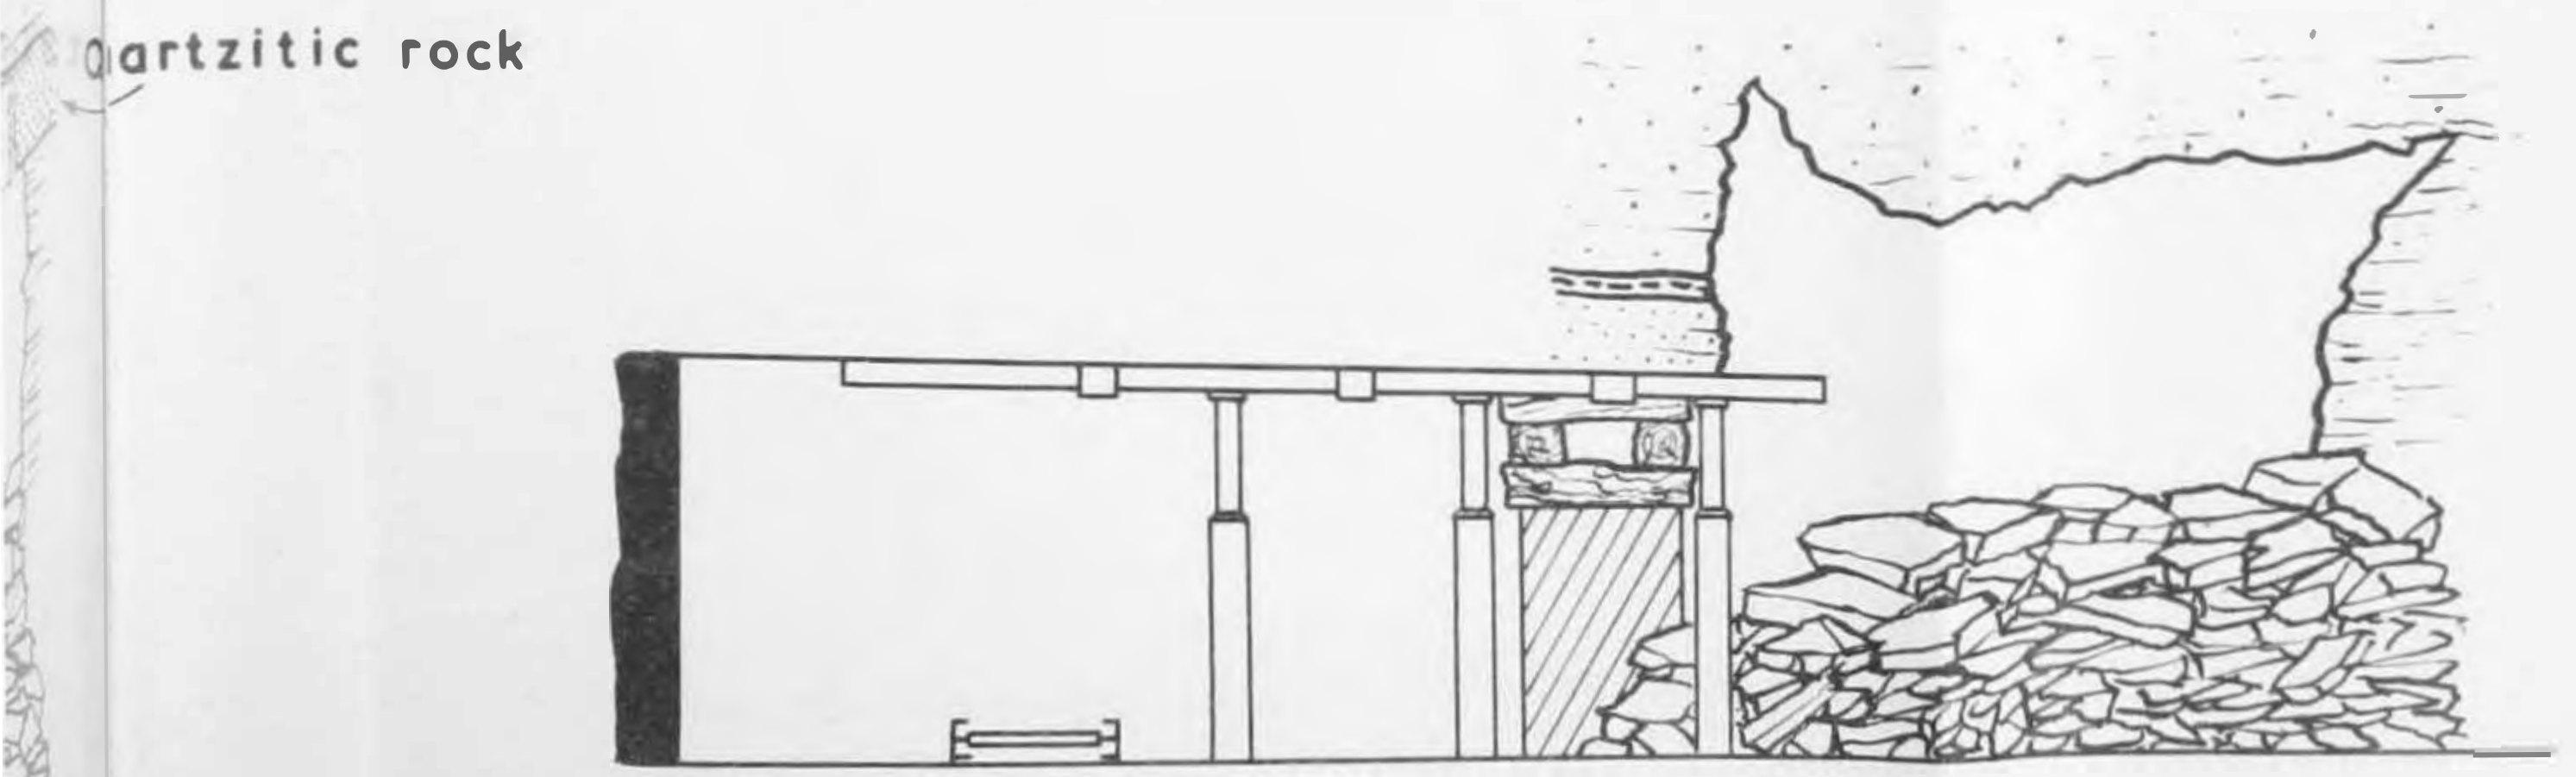
CROSS SECTIONS SHOWING EXPOSURE AND EXTENT

19. The only major difficulty encountered in the working of O.10 unit arose from a large roof cavity which developed in the intake near two parallel faults some 170 yards from the main intake. The cavity apparently began at the roadhead and extended as the face advanced until it was at least 30 feet long and some 20 to 30 feet high from the roof of the seam, and certainly as high as the 'rider' coal. The arches set beneath the cavity were originally covered with lagging timber and some debris. This condition might have been altered by subsequent repair work, but it seems more than probable that by the time the explosion occurred there was a considerable thickness of fallen stone above the lagging. Firedamp apparently face ripping until, but not after, 9th May, 1960 ; at the time of the explosion it was not considered necessary to maintain a brattice sheet at the face ripping. Small quantities of firedamp continued to be found quite frequently elsewhere in the unit.

89. In roof conditions which predispose cavity formation at roadheads, the original excavation may be made smaller, and thus easier to control, by the adoption of the pilot method of roadway formation. In this method, which is not uncommon in South Wales, a small roadway is taken near the face and a larger one made a short distance outbye. Alternatively, where the floor is not liable to excessive heave, unduly thick roof rippings may be avoided by floor ripping or by a combination of roof and floor ripping, as was adopted in O.18 intake. The development of mechanical, perhaps pneumatic, means of conveying stone from the excavation to the pack spaces in either of these systems would be very helpful; much more difficult problems in mining engineering have been successfully overcome. The desirability or otherwise of adopting either of these alternatives would fall to be determined in the light of all the circumstances.
