EXPLOSION AT SIX BELLS COLLIERY  
MONMOUTHSHIRE

# EXPLOSION AT SIX BELLS COLLIERY, MONMOUTHSHIRE

On the causes of, and circumstances  
attending, the explosion which occurred at  
Six Bells Colliery, Monmouthshire,  
on 28th June, 1960

T. A. ROGERS, C.B.E., M.I.Min.E.  
H.M. Chief Inspector of Mines and Quarries

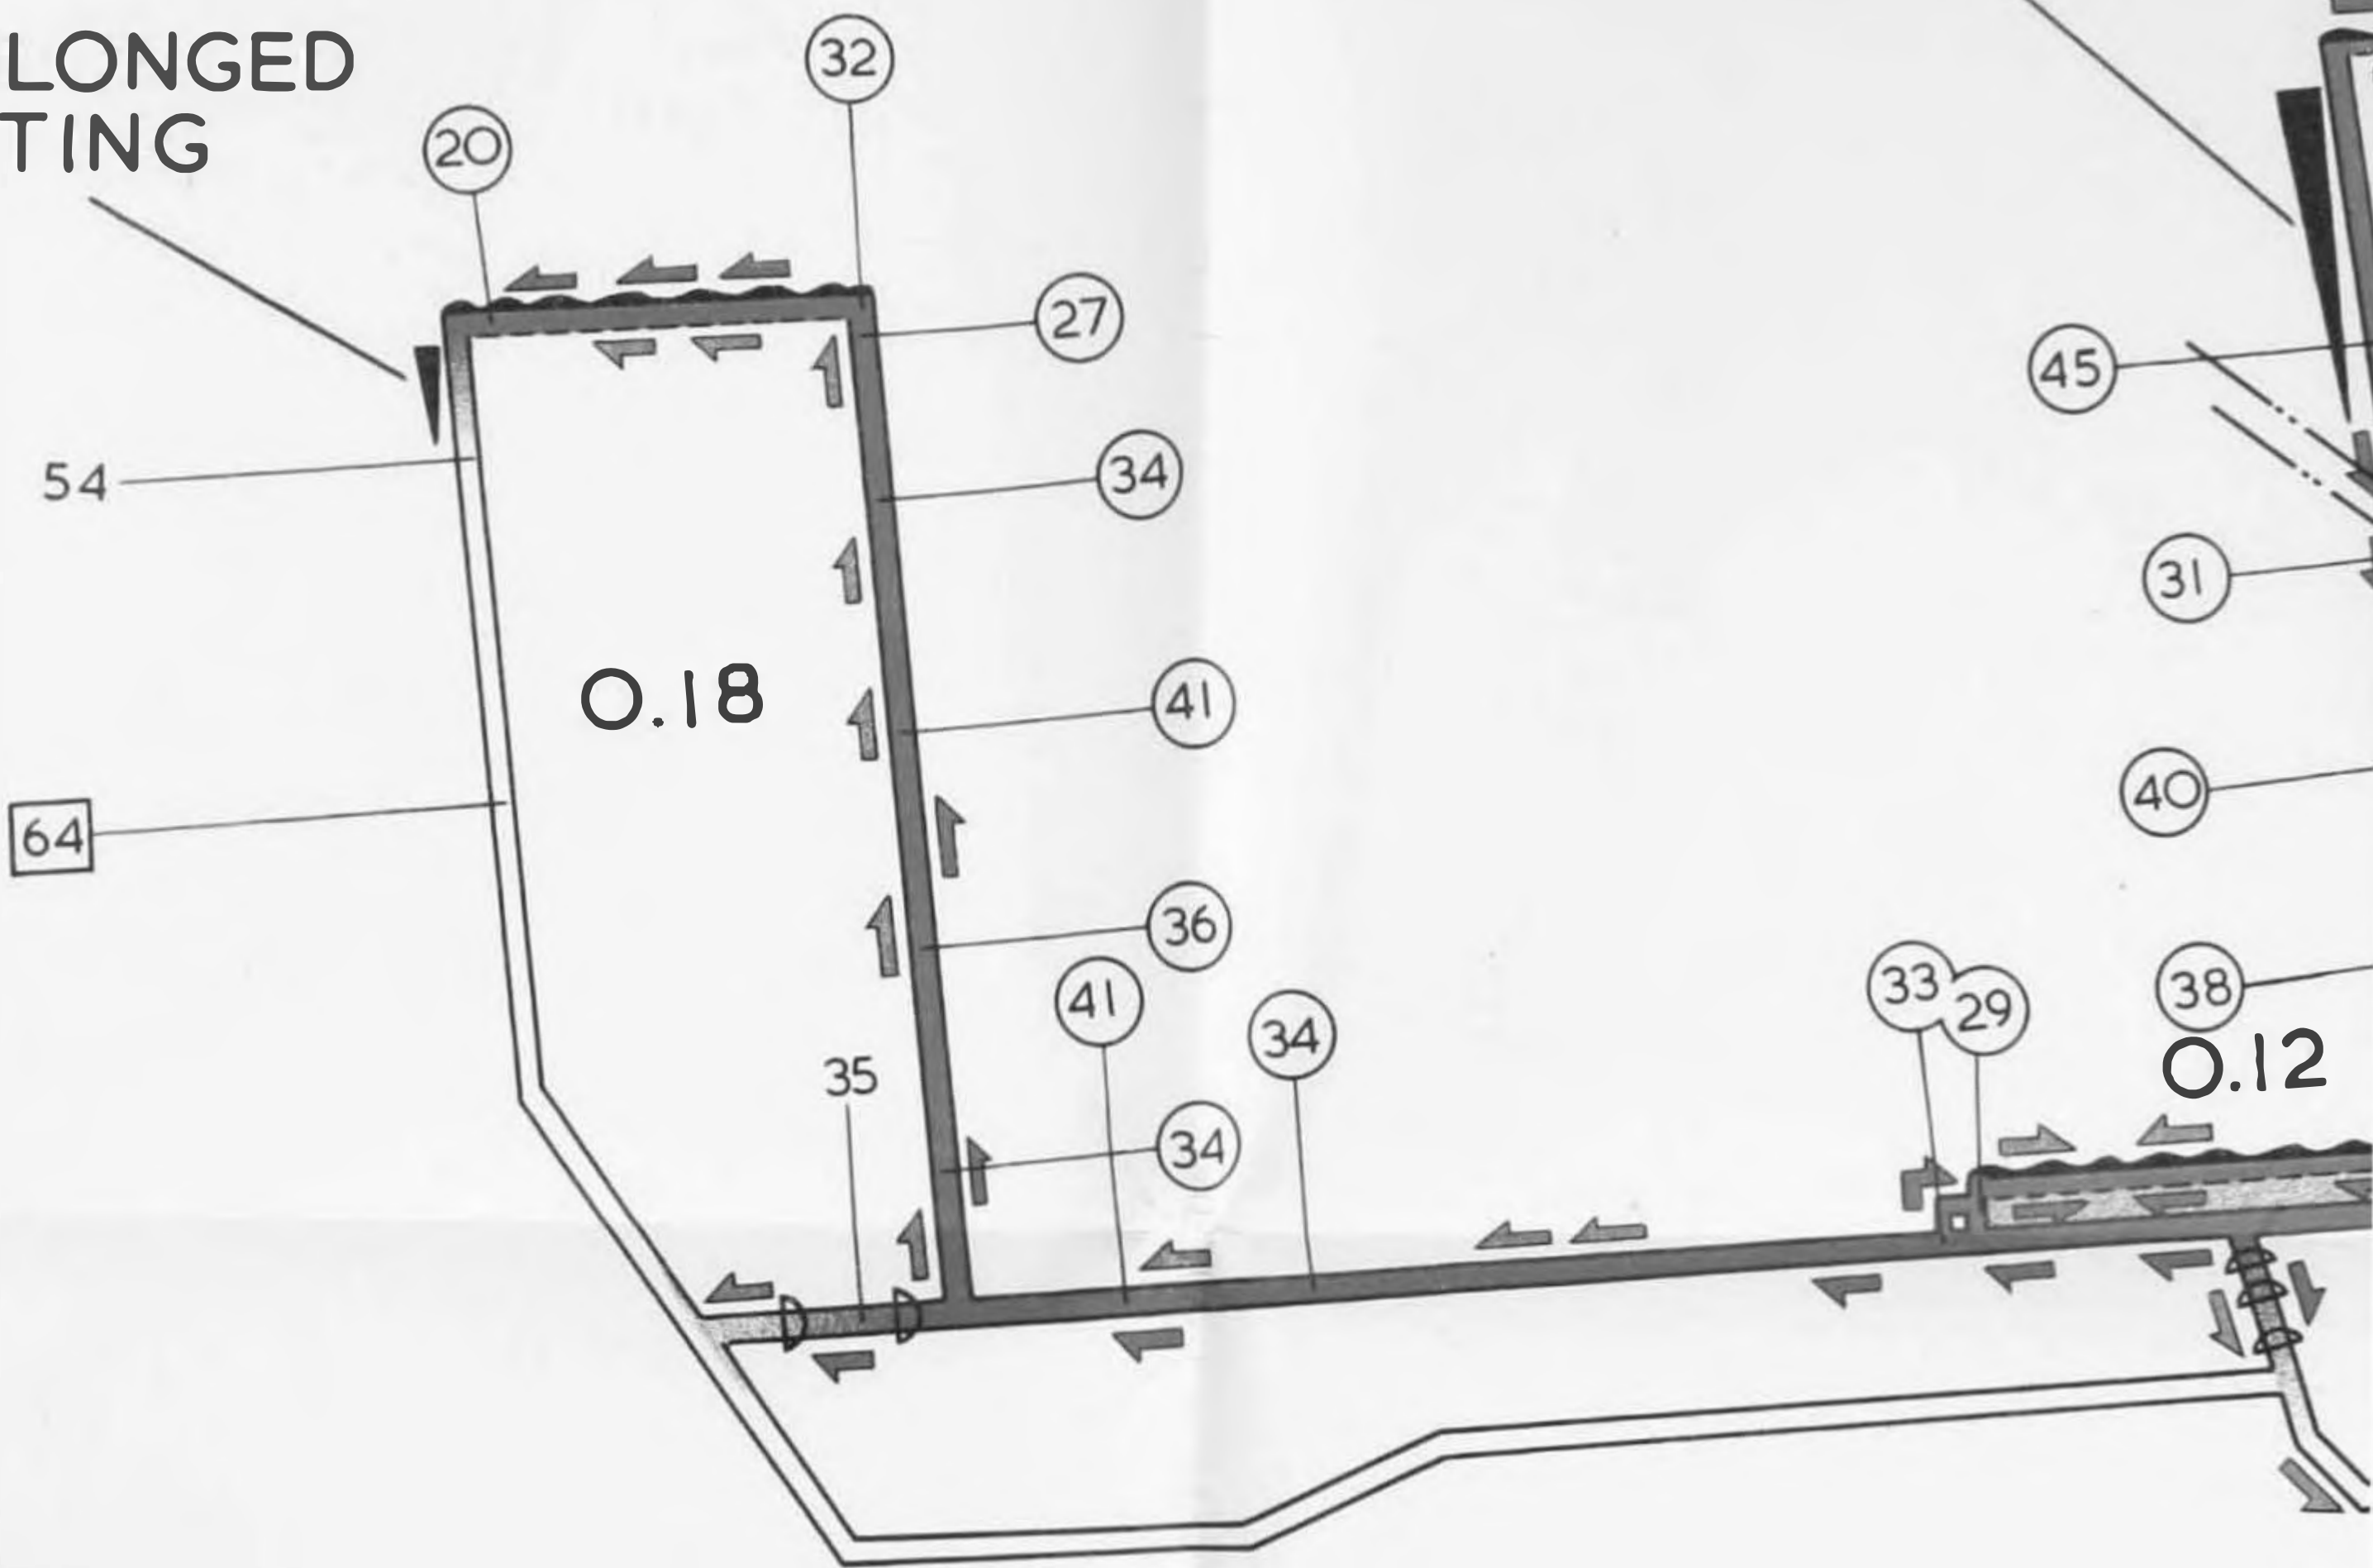
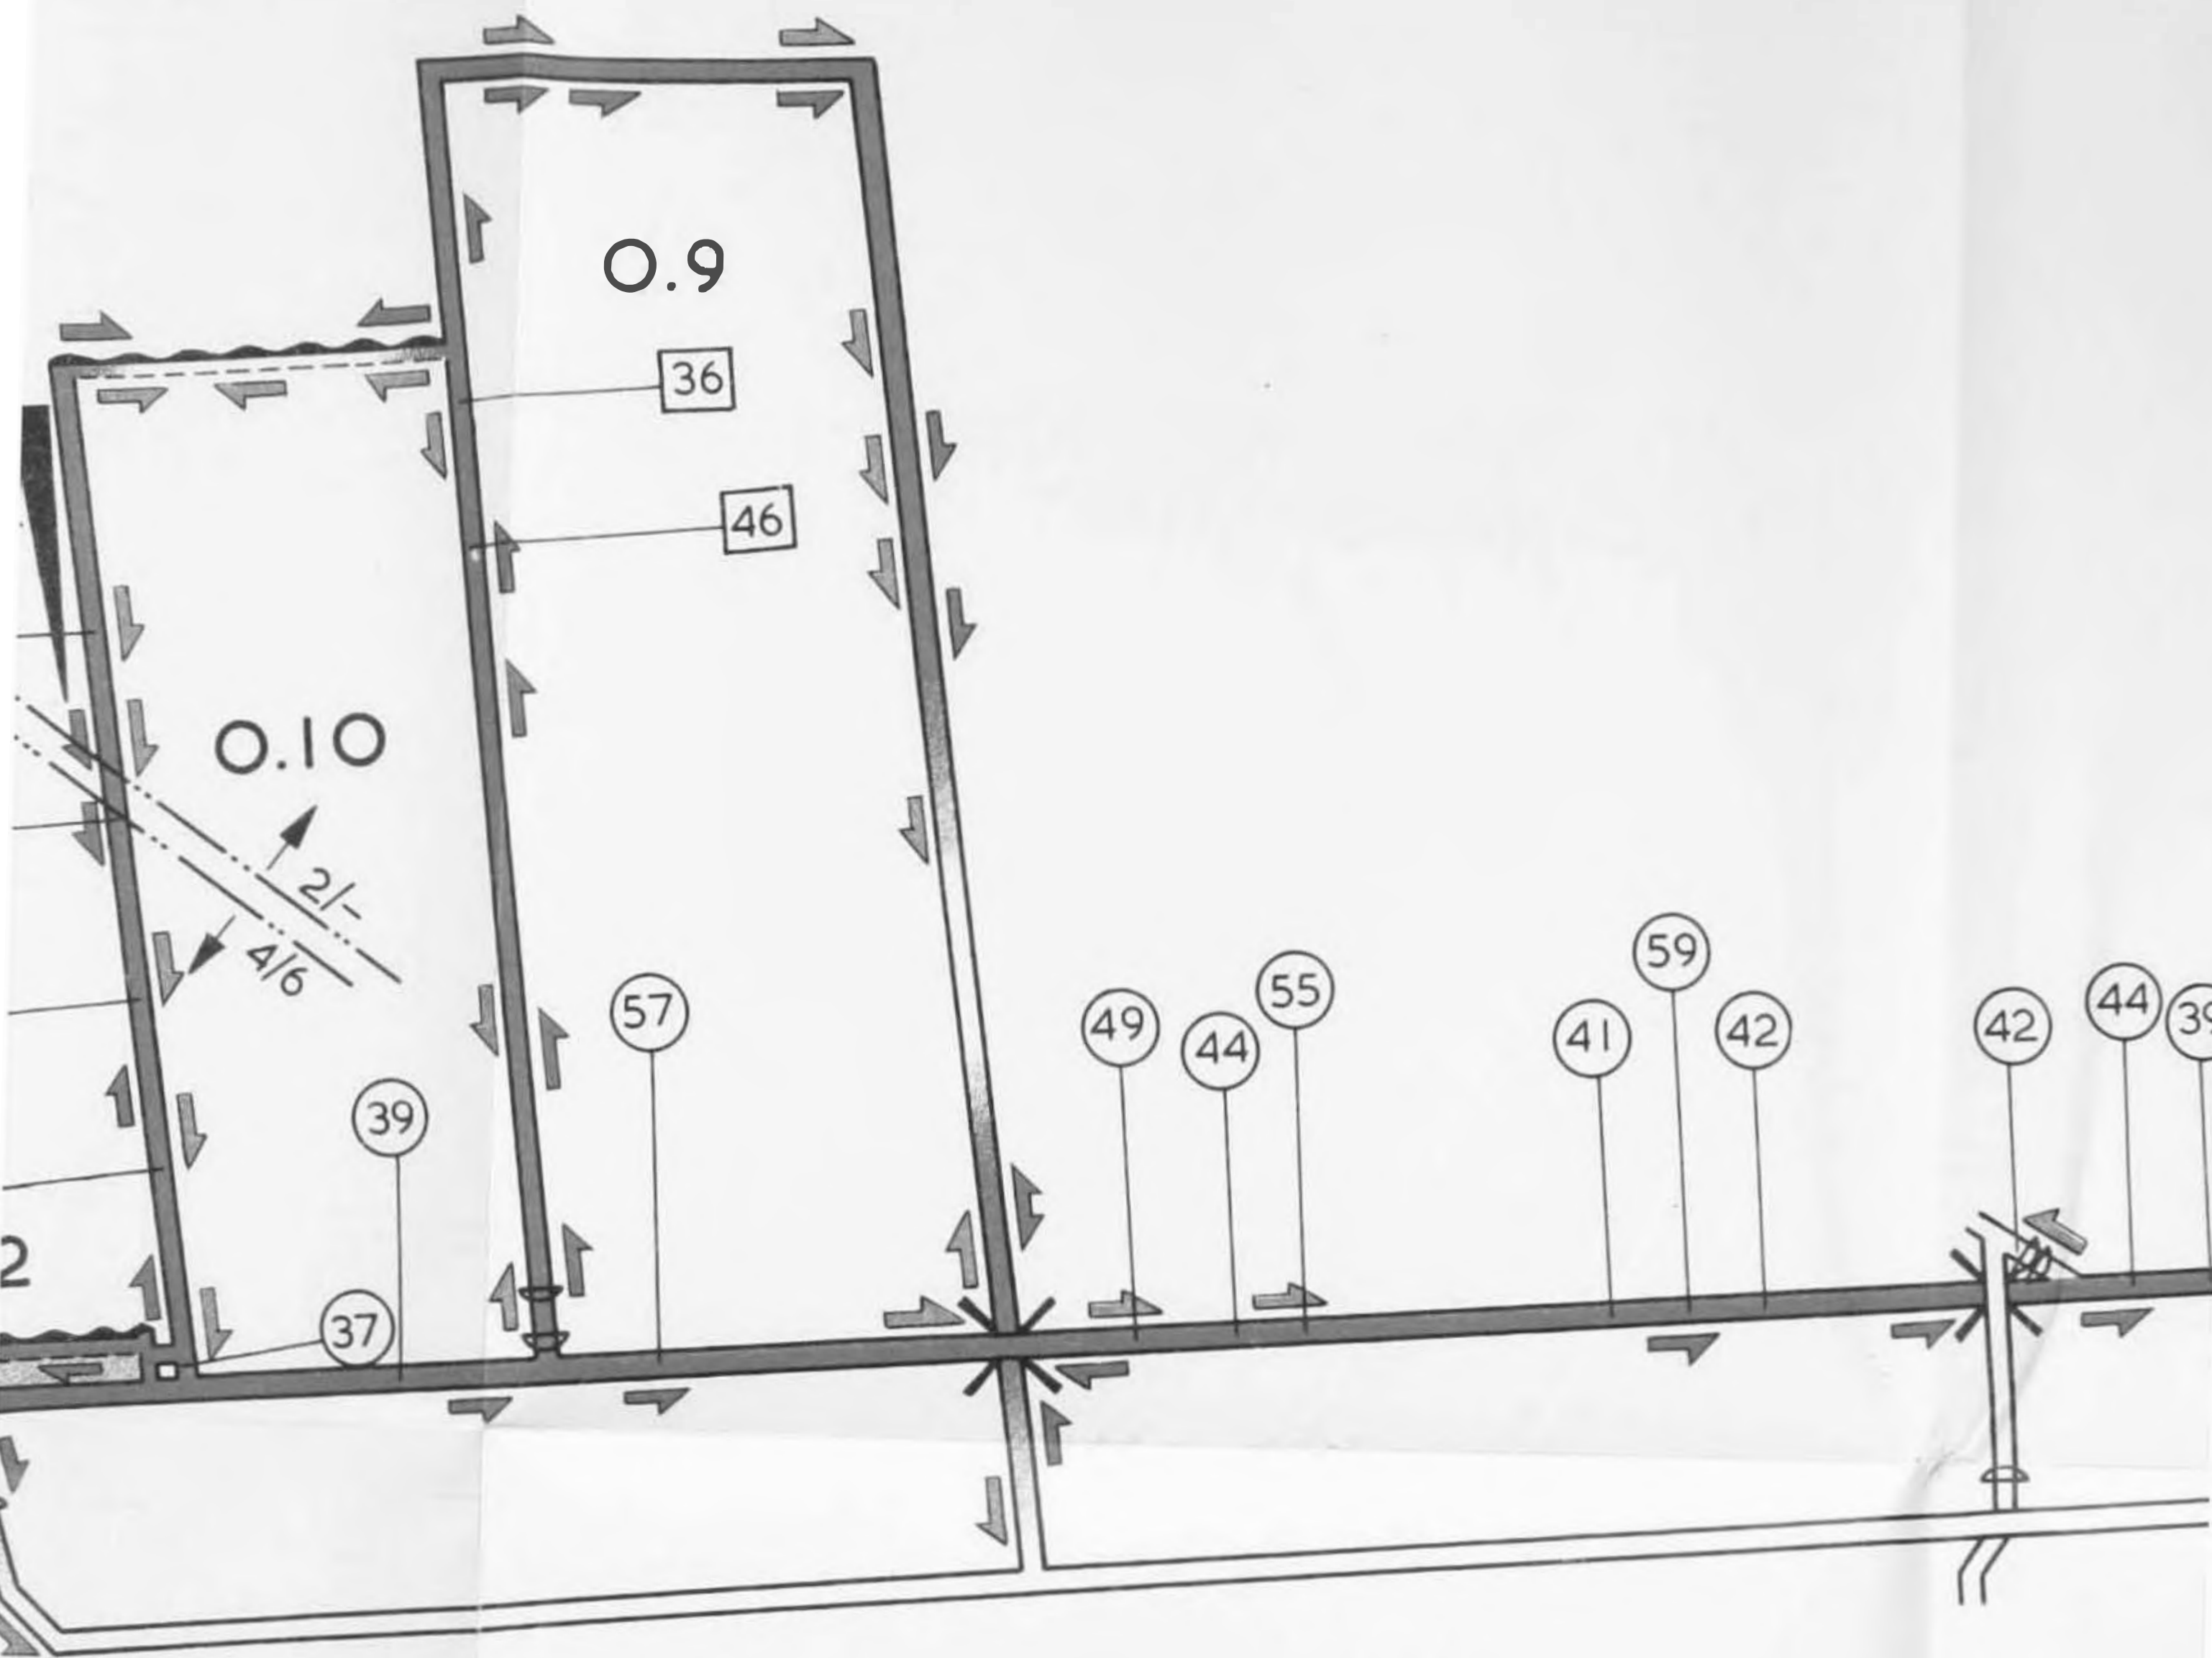
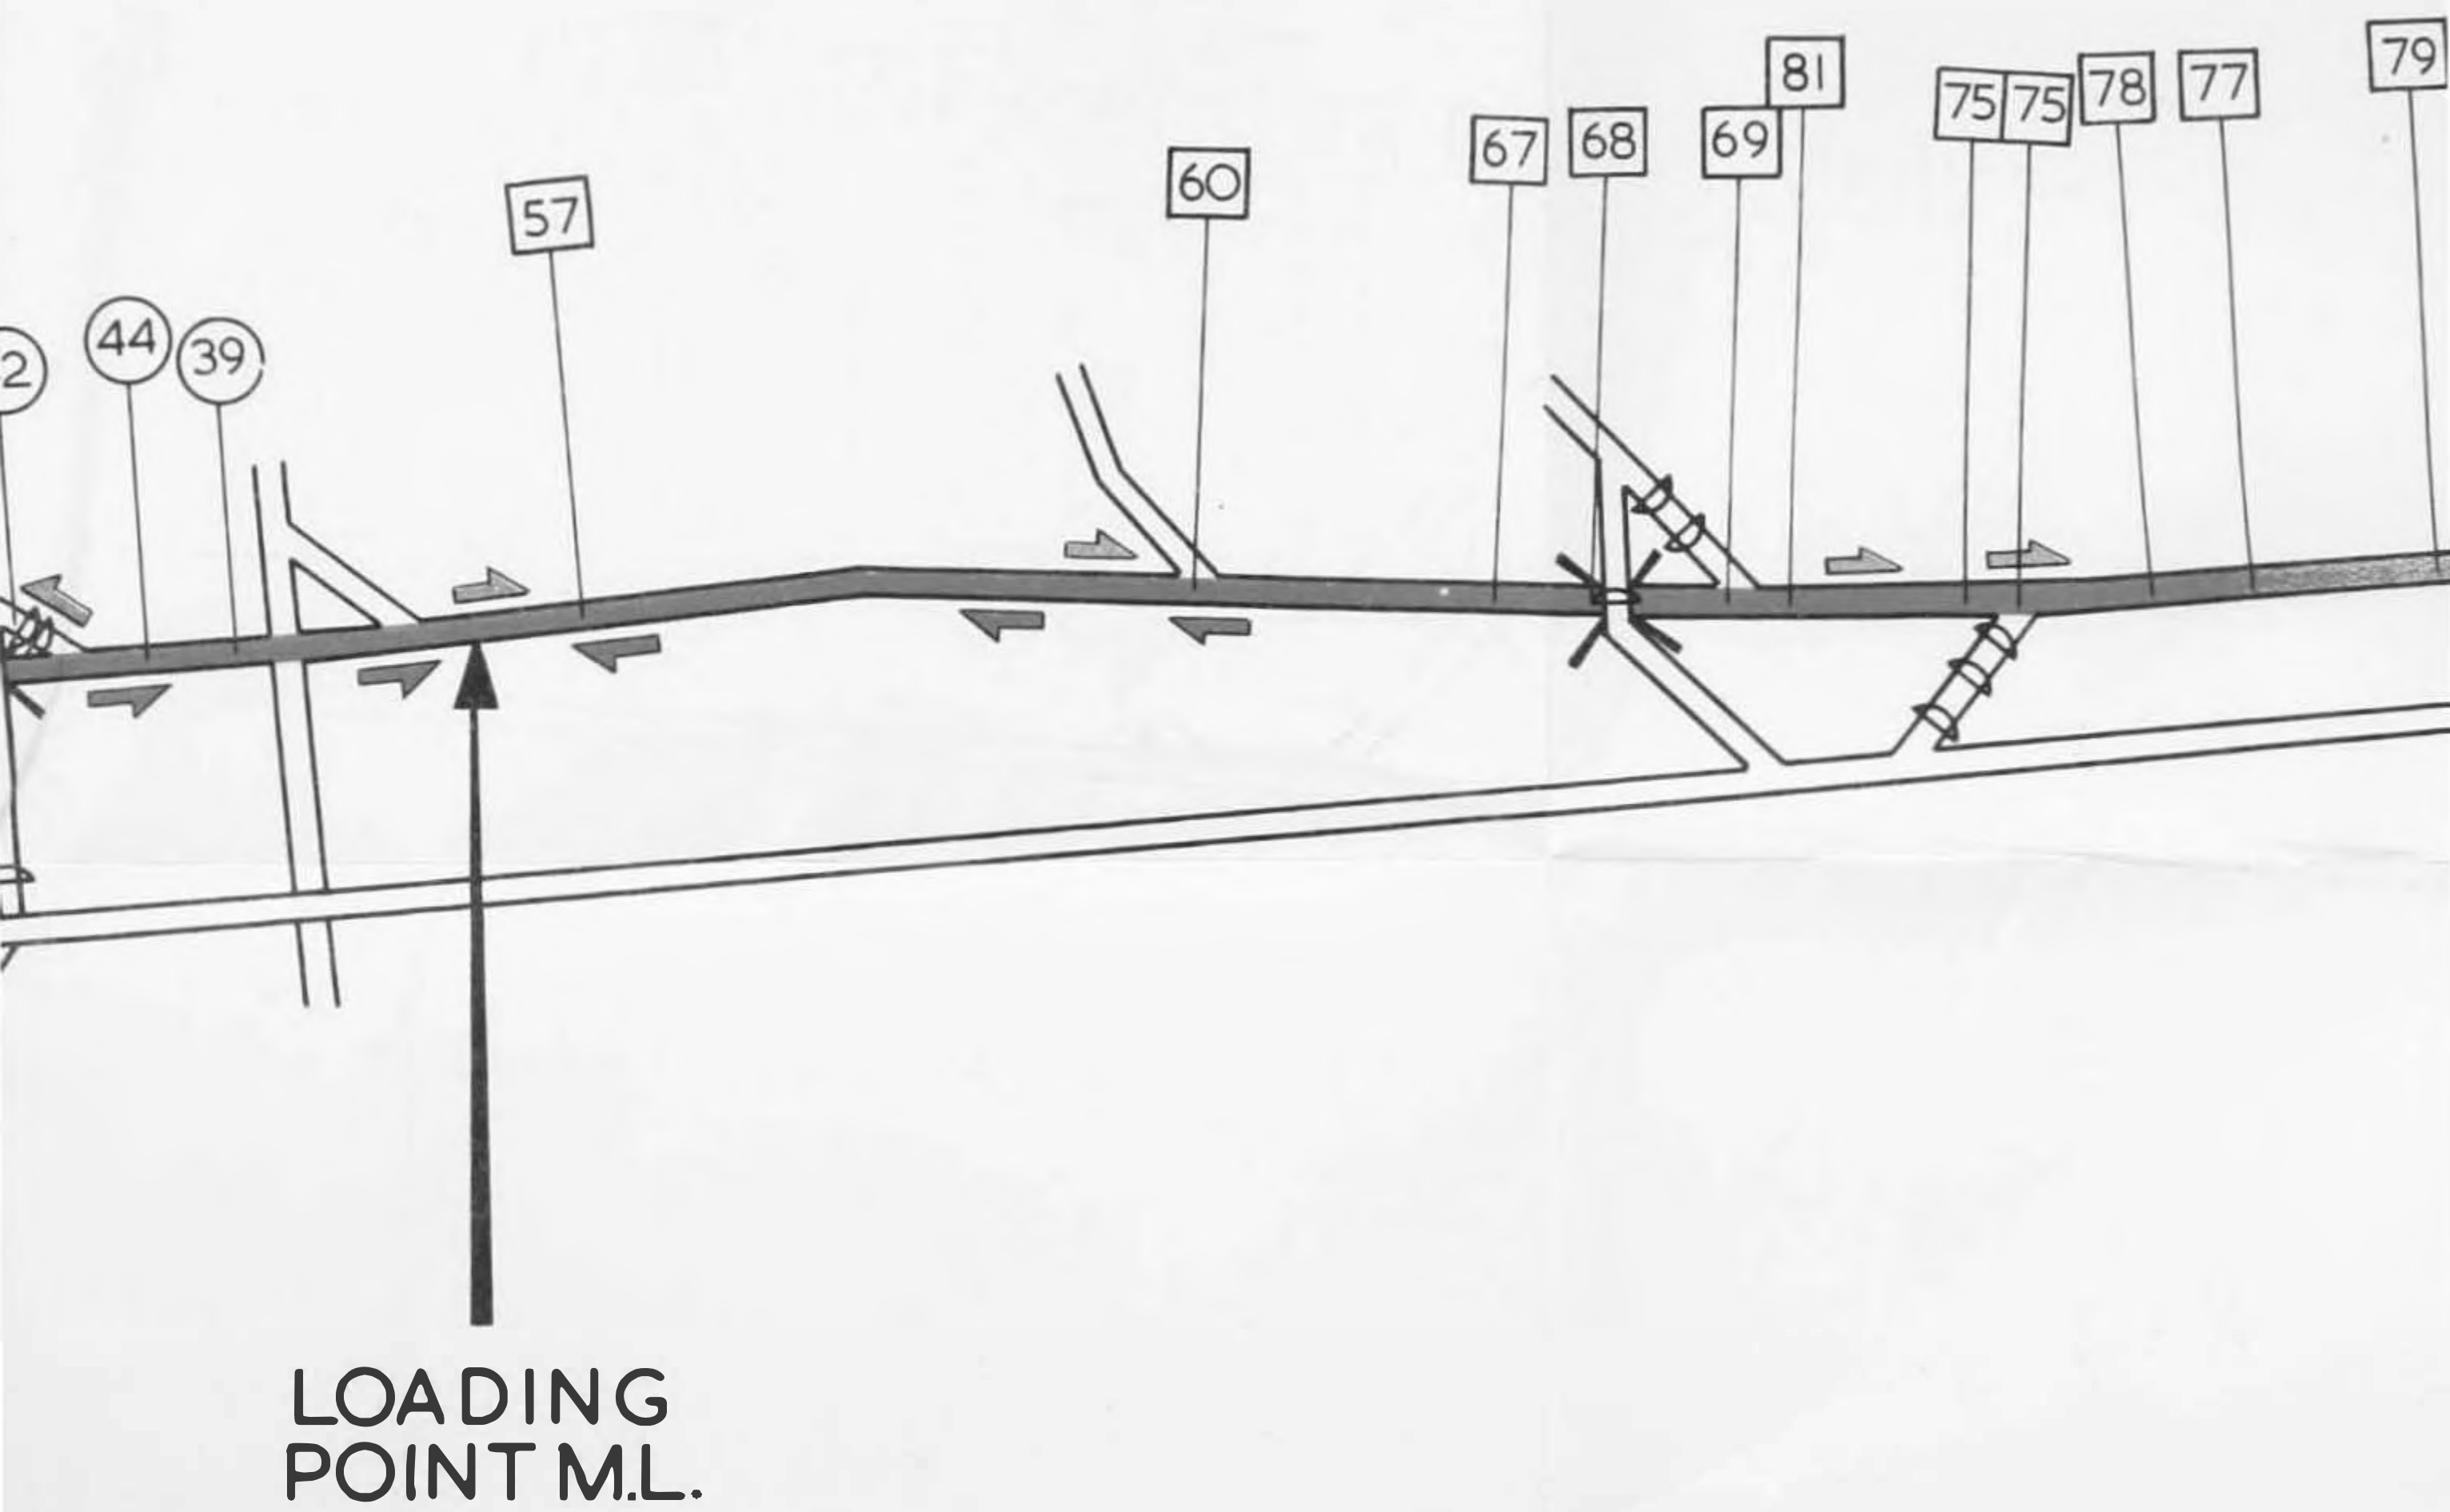
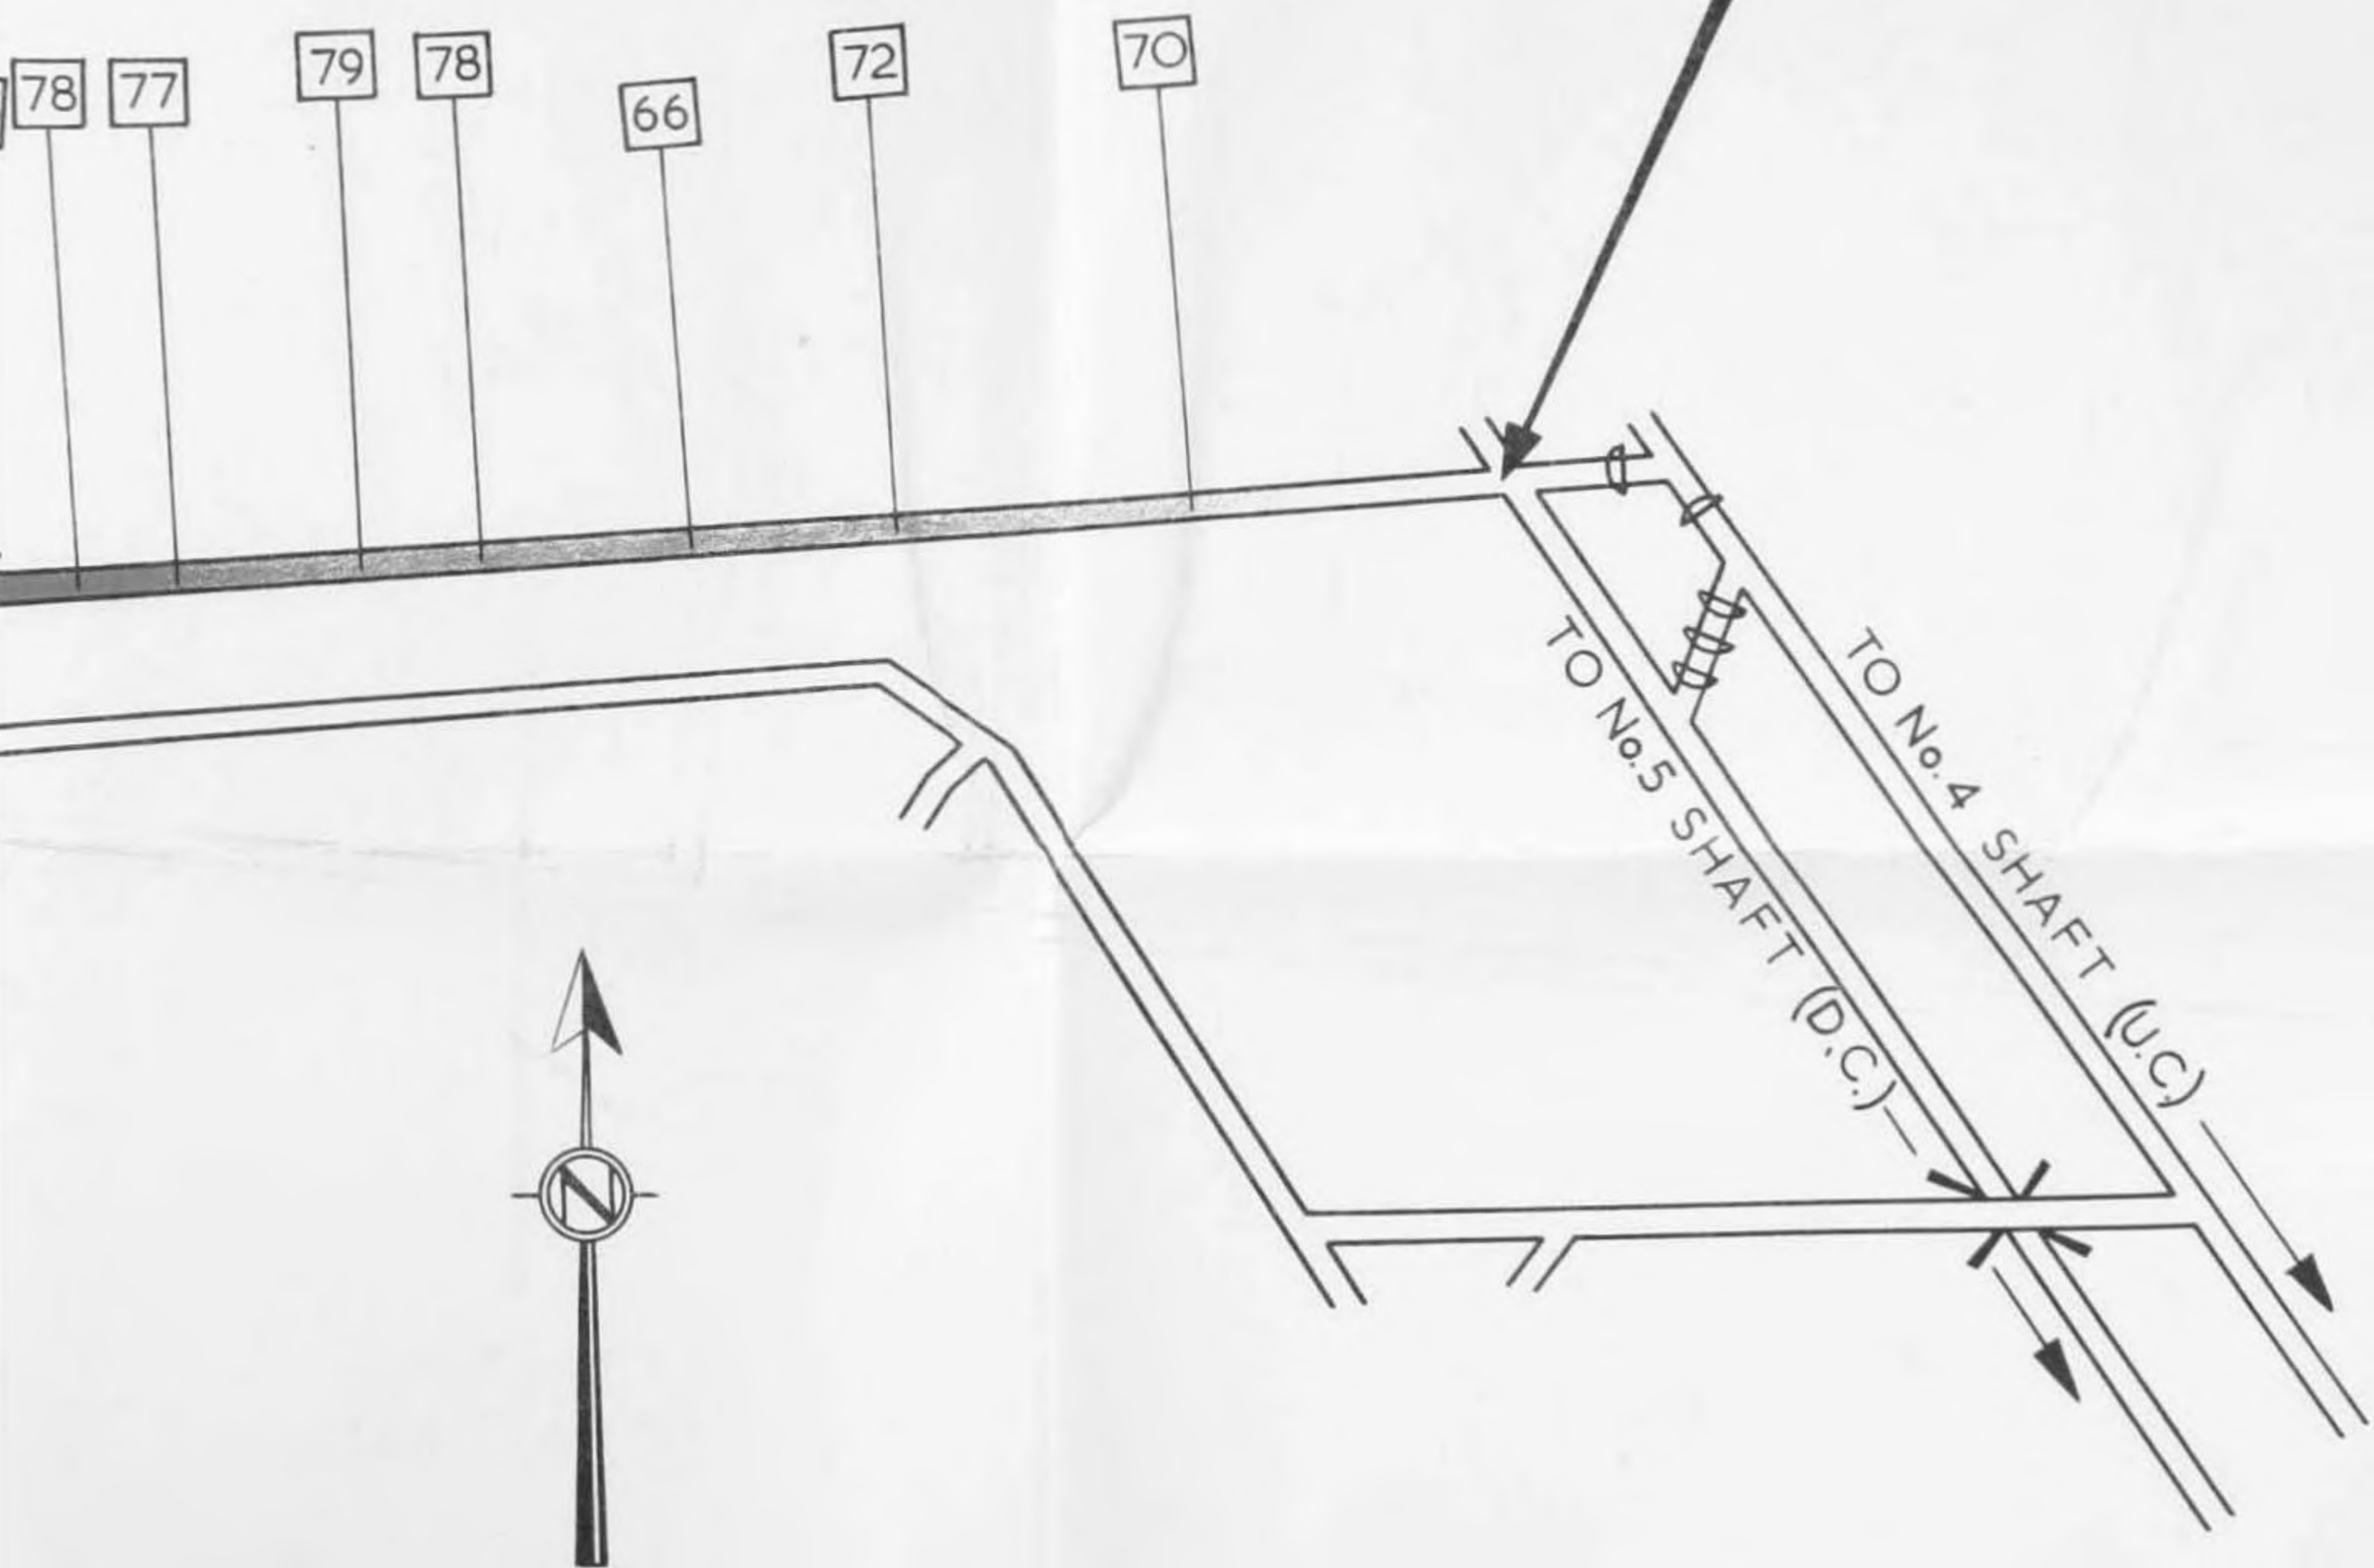
PLAN No.3  
 SIX BELLS COLLIERY 'V'  
 EXPLOSION INVESTIGAT

39. Microscopic examination of over 500 specimens of dust and fibrous material indicated that flame had swept, as shown on Plan No. 3, through some 3,000 yards of roadway and each of the faces with the exception of O.10. Flame had traversed the main intake road, both roads serving O.10, most of the old O.9 return, the intake of O.18 and its return for 30 yards outbye from the face. The main return was affected only locally by flame through the . . . . . There were signs of prolonged burning of firedamp in two lengths of roadway, for 70 yards outbye from O.10 intake roadhead and for about 25 yards outbye from O.18 return roadhead.

41. Specimens of coked dust indicated the directions of flame to have been as shown by the red arrows on Plan No. 3. These indications of direction were generally consistent with the indications of blast. Minor and local contra-indications observed were not at all unusual. There were clear signs that flame entered both ends of O.12 face. Coked dust depositions found in O.10 supply road indicated that flame had travelled from the main intake to O.9 old face and along it to O.9 return where it died out at about 200 yards from the face.
