NATURE AND CAUSE INVESTIGATION REPORT ON
FATAL ACCIDENT

JACKS QUARRY
COLLINSVILLE
SUNDAY 29 JULY 2018

LEAD INVESTIGATING OFFICER:	Steven Firth	Inspector of Mines – Mining	Townsville
INVESTIGATING OFFICERS:	Mark Desira	Inspector of Mines – Occupational Hygiene	Townsville
	Noel Towers	Inspector of Mines – Mining	Mackay
	Alan Graham	Inspector of Mines – Mechanical	Townsville
SUPPORT OFFICER:	John Barron	Principal Investigations Officer	Brisbane
DATE of REPORT:	Tuesday 29 January 2019		
FILE REF:	MDEA-B35EZY - IR

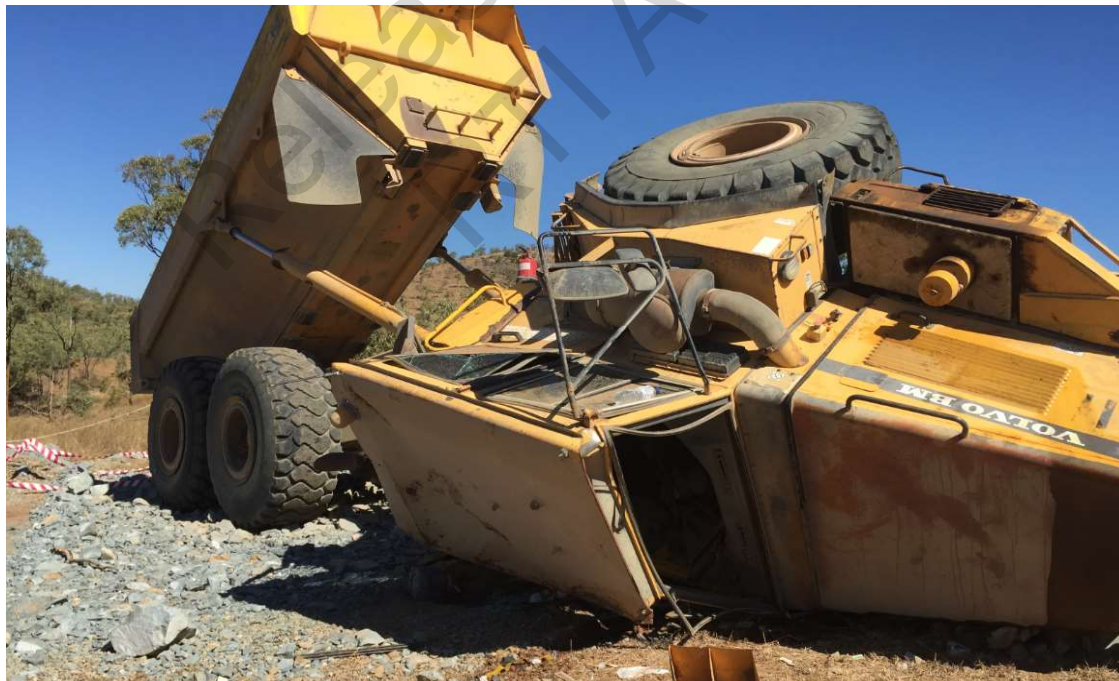
s73 Irrelev failed to negotiate the turn into the intersection and hit an embankment further down the haul road. The truck rolled, spilling the load before coming to rest with the engine cab on its side. s73 Irrelev was trapped inside the cab.

Figure 1. Accident scene 30 July 2018

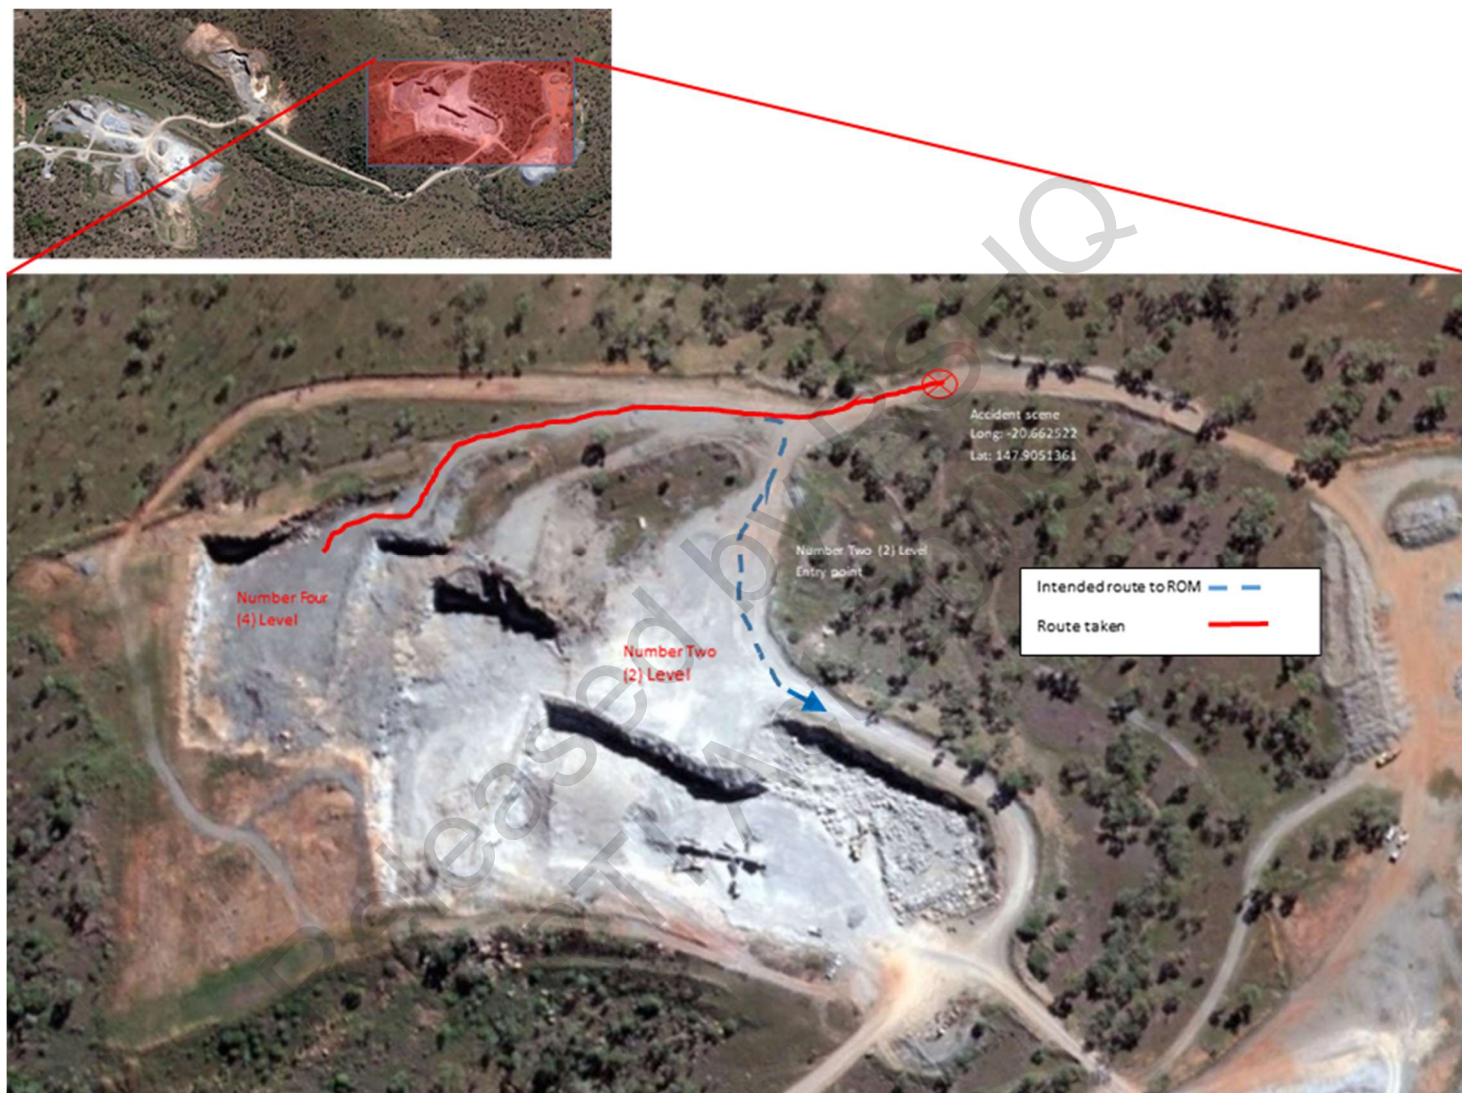
While travelling down the haul road, s73 Irrelev failed to negotiate the right hand turn to the Number Two (2) Level entry point and continued through the haul road intersection³⁶.

Figure 4. Satellite image with an overlay to demonstrate the probable vehicle route (in red), intended vehicle route from the intersection exit point and approximate location of the accident scene.

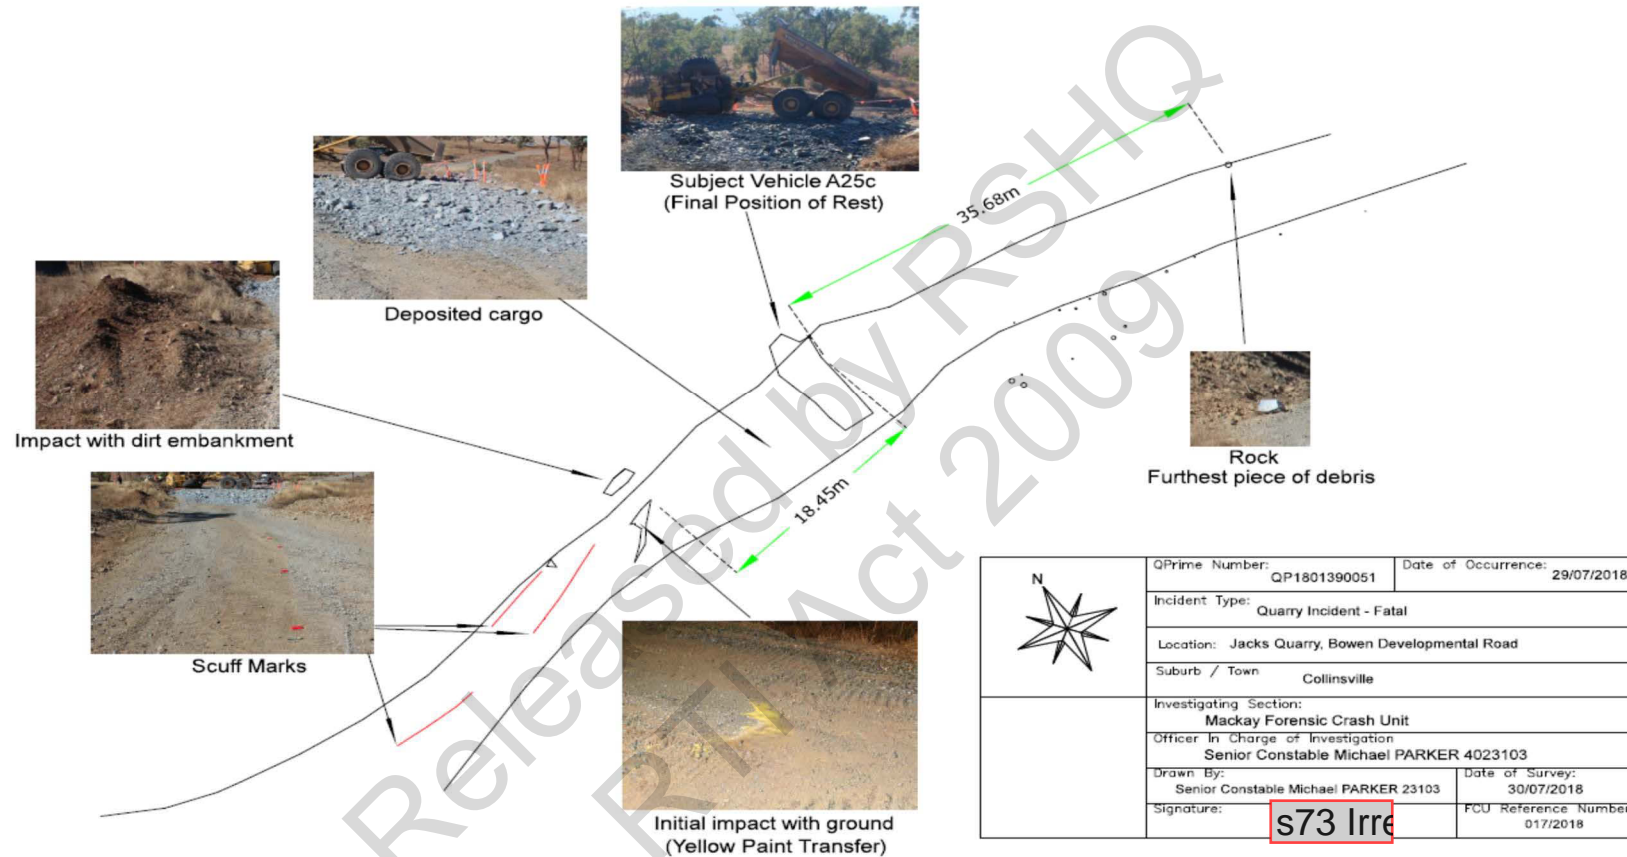
Figure 5. Forensic Crime Unit overhead survey of the scene with photos³⁸

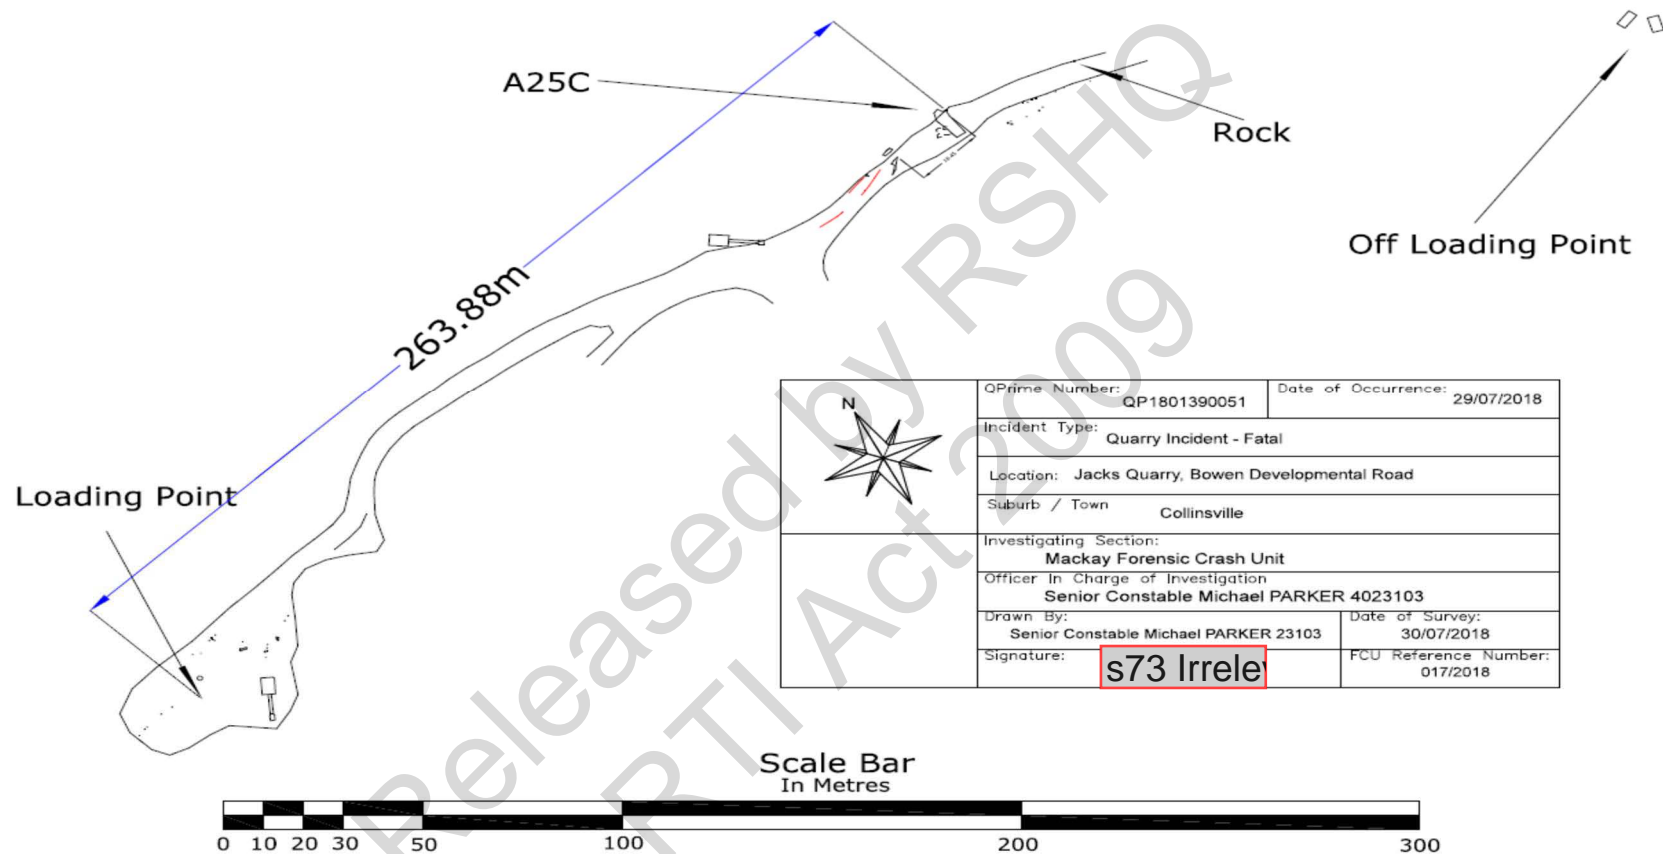
Figure 6. Forensic Crime Unit overhead survey of the scene³⁹

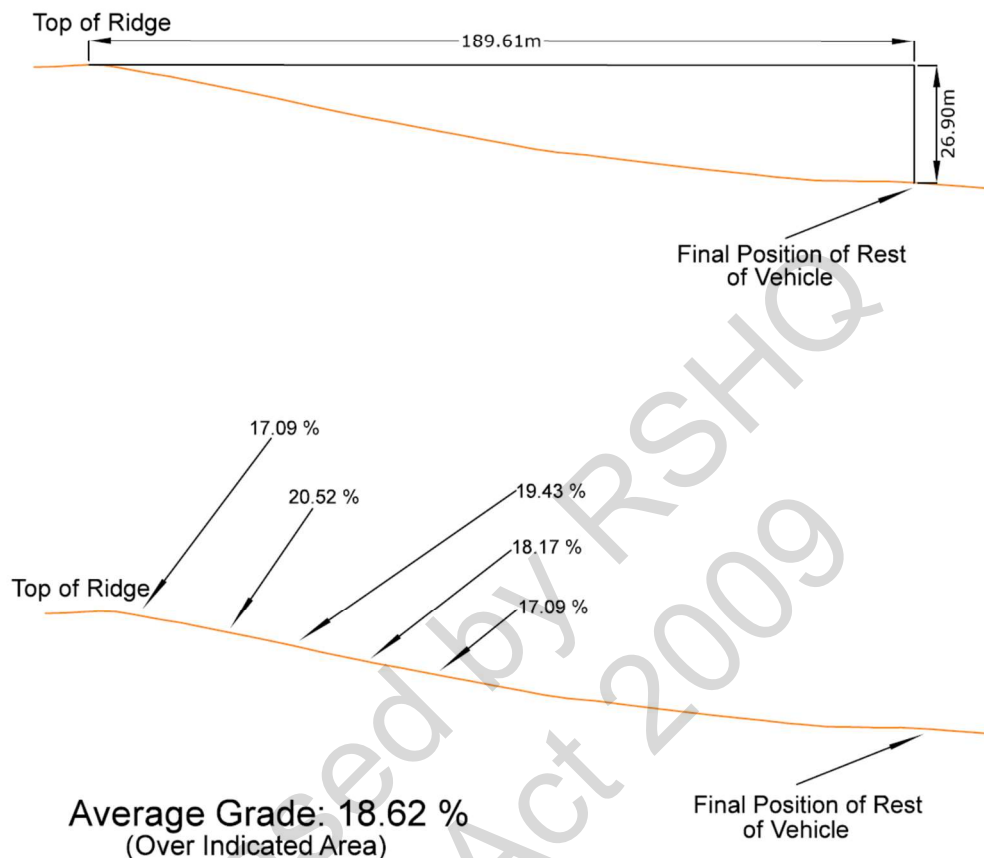
The FCU conducted a survey of the scene and recorded measurements of the haul road profile from the top of the ridge on Number Four (4) Level to the final position of rest of the truck. No evidence of braking, sliding or tyres skidding were identified on the haul road except for scuff marks left in the road in close proximity to the accident scene⁷⁵. QPS observed a maximum gradient of 20.52 % with an average gradient of 18.62 % over 189.61 metres⁷⁶. The gradients recorded were within OEM operating capability of the Volvo A25C (6x6)⁷⁷.

Figure 8. Forensic Crime Unit survey map side profile (grade)
