# **CORONERS COURT OF QUEENSLAND**

## **FINDINGS OF INQUEST**

<b>CITATION:</b>	<b>Inquest into the death of Daniel Geoffrey Springer</b>
<b>TITLE OF COURT:</b>	Coroners Court of Queensland
<b>JURISDICTION:</b>	NORTHERN
<b>FILE NO(s):</b>	2017/3427
<b>DELIVERED ON:</b>	23 February 2021
<b>DELIVERED AT:</b>	CAIRNS
<b>HEARING DATE(s):</b>	23 May 2019, 2-6 March 2020, 2 June 2020
<b>FINAL SUBMISSION:</b>	12 August 2020
<b>FINDINGS OF:</b>	Nerida Wilson, Northern Coroner
<b>CATCHWORDS:</b>	Coroners: inquest, mining accident; BHP Billiton Mitsubishi Alliance Coal Operations; Goonyella Mine; excavator bucket; external steel vertical wear plate package; indentions; build up of stored energy; air carbon arc gouging; 1.150 metre spring-back event; fatal injuries to head due to industrial accident; death of qualified boilermaker; no prior industry knowledge regarding magnitude of spring-back.

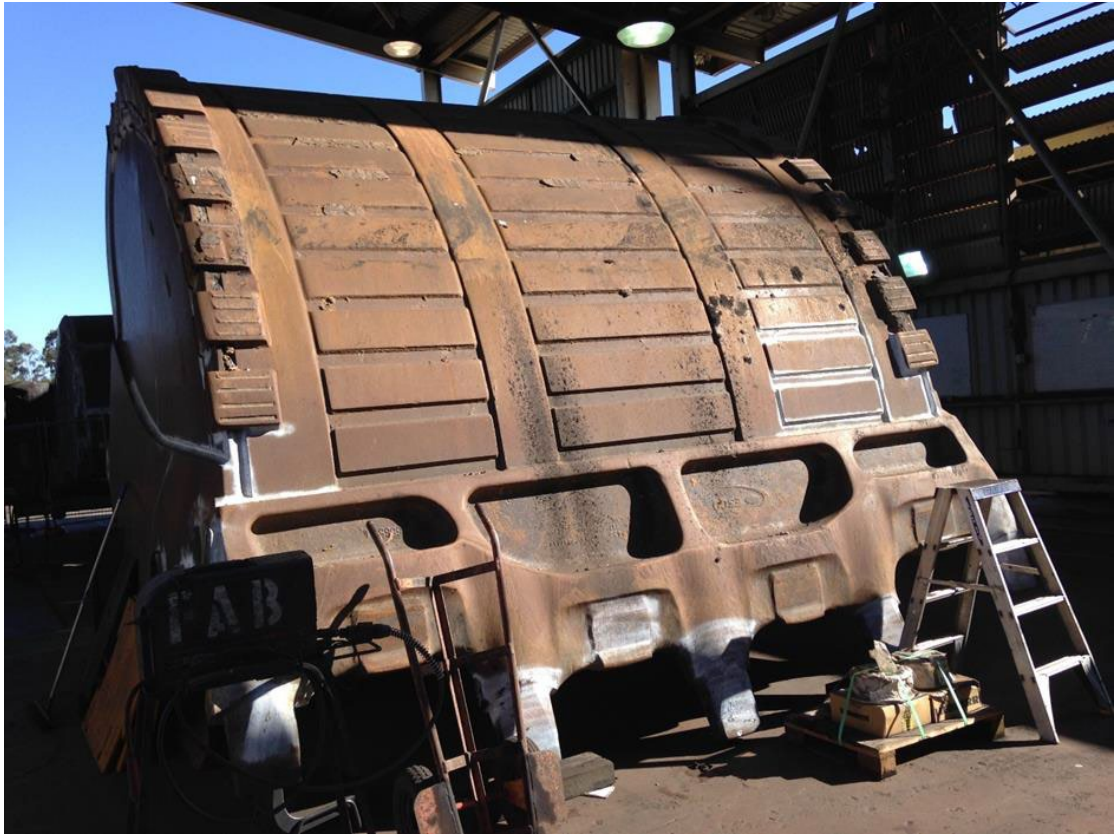
[OEM] Original wear package – smaller horizontal plates

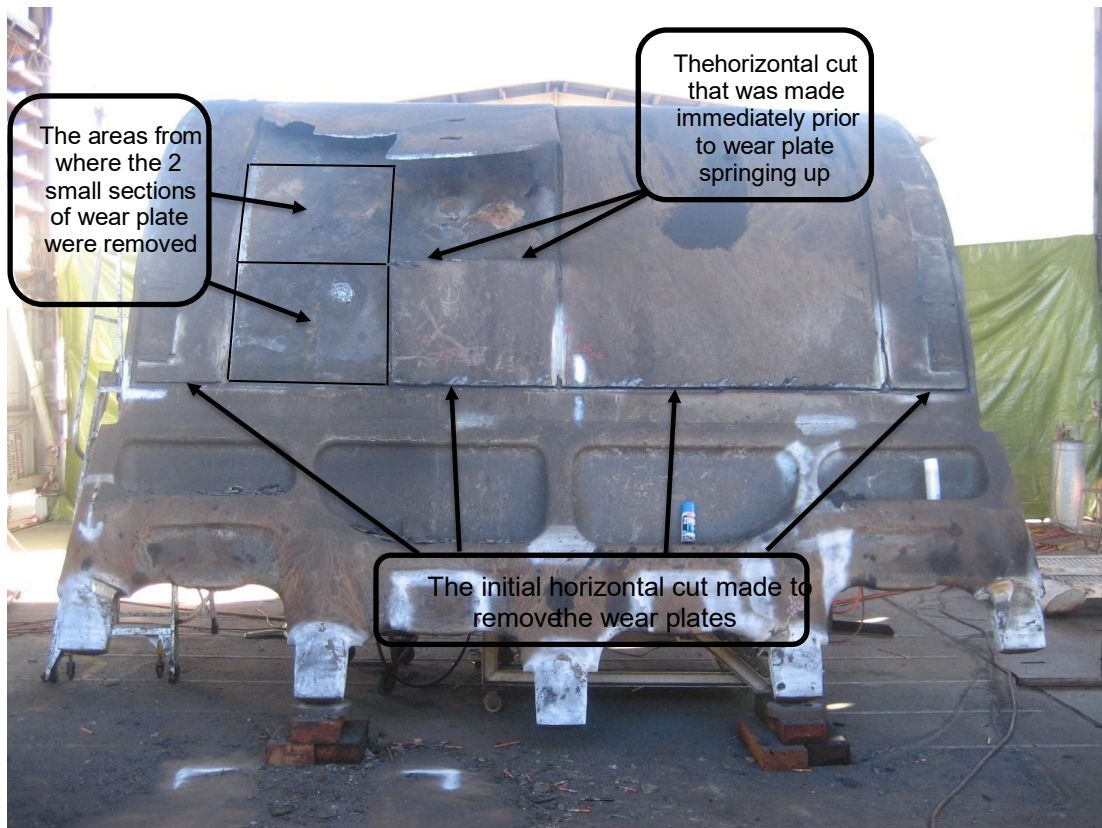
54. As a result of regular heavy use the external wear plate covering the outside of the bucket became indented, creating a build up of stored energy or tension, and when released through the air carbon arc gouging process, the plate sprang back or out approximately 1.150 metres striking Daniel to the head. At rest, the protruding metal after the spring back event, measured 600-650mm (depicted in the attached photographs).

Excavator bucket post incident – depicts the work performed immediately prior to the spring back event

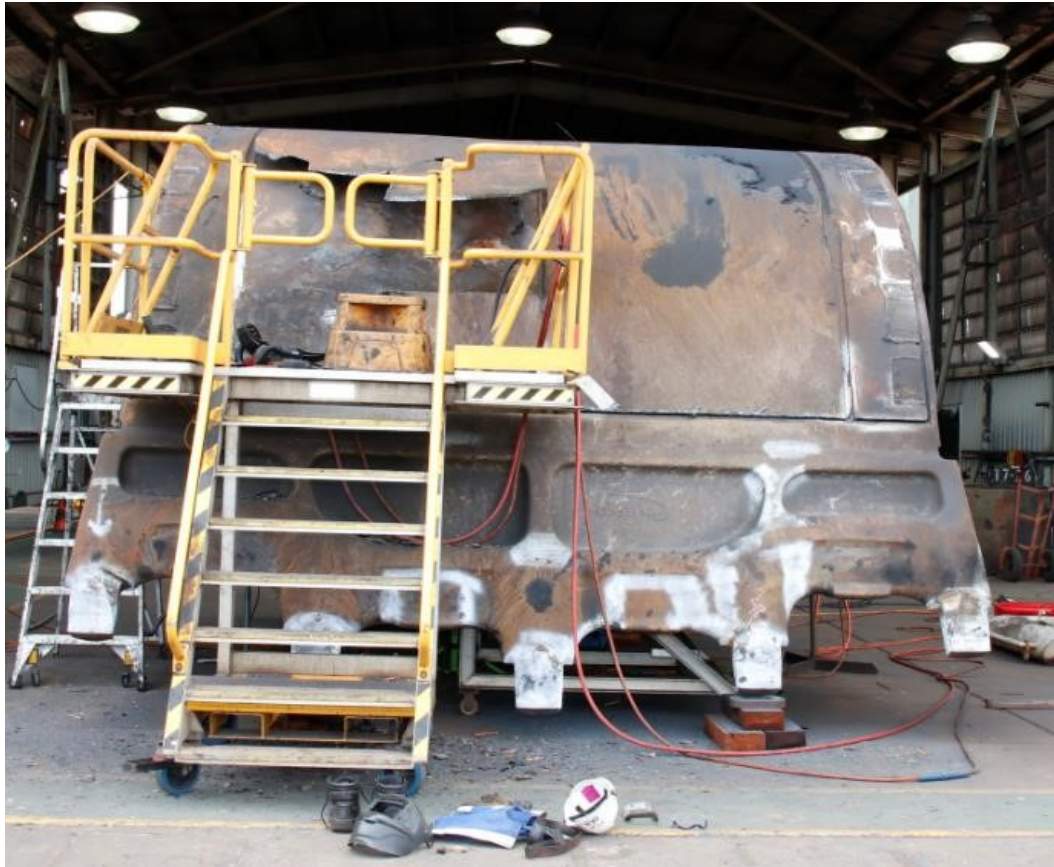
Photo of work platform in situ from which Mr Springer was working on bucket #1 at the time of the spring back event.

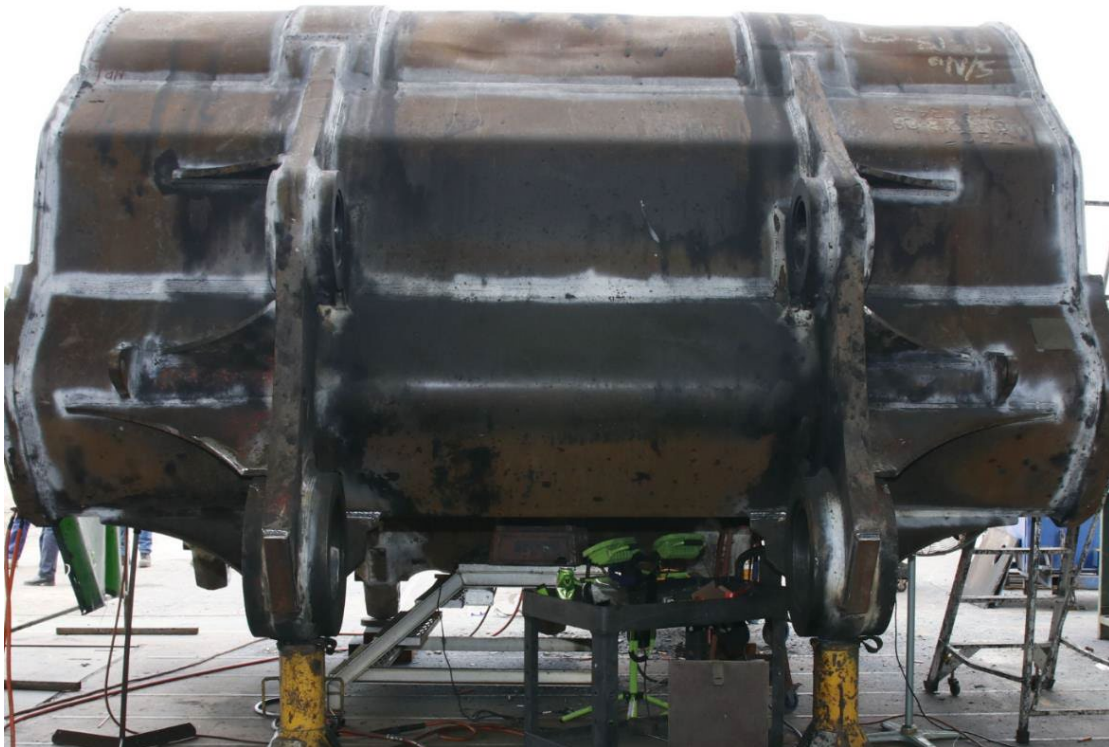
### INDENTATIONS

- Indentations in the wear plate were the major reason for the build-up of stored tension which caused the wear plate to violently spring out.
  - The Maintenance Manager at Goonyella did not ensure a risk assessment was conducted before the modification to the bucket's wear plates were carried out in 2014.

- m) The indentation of the plate was the motivator for spring-back;
- n) Continued damage to a wear plate increases the stored energy and also how a perforation to the perimeter welds allow dirt ingress and that dirt ingress provides a compliant counter-face which increases the probability of severe indentation, further increasing the likelihood of stored energy.;
