**UNITED STATES DEPARTMENT OF LABOR
MINE SAFETY AND HEALTH ADMINISTRATION
COAL MINE SAFETY AND HEALTH**

REPORT OF INVESTIGATION

**Fatal Underground Mine Explosion
April 5, 2010**

**Upper Big Branch Mine-South, Performance Coal Company
Montcoal, Raleigh County, West Virginia, ID No. 46-08436**

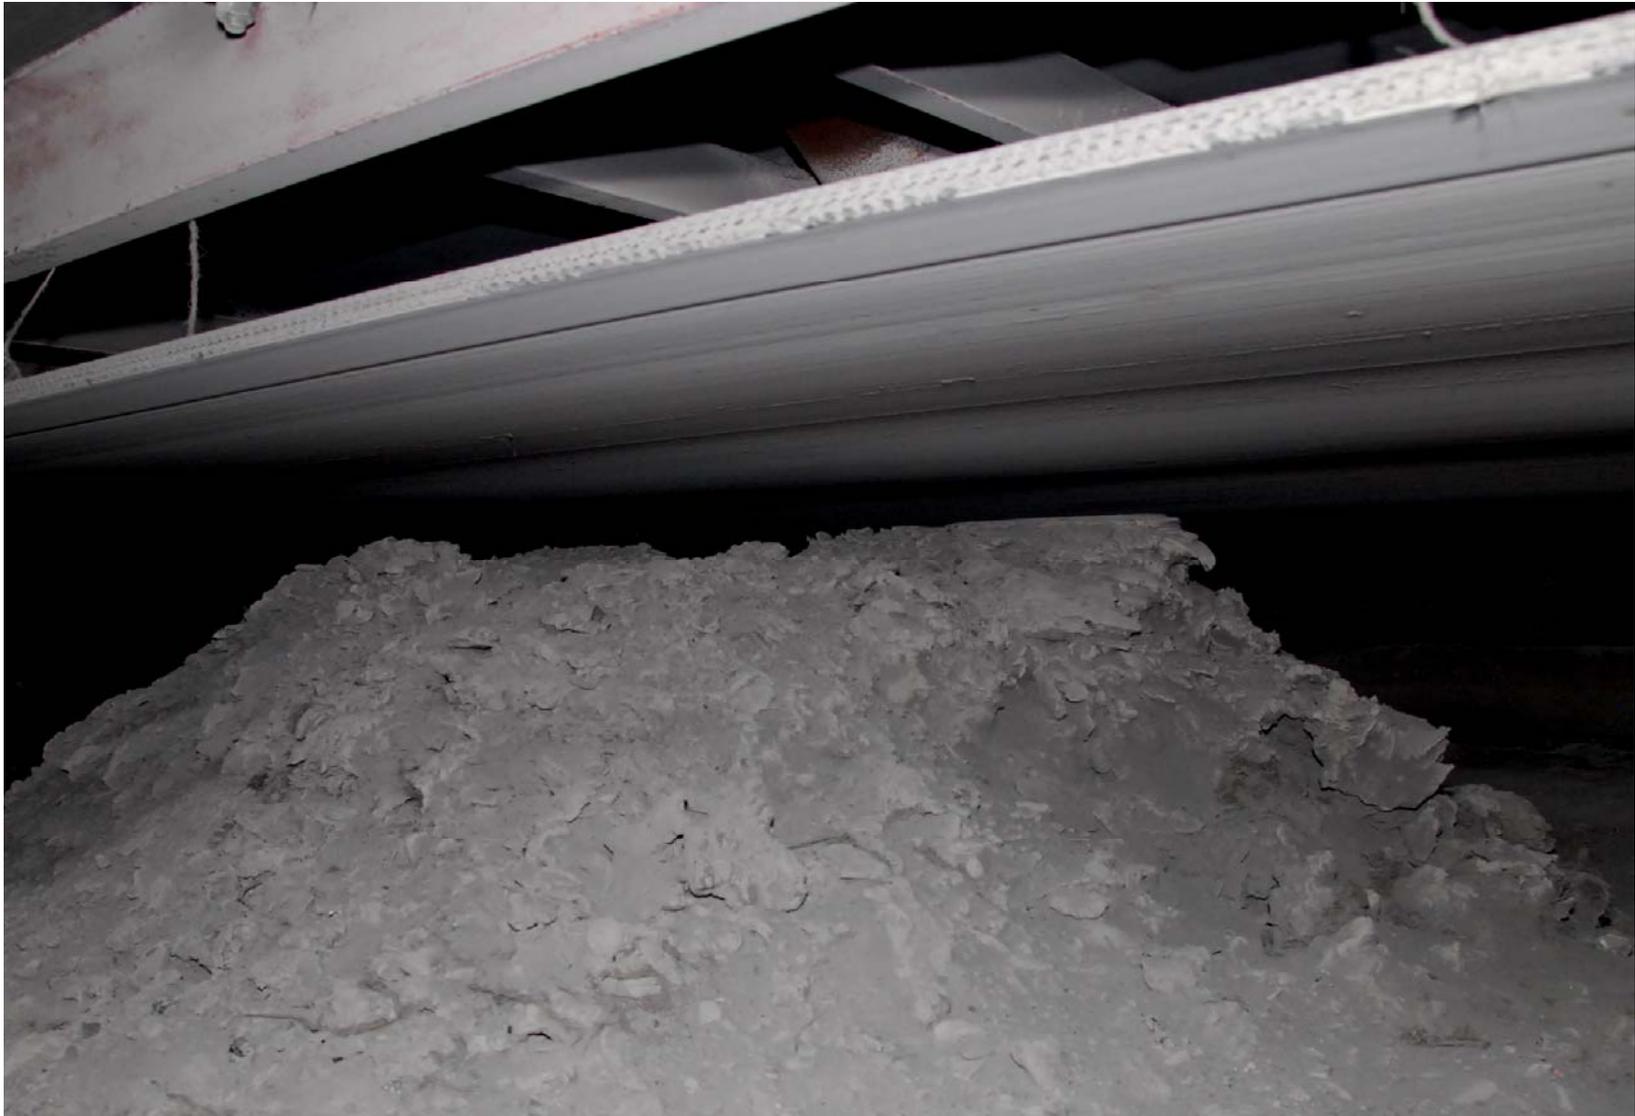
During the underground investigation, MSHA identified accumulations in over 50 locations along the conveyor belts. These accumulations were allowed to pile up below and around the belt and belt structure, and along portions of ribs that were not cleaned up during initial development. Examples of this are shown in Figures 8 and 9. The size and number of these accumulations demonstrate that the hazards existed for a long period of time.

Figure 8. Accumulations of loose coal with the top of the pile flattened due to rubbing the moving belt.

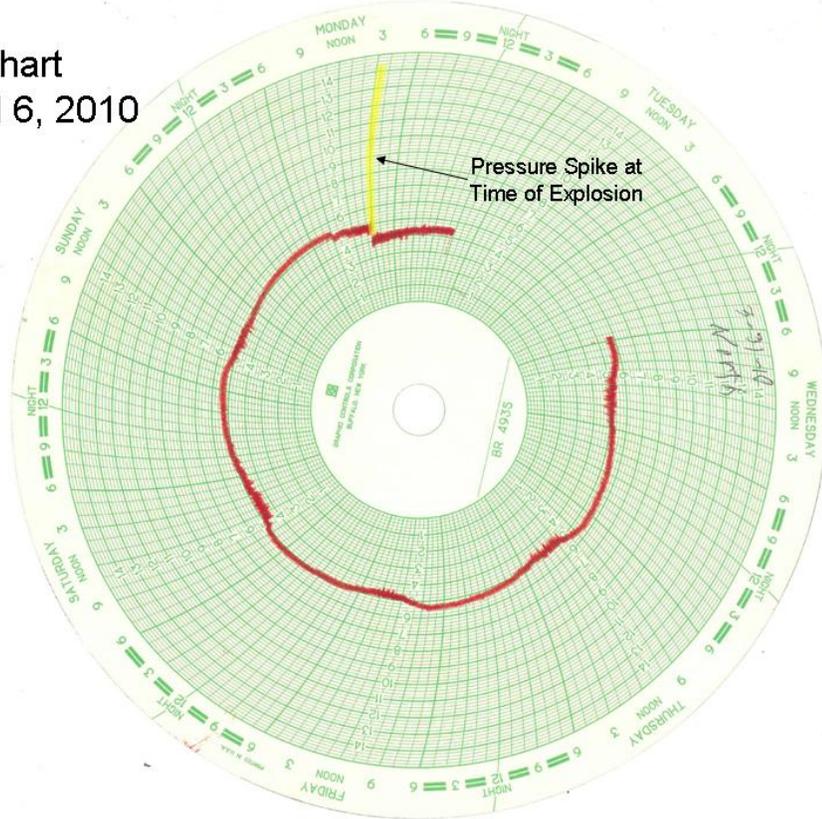
Figure 24. Chart for North Fan, showing pressure spike at time of explosion.

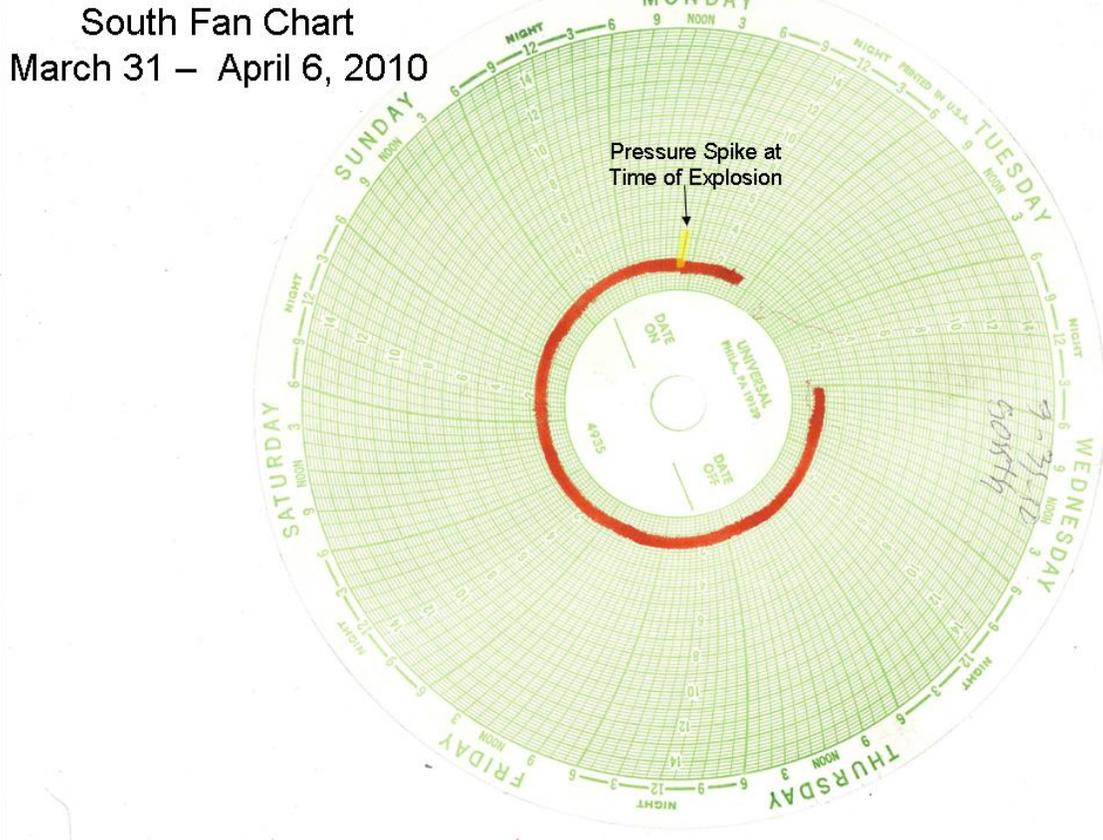
Figure 25. Chart for South Fan, showing pressure spike at time of explosion.

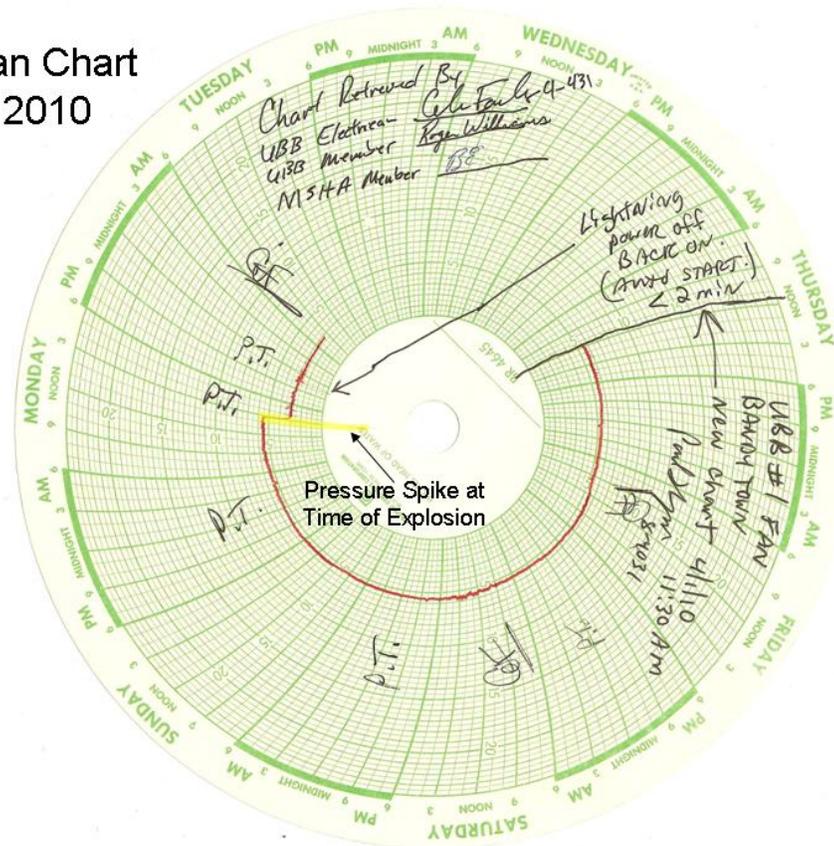
Bandytown Fan Chart April 1 – 6, 2010

Figure 26. Chart for Bandytown fan showing pressure spike at the time of the explosion.

Although the fan charts shown in Figures 24 to 26 were not aligned correctly on the pressure recorder to correspond with actual time, each fan chart shows the pressure spike from the explosion. The North fan recorded a spike of over 9 in. w.g. over its normal pressure of 4.8 in. w.g. The South fan recorded a spike of 2 in. w.g. over its normal pressure of 1.4 in. w.g. The Bandytown fan spike went downward off the chart because this fan was exhausting and the pressure spike was positive. The magnitude of the spike cannot be determined but it was greater than the fan operating pressure. Several small variations in fan pressure were noted on the Bandytown fan chart following the explosion, although persons who were underground during that time reported no additional explosions.
