## **Mines Inspectorate (Coal)**

### **Nature and Cause Investigation Report for the Chief Inspector of Mines**

#### **Incident at Saraji Coal Mine on the 31st December 2018 – Resulting in the Death of Allan John Houston**

**Date of report – 03/07/2019**

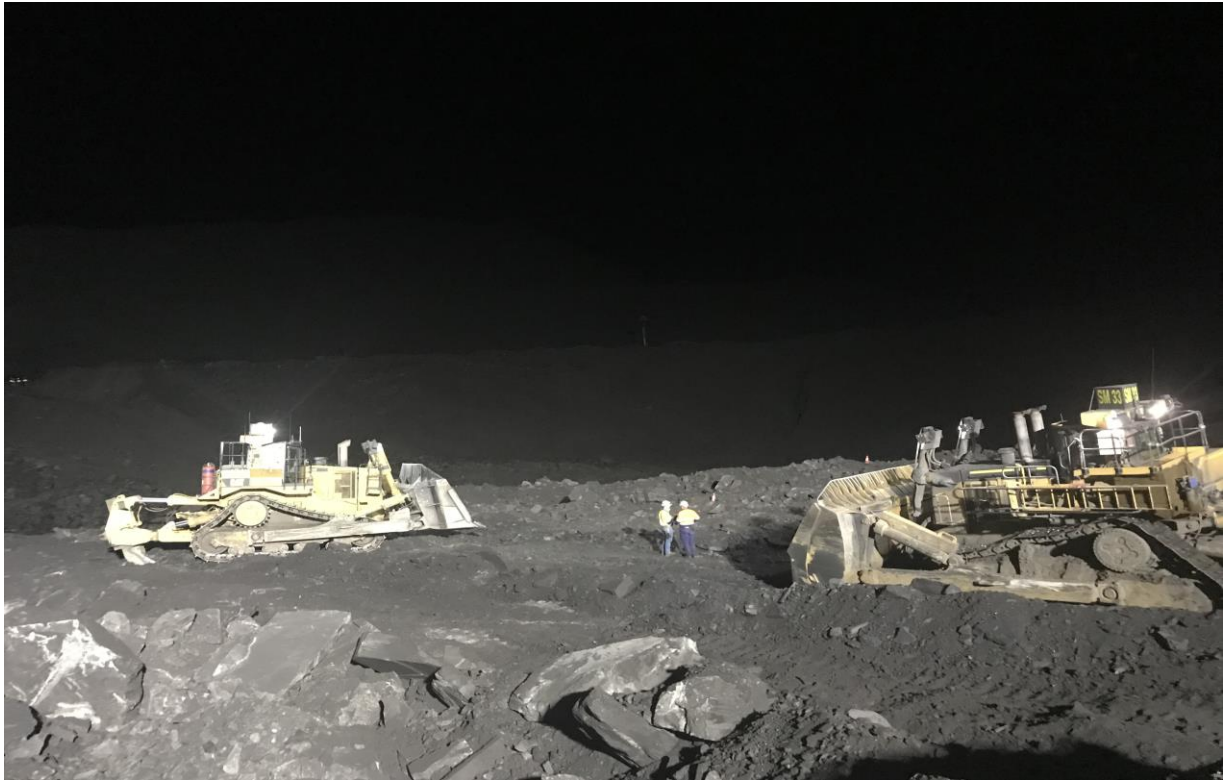
A re-enactment<sup>23 24</sup> was conducted of the conditions at the time of the accident. Inspector Callinan and Principal Investigations Officer Tolhurst conducted illumination testing. The first readings were conducted in the area around a dozer similar to dozer 804. The illumination readings were taken at different levels and locations to determine the amount of the illumination in dozer 804 operation area. The second series of tests were conducted while a second dozer was positioned in the slot adjacent to dozer 804. This dozer was positioned as it would have been at the time of the incident and was operating during the testing.

**Position of dozers during illumination testing.**

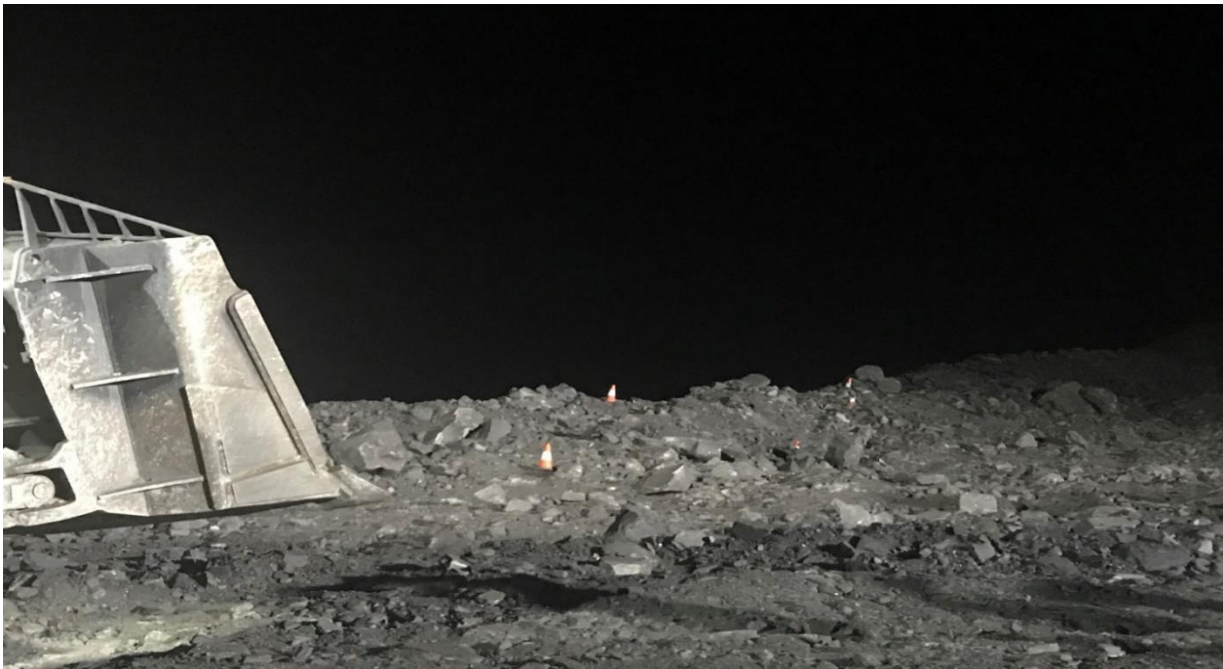
Lighting was provided to the Ramp 2 North dozer push by two mobile lighting plants. These lighting plants were situated on the adjacent high wall. Additional lighting was provided to the work area by the dozers on board external lights. Interviews conducted found that the workers believed that the lighting in the area was adequate for the task being conducted<sup>21 22</sup>.

Rubidium Lighting Engineers was engaged to examine photos, videos, and lighting plant data to assist in determining the adequacy of the artificial light. In the summary of their report<sup>25</sup>, it states that from the photographs provided, it appears that the portable lighting towers located on the bench above the incident site provided good orientation lighting and assisted in revealing the edge of the working area.

**Photograph of area where dozer 804 drove over edge showing lighting.**
