Investigation information release

Workers injured by suspected gas and rock burst at underground coal mine

Incident date: 6 April 2025

Investigation information release IIR25-05

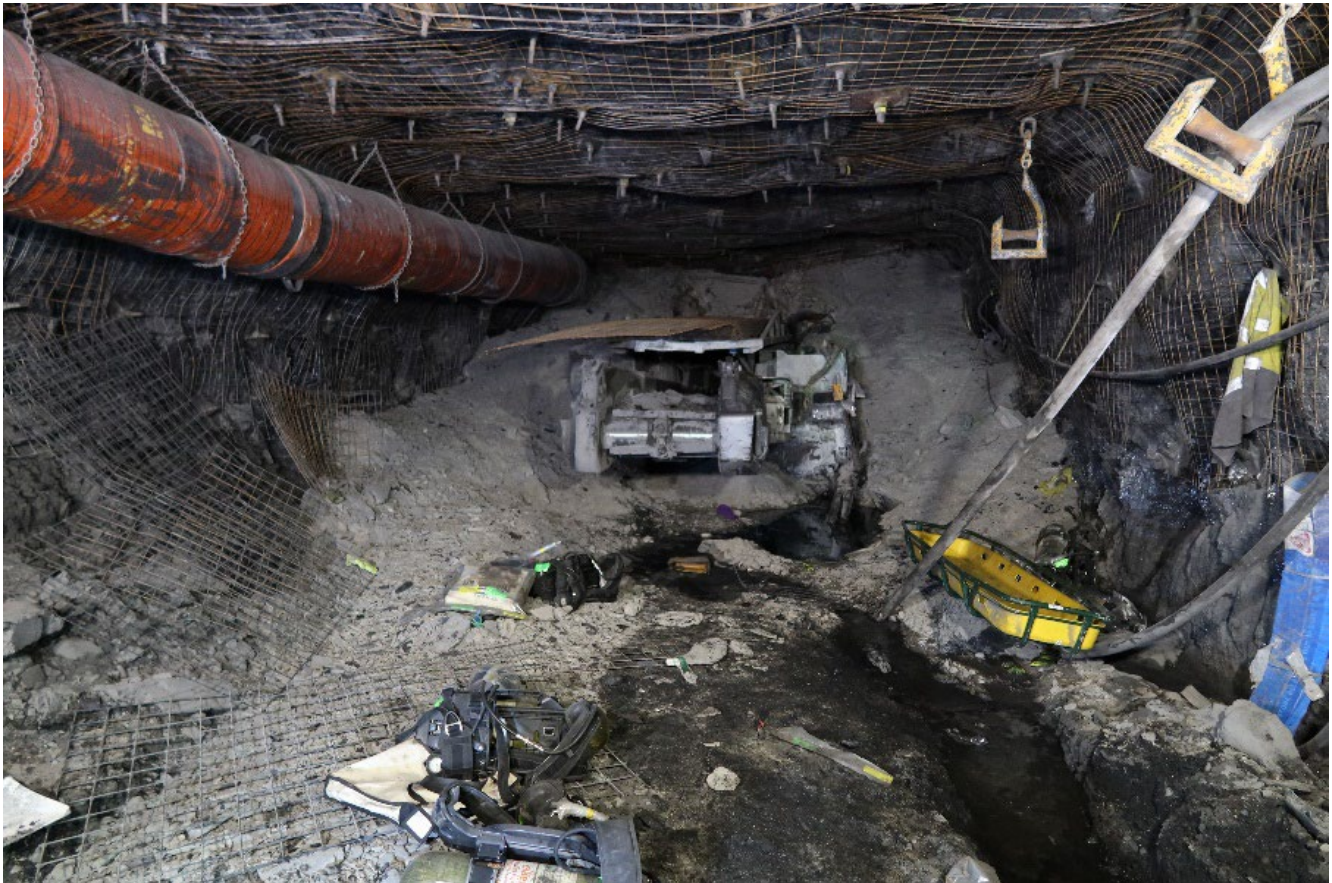
Figure 1: The continuous miner partially buried in rock material in Razorback Mains B heading 11-12 cut-through

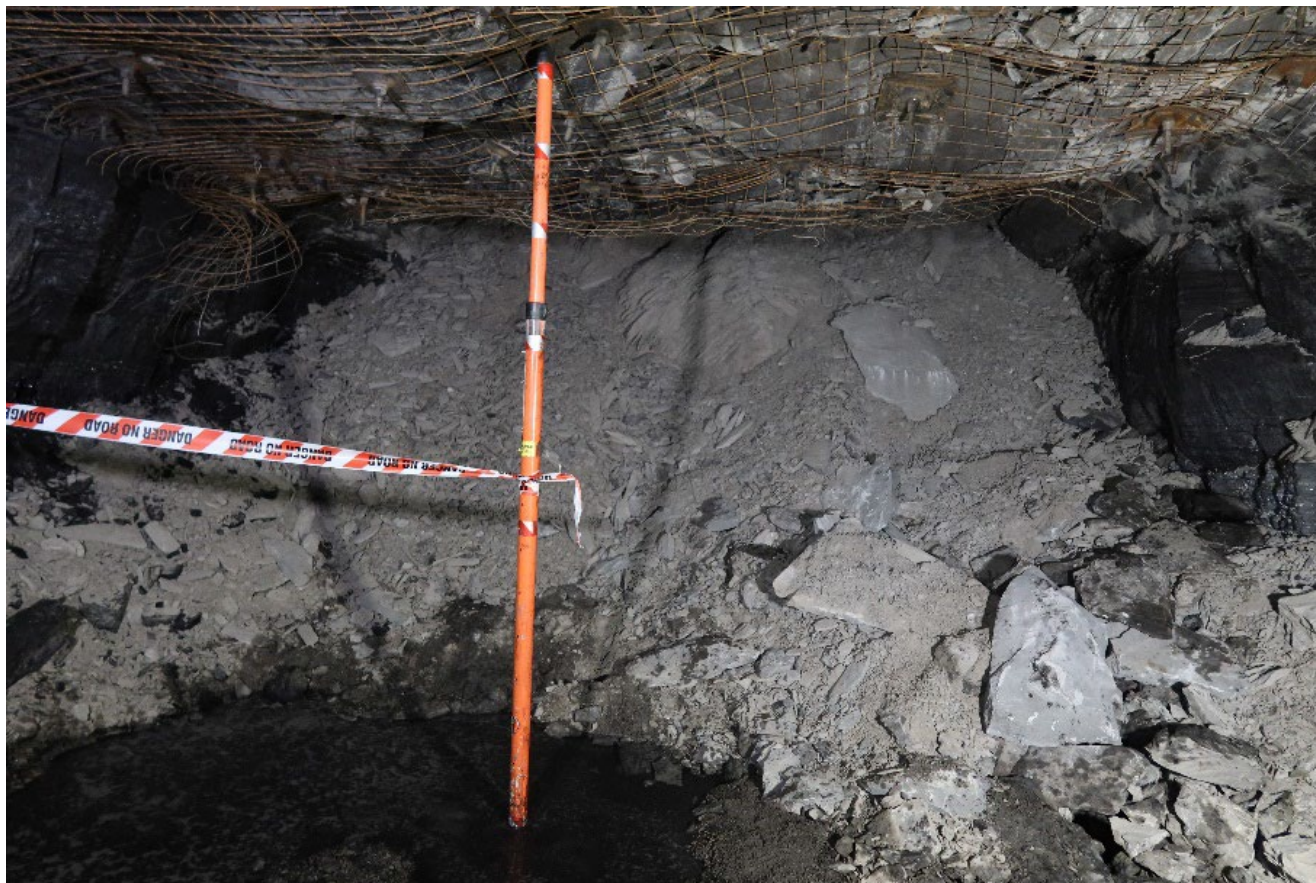
Figure 2: A pile of ejected rock after recovering the continuous miner from Razorback Mains B heading 11-12 cut-through

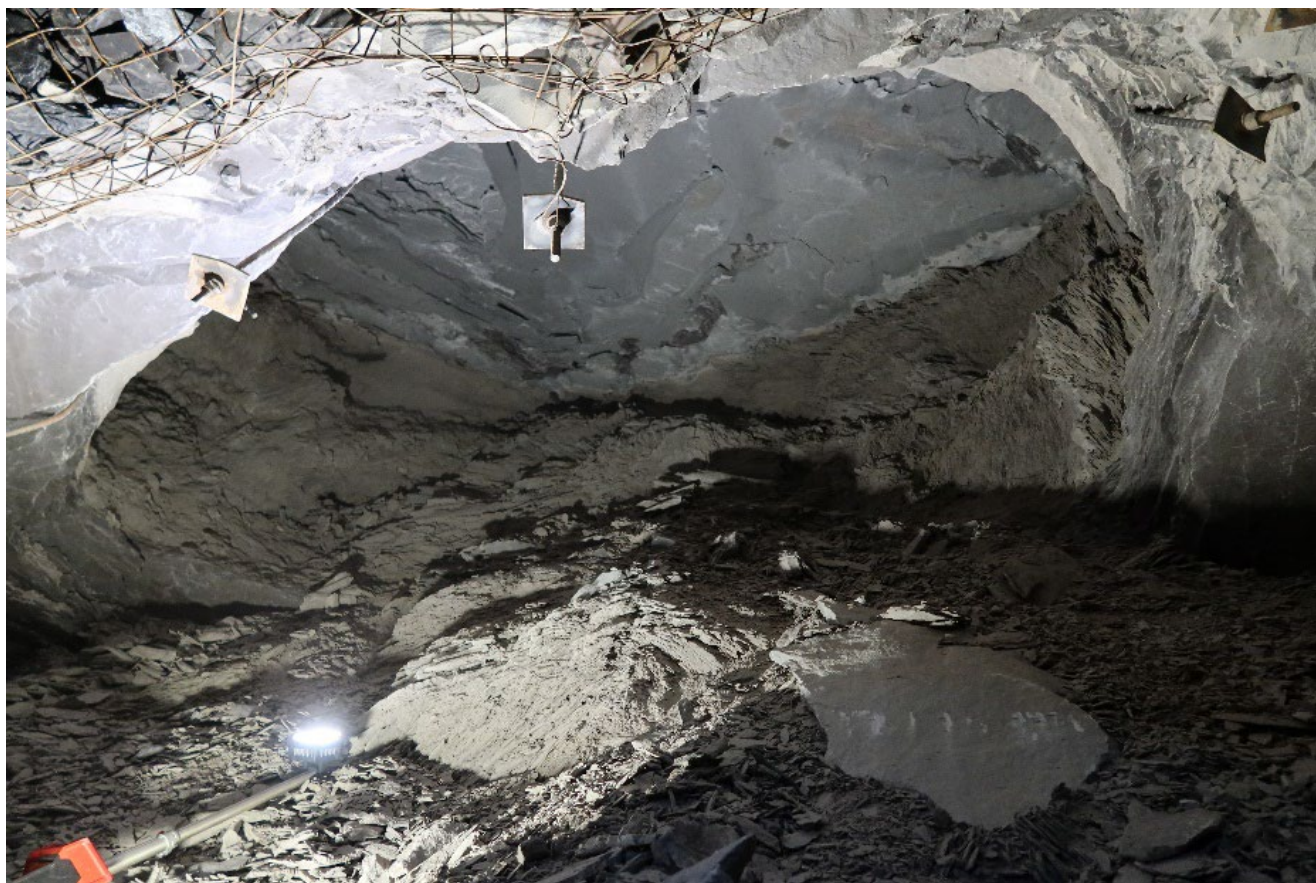
Figure 3: The void above the coalface in Razorback Mains B heading 11-12 cut-through
