## FIRE INVESTIGATION

**INCIDENT LOCATION** Longwall 104  
AngloAmerican Grosvenor Mine  
MORANBAH Q 4744

**DATE OF INCIDENT** Wednesday 6 May 2020, about 2.57pm

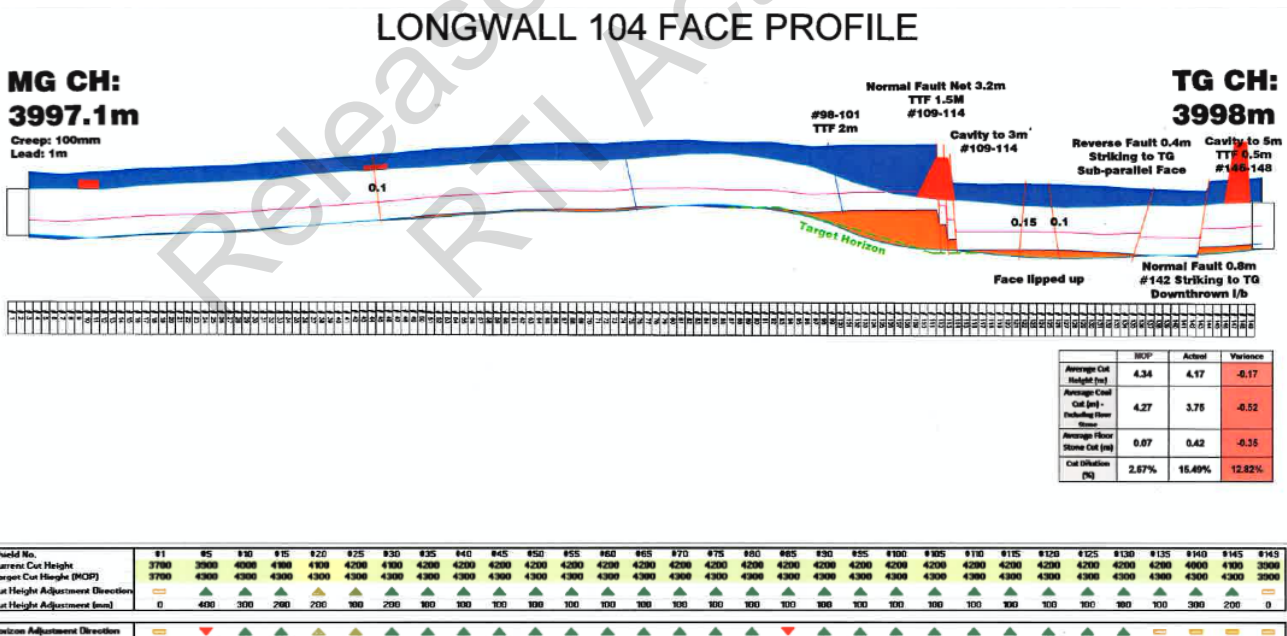
Image 1 The Longwall profile

Longwall 104 comprised a coalface of about 300m length between the Maingate and Tailgate with 149 Chocks numbered from the Maingate end. The coalface was typically 4.2m high with the overall profile rising slightly in elevation between Chock 1 and about Chock 90 then descending sharply through to about Chock 114 in the area of a fault and 3m ceiling cavity. The face profile obtained in briefings follows.

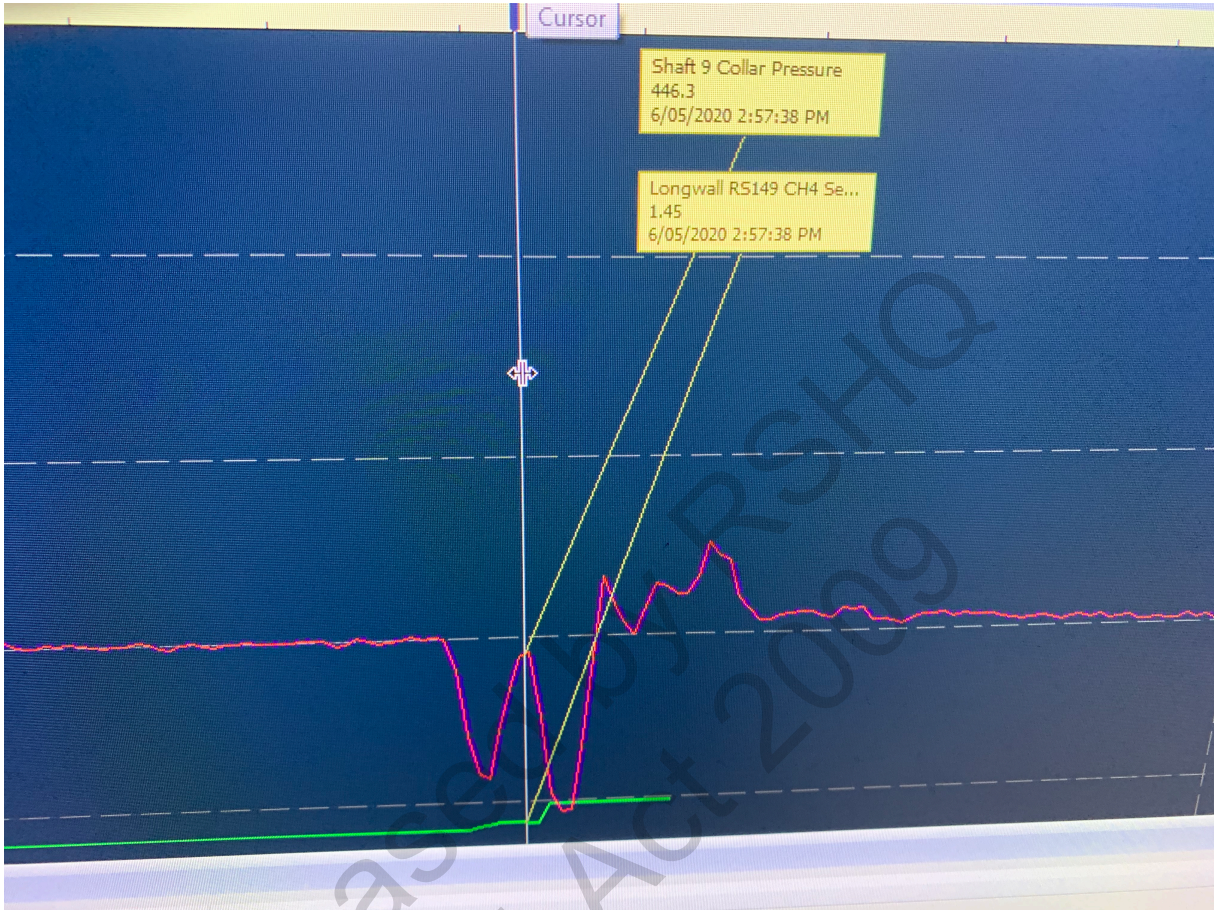
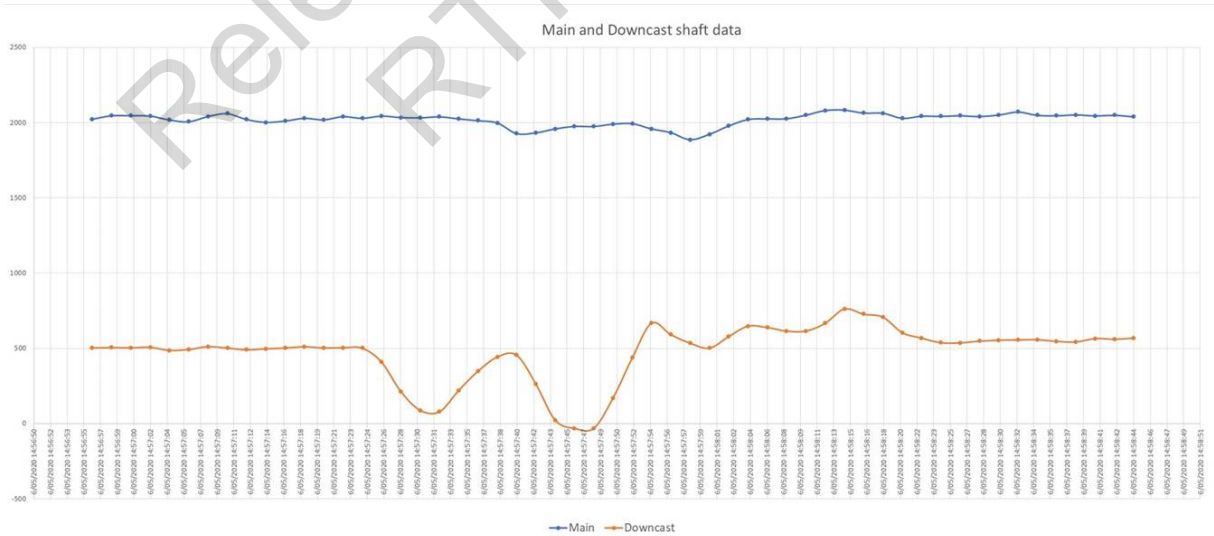
Though I have not been provided a printout of data, I saw a screenshot of graphical data captured by Mark LYNDON, an electrical inspector of the Inspectorate, that confirms two spikes in pressure data measured at a goaf well about 15 seconds apart (Image 2) and an image of some other data (Image 3) collected by you. Though not familiar with the measurement tools, the data is meaningful to the extent that it confirms the reported observations of sch4p4(6) Personal inform

Images 2 & 3 Reproductions of the screenshot and other data indicating two pressure waves

The alternate possibility seems to be that there were two ignitions. Unless there is a way of locating data in support of this, one could not draw the conclusion, but it at least provides an explanation of the graphical data in Images 2 & 3 and the reported observations of sch4p4( 6) Personal inf. Assuming that the first overpressure was the result of the ignition of methane, the overpressure may have then caused distribution of the gas to create another pocket within the gas' explosive limits, which might have ignited at the same ignition source as the first. An alternate theory is the possibility that the second overpressure was the result of the ignition of coal dust uplifted by the initial pressure wave. The Inspectorate investigators have much greater experience in underground operations than the writer, so I defer to their expertise.

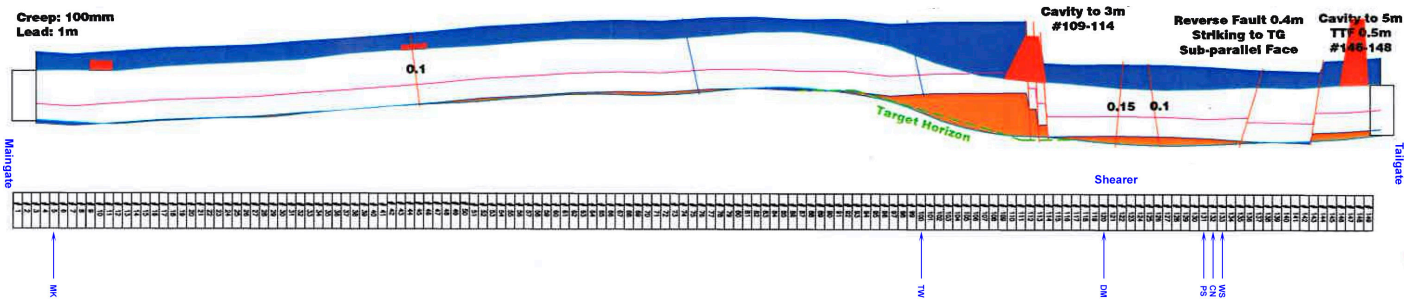
The writer understands that of these, sch4p4( 6) Personal info suffered the most significant burns. The indicated locations of these personnel and sch4p4( 6) Personal info are provided by the representation of Image 4, where their names are given by their initials.

Image 4 Indicated locations of personnel

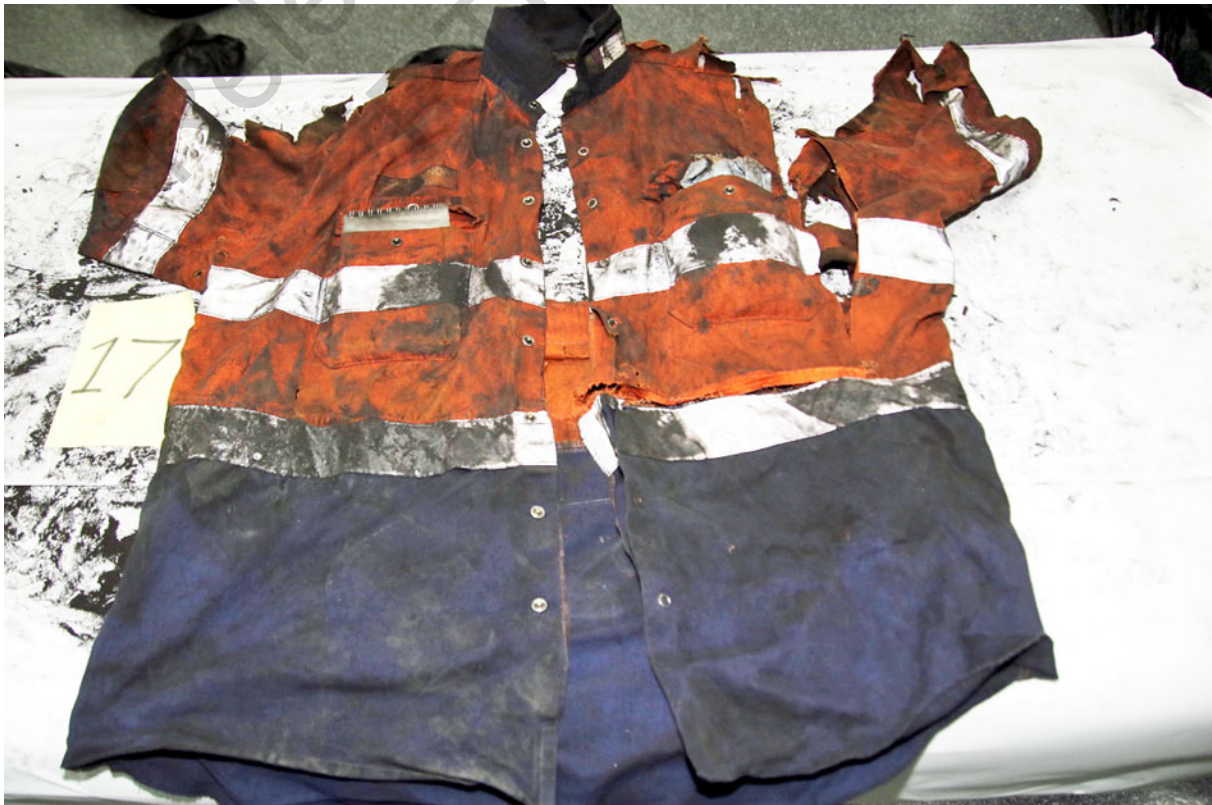
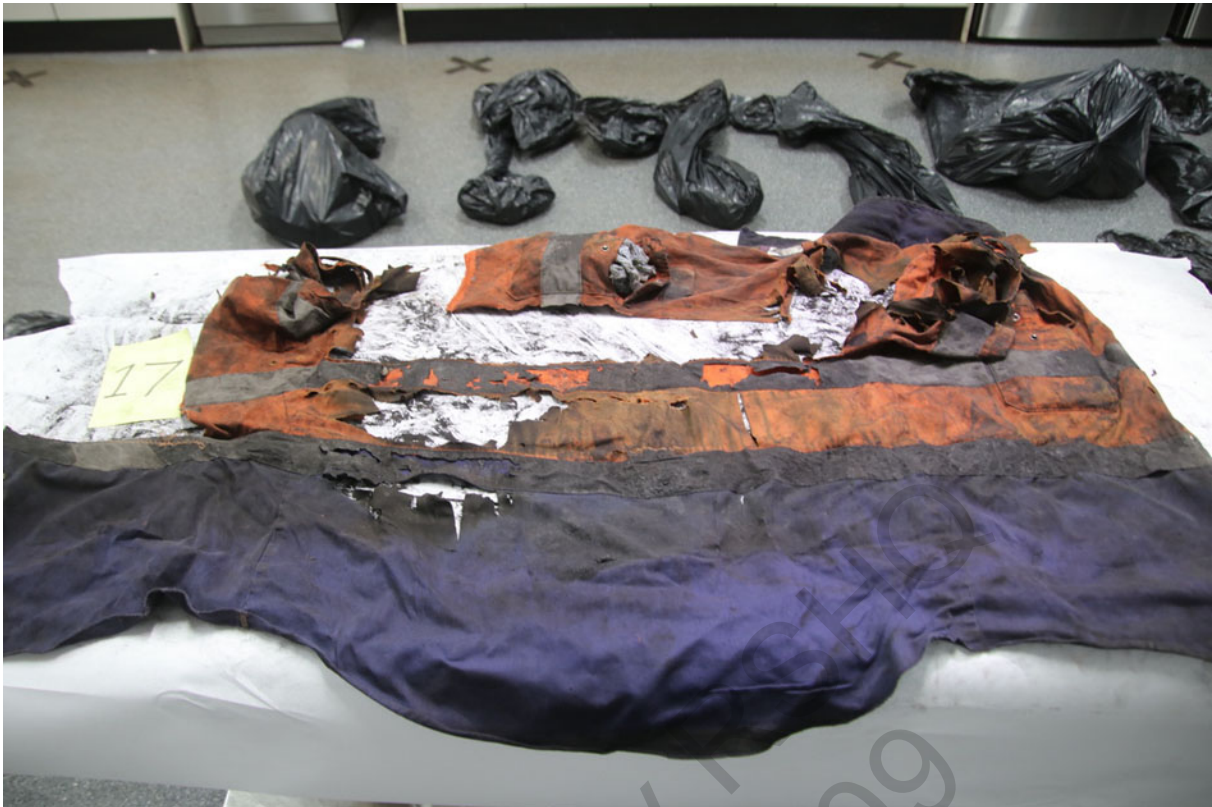
The shirt worn by sch4p4( 6) Pers is seen in Images 5 & 6, and demonstrated most significant damage to the upper back. In Image 6, one notes that the predominant heat damage at the back is toward the left side.

**Image 6** The back of the shirt worn by sch4p4(6) P

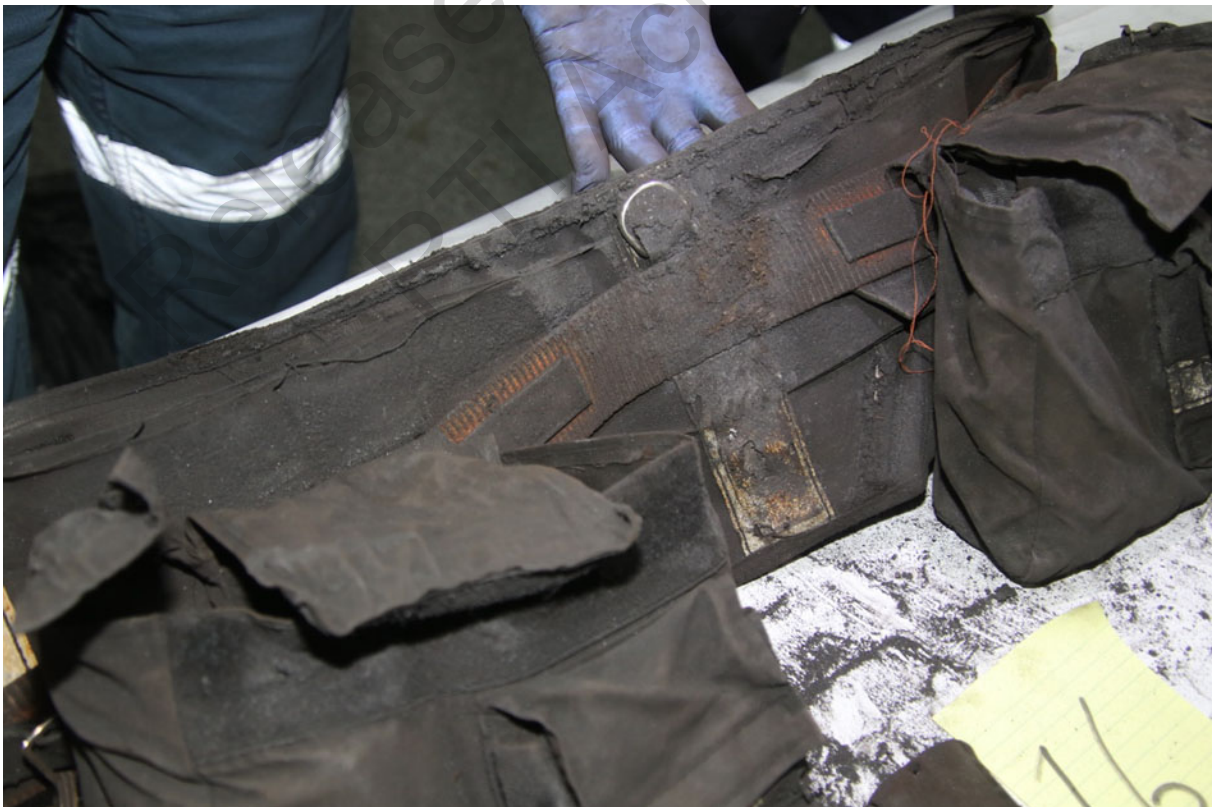
sch4p4(6) Pers's underground belt is seen in Image 7, viewed from the rear. The heat damage here appears to be consistent with the shirt damage, exhibiting most significant effect from the centre to left side.

**Image 7** The underground belt worn by sch4p4(6) P

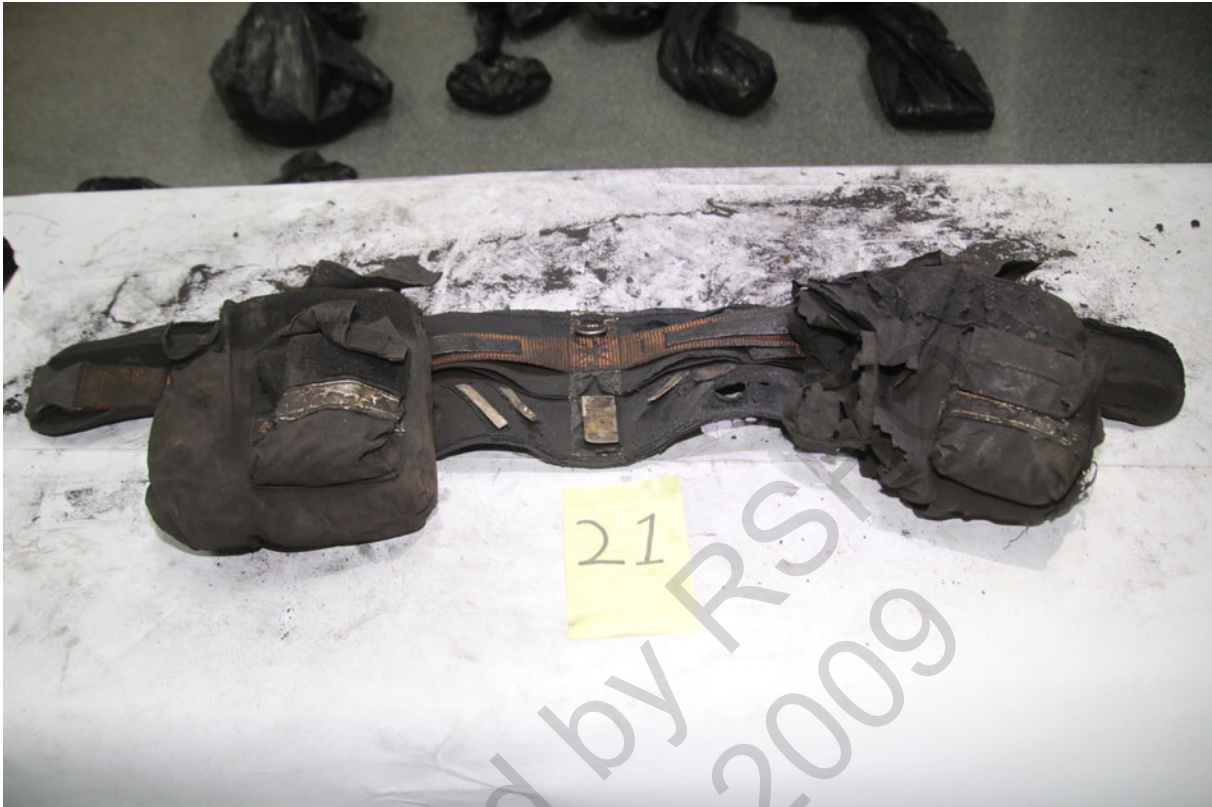
Damage to the underground belt worn by sch4p4(6) Personal is seen in Image 8. It exhibits local fire damage to the rear of the right hand side pocket. It tends to indicate that, with respect to the right pocket, a directionality from the left.

**Image 8** Underground belt – sch4p4(6) Pers t Chock 133

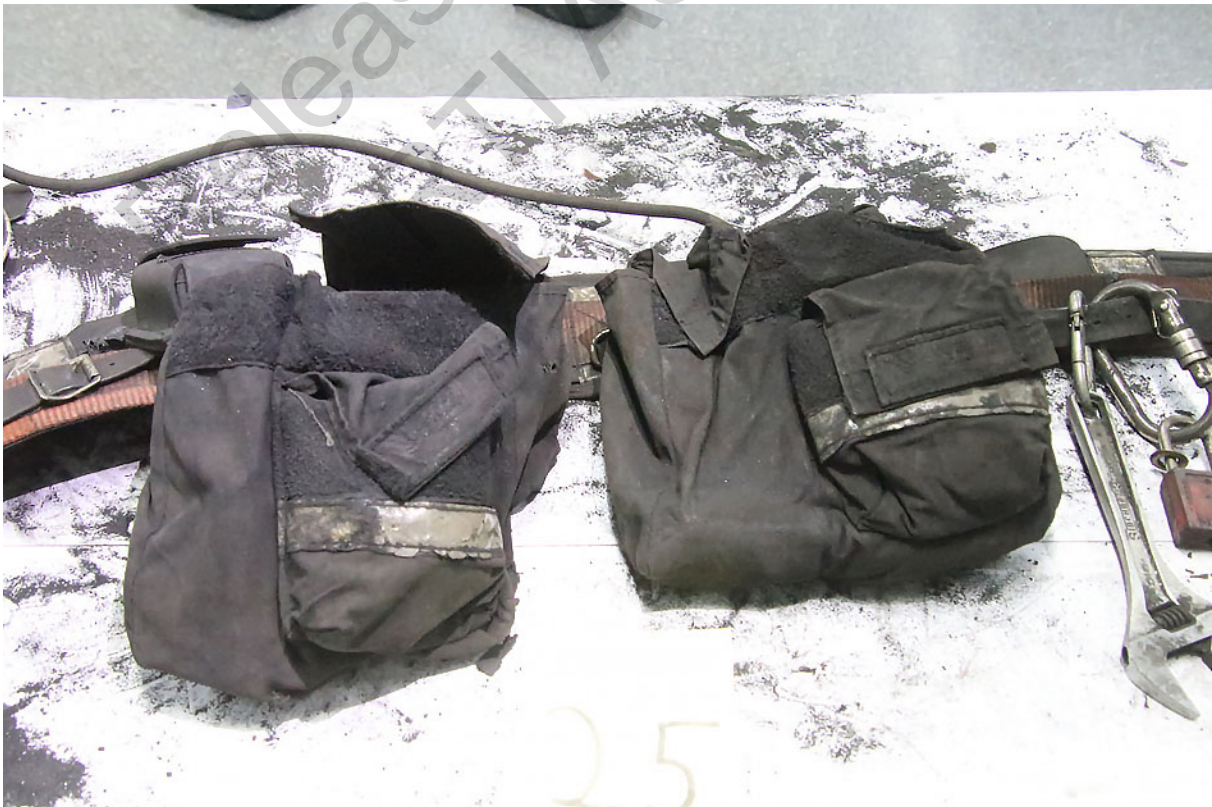
The underground belt for sch4p4(6) Personal inform is seen in Image 9 and is burnt from the left.

**Image 9** Belt from sch4p4(6) Perso at Chock 120

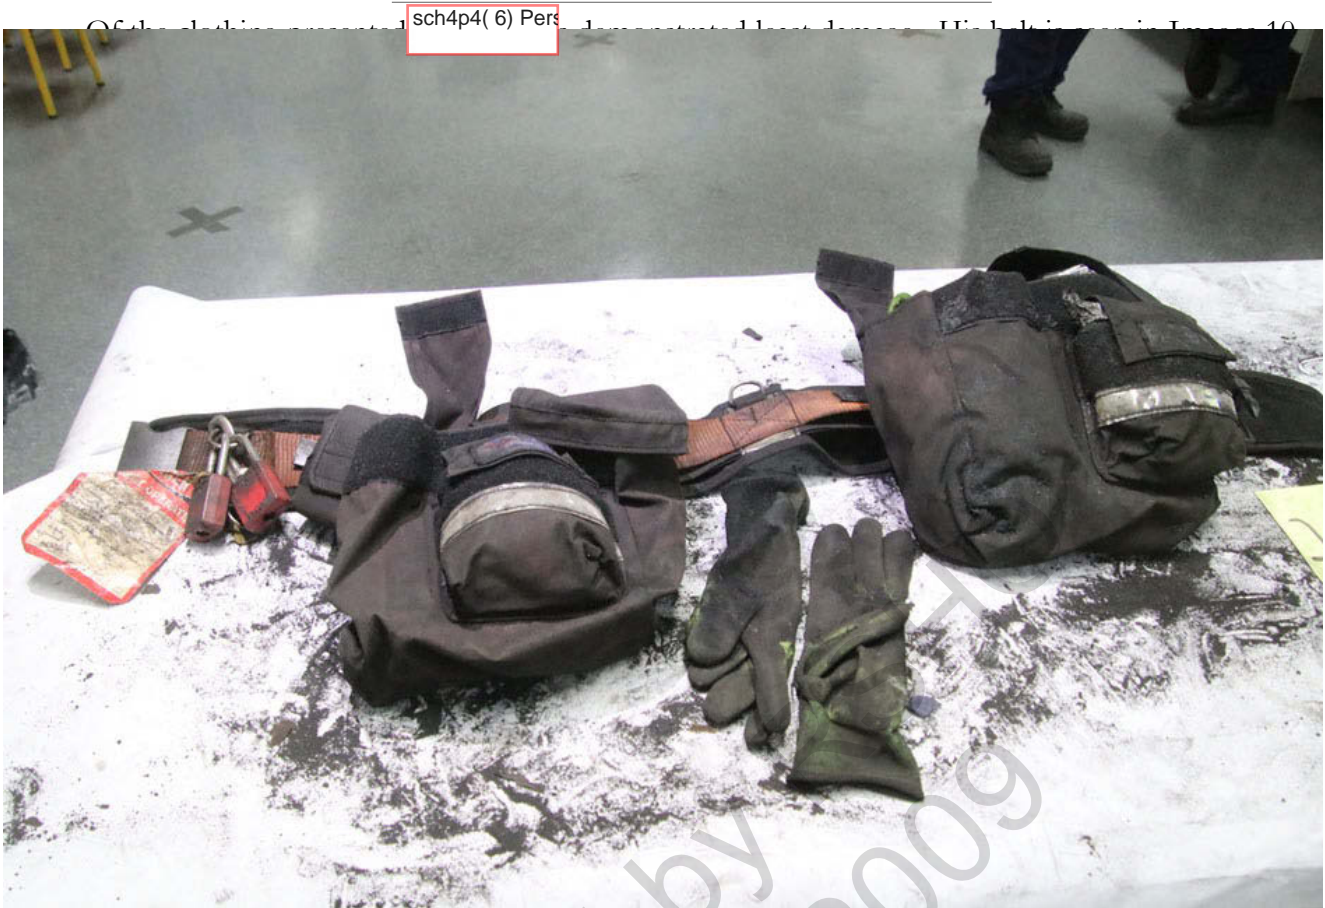
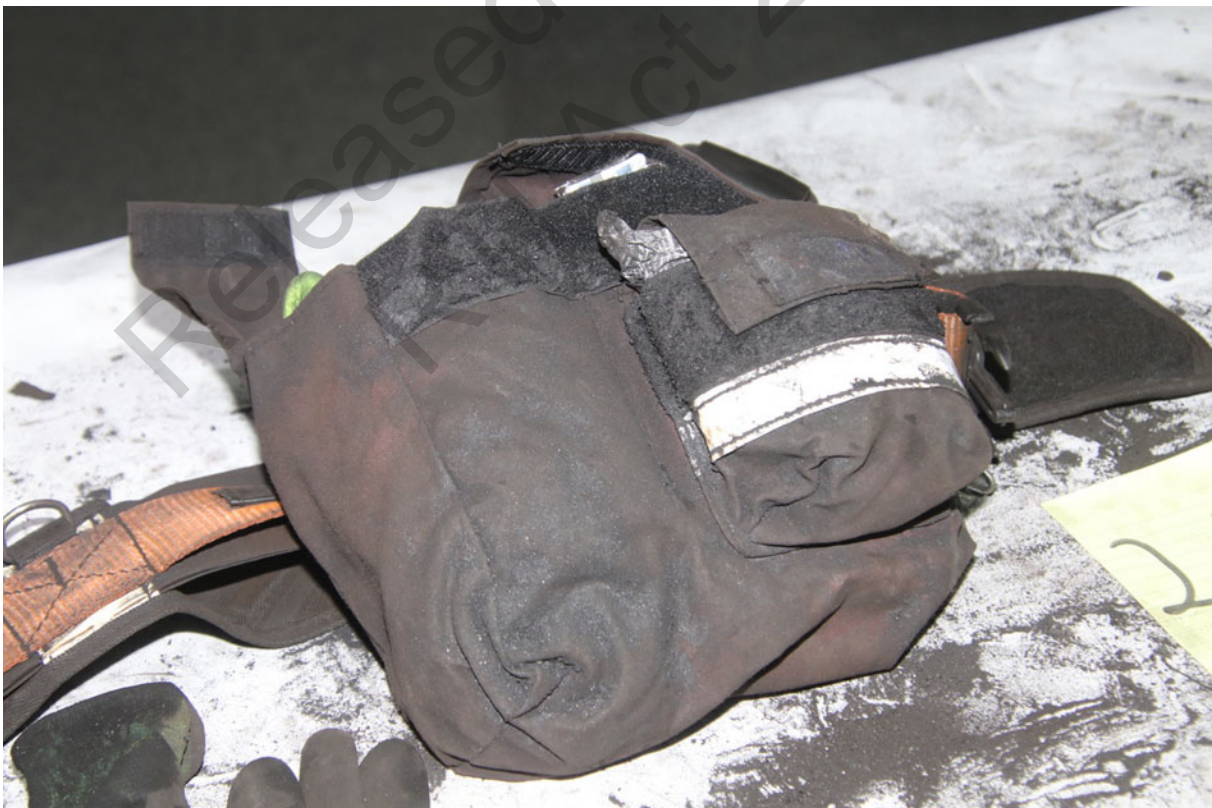
Images 10 & 11 sch4p4( 6) underground belt from Chock 100

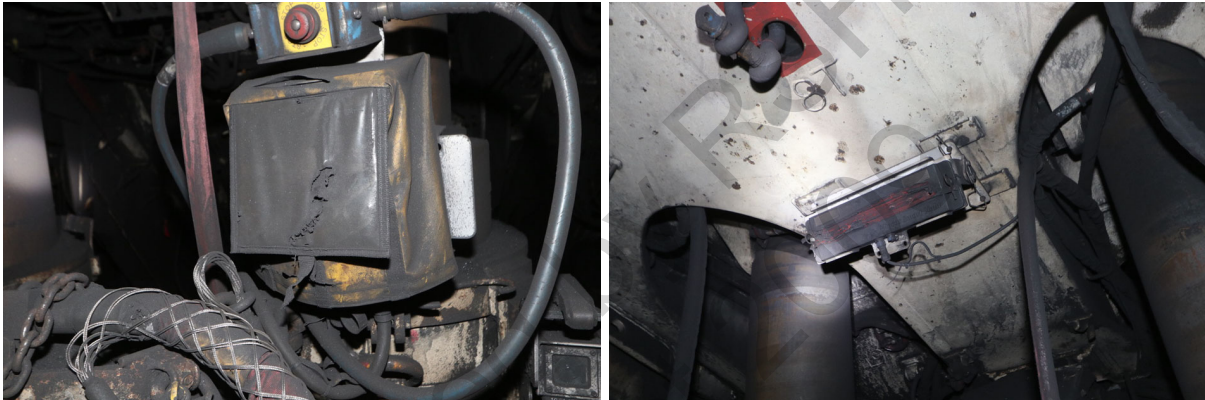
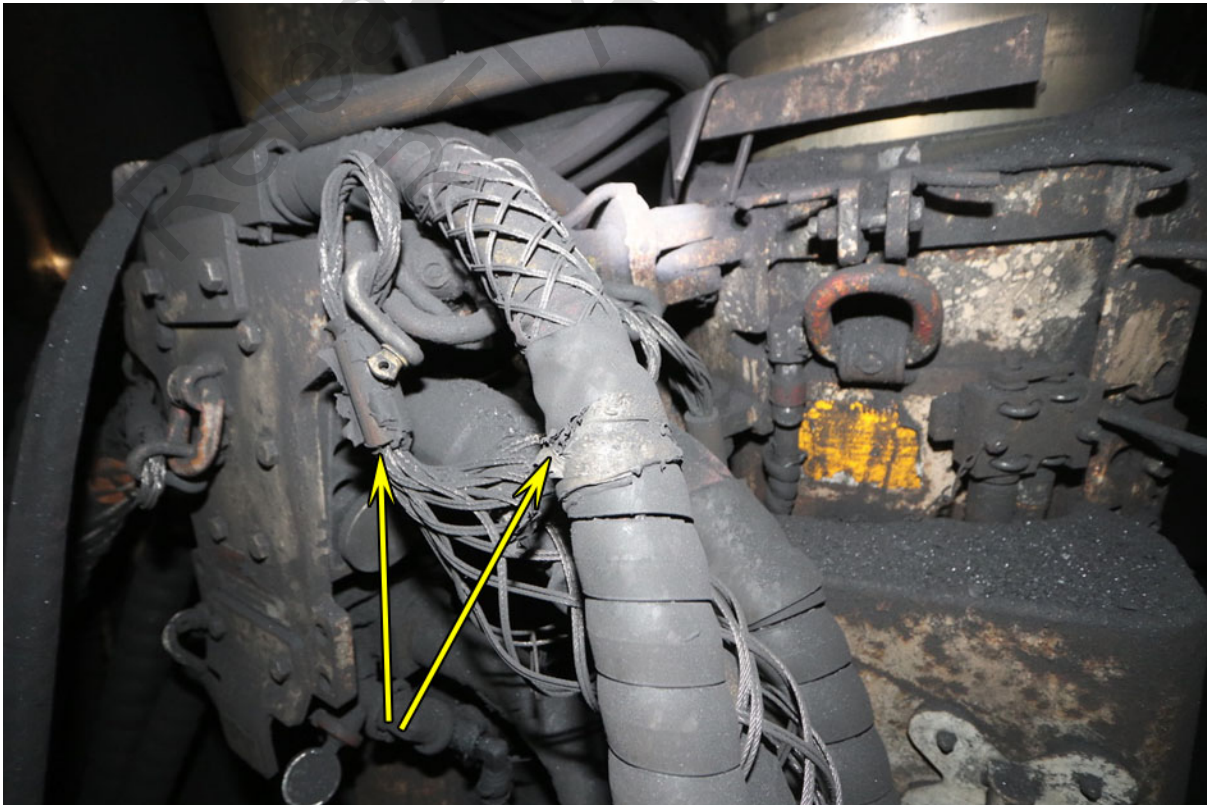
There appeared to be varying intensities of fire damage to combustible elements at the Chocks along the Longwall from about Chock 107 through to Chock 141. Very little heat damage was seen closer to the Maingate end. For example, the limited heat damage observed at the cover of the communications module and an overhead LED light at Chock 100 is seen in Images 12 & 13, while some degree of flame exposure was evident at Chock 101 (Image 14).

Images 12 – 14 Limited damage to fixtures at Chock 100 (above) with slight damage observed at some surfaces at the adjacent Chock 101

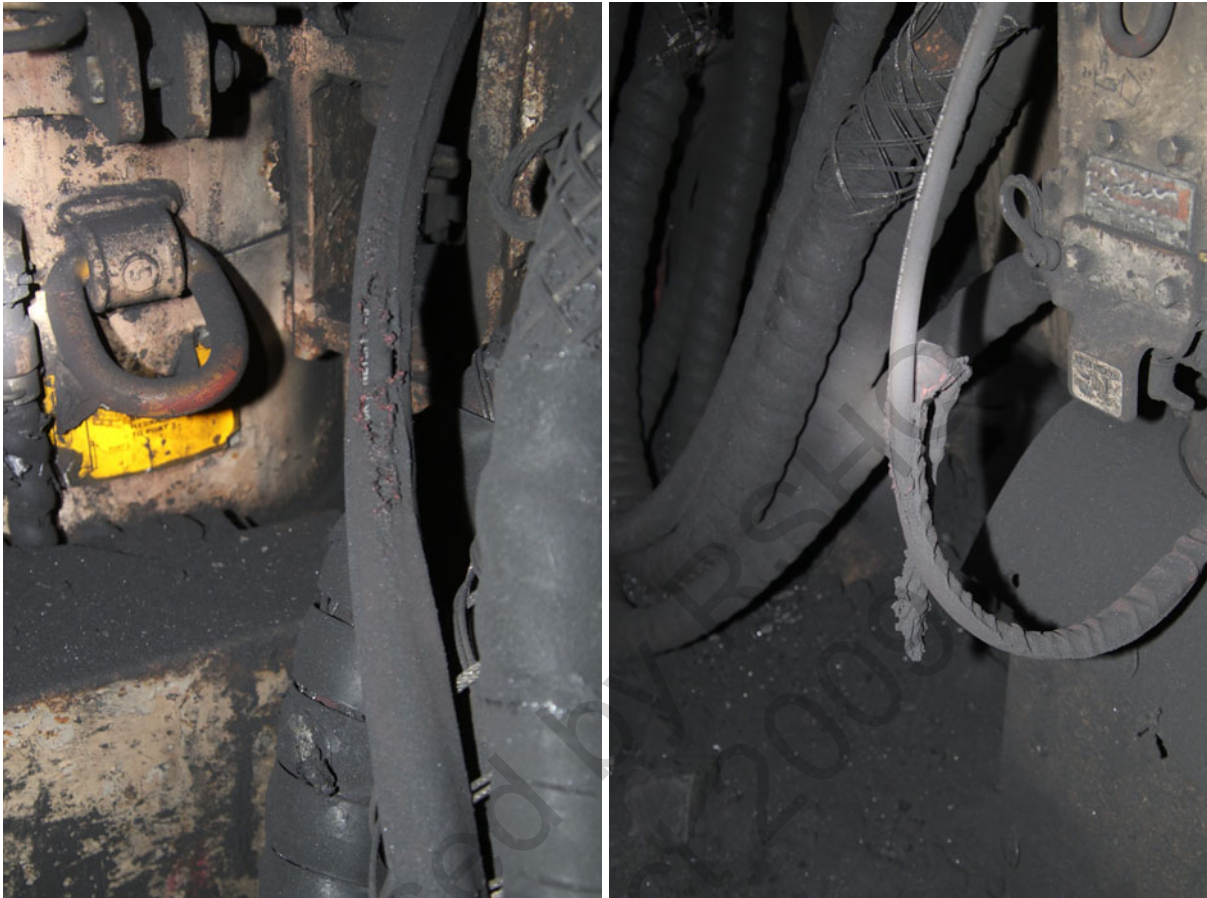
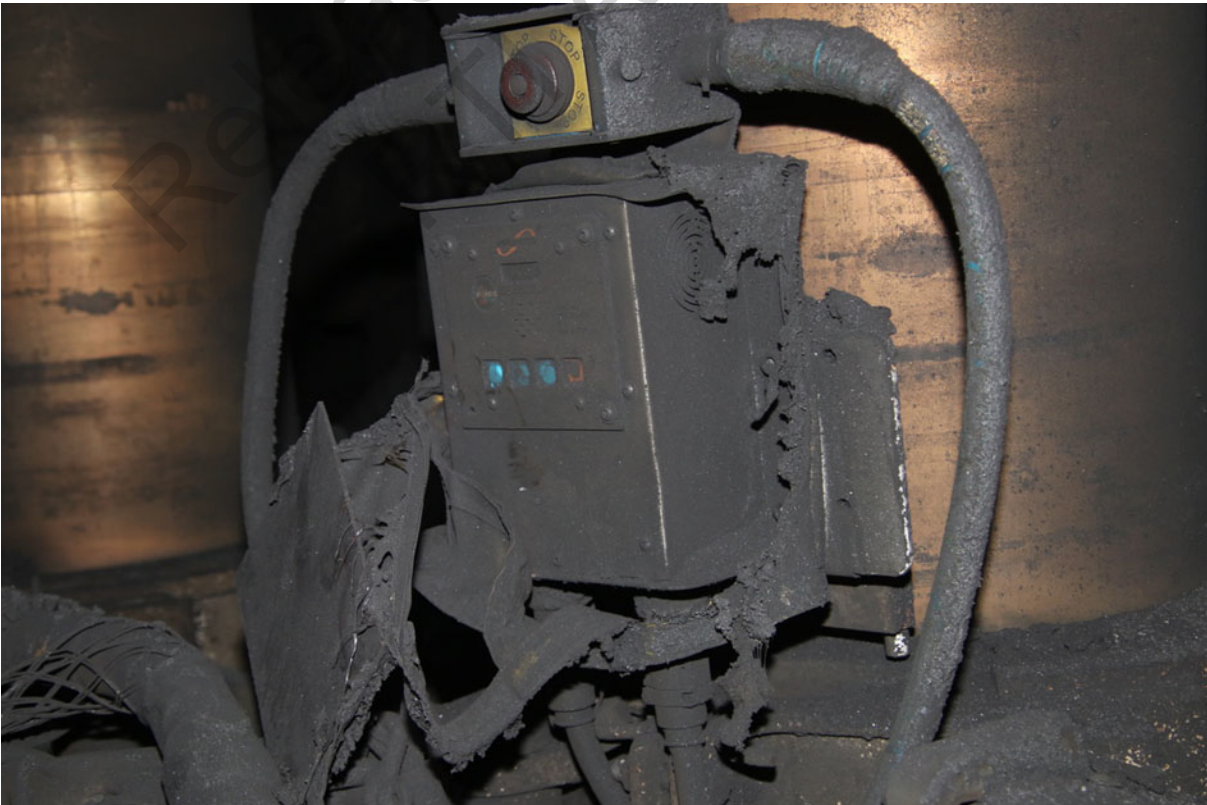
At Chocks 107 & 108 greater damage was observed to coverings on hoses (Images 15 & 16), and the cover on the communications module at Chock 110 (Image 17) suffered significantly greater damage than that at Chock 100.

Images 15 – 17 Increasing fire damage in surfaces from Chocks 107 to 110

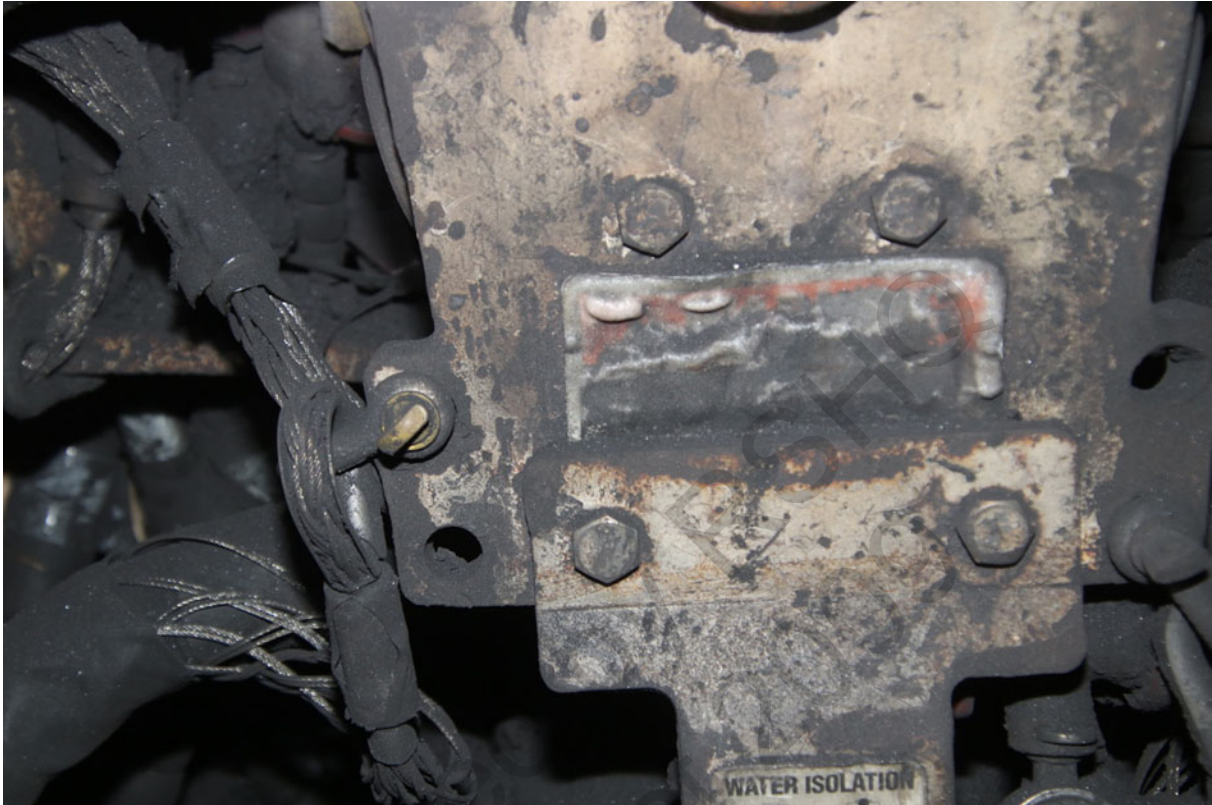
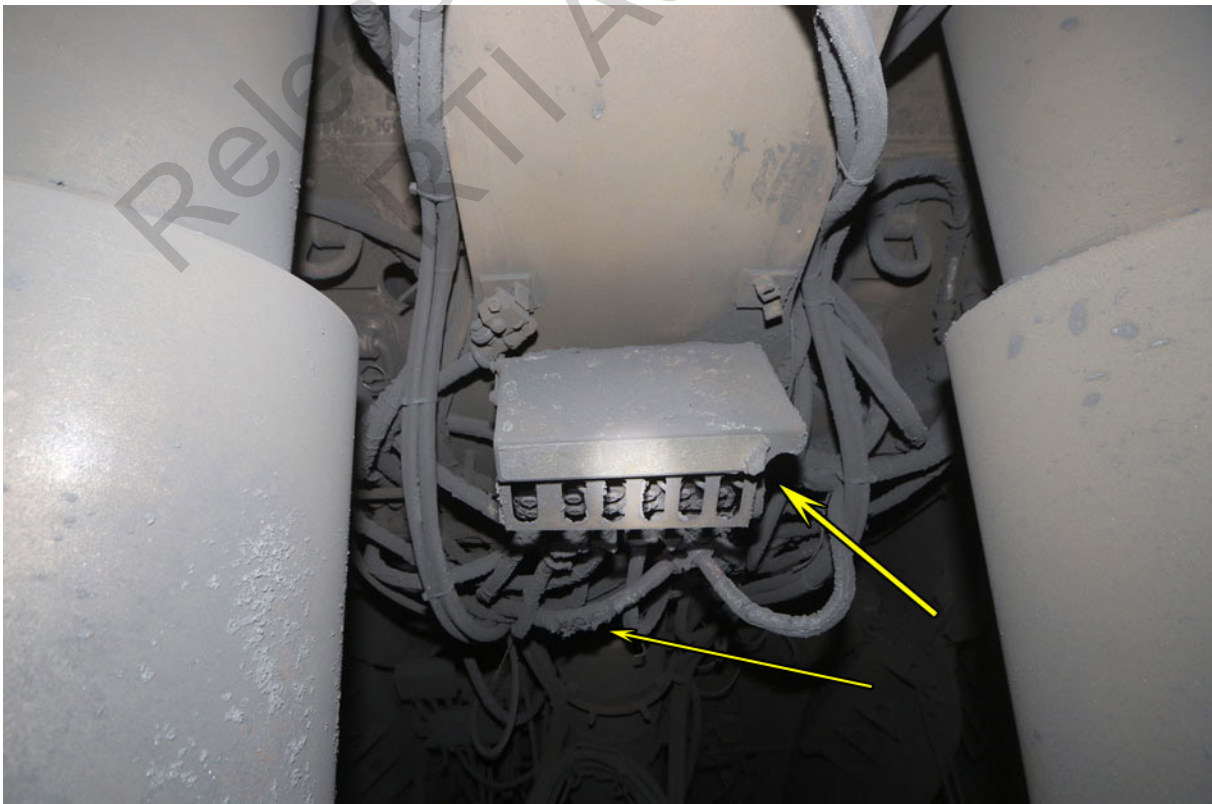
The writer searched for other directional indicators. A label on Chock 107 (Image 18) indicated that a flame advanced across it from the Tailgate direction (from the left in this image), while other indicators nearer the Tailgate demonstrated flame advancement from the Maingate end. Image 19, for example, shows a plastic label over the elevated valve bank at Chock 123 that is melted from the Maingate side (right in this image) with local damage to the covering on adjacent hoses.

Images 18 & 19 Directionality indicia in plastic surfaces on Chocks 107 and 123 that point to a flame developing from between

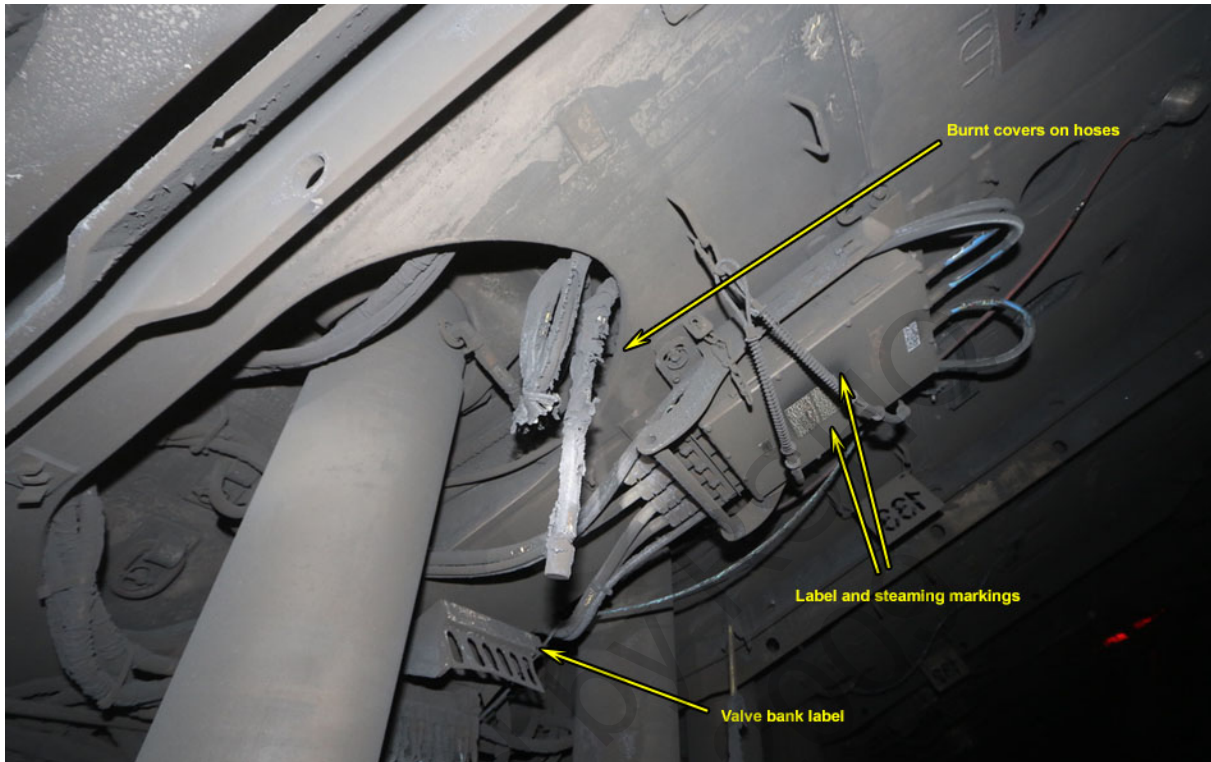
Even though the hoses above the rear walkway of Chock 123 demonstrated local fire damage, the damage seen at some hoses over the rear over Chock 133, and the plastic label on its valve bank were more severely damaged (Image 20), while another burnt label was surrounded by a streaming surface character indicative of a fire developing from the Maingate end.

**Image 20** Some evidence seen high at Chock 133

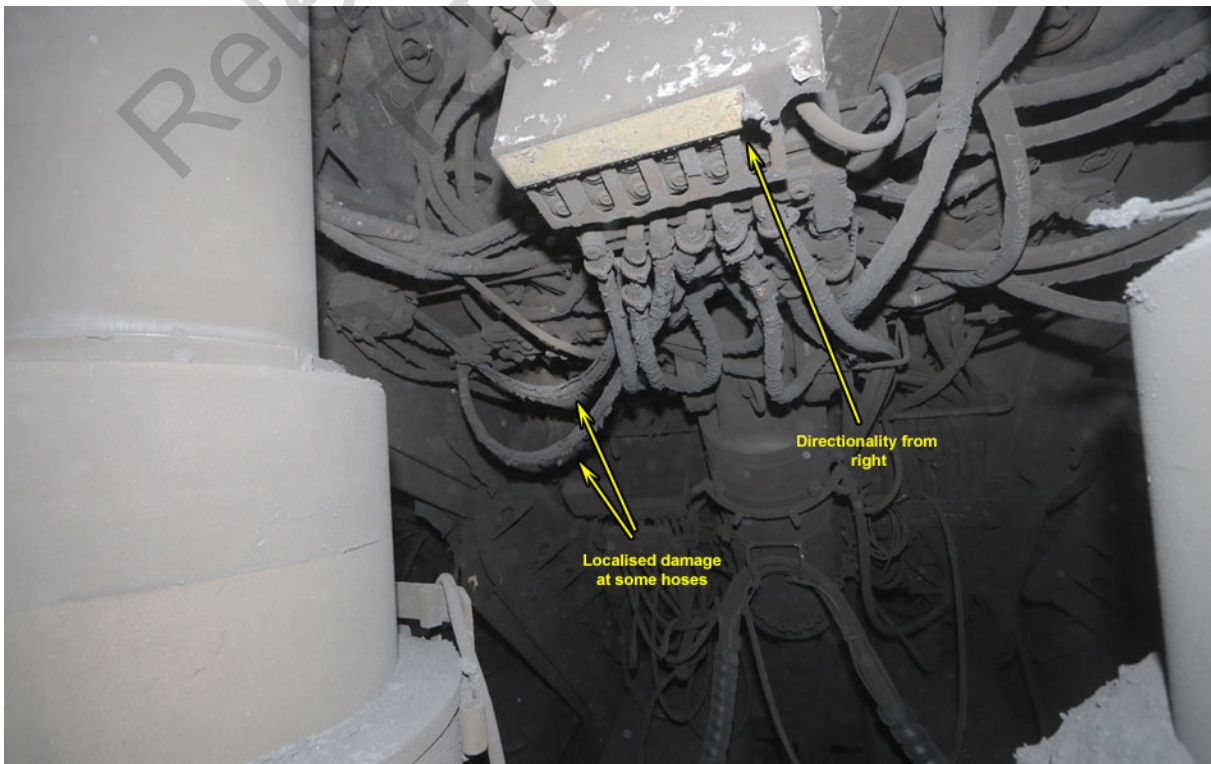
Such was the fire pattern. Both a general directionality and evidence of localised intensity were seen about the Chocks before the Longwall. The area of the valve back at Chock 136 provided evidence of more significant damage rearward of the valve bank and to its left (Tailgate aspect) while the plastic label was directionally burnt from the right (Maingate side) (Image 21).

**Image 21** Some evidence seen high at Chock 136

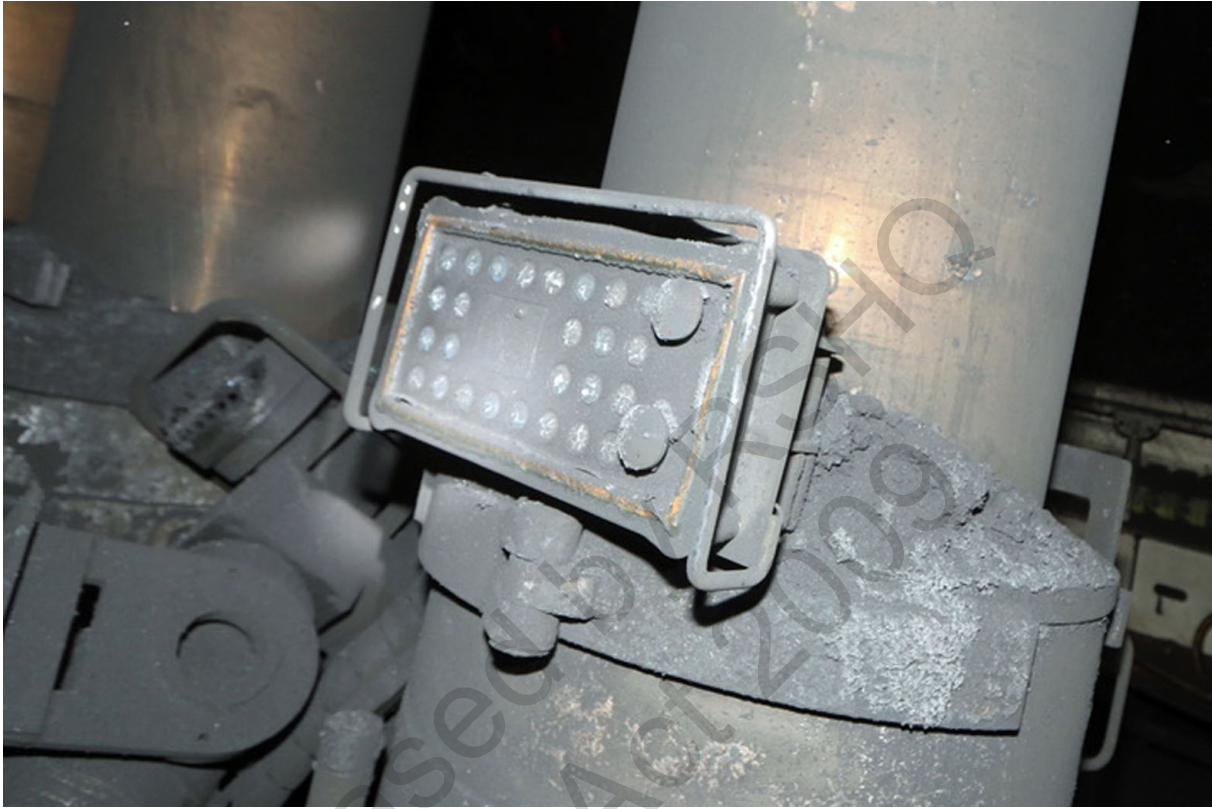
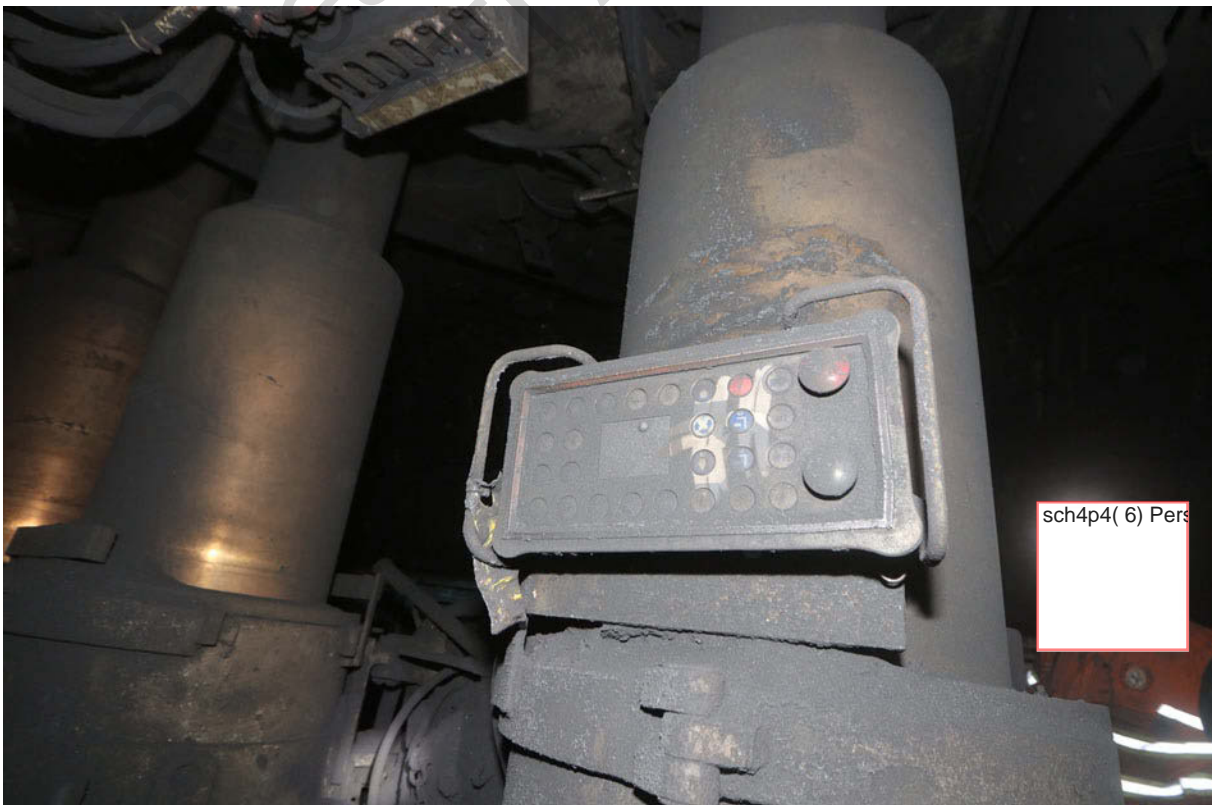
The damage appeared to diminish beyond the Tailgate end of the Longwall to a point just past the side access roadway number 37 in the Tailgate. By following the directionality indicia, I found that the general area of Chock 111, which demonstrated significant local damage, appeared to be the centre from which the directional indicators travelled. The extent of damage to a controller for Chock 111 is seen in Image 22. By contrast, the controller in this position on the adjacent Chock 110 was substantially less damaged (Image 23), and overhead damage at the valve bank at Chock 111 was substantial (Image 24).

Images 22 & 23 Substantial damage at the rear controller of Chock 111 compared to lesser damage at Chock 110

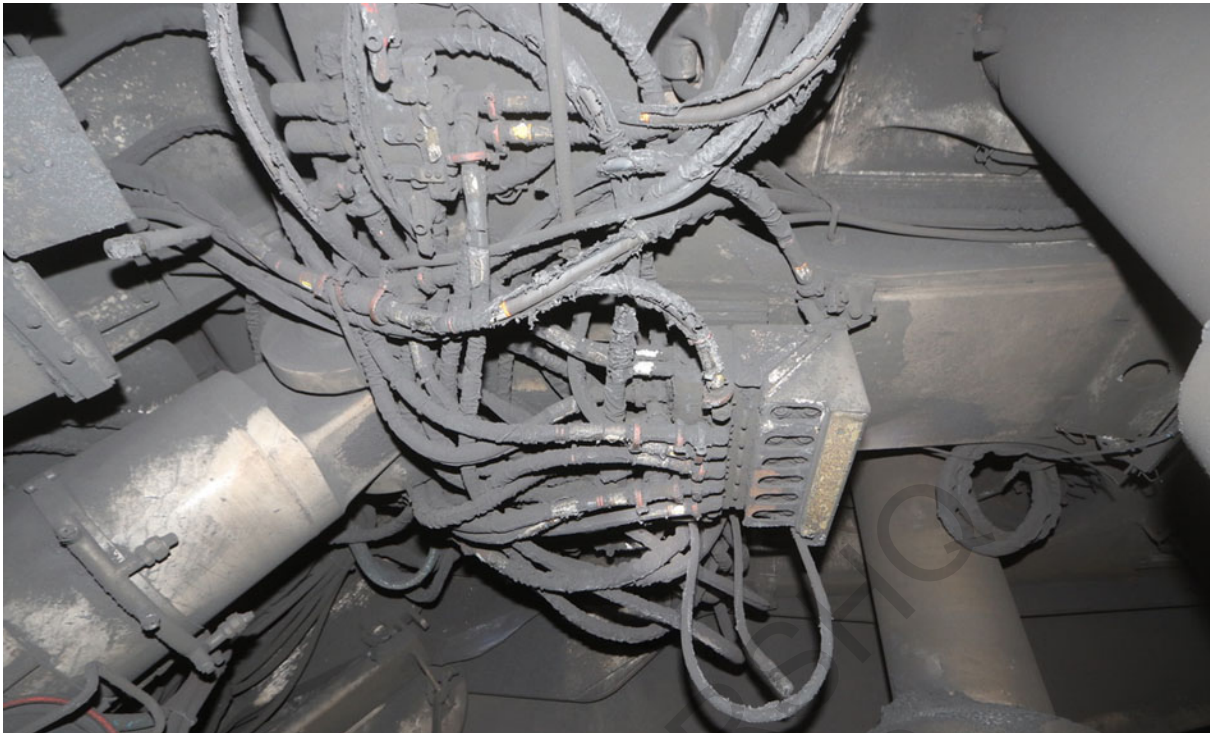
**Image 24** The valve bank at Chock 111

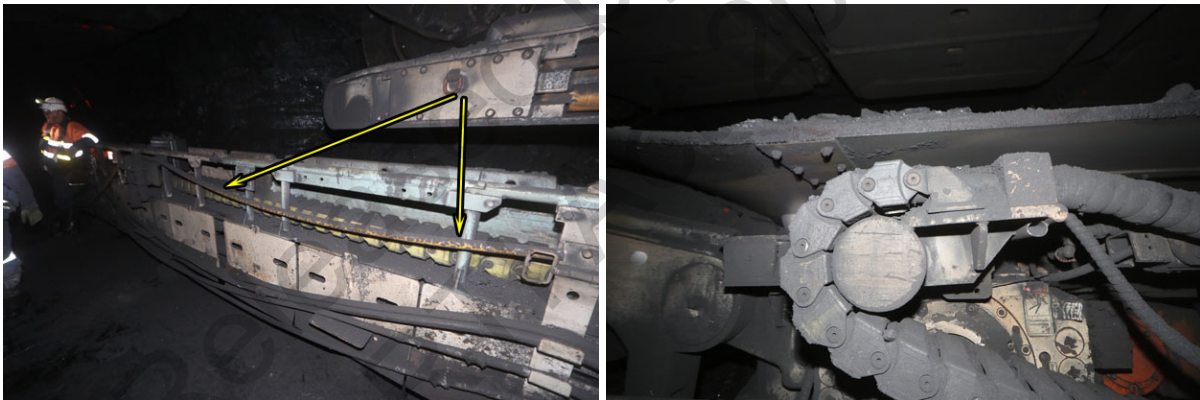
Some reasonably low elevation fire damage was observed on cable covers and the bretby of the Shearer in the vicinity of Chock 120 (Images 25 & 26).

**Images 25 & 26** Reasonably low elevation fire damage at the Shearer
