## FIRE INVESTIGATION

**INCIDENT LOCATION** Longwall 104  
AngloAmerican Grosvenor Mine  
MORANBAH Q 4744

**DATE OF INCIDENT** Wednesday 6 May 2020, about 2.57pm

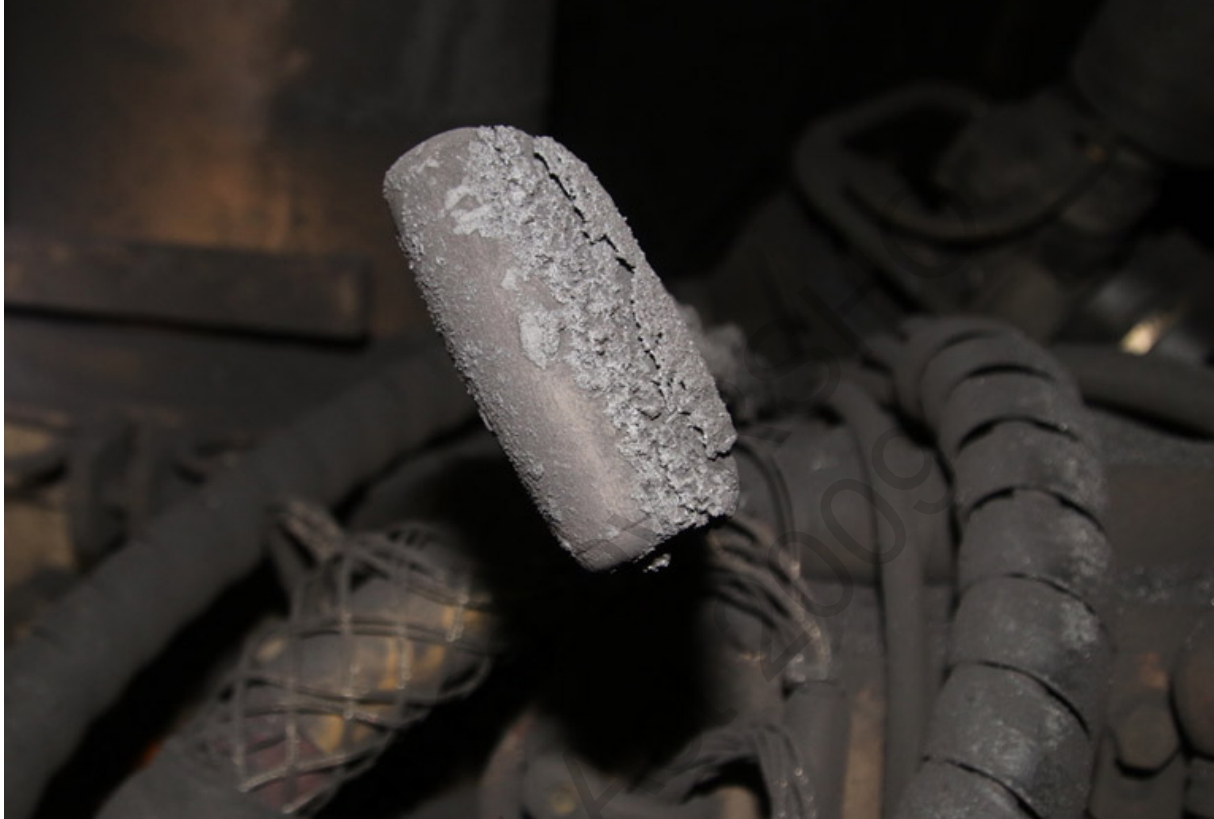
The sudden overpressure is also likely to uplift fine particles. I would expect a pressure wave from methane deflagration to uplift coal dust and ignite it. This was evident in the evidence, such as seen in Image 27, where uplifted coal dust has ignited, but then condensed onto the side of the handle of a shovel from the direction of ventilation travel.

**Image 27** Ignited coal dust has condensed onto the side of surfaces by passing ventilation

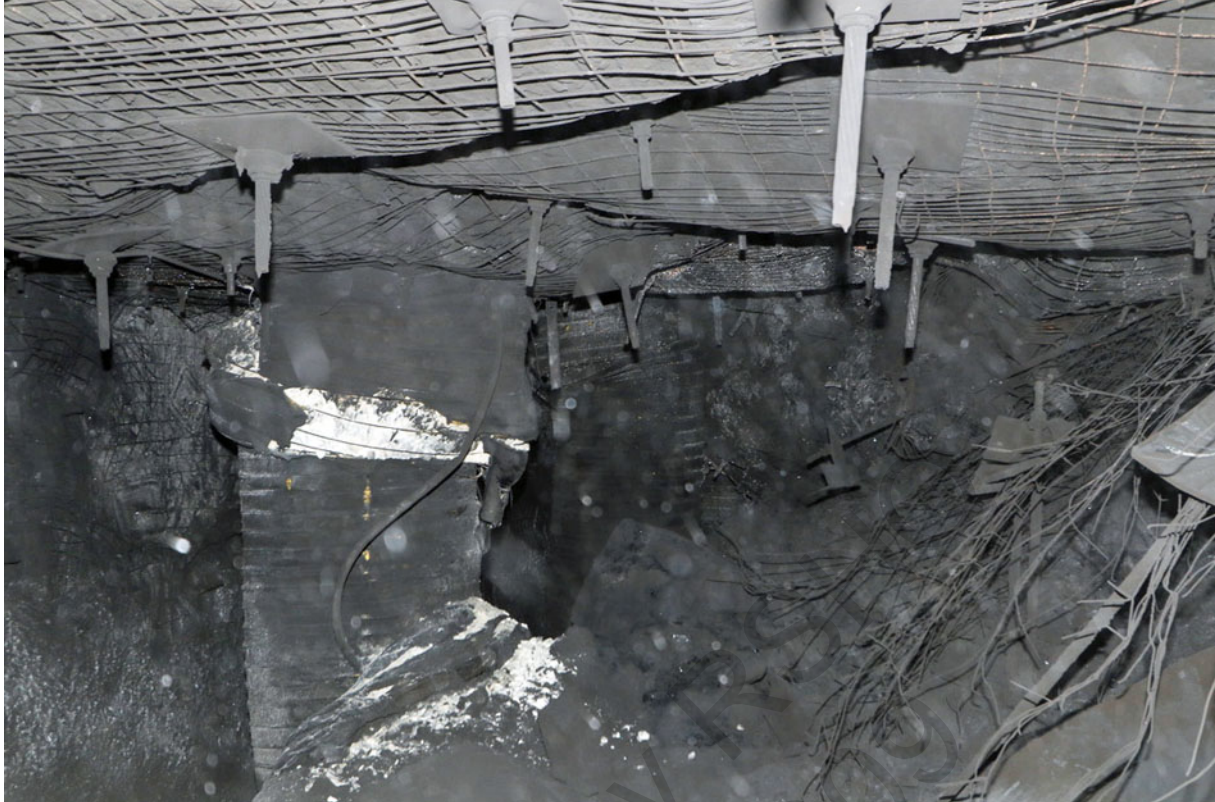
The first matter at hand was the issue of the two pressure waves. It was clear that there had been sudden collapse of the roof in the goaf, evidenced in Image 28 at the Tailgate about 15m to the rear of the Chocks. Whether it is possible that this was responsible for the first overpressure could be explored by examining historical data for previous blocks where roof falls have occurred. Such an examination of data could show the expected range of waves from such events for comparison. Geotechnical experts may also be of assistance.

**Image 28** Evidence of a roof fall in the goaf to the rear at the Tailgate

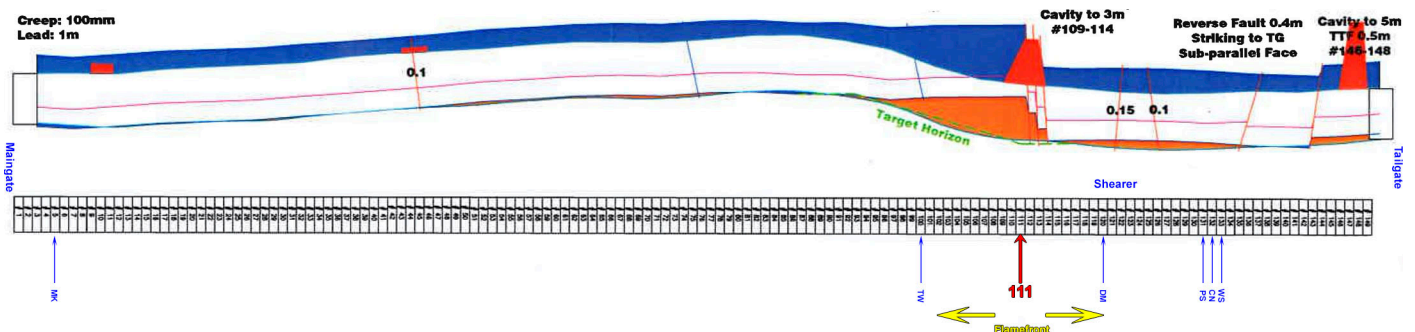
**Image 29** The location of Chock 111  
File A

The evidence indicates that the flamefront originated in the vicinity of Chock 111. Evidence in the sighted clothing from some personnel provides consistency, with fire appearing to approach from the right of [sch4p4(6) Personal information] and from the left of [sch4p4(6) Personal information]. The source of ignition is not yet concluded.
