## FIRE INVESTIGATION

**INCIDENT LOCATION** Longwall 104  
AngloAmerican Grosvenor Mine  
MORANBAH Q 4744

**DATE OF INCIDENT** Wednesday 6 May 2020, about 2.57pm

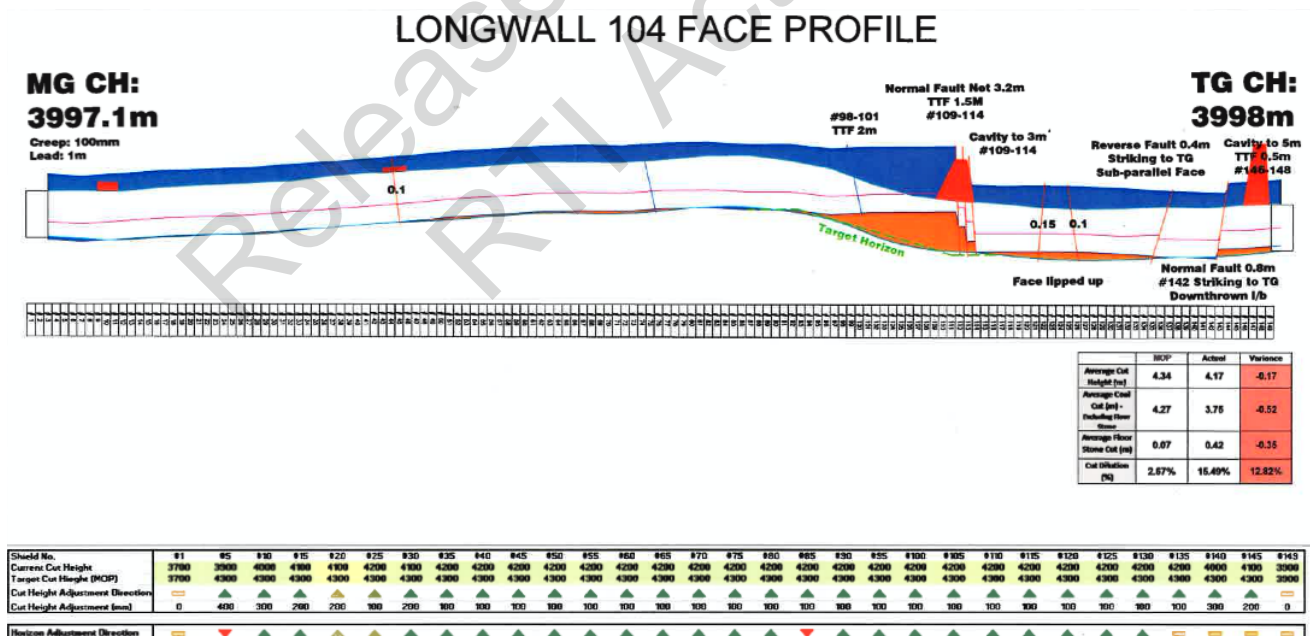
Image 1 The Longwall profile

Longwall 104 comprised a coalface of about 300m length between the Maingate and Tailgate with 149 Chocks numbered from the Maingate end. The coalface was typically 4.2m high with the overall profile rising slightly in elevation between Chock 1 and about Chock 90 then descending sharply through to about Chock 114 in the area of a fault and 3m ceiling cavity. The face profile obtained in briefings follows.

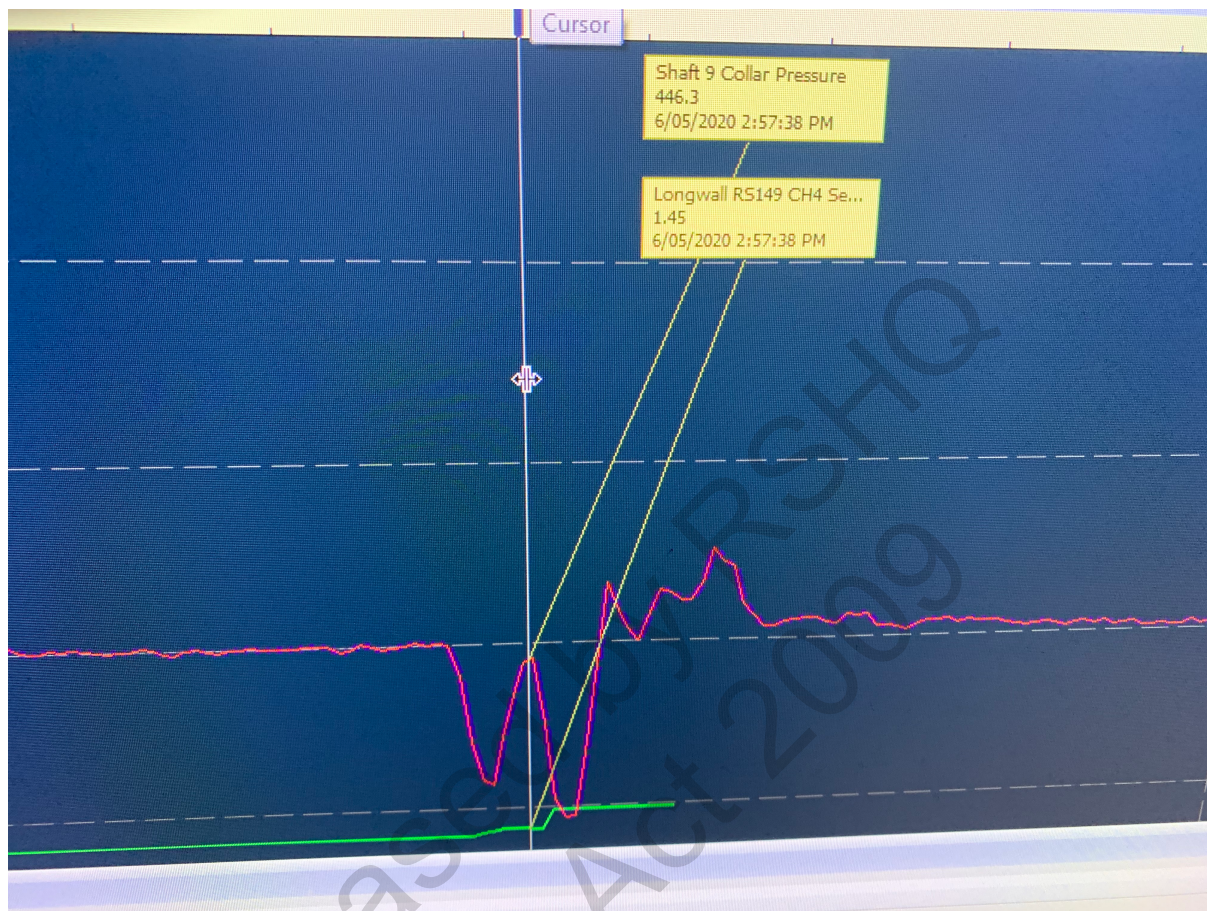
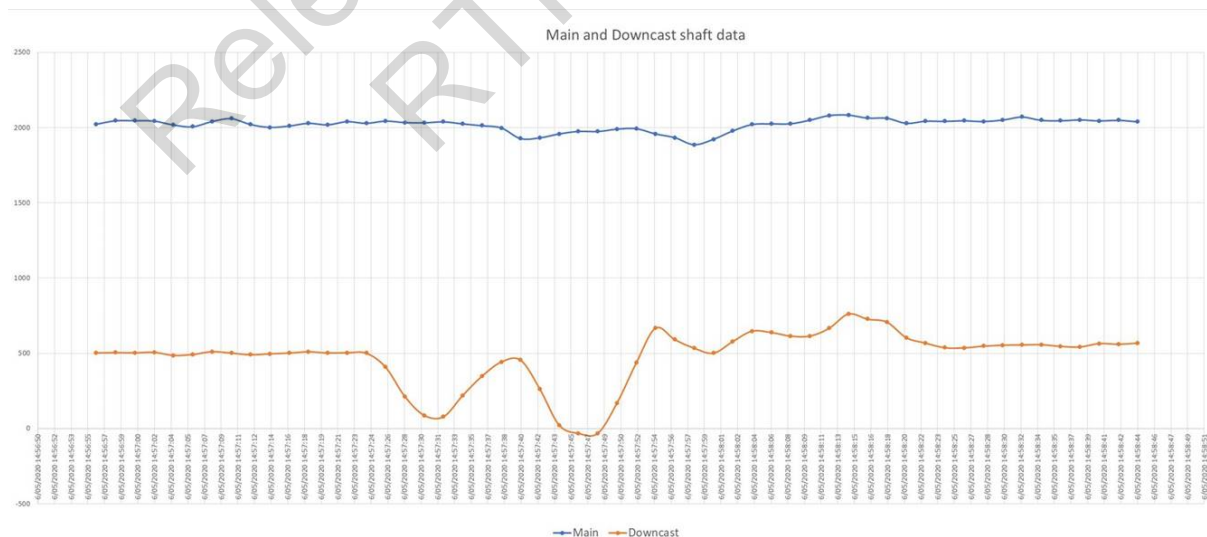
Though I have not been provided a printout of data, I saw a screenshot of graphical data captured by Mark LYNDON, an electrical inspector of the Inspectorate, that confirms two spikes in pressure data measured at a goaf well about 15 seconds apart (Image 2) and an image of some other data (Image 3) collected by you. Though not familiar with the measurement tools, the data is meaningful to the extent that it confirms the reported observations of sch4p4(6) Personal information

Images 2 & 3 Reproductions of the screenshot and other data indicating two pressure waves

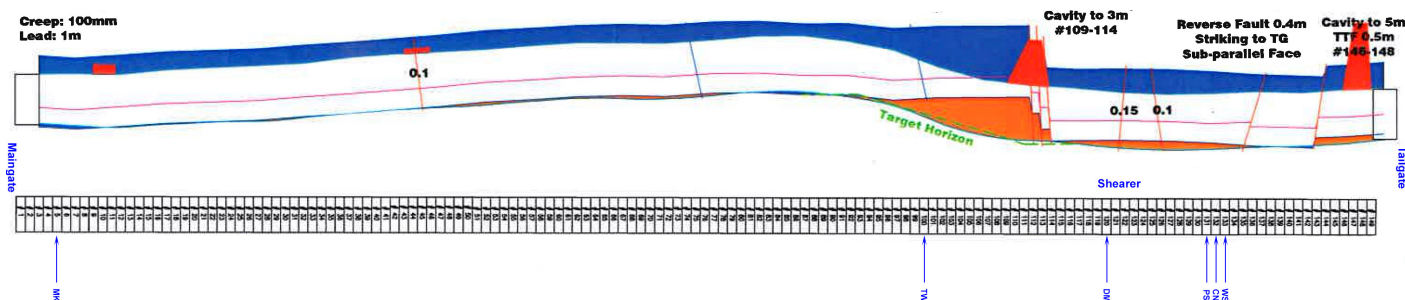
The writer understands that of these, [sch4p4( 6) Personal info] suffered the most significant burns. The indicated locations of these personnel and [sch4p4( 6) Personal info] are provided by the representation of Image 4, where their names are given by their initials.

Image 4 Indicated locations of personnel

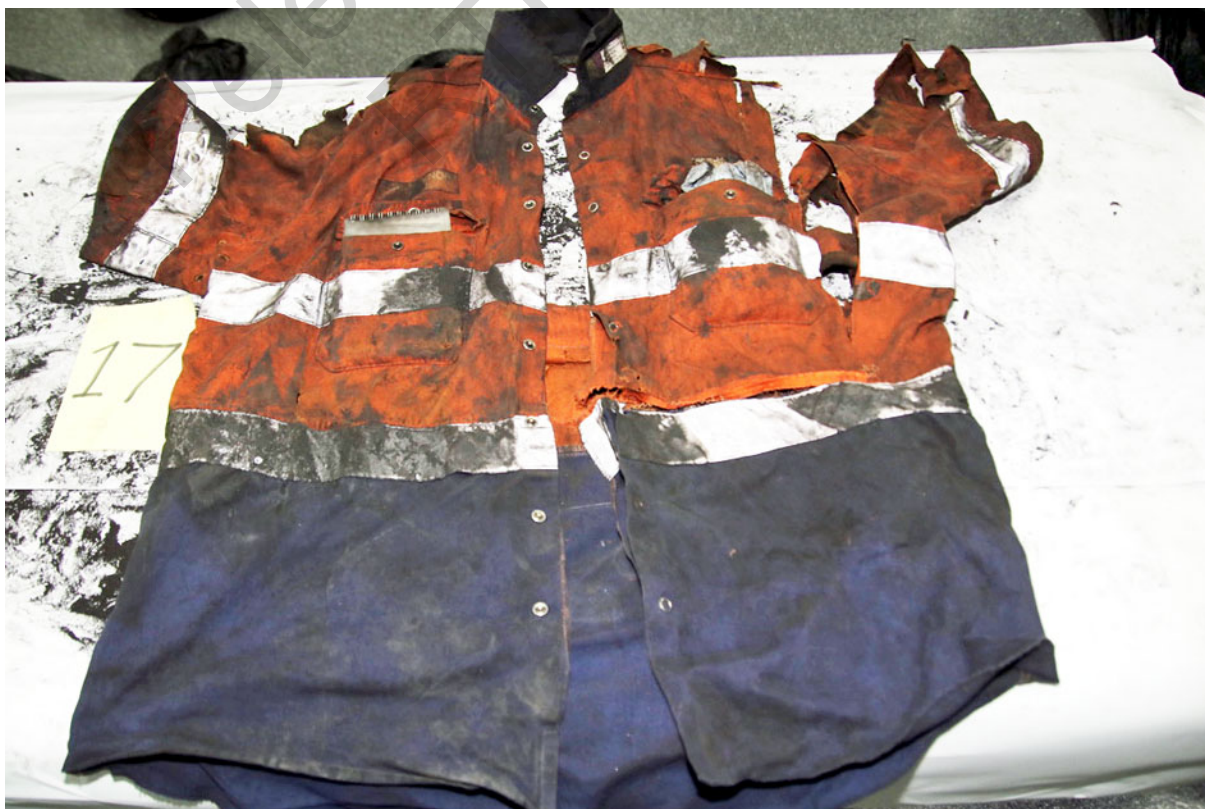
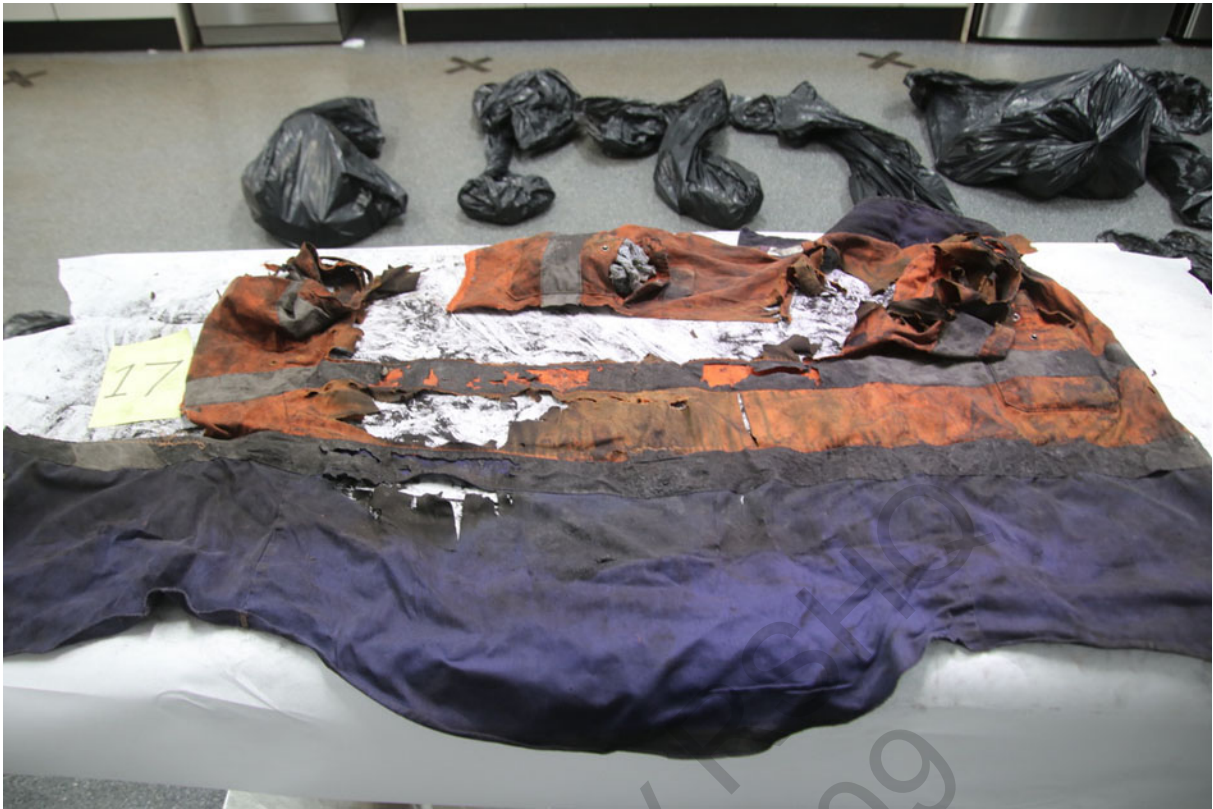
The shirt worn by [sch4p4( 6) Pers] is seen in Images 5 & 6, and demonstrated most significant damage to the upper back. In Image 6, one notes that the predominant heat damage at the back is toward the left side.

**Image 6** The back of the shirt worn by sch4p4( 6) P

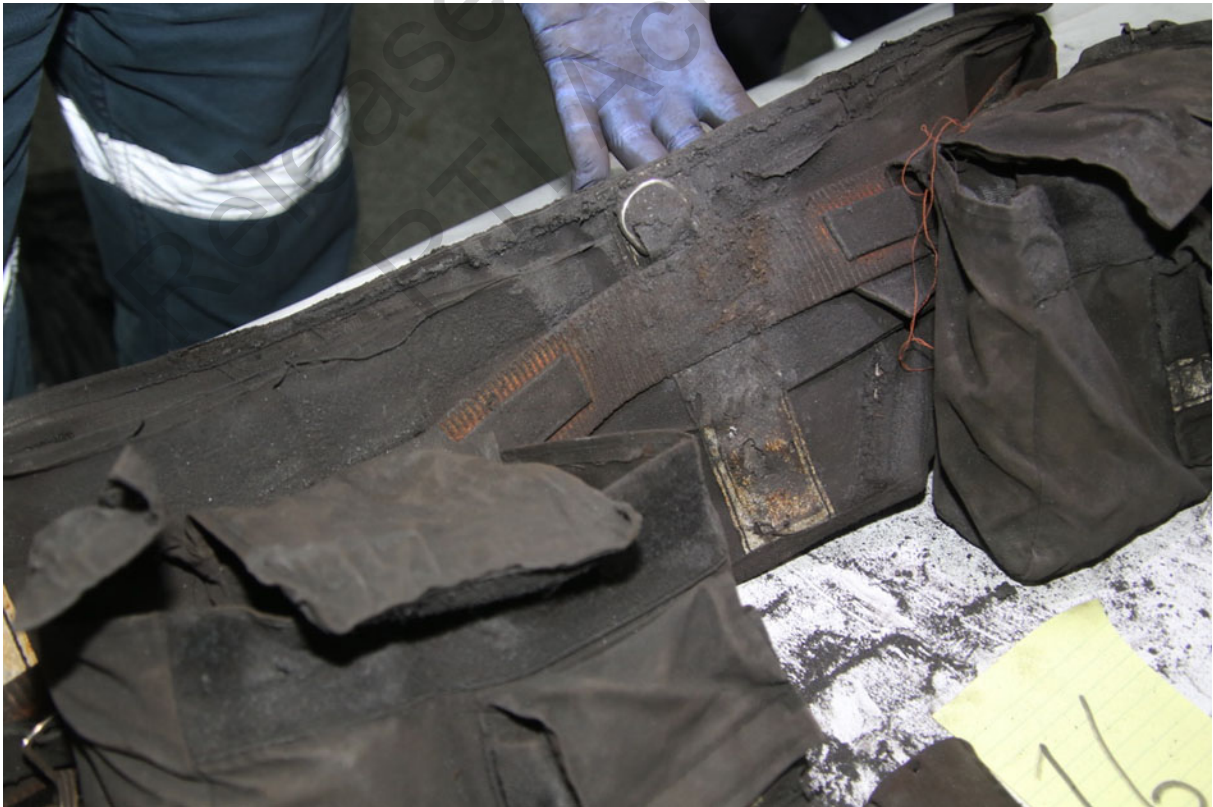
sch4p4( 6) Pers's underground belt is seen in Image 7, viewed from the rear. The heat damage here appears to be consistent with the shirt damage, exhibiting most significant effect from the centre to left side.

**Image 7** The underground belt worn by sch4p4( 6) P

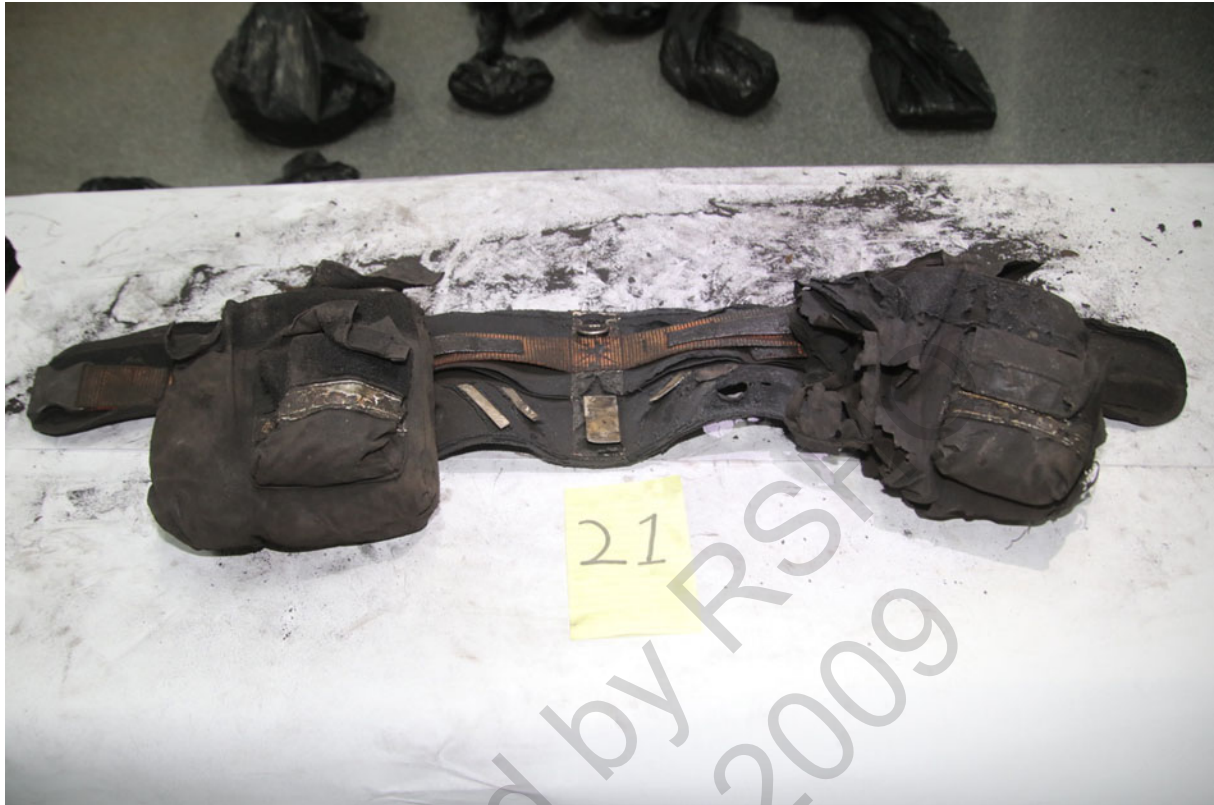
Damage to the underground belt worn by sch4p4( 6) Personal is seen in Image 8. It exhibits local fire damage to the rear of the right hand side pocket. It tends to indicate that, with respect to the right pocket, a directionality from the left.

**Image 8** Underground belt – sch4p4( 6) Personal at Chock 133

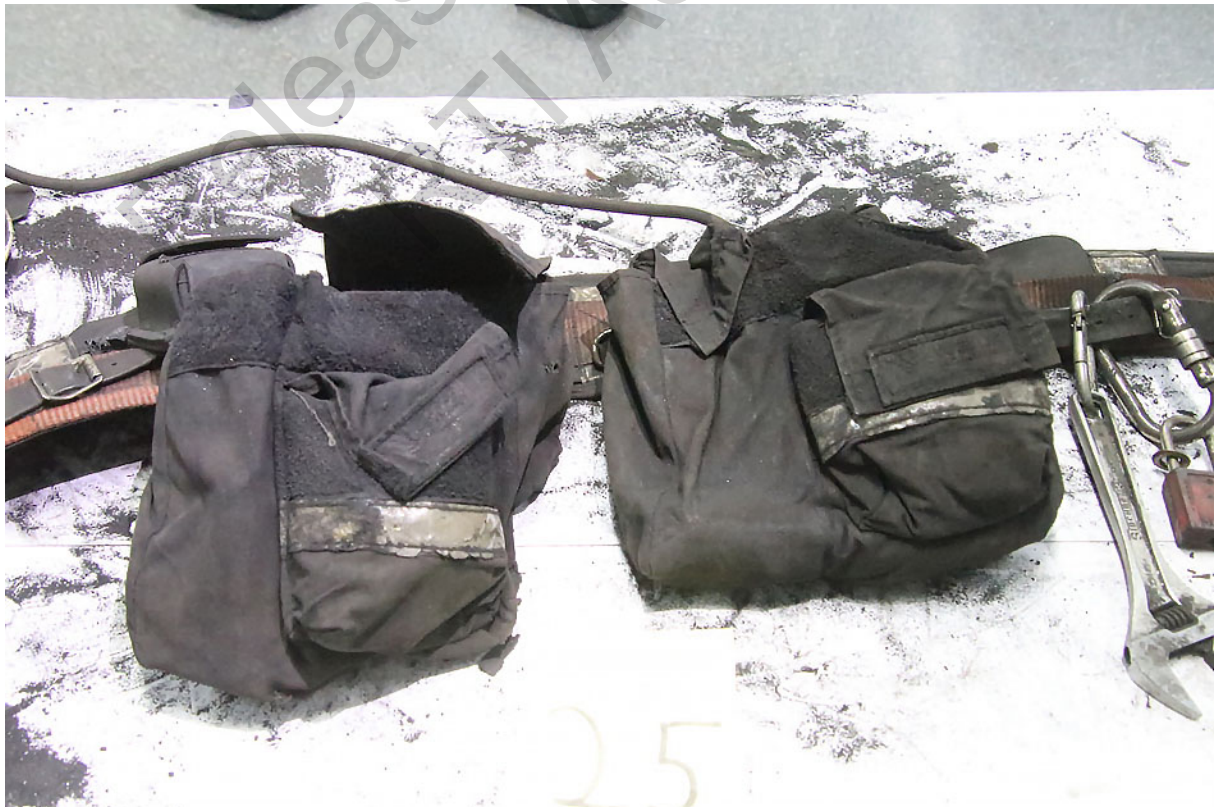
The underground belt for sch4p4( 6) Personal informant is seen in Image 9 and is burnt from the left.

**Image 9** Belt from sch4p4( 6) Personal at Chock 120

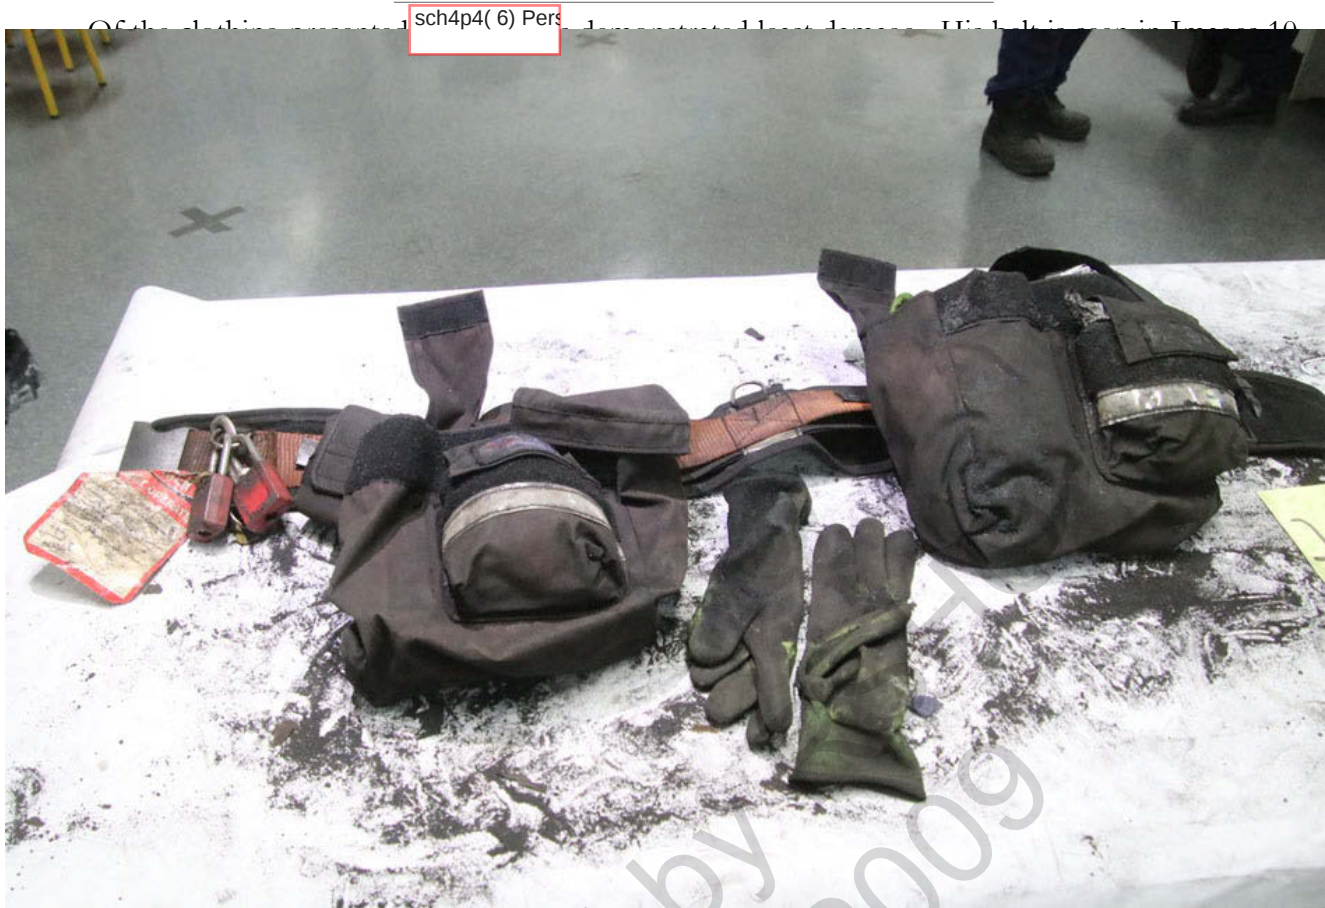
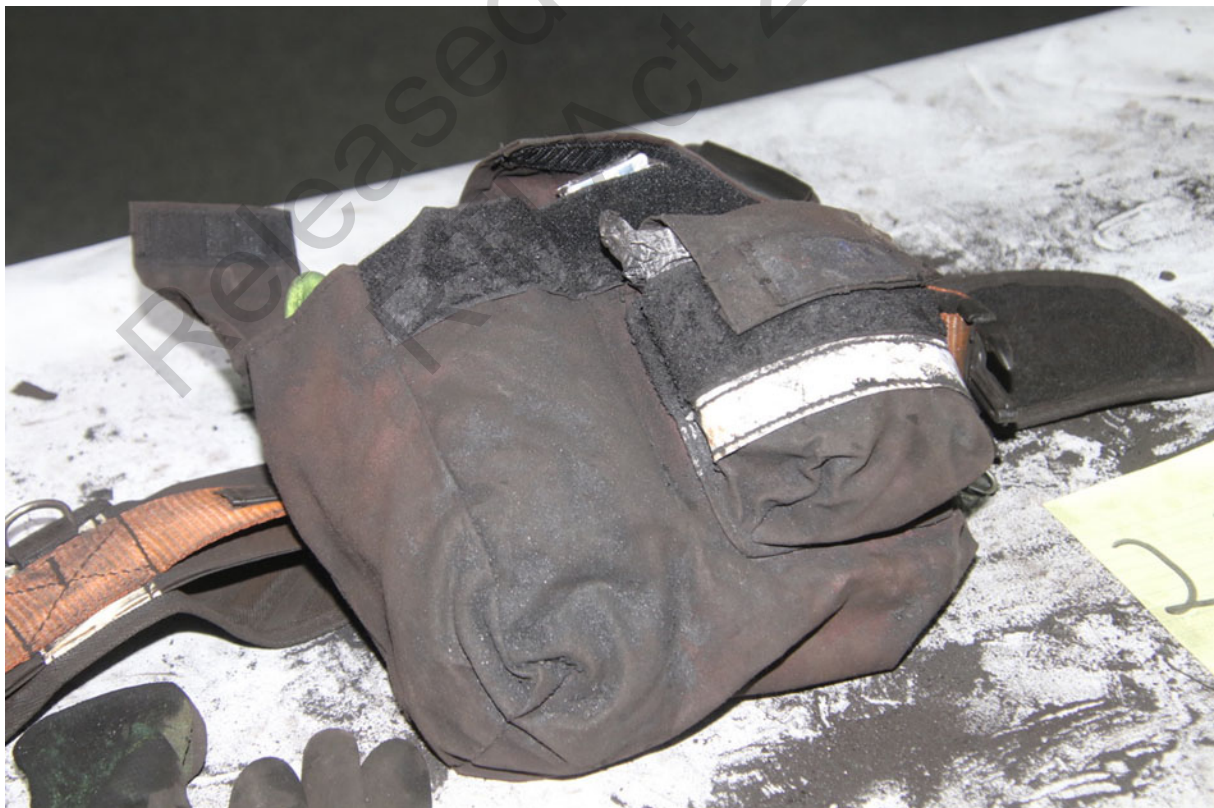
Images 10 & 11 sch4p4( 6) underground belt from Chock 100

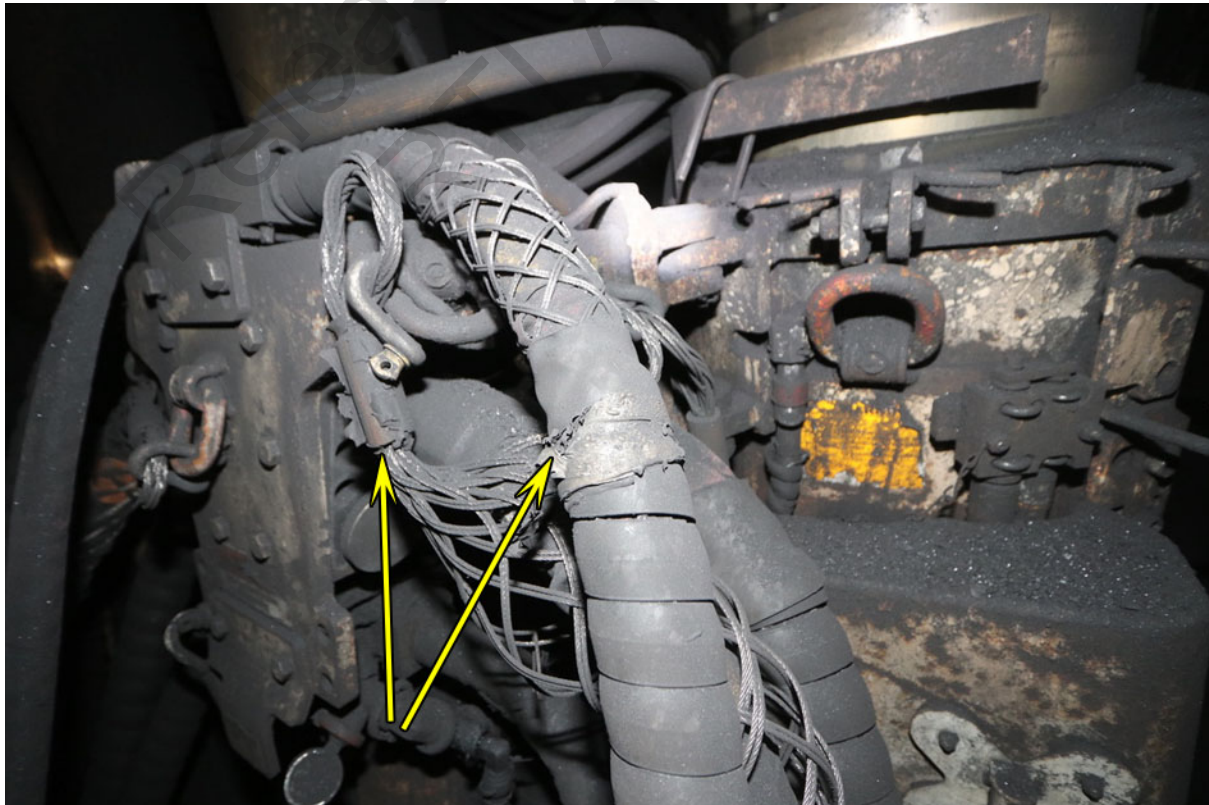
There appeared to be varying intensities of fire damage to combustible elements at the Chocks along the Longwall from about Chock 107 through to Chock 141. Very little heat damage was seen closer to the Maingate end. For example, the limited heat damage observed at the cover of the communications module and an overhead LED light at Chock 100 is seen in Images 12 & 13, while some degree of flame exposure was evident at Chock 101 (Image 14).

**Images 12 – 14** Limited damage to fixtures at Chock 100 (above) with slight damage observed at some surfaces at the adjacent Chock 101

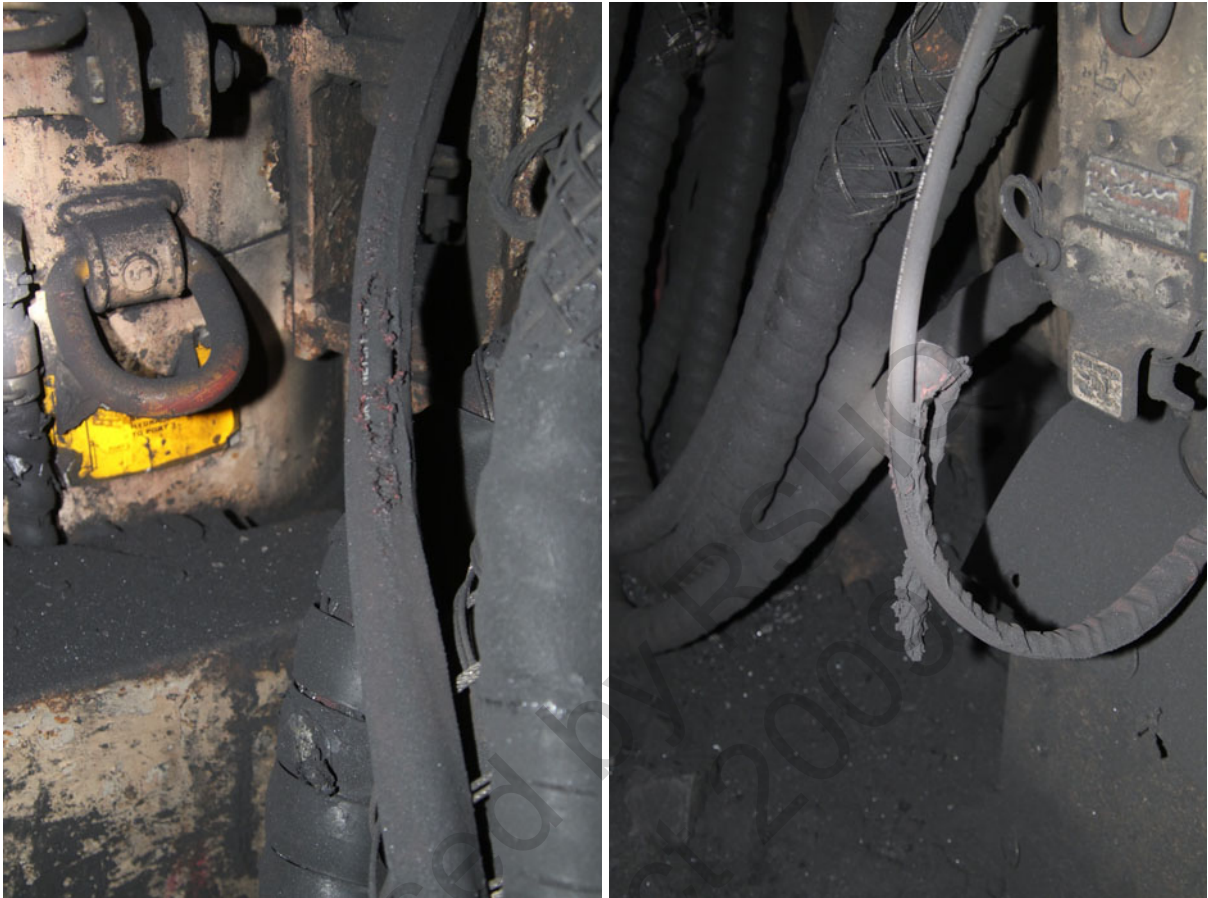
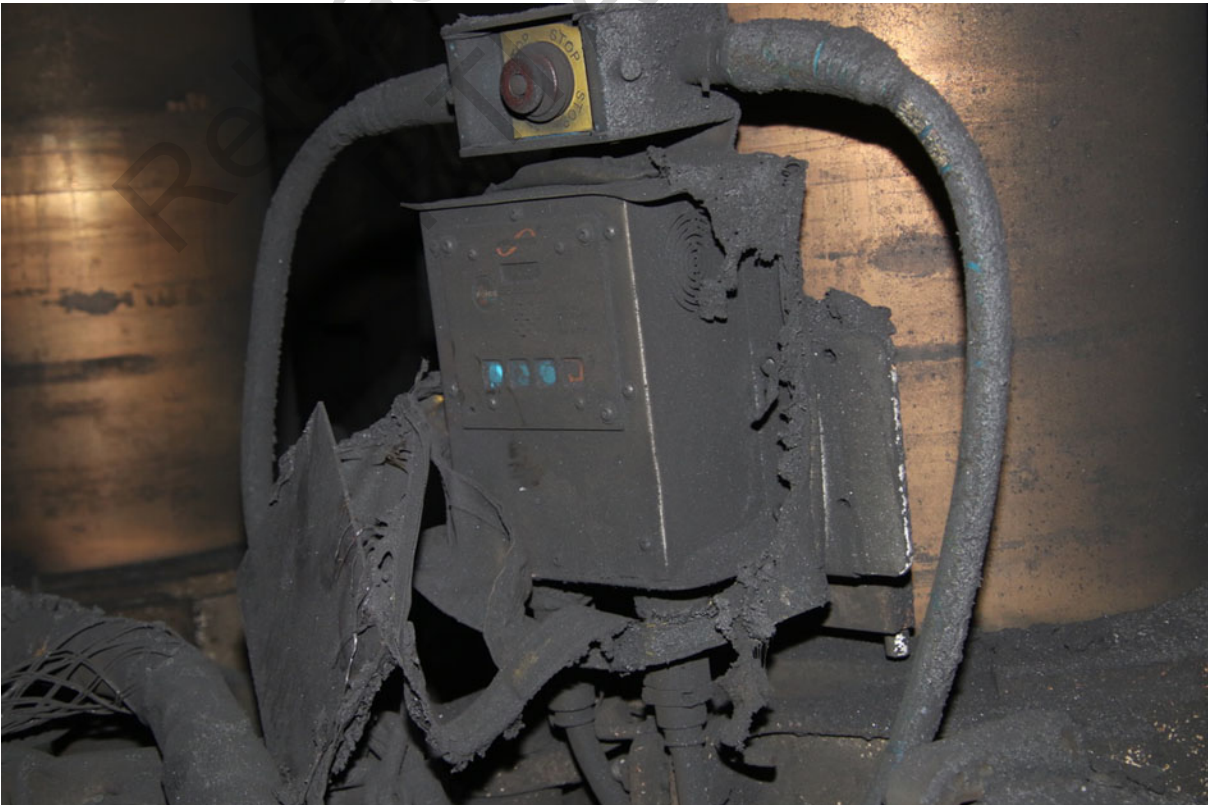
At Chocks 107 & 108 greater damage was observed to coverings on hoses (Images 15 & 16), and the cover on the communications module at Chock 110 (Image 17) suffered significantly greater damage than that at Chock 100.

Images 15 – 17 Increasing fire damage in surfaces from Chocks 107 to 110

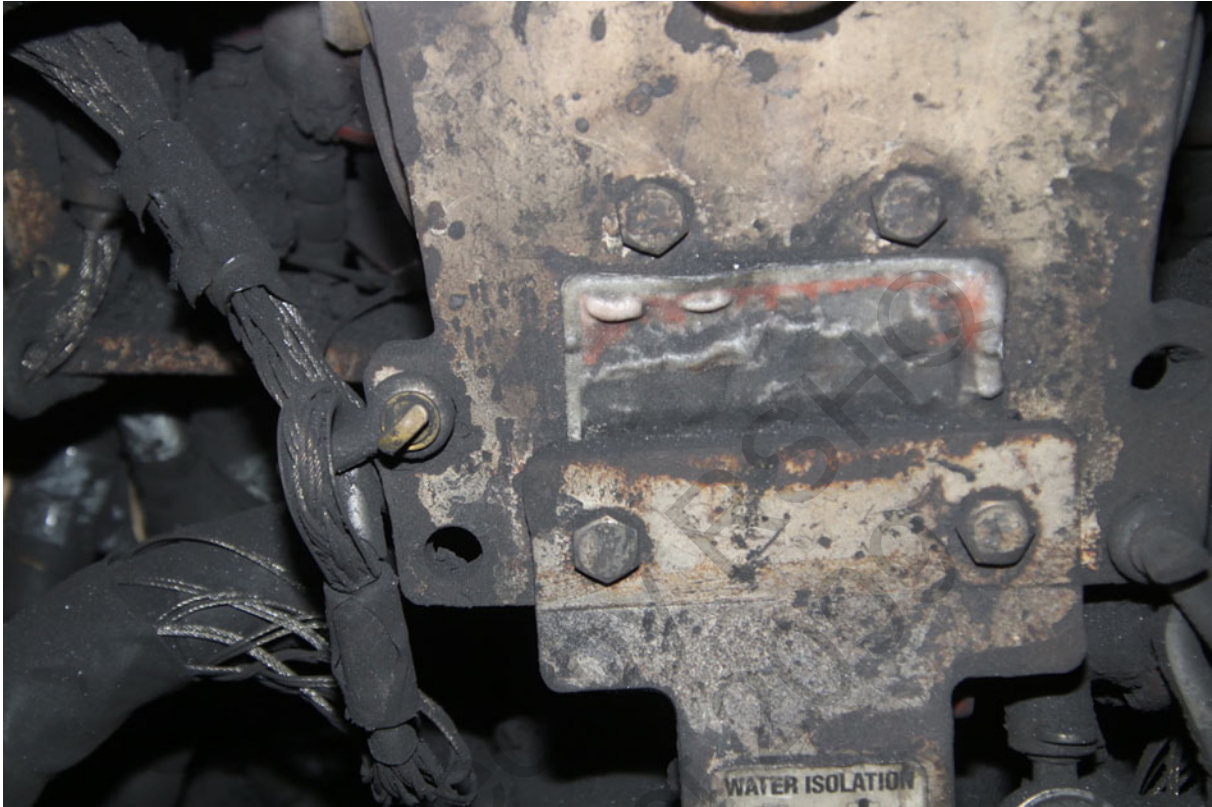
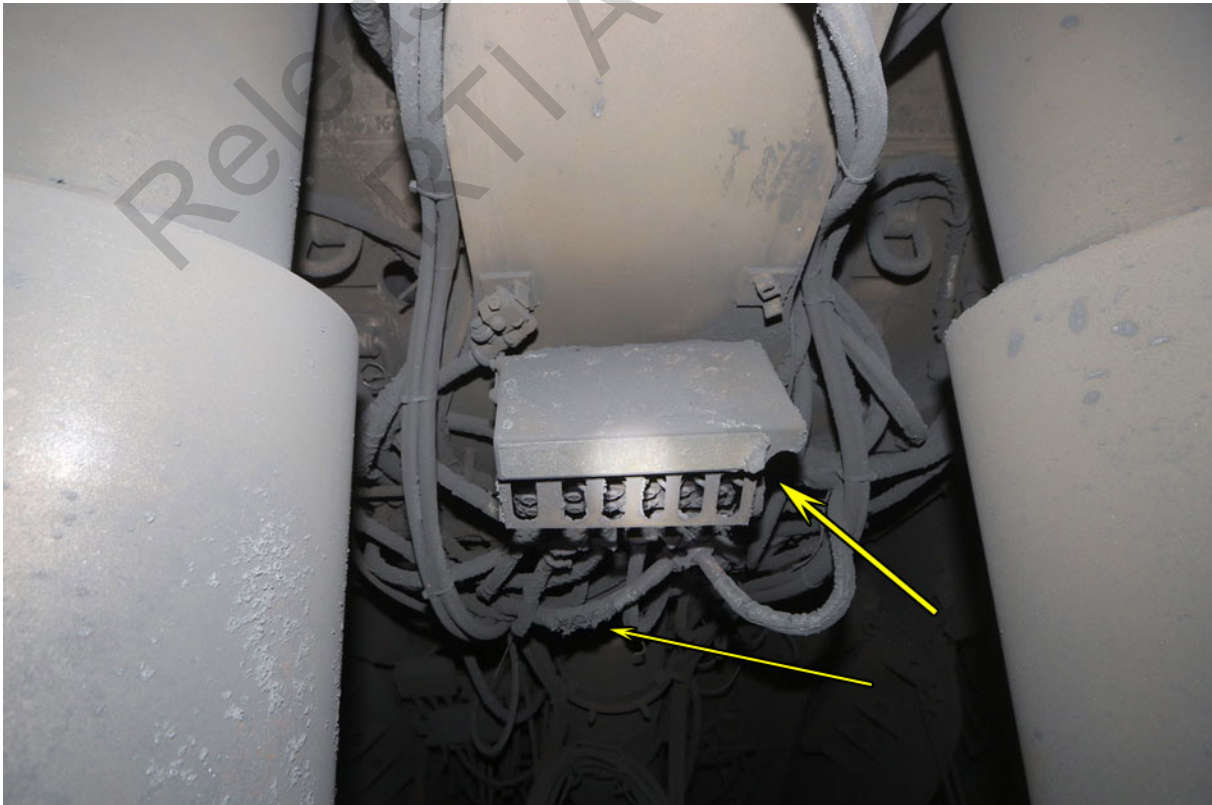
The writer searched for other directional indicators. A label on Chock 107 (Image 18) indicated that a flame advanced across it from the Tailgate direction (from the left in this image), while other indicators nearer the Tailgate demonstrated flame advancement from the Maingate end. Image 19, for example, shows a plastic label over the elevated valve bank at Chock 123 that is melted from the Maingate side (right in this image) with local damage to the covering on adjacent hoses.

Images 18 & 19 Directionality indicia in plastic surfaces on Chocks 107 and 123 that point to a flame developing from between

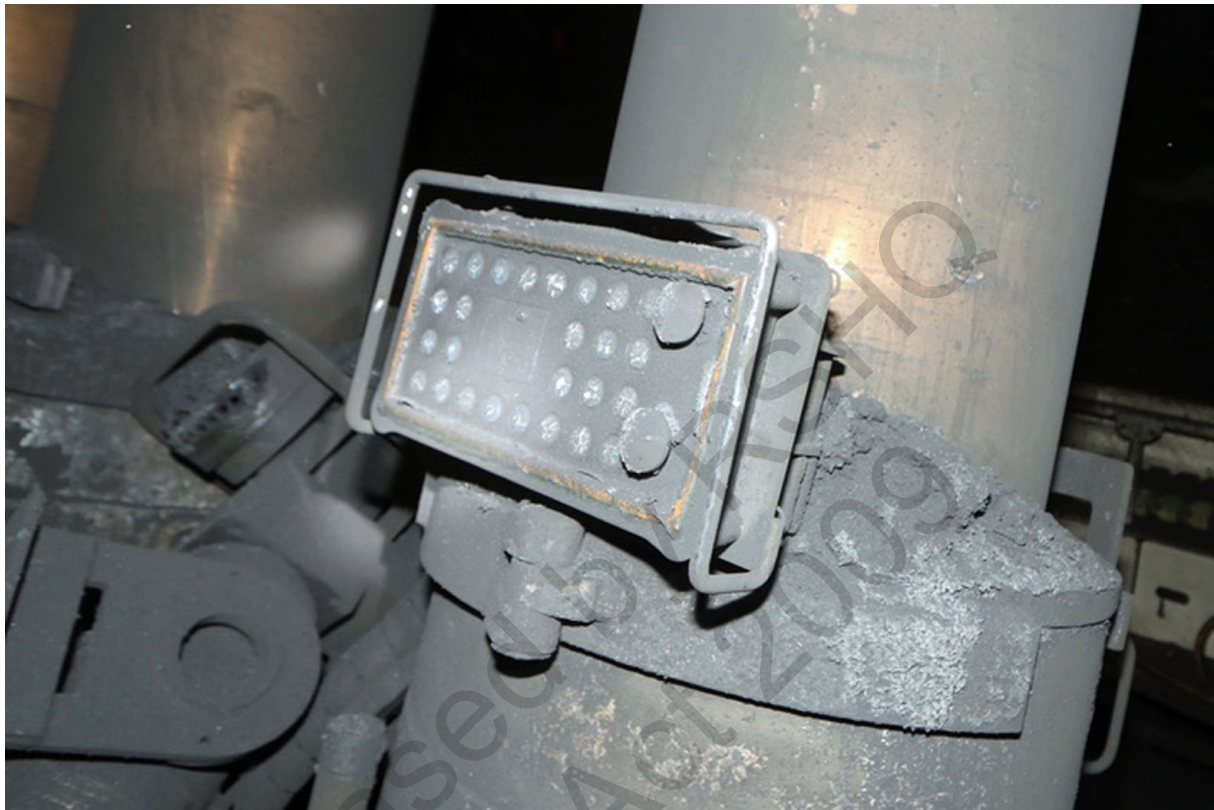
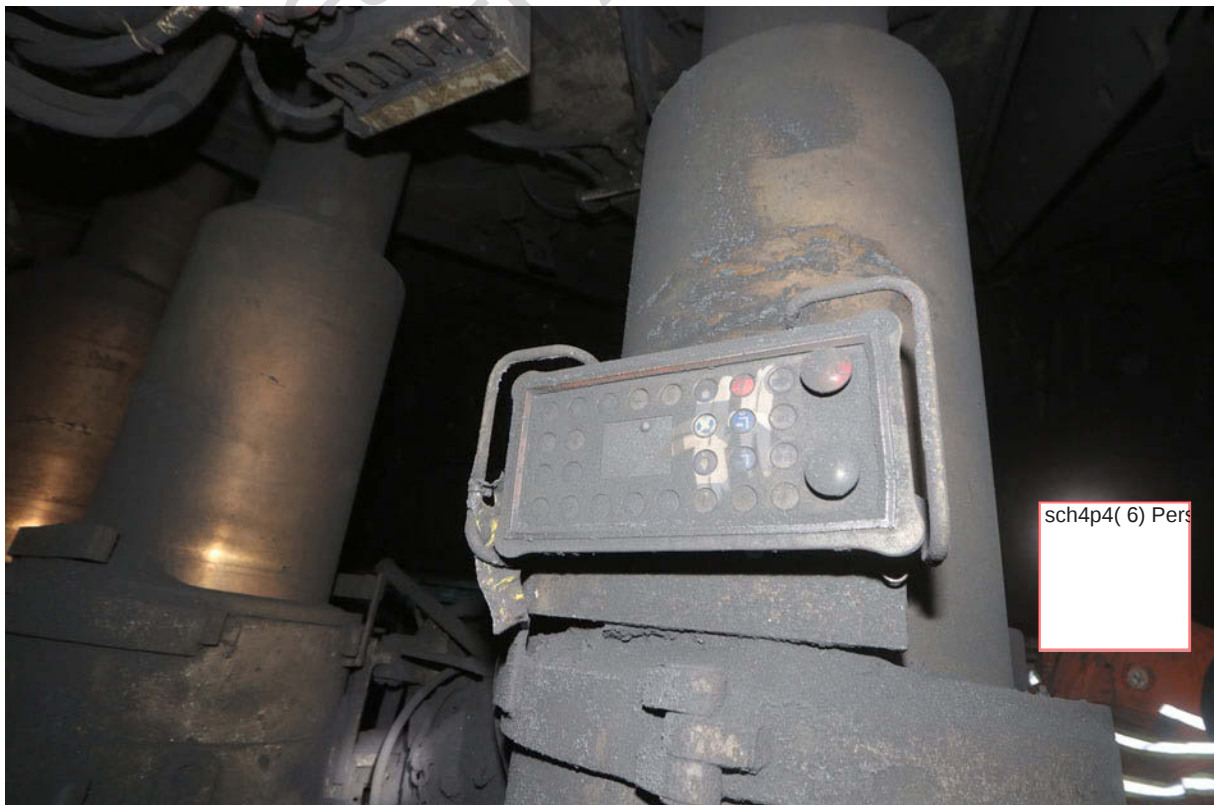
The damage appeared to diminish beyond the Tailgate end of the Longwall to a point just past the side access roadway number 37 in the Tailgate. By following the directionality indicia, I found that the general area of Chock 111, which demonstrated significant local damage, appeared to be the centre from which the directional indicators travelled. The extent of damage to a controller for Chock 111 is seen in Image 22. By contrast, the controller in this position on the adjacent Chock 110 was substantially less damaged (Image 23), and overhead damage at the valve bank at Chock 111 was substantial (Image 24).

**Images 22 & 23** Substantial damage at the rear controller of Chock 111 compared to lesser damage at Chock 110

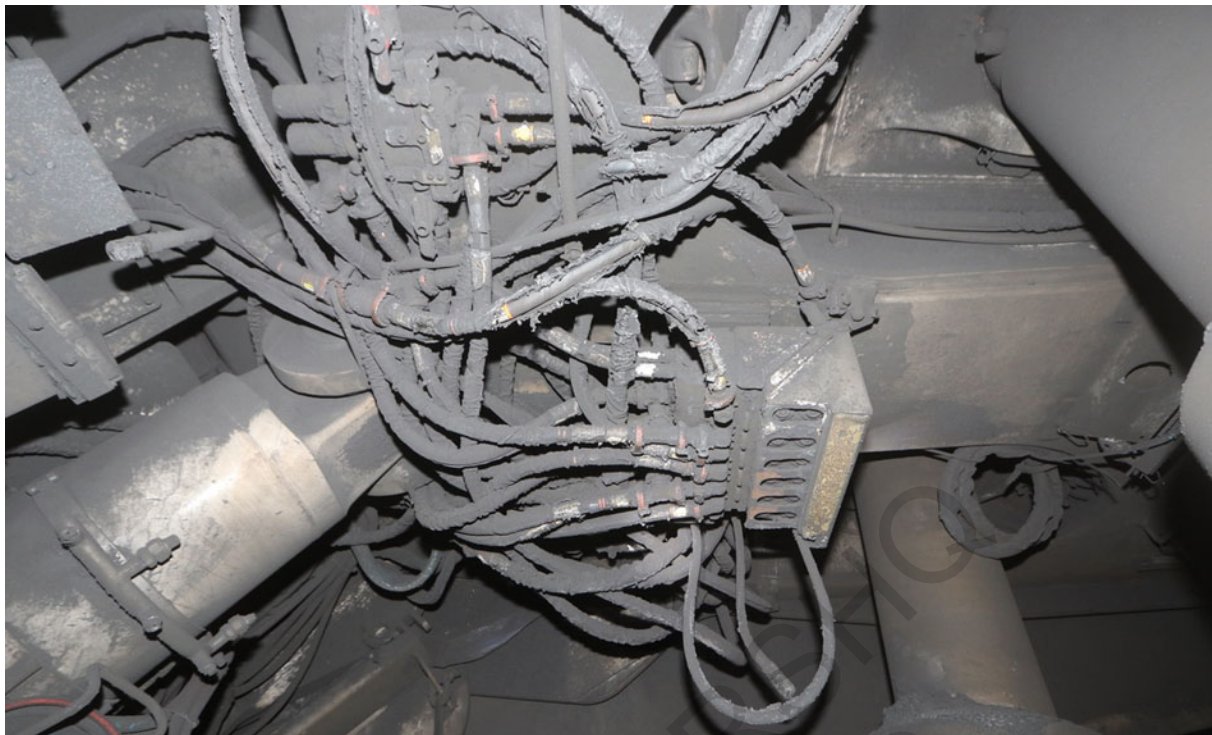
**Image 24** The valve bank at Chock 111

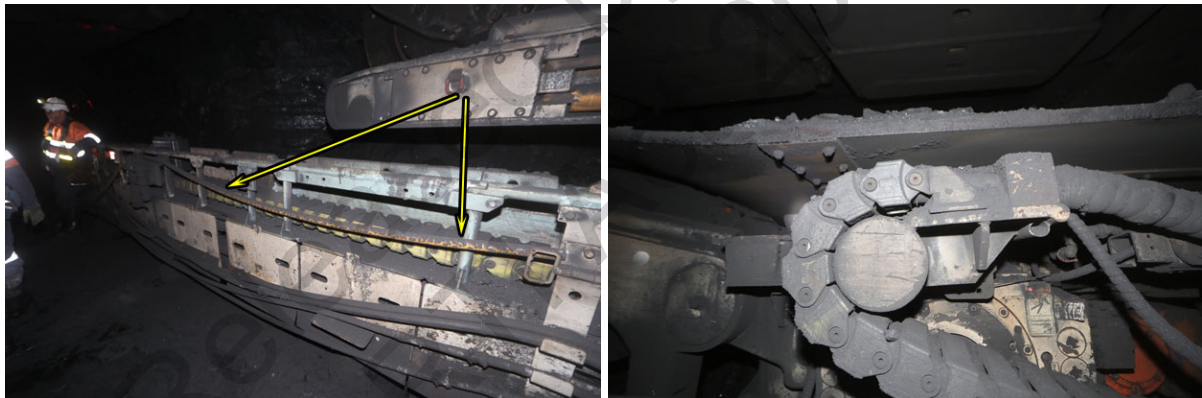
Some reasonably low elevation fire damage was observed on cable covers and the bretby of the Shearer in the vicinity of Chock 120 (Images 25 & 26).

**Images 25 & 26** Reasonably low elevation fire damage at the Shearer

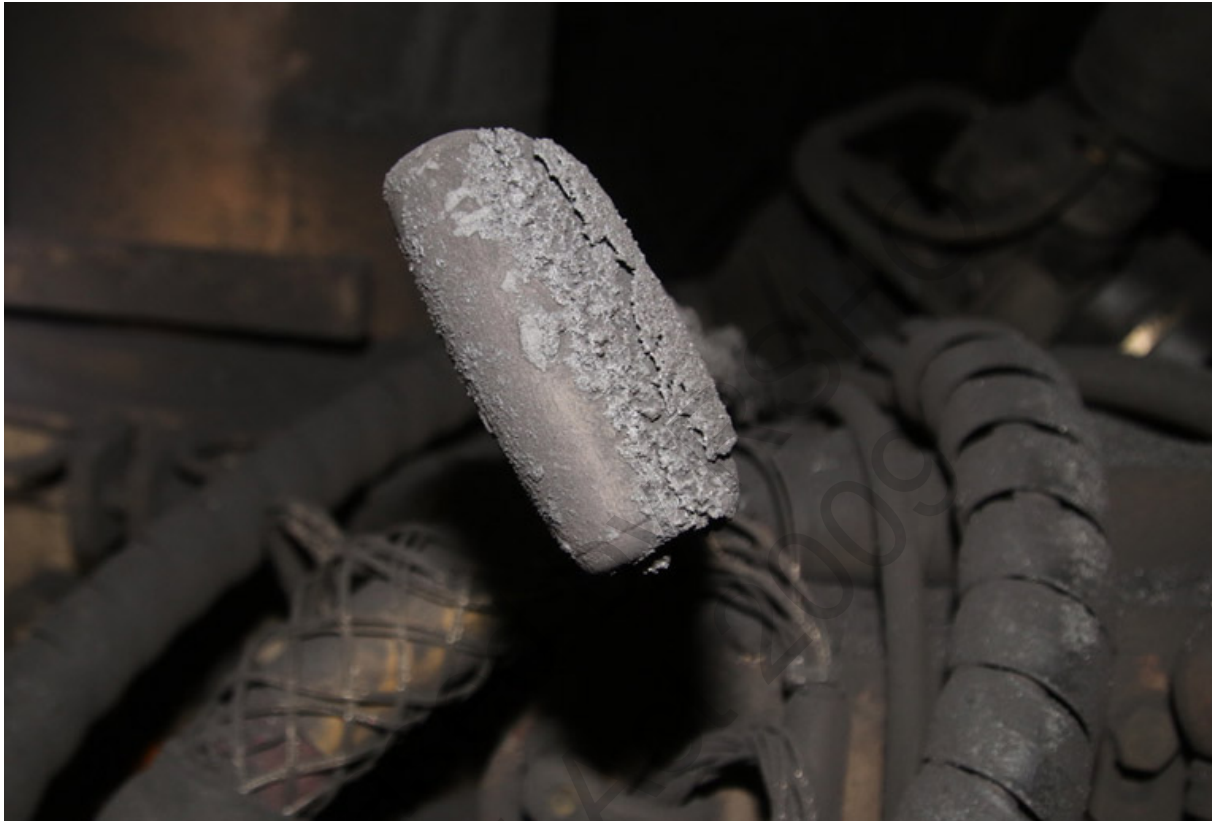
The sudden overpressure is also likely to uplift fine particles. I would expect a pressure wave from methane deflagration to uplift coal dust and ignite it. This was evident in the evidence, such as seen in Image 27, where uplifted coal dust has ignited, but then condensed onto the side of the handle of a shovel from the direction of ventilation travel.

**Image 27** Ignited coal dust has condensed onto the side of surfaces by passing ventilation

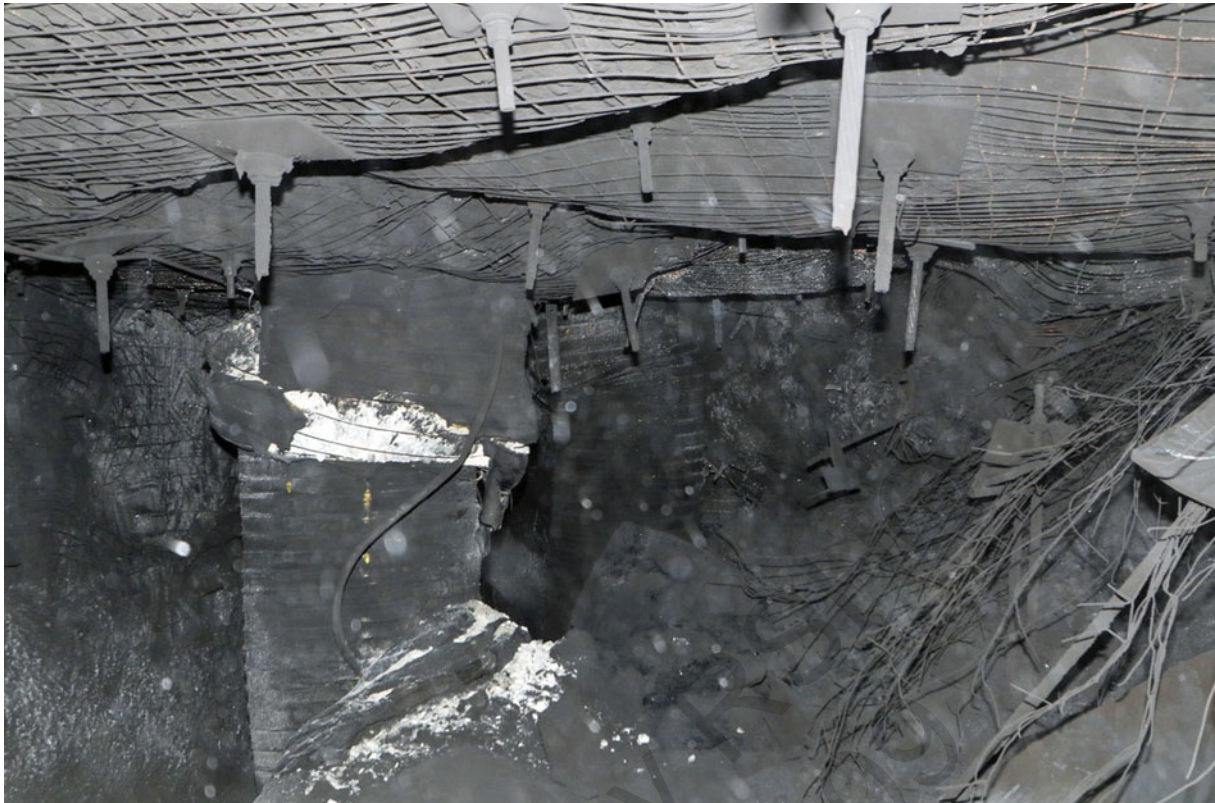
The first matter at hand was the issue of the two pressure waves. It was clear that there had been sudden collapse of the roof in the goaf, evidenced in Image 28 at the Tailgate about 15m to the rear of the Chocks. Whether it is possible that this was responsible for the first overpressure could be explored by examining historical data for previous blocks where roof falls have occurred. Such an examination of data could show the expected range of waves from such events for comparison. Geotechnical experts may also be of assistance.

**Image 28** Evidence of a roof fall in the goaf to the rear at the Tailgate

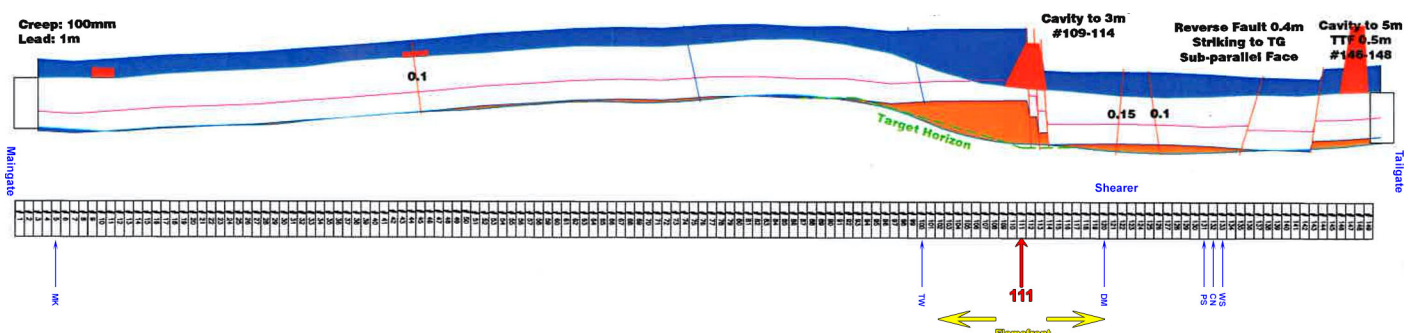
**Image 29** The location of Chock 111  
File A

The link between the collapsed roof and the fire indicates that a wave of gas was suddenly pushed through the Chocks from the goaf in varying concentrations along the Longwall. Though the ignition source is as yet unidentified, it might have existed just within the goaf in the vicinity of Chock 111, and so the fire then spread to the left and right rapidly in the gas that contemporaneously entered from the goaf. If personal gas monitoring devices had not detected a rise in gas concentration, the suddenness of gas being forced through the chocks and immediacy of its ignition may provide the explanation.
