# North Goonyella Spontaneous Combustion

September 2018

# North Goonyella

27 Sept 2018

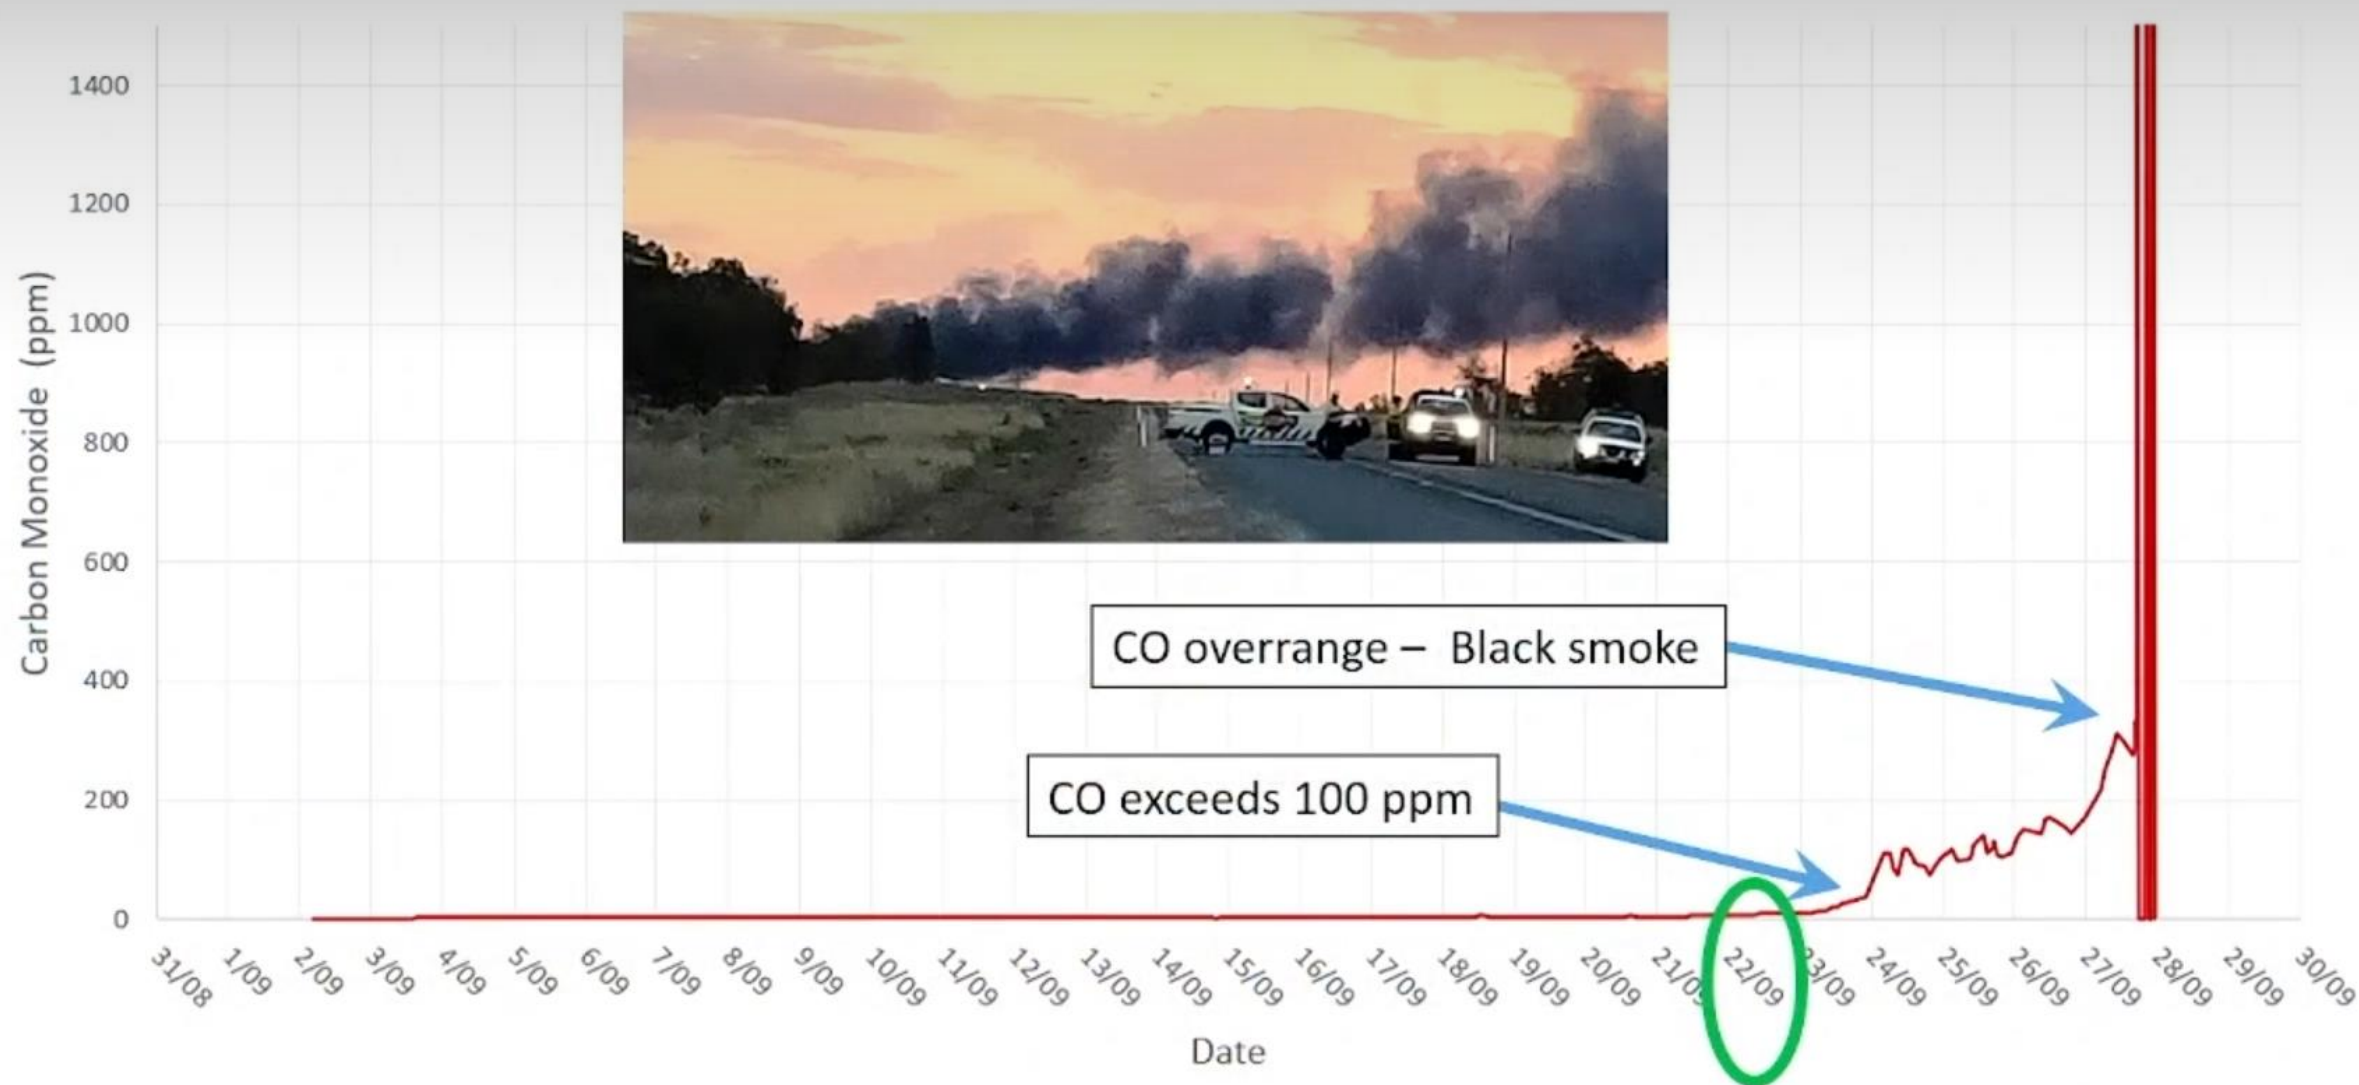
H40 Shaft Carbon Monoxide from Tube Bundle

# Carbon monoxide increases at return shaft to over 100ppm on the 24th of September. Off scale 27th September, shaft discharging black smoke

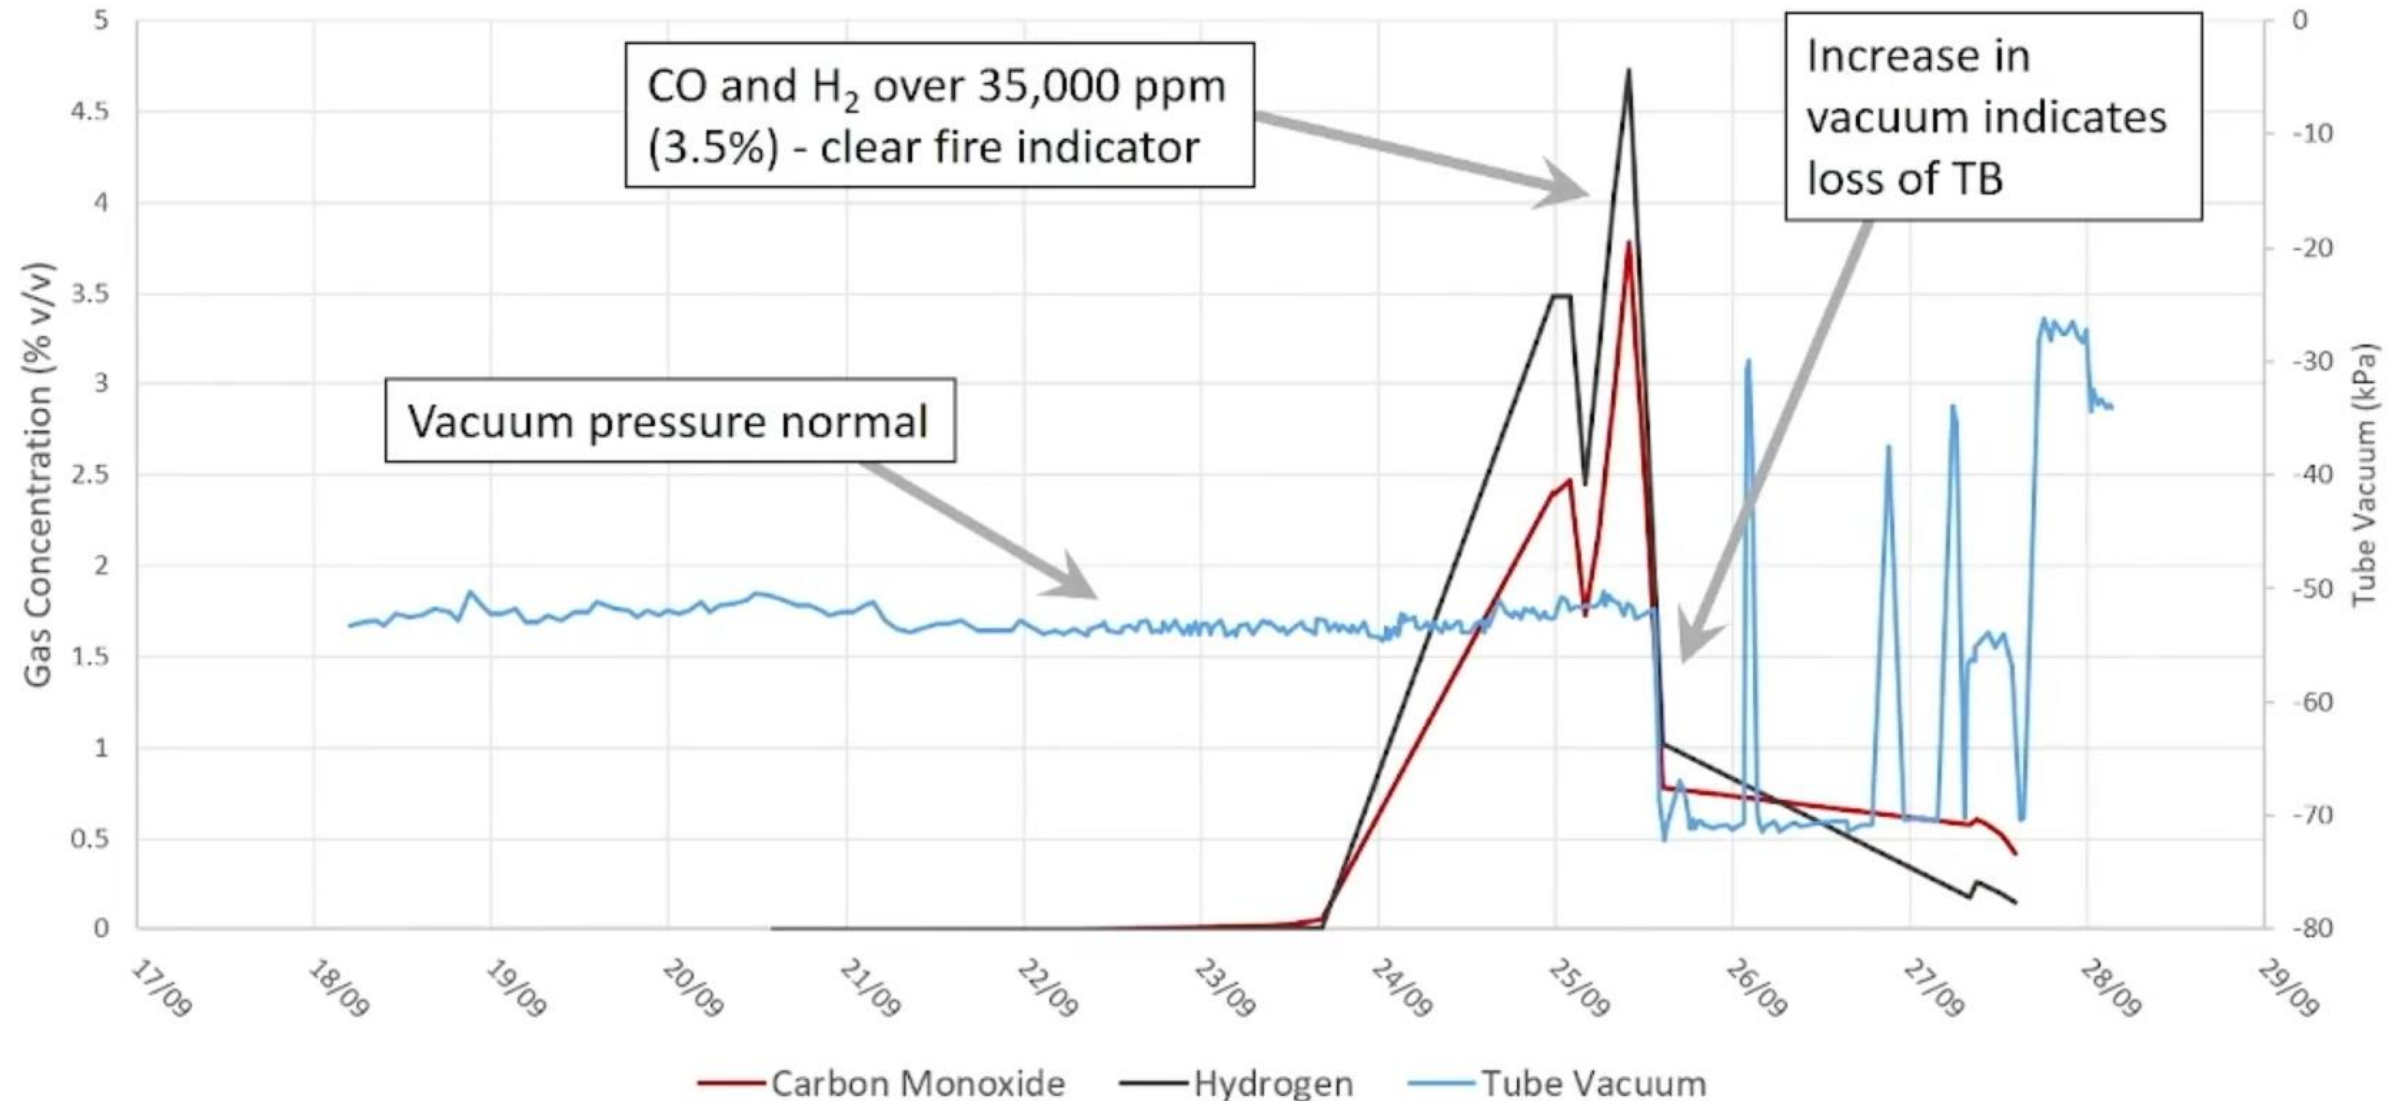
Tube 38 E-frame Tube Vacuum and Carbon Monoxide, Hydrogen from GC analysis

# Carbon monoxide and Hydrogen at high levels indicate concentrated fire gases at the E-Frame tube

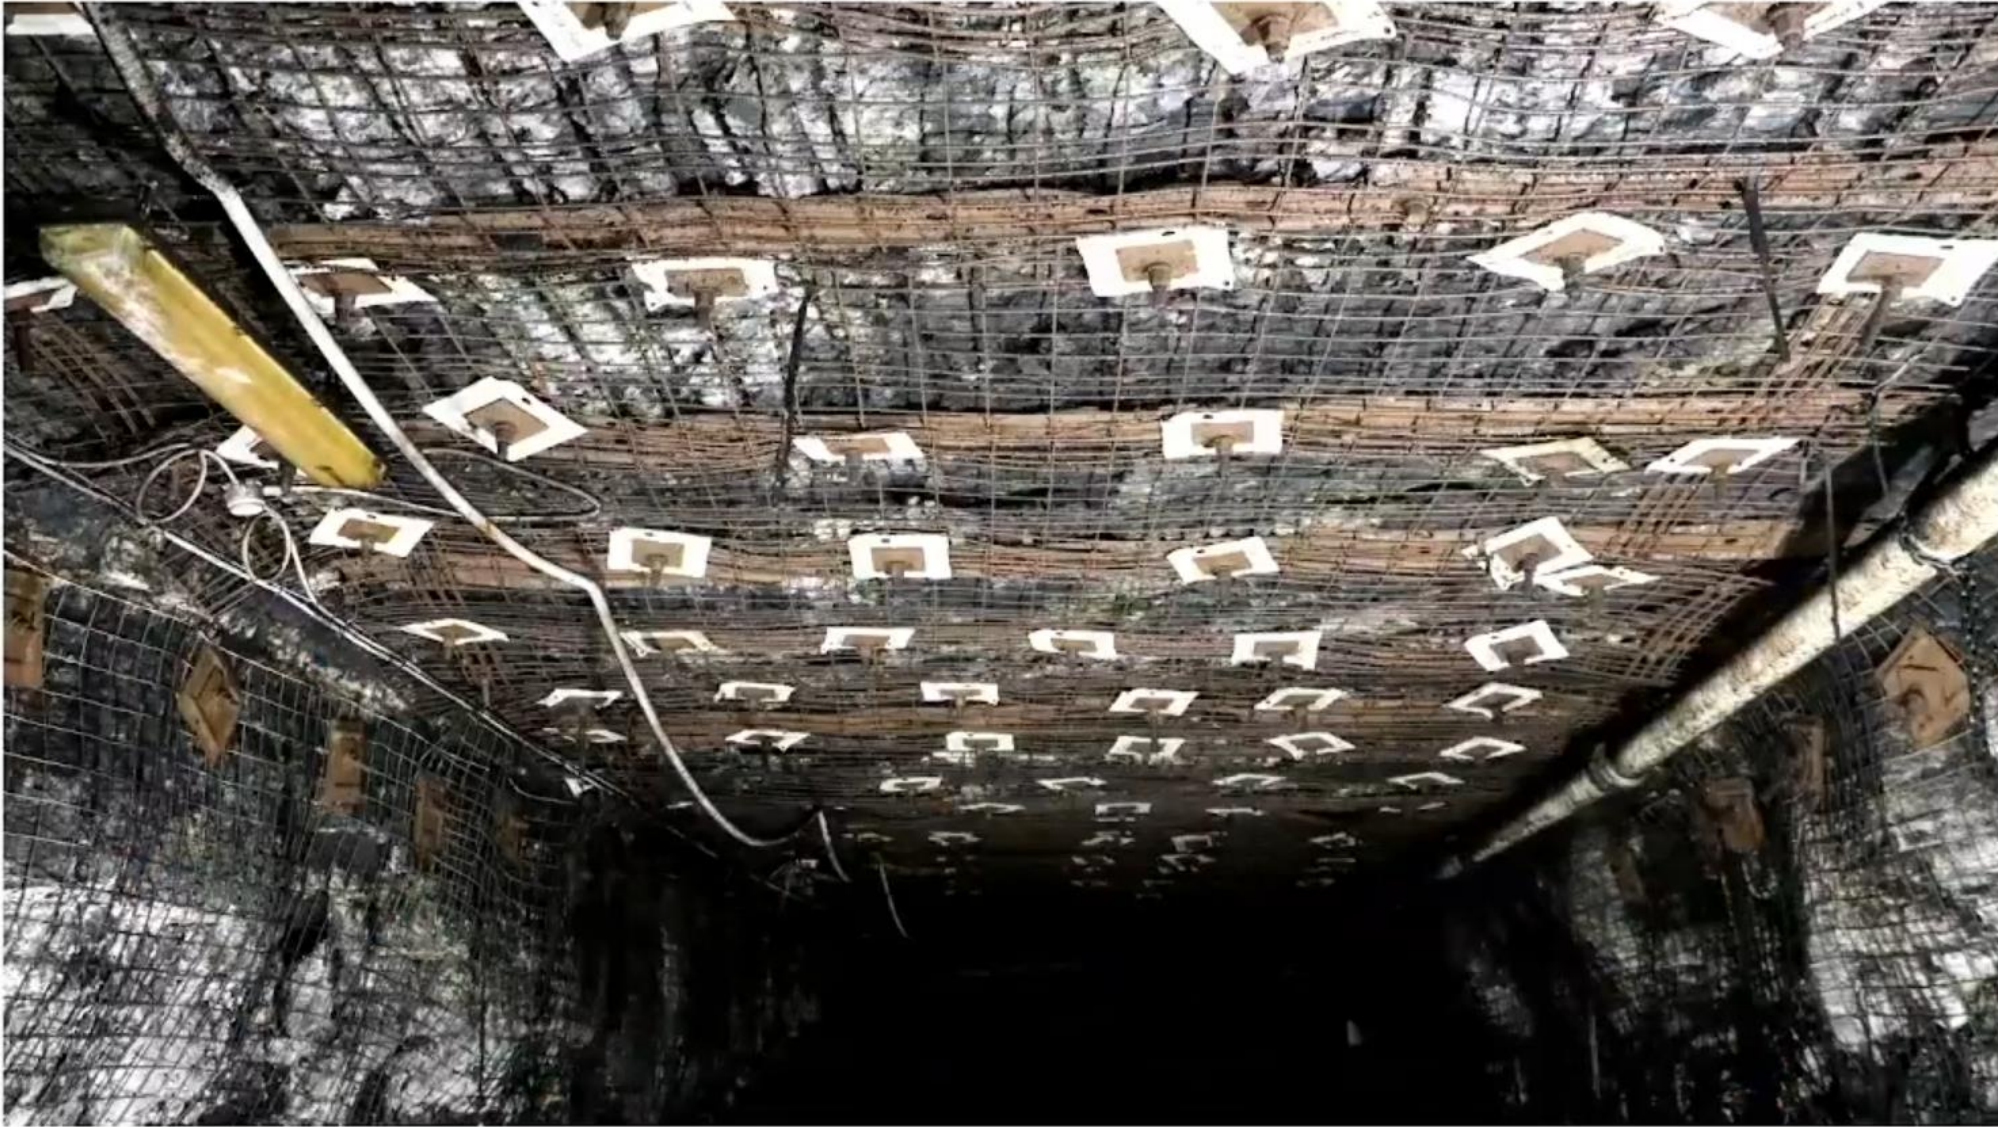
G to H Hdg 8 C/T

# Galvanised Butterfly Plates

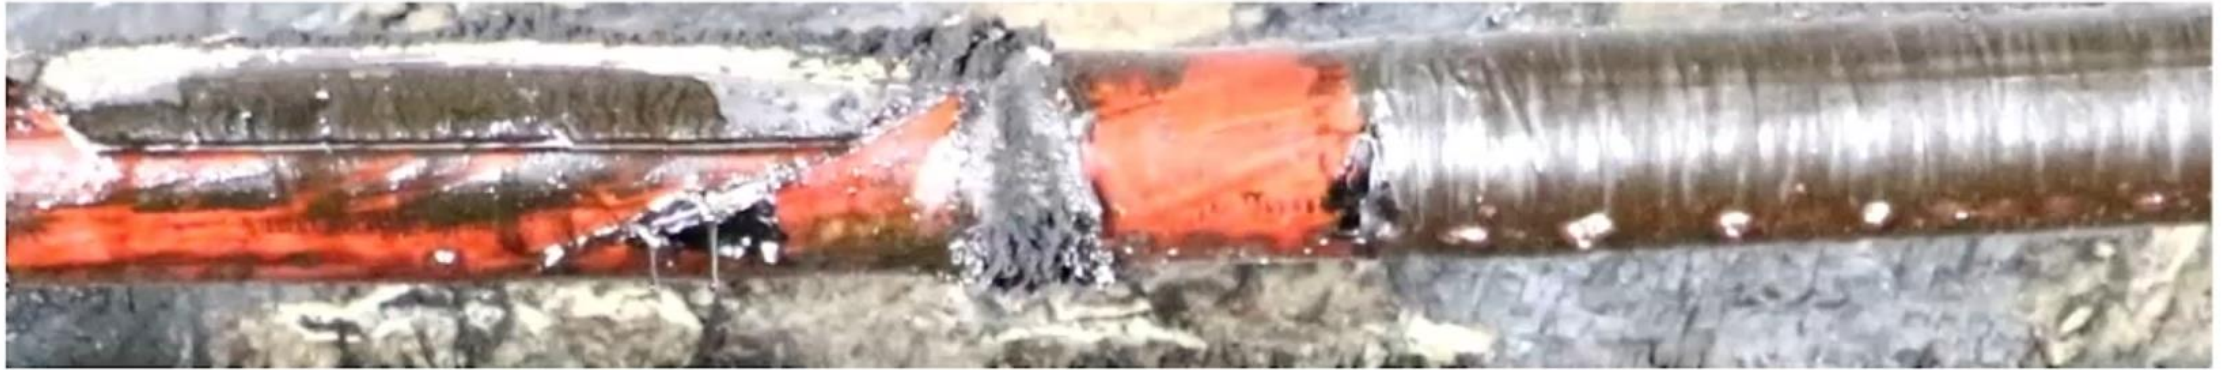
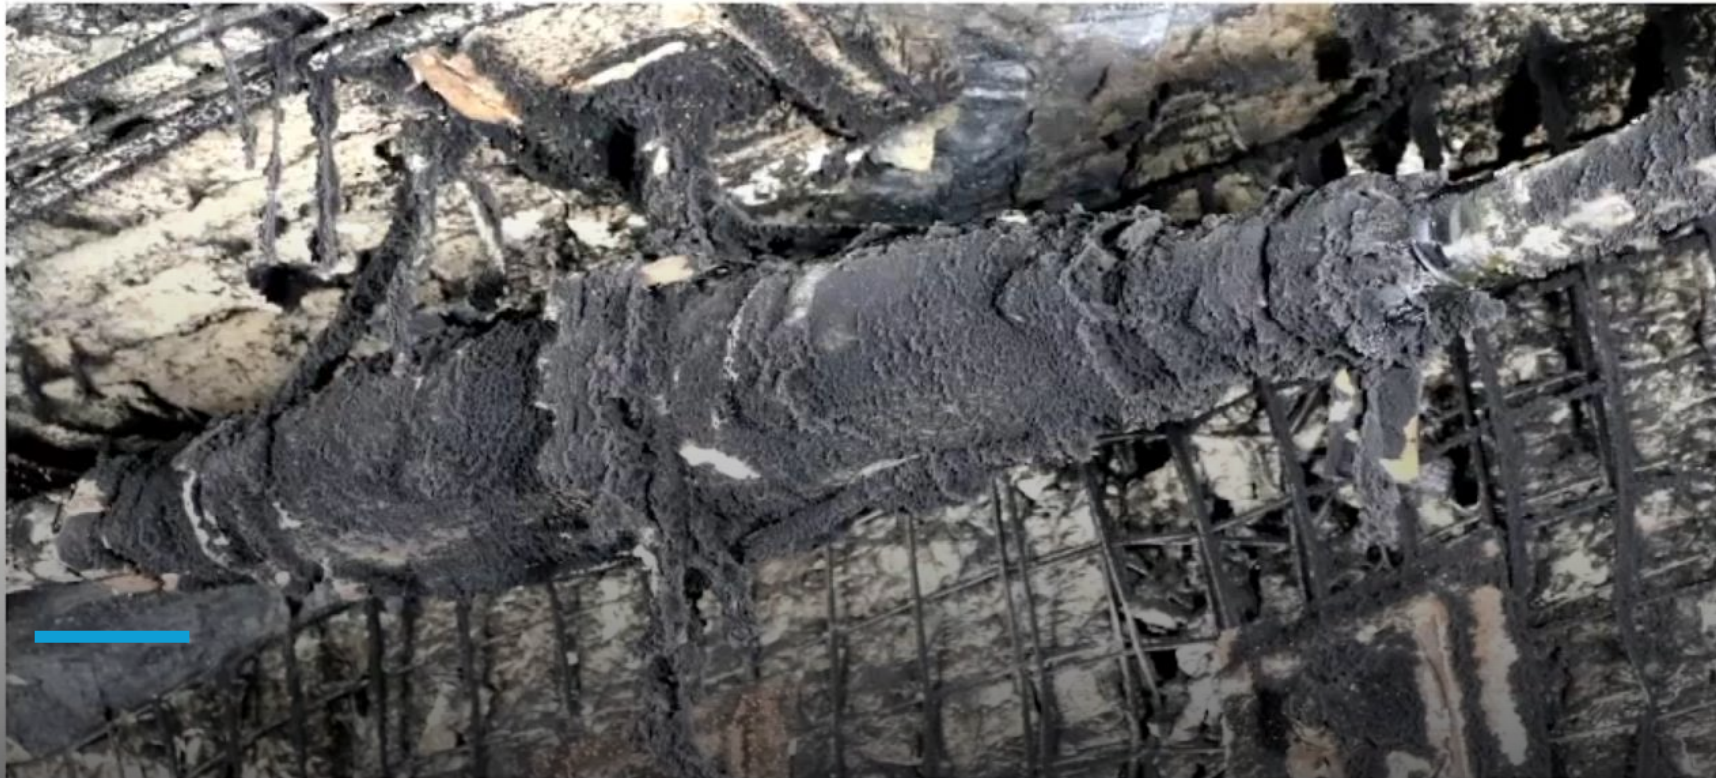
# Electrical Equipment HT Cables

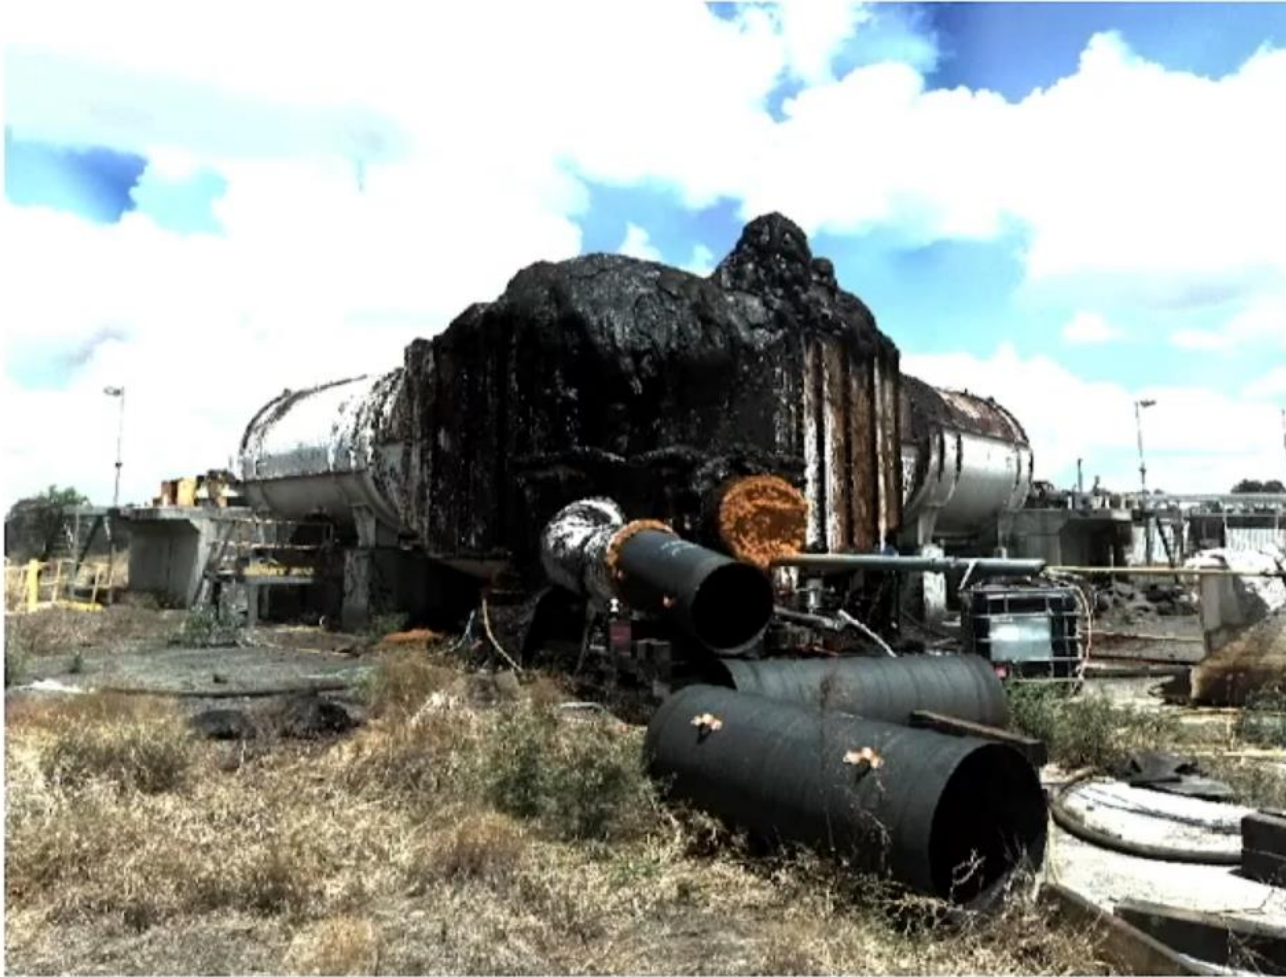
*Laser scan image*

- Initially, intakes remained as intakes, returns remained as returns.
- As access to the main shaft became closed-off, air reversal occurred resulting in the main air intake shaft and drift becoming exit points for POCs.
- Loss of ventilation shaft reverses the outbye section of the ventilation circuit.

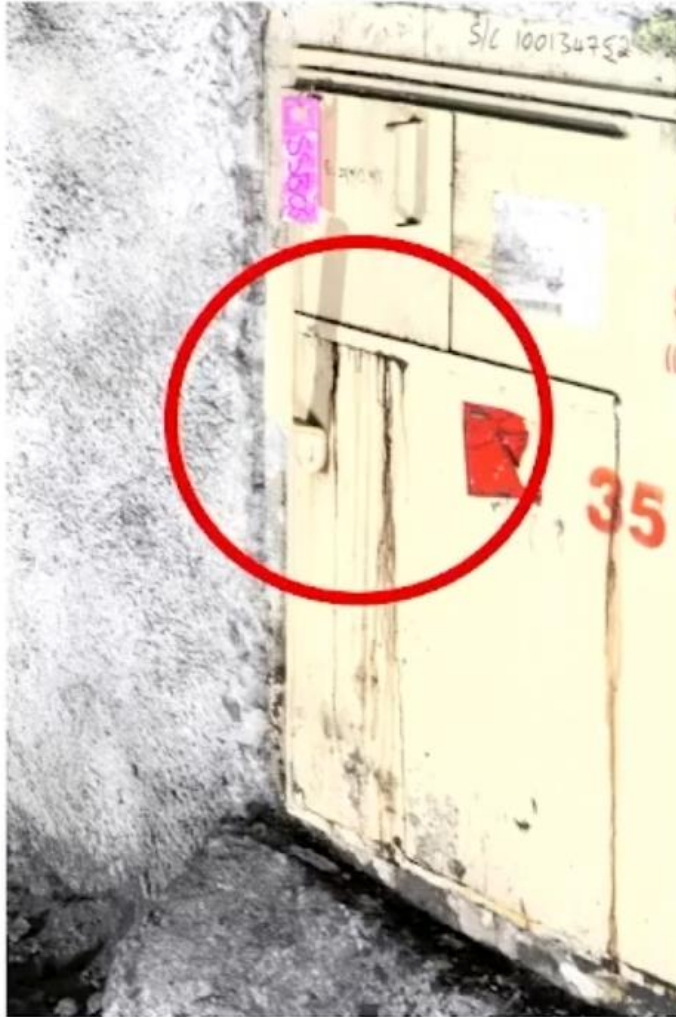
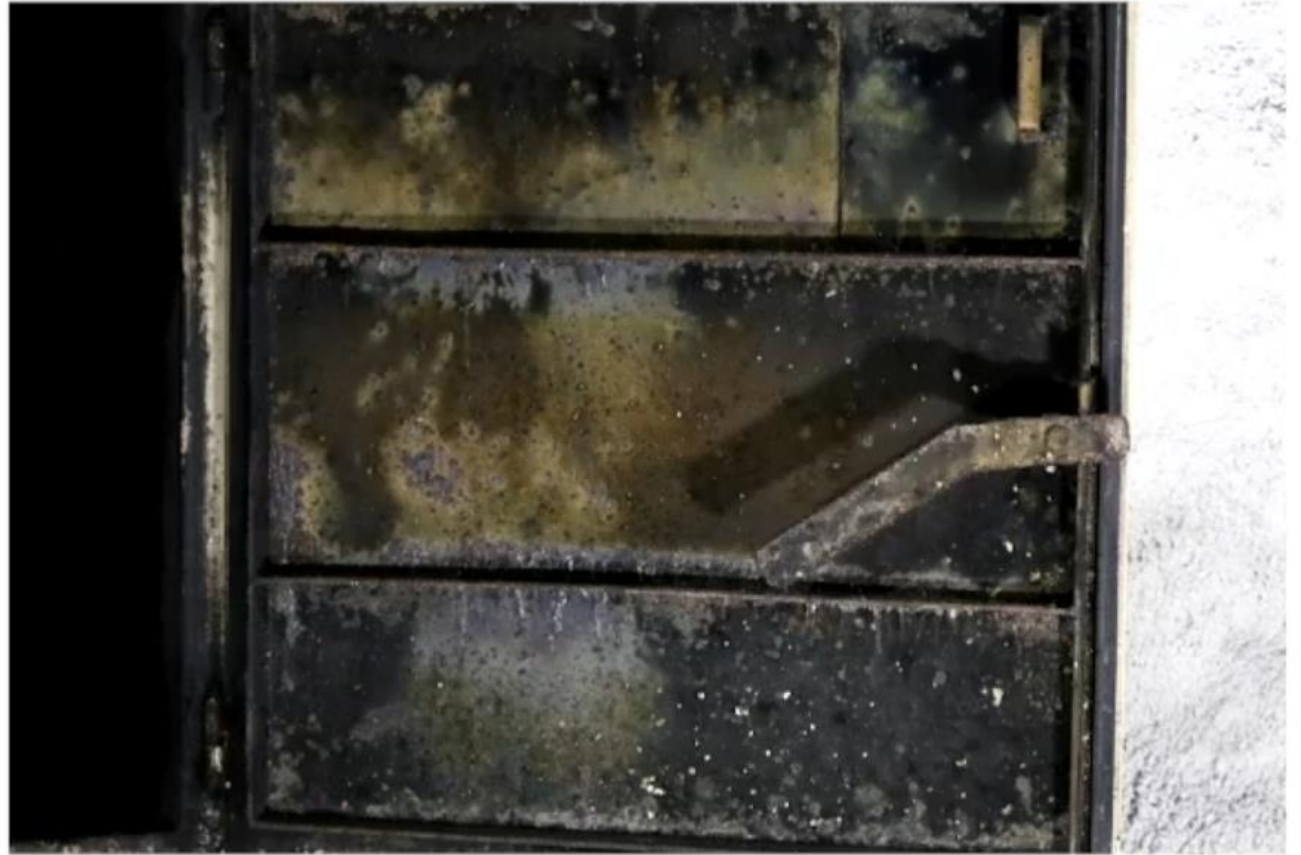
# Intake and return sides of ventilation structures (2-3 km outbye of the mine fire)

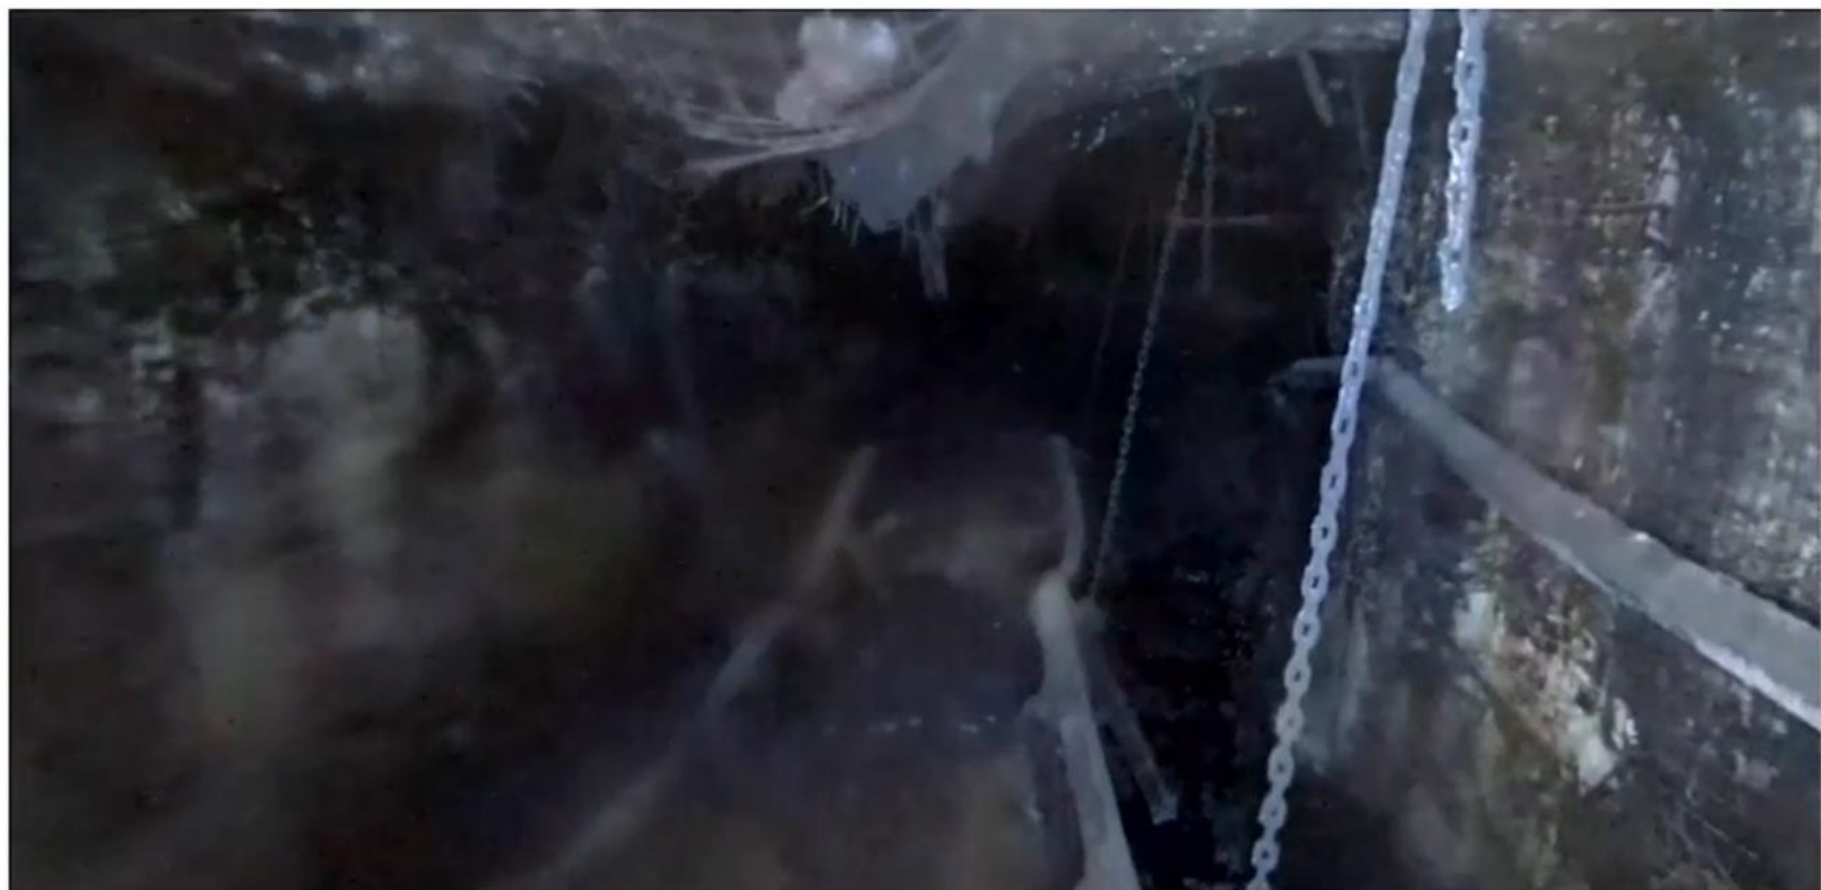
# Borehole Camera Footage

- Conveyor belt disintegration  
(NIOSH testing – Similar conveyor belt)  
**310°C**
- Deformed belt structure mains belt road  
(ASME B31.1-1995)  
**400°C to 500°C**
- Carbon steel melting point  
**1350°C - 1530°C**

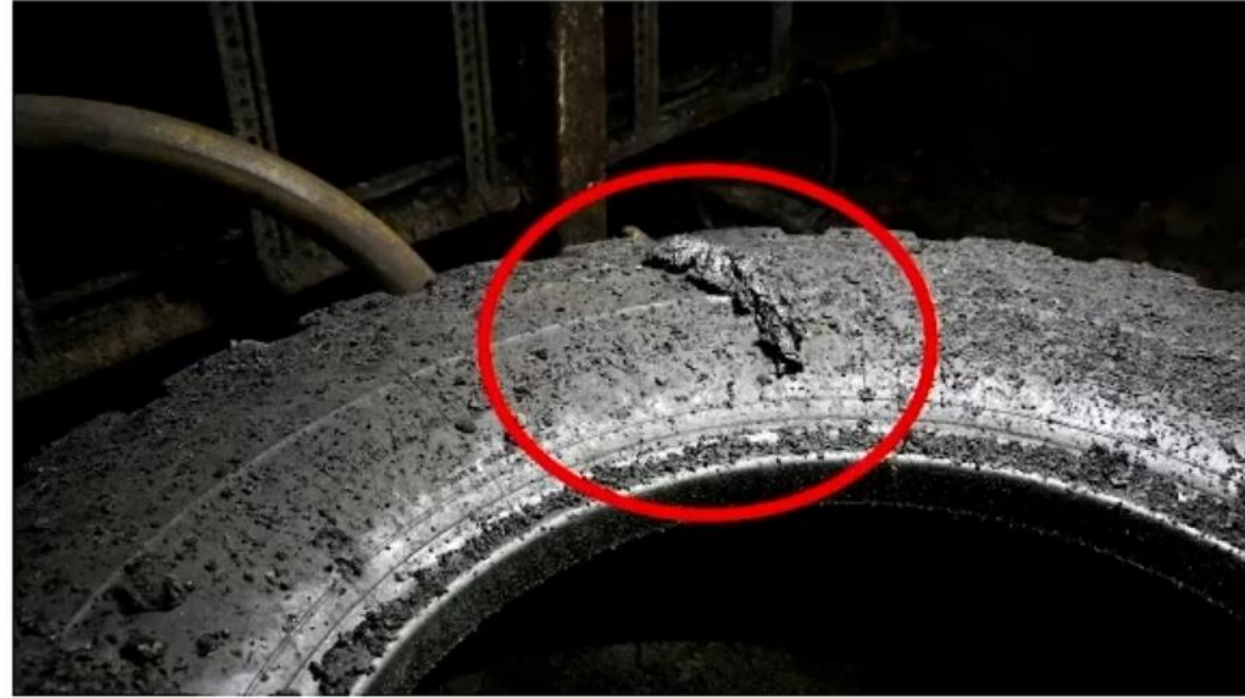
# Coal tar deposits (several locations)

- The coal tarring occurred at temperatures above **800°C** (presence of naphthalene)
- Temperature is consistent with the deformed steel structures
- Coal tar remains vaporised until the gas carrying it is cooled, when it either condenses on a cool surface or remains in fine aerosol drops

Coal tar deposited at shaft bottom  
(**2-3 km** from source)

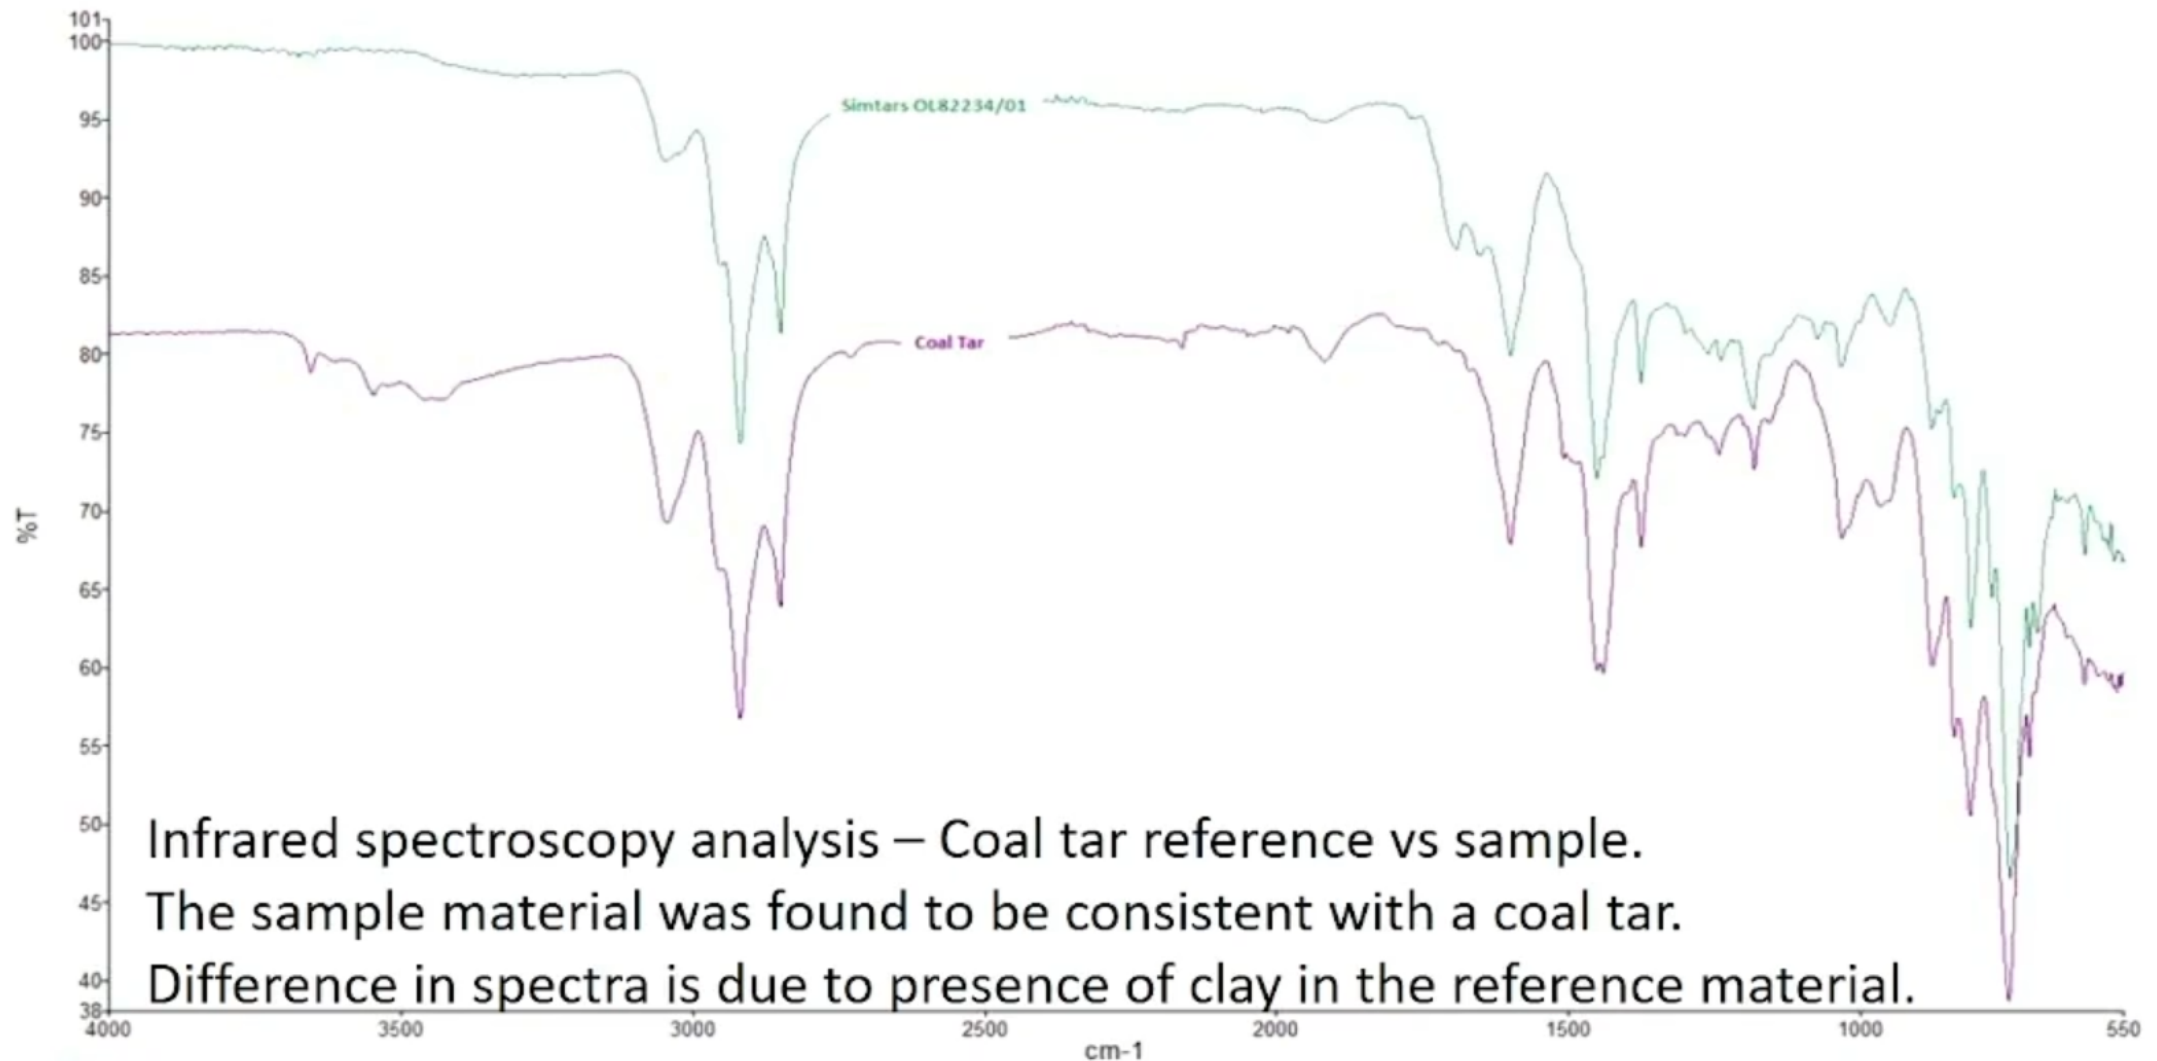
# Coal tar sample analysis

Infrared spectroscopy analysis – Coal tar reference vs sample.  
The sample material was found to be consistent with a coal tar.  
Difference in spectra is due to presence of clay in the reference material.
