## Investigation report

Investigation into a fatal collision between a Caterpillar 793D haul dump truck and a Toyota Landcruiser at Ravensworth open cut mine on 30 November 2013

Report prepared by the NSW Mine Safety Investigation Unit for the Secretary of NSW Trade & Investment

March 2015

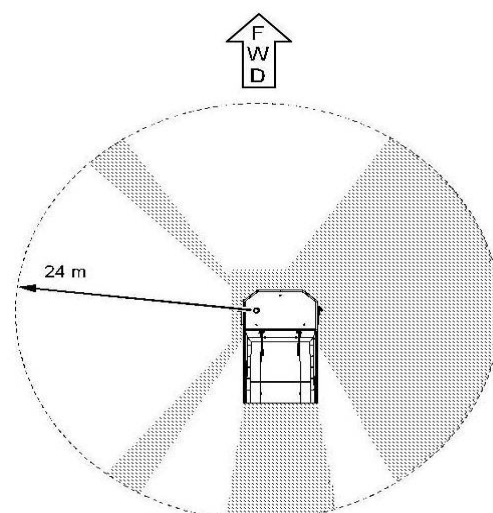
“The size and the configuration of this machine may result in areas that cannot be seen when the operator is seated. Illustration 1 provides an approximate visual indication of the areas of significant restricted visibility. Illustration 1 indicates the restricted visibility areas at ground level inside a radius of 24.00 m (78.74 ft) from the operator on a machine without the use of optional visual aids. This illustration does not provide areas of restricted visibility for distances outside a radius of 24.00 m (78.74 ft).”

**Figure 6. Illustration 1, extracted from Operation and maintenance manual of Caterpillar 793D Note: The shaded areas of illustration 1 indicate the approximate locations with significant restricted visibility.**

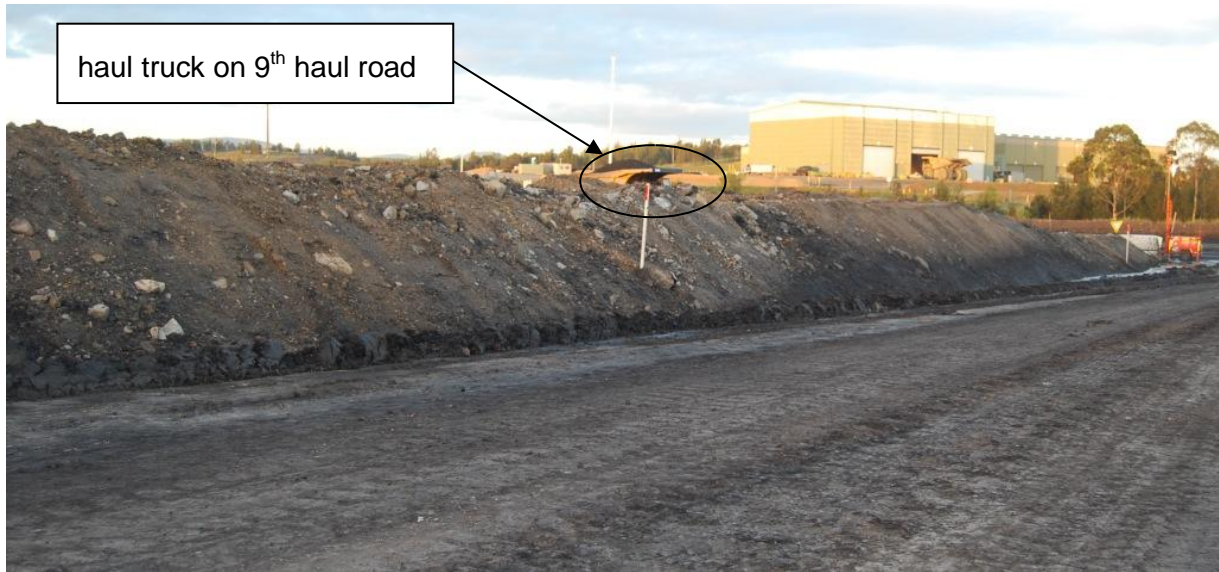
Figure 13. Photograph of windrow on 8<sup>th</sup> ramp taken by investigators at the mine on 1 December 2013.

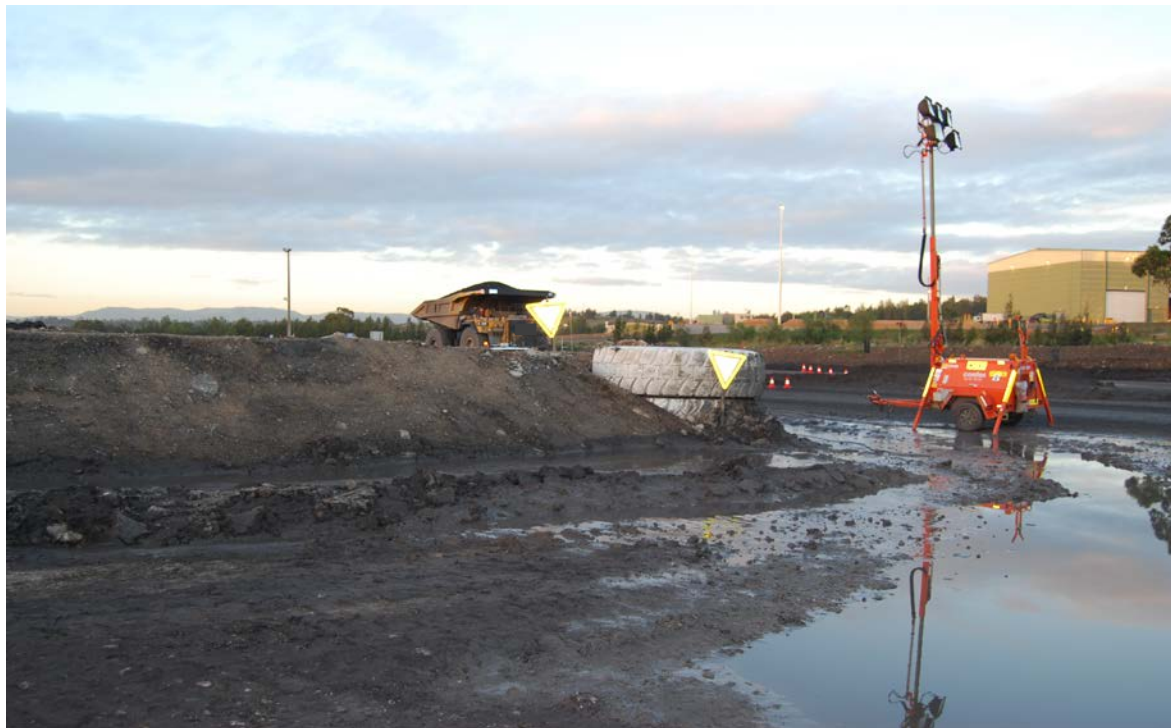
Figure 14. Photograph of windrow on 8<sup>th</sup> ramp taken by investigators on 1 December 2013.

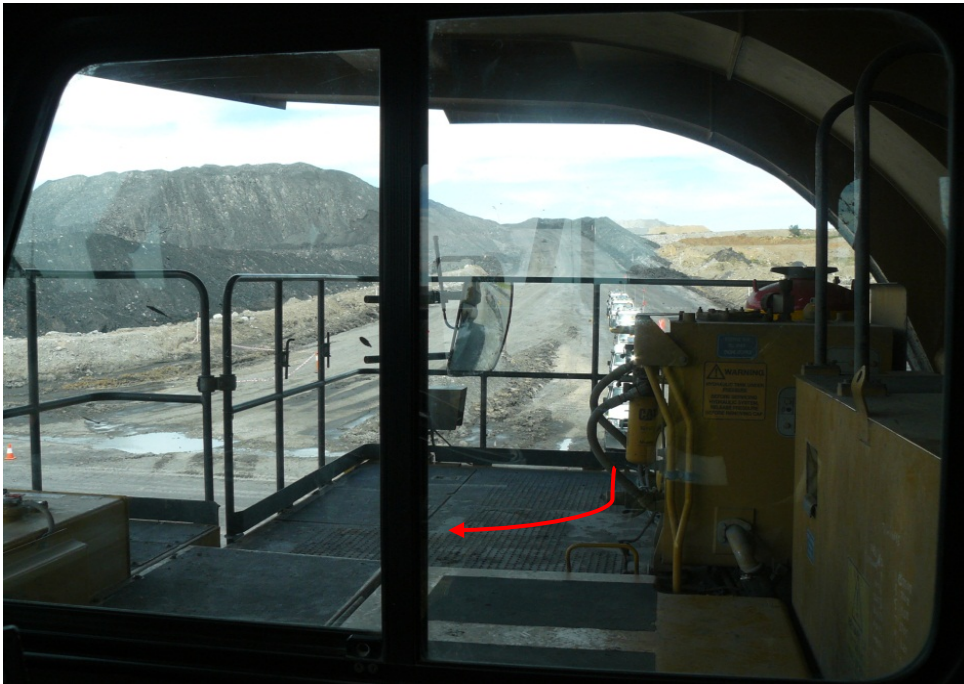
Figure 15. Photograph taken by investigators from truck operator's cabin (passenger seat) at Ravensworth mine on 2 December 2013. The truck was positioned at the center of the intersection. Note the significant blind spot on the right-hand side of the truck and the Landcruiser direction of travel (red arrow).

Investigators made the following observations during the simulations: The Landcruiser could not be seen when it was positioned in the truck's blind-spots. The lack of clearance/side lighting and reflective material on the truck made it difficult to detect at night. Lines of sight from the Landcruiser were obscured by the 8<sup>th</sup> ramp windrow in numerous places, making it difficult to see the truck on the haul road. The absence of direct artificial lighting and the impact of secondary (incidental) lighting from the mine infrastructure area (MIA) at the intersection caused background glare.

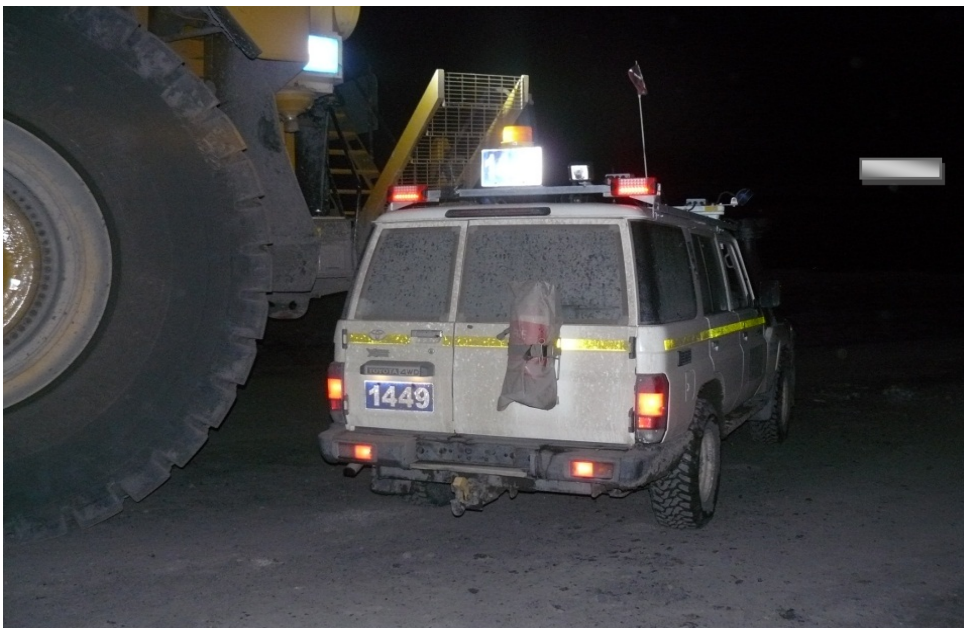
Figure 16. Photograph taken by investigators on 5 December 2013. The light vehicle is positioned in the truck's blind spot on the right-hand side of the truck simulating the right-hand turn made by Ms Forshaw.

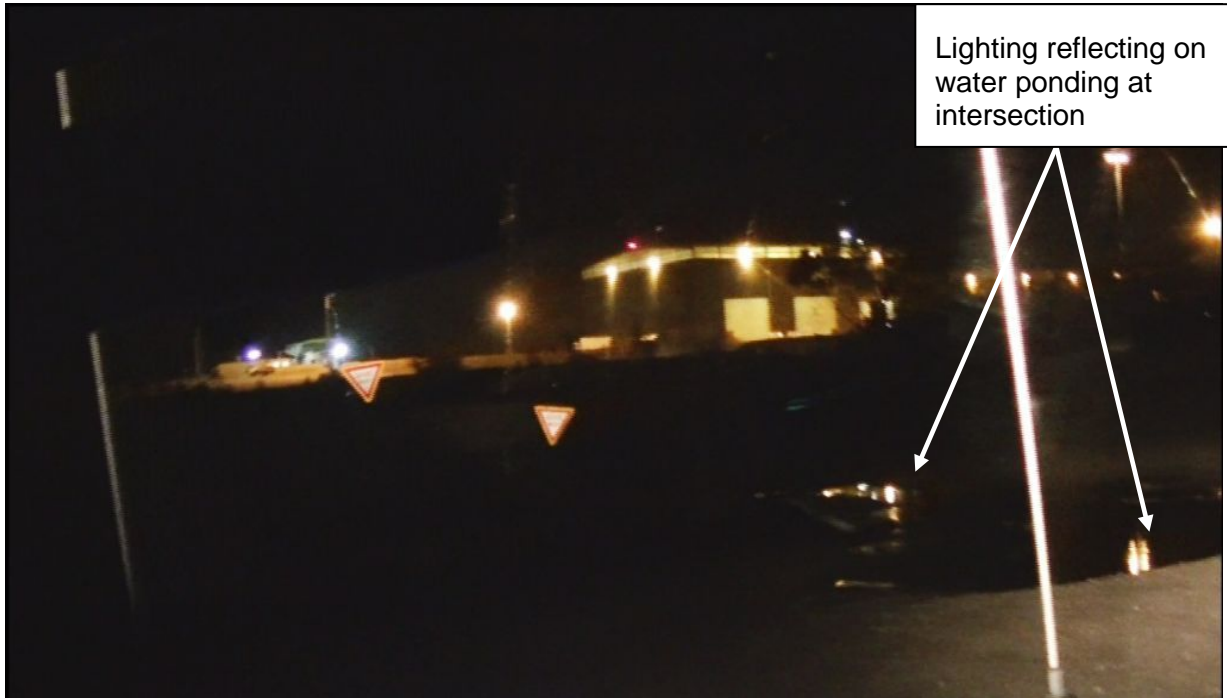
Figure 17. Screenshot from video taken by investigators on 5 December 2013. Taken from inside a light vehicle (passenger side) on the 8<sup>th</sup> ramp stockpile near the intersection.

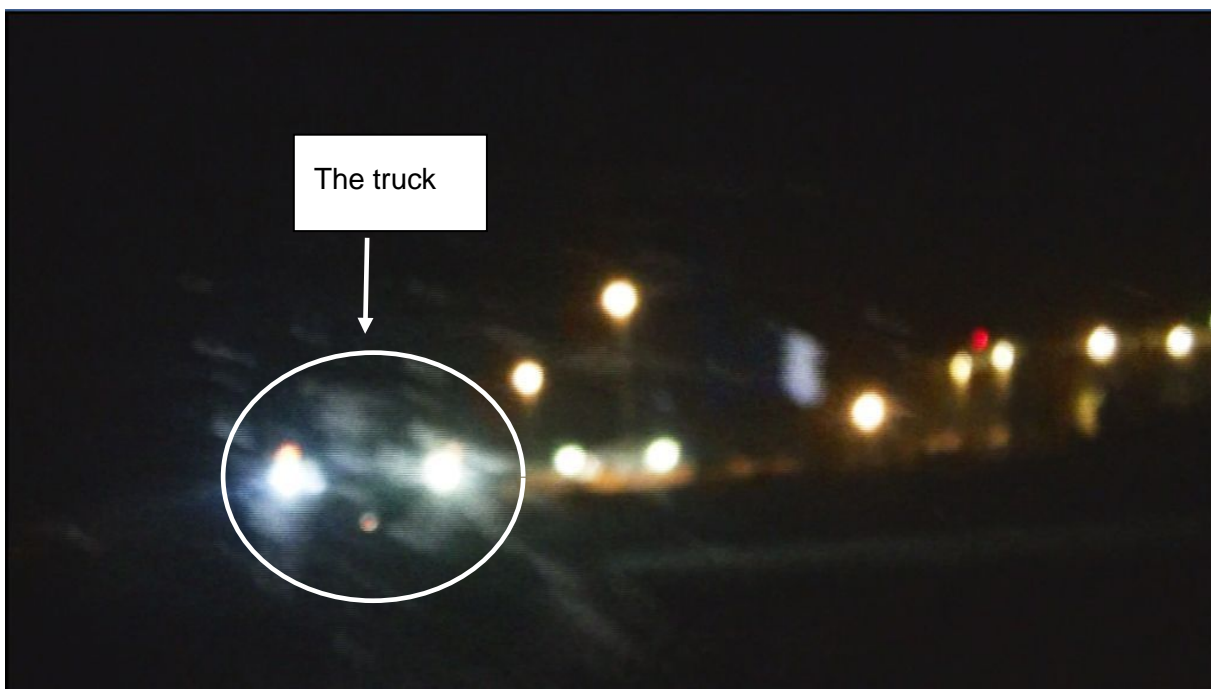
Figure 18. Screenshot from video taken by investigators on 5 December 2013 from inside a light vehicle travelling through the intersection. The truck was positioned on the haul road 50 metres from the intersection. Workshop lighting is visible in the back ground.

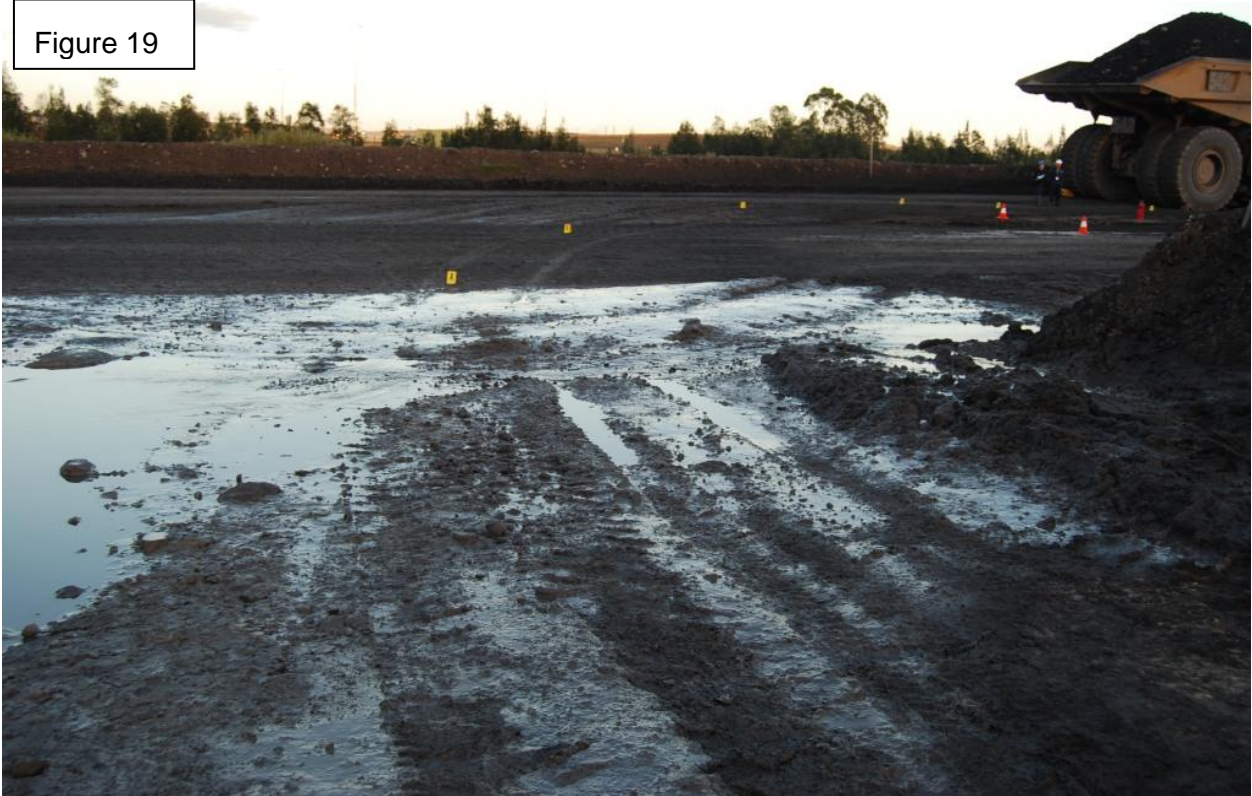
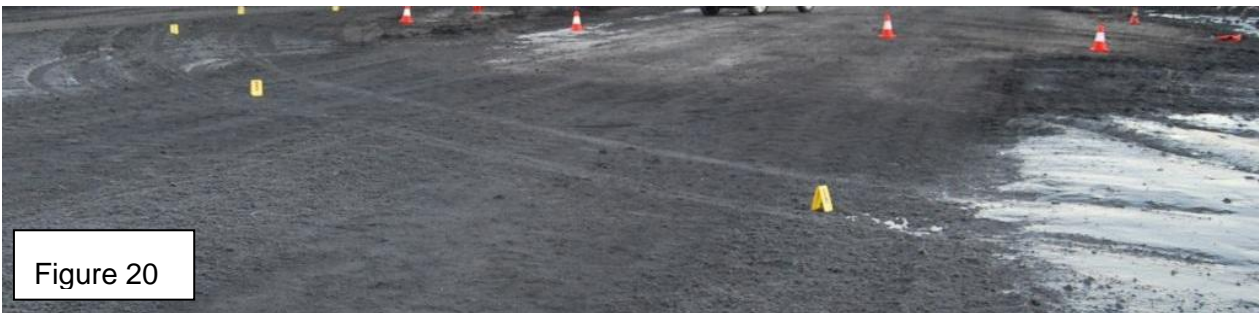
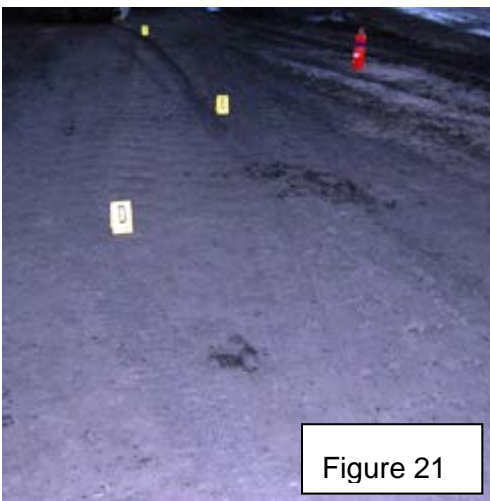
Figures 19, 20, and 21. Photographs of the tyre marks of the Landcruiser at the incident site taken by investigators at the mine on 1 December 2013.

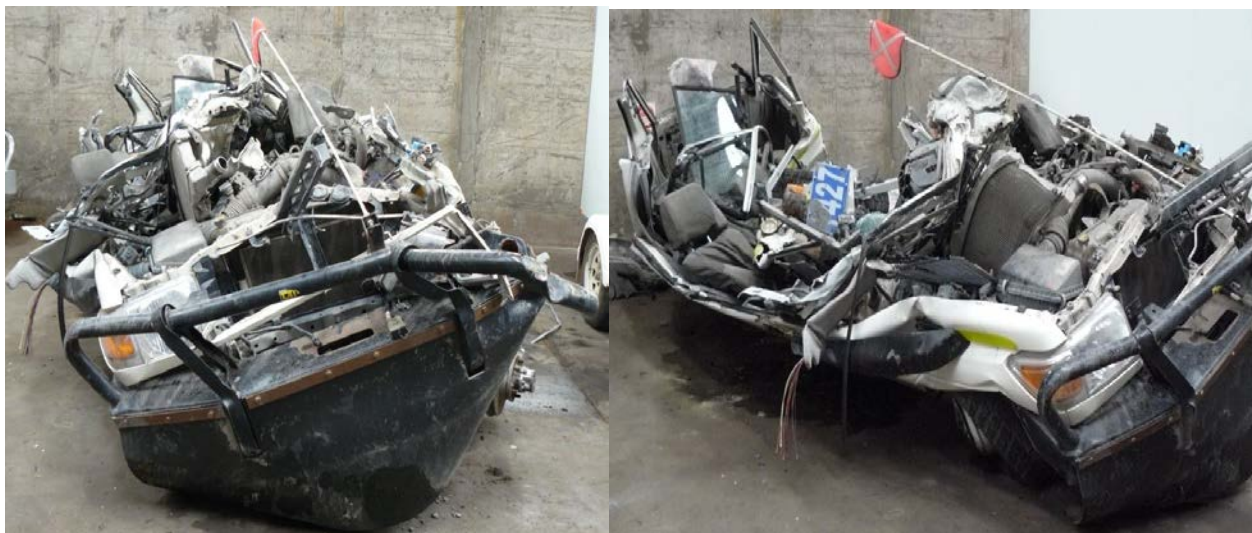
Figure 22. Photographs of the Landcruiser taken by investigators at the Newcastle Police holding yard on 8 January 2014.

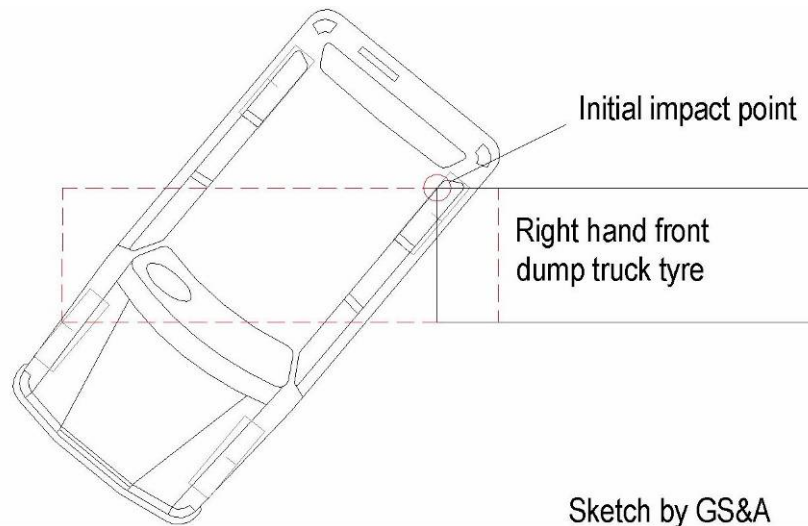
The most probable point of initial impact on the Landcruiser would have occurred near the turret seam just forward of the door pillar (rear passenger side). Figure 23, is an unscaled sketch of a plan view of the most probable point of impact.

Figure 23. Unscaled sketch of a plan view of the most probable impact point

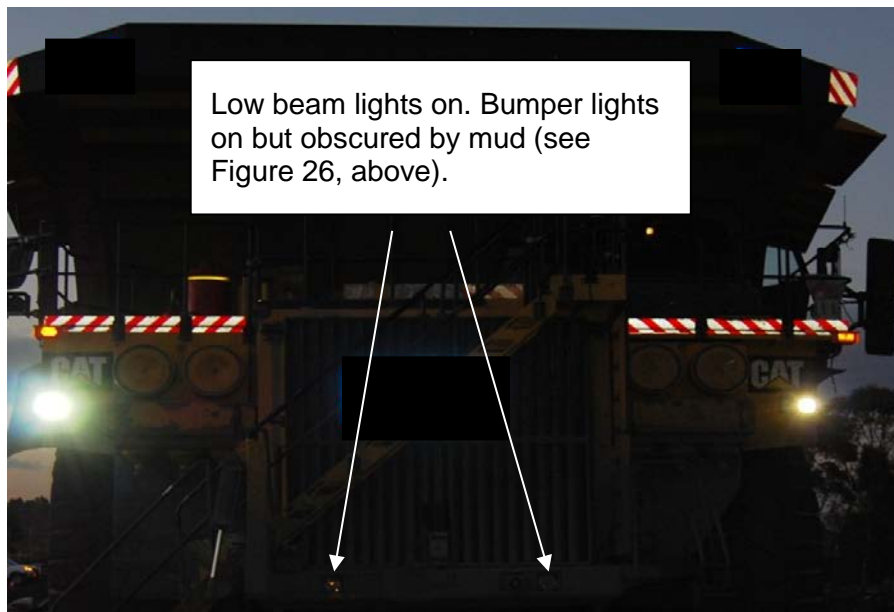
Figure 27. Photograph of the truck taken by investigators on 1 December 2013 at 5 am when the truck was first started after the incident. Low beam lights and bumper lights were on.

Investigators observed during the night time simulations of the incident on 5 December 2013 using the truck, that the recessed right hand side low beam light lens could not be seen from certain angles on the right-hand side of the truck.

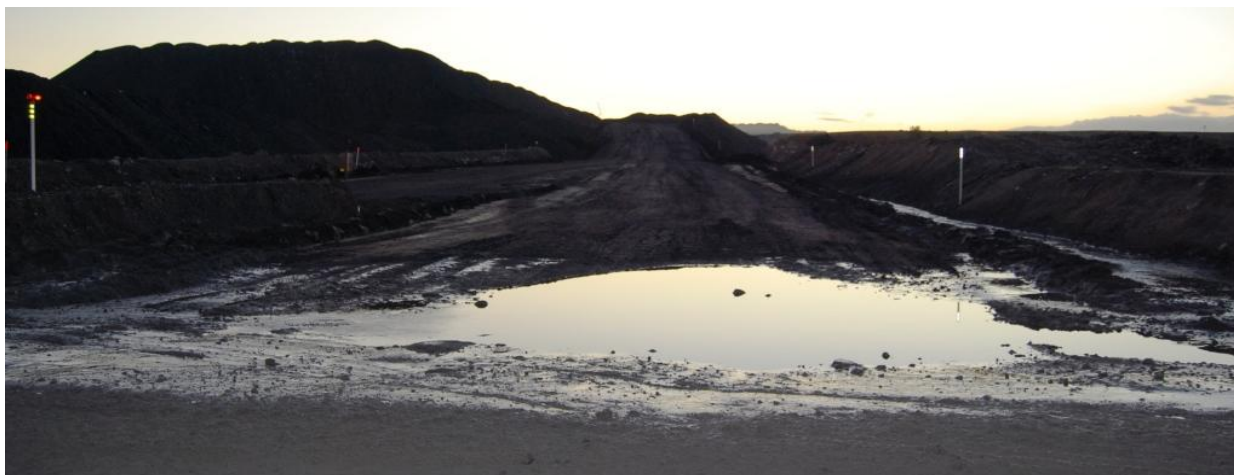
Management of the mine indicated that water across the intersection was an anticipated occurrence, such as during and after rain events and the road had a spoon drain across the intersection, requiring all vehicles to slow down on their approach. The water ponding remained unresolved at the time of the incident. This appears to be inconsistent with the local standard for haul road maintenance which stated '*Repairs to any defective section of roadway shall take place as soon as practical [sic]*' (ref. Section 6.1 of RDCG).

Figure 29. Photograph taken of incident site by investigators on 1 December 2013.
