Moranbah Investigation Report

**Fatal collision - 8 July 2010 - Occupational crossing 5805
Goonyella Riverside Mine - Near Moranbah**

Final report, Rail Safety Investigation TMR3584

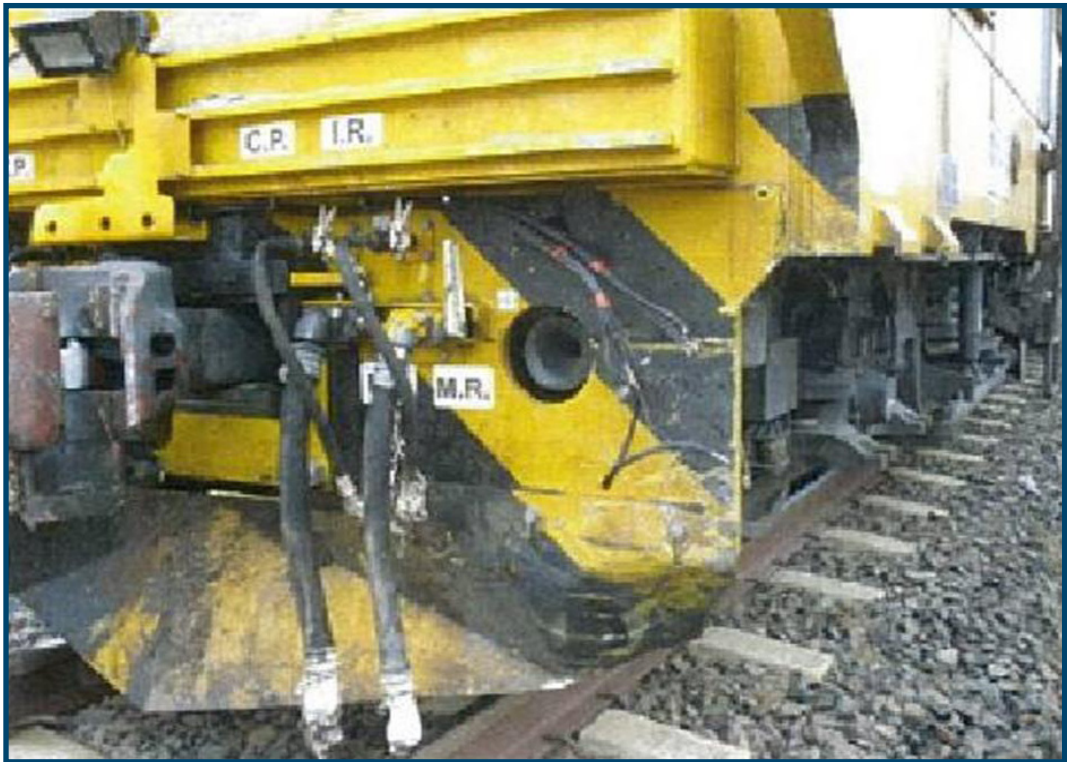
Picture 1: Damage to locomotive

Minor superficial damage was caused to the lead locomotive on the left hand front corner below the level of the locomotive cabin (refer Picture 1).

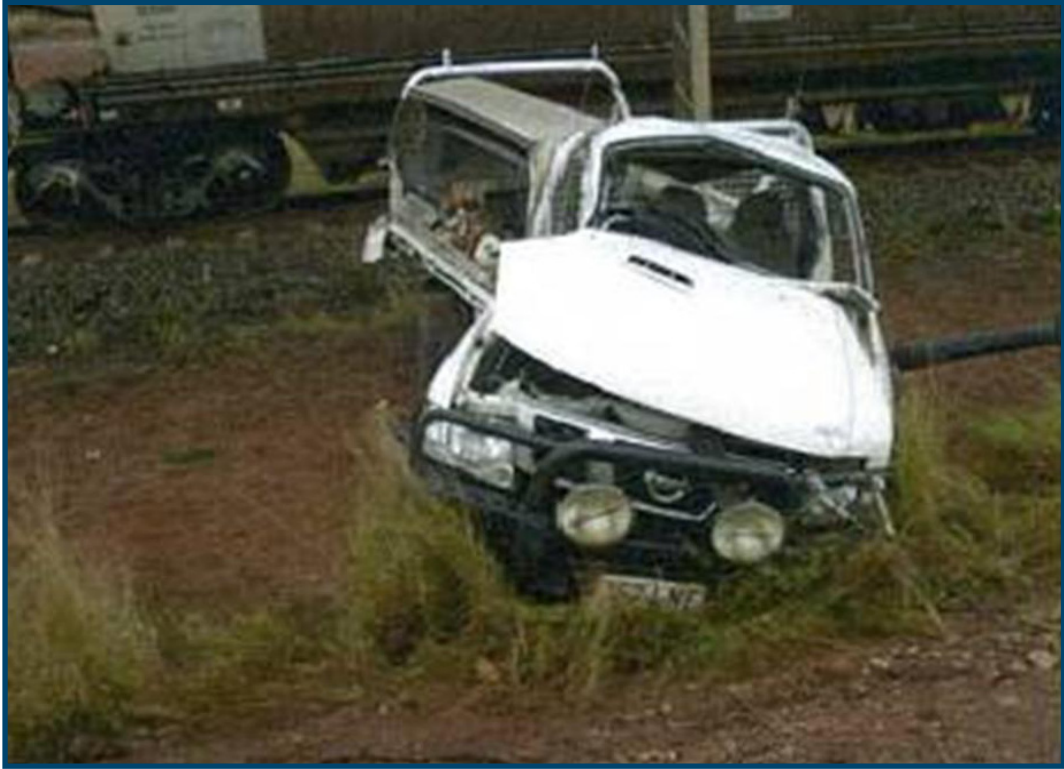
Picture 2: Damage to road vehicle

The utility suffered extensive damage as a result of the collision and was unreparable (refer Picture 2). The impact was evident on the driver's side of the vehicle with the chassis being bent and substantial structural damage caused to the entire vehicle.

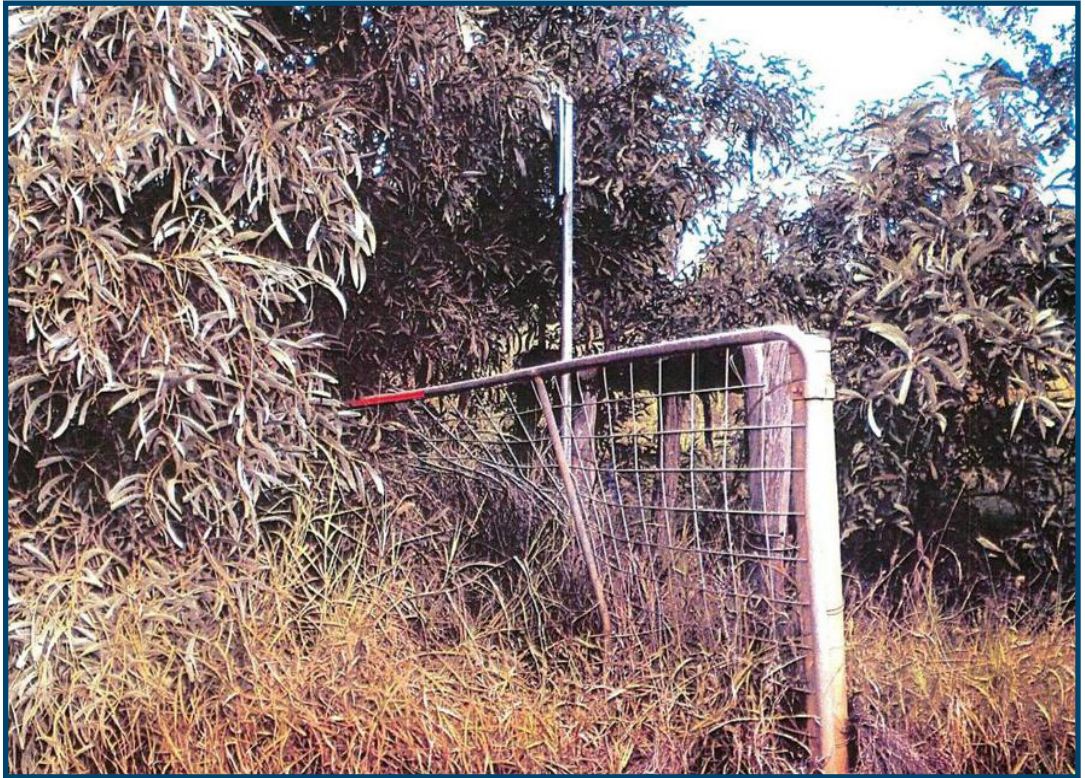
Picture 3: Damaged gate

At the time of the incident, the gate was damaged and had a large tree growing in front of it (refer Picture 3) that prevented the gate being closed and locked. The tree in front of the gate also obscured the prohibited access sign (refer Picture 4). The condition of the gate and sign appears not to have been identified in the safety audit conducted by the railway manager in 2008.

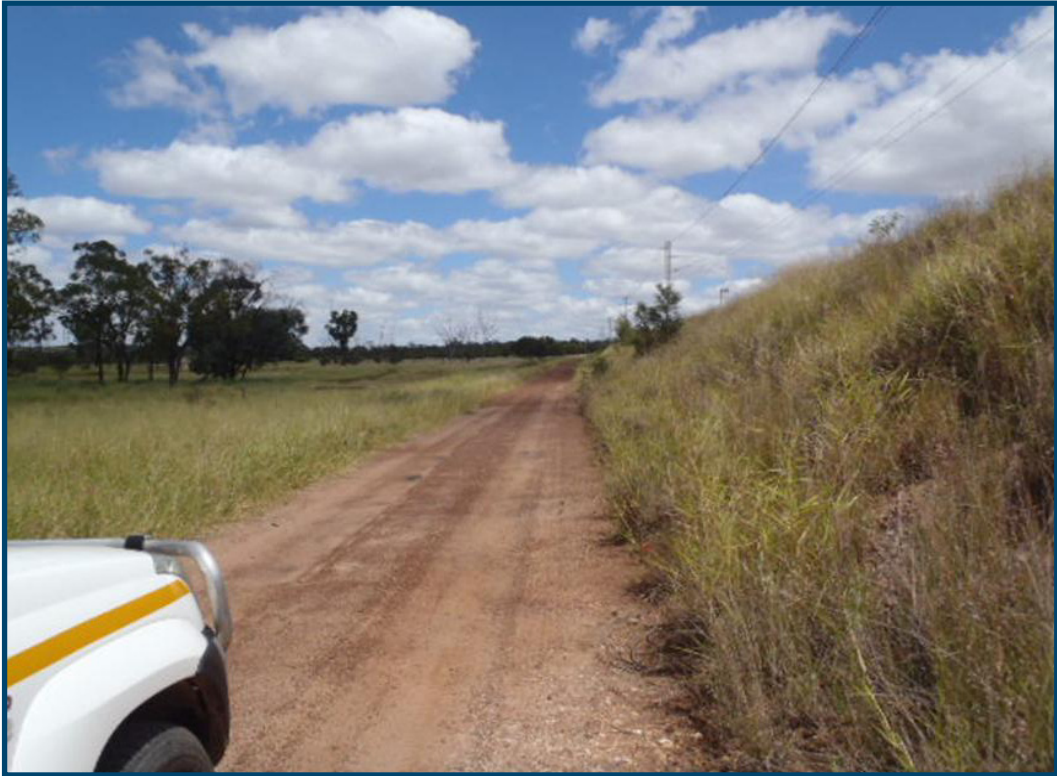
Picture 5: Track elevation

Between Occupational Crossings 5804 and 5805 the access road dips into a gully and then gradually rises towards Occupational Crossing 5805. The railway track is on the right hand side of the access road when heading west (in the direction of the train and the utility). The railway track has a gradual rise from Occupational Crossing 5804 to 5805 and as a result the vertical separation of the access road and railway track varies. Picture 5 shows the difference in elevation from the access road and railway track when exiting the gully. The railway track is over two metres in height and above the vehicle driver's field of vision.

The departmental investigation team found that the railway line and any subsequent train on the railway track could not be seen from a light road vehicle such as the vehicle involved in this incident.

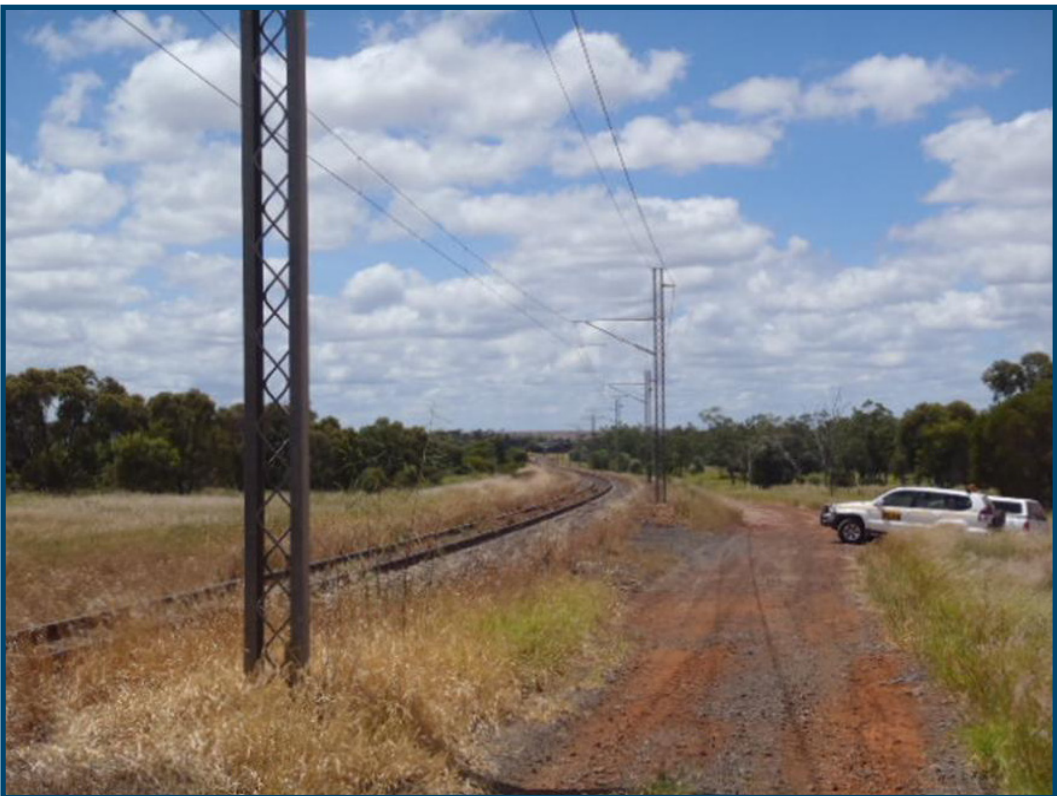
Picture 6: View east from Occupational Crossing 5805

In the immediate vicinity of Occupational Crossing 5805, the rail corridor access road and railway track meet. Picture 6 shows the view from the crossing back towards the east and demonstrates the rise of the rail corridor access road to meet the railway track at the crossing.

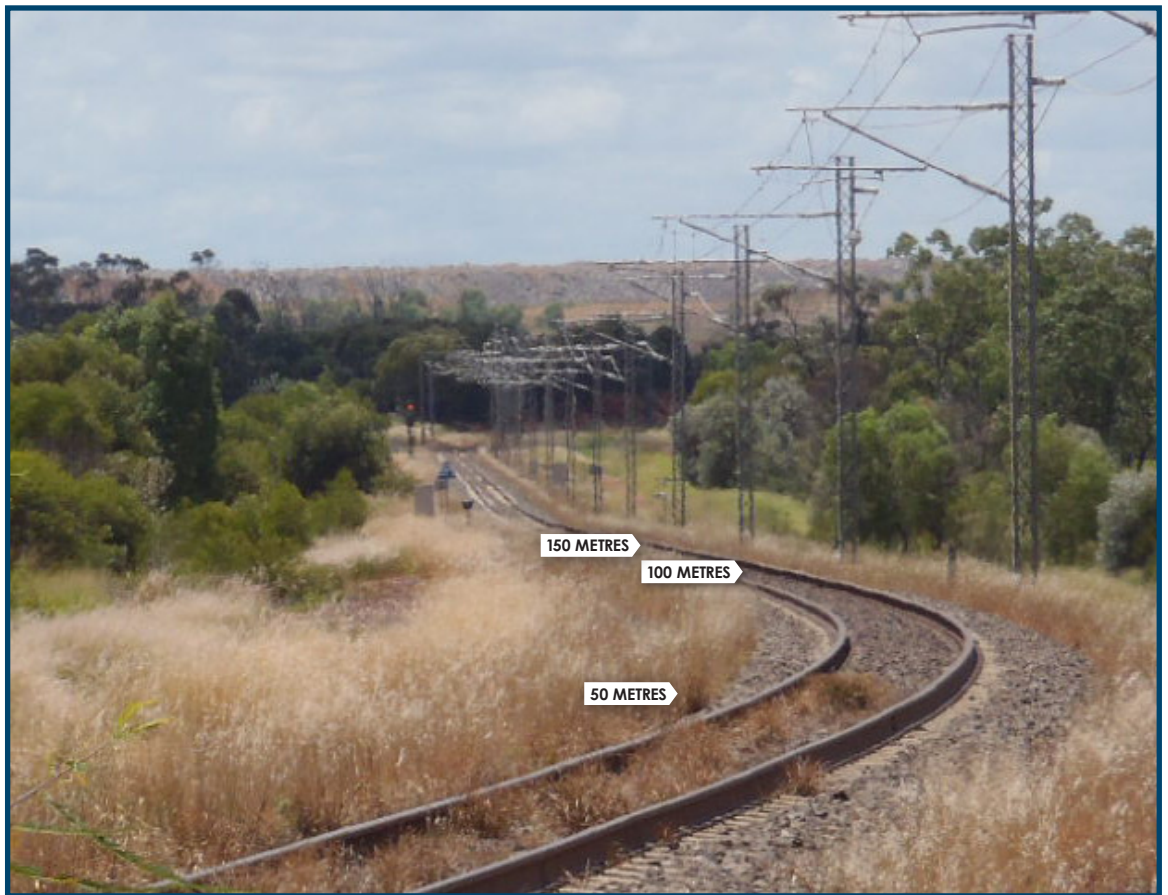
Picture 7: Curvature of track (showing distances from 5805)

As a result of the geography of the land and the curvature of the track, the vision directly behind the utility involved in the collision would have precluded a view of the railway track to the east and the train headlight that would have been above the driver's field of vision in the rear view mirror.

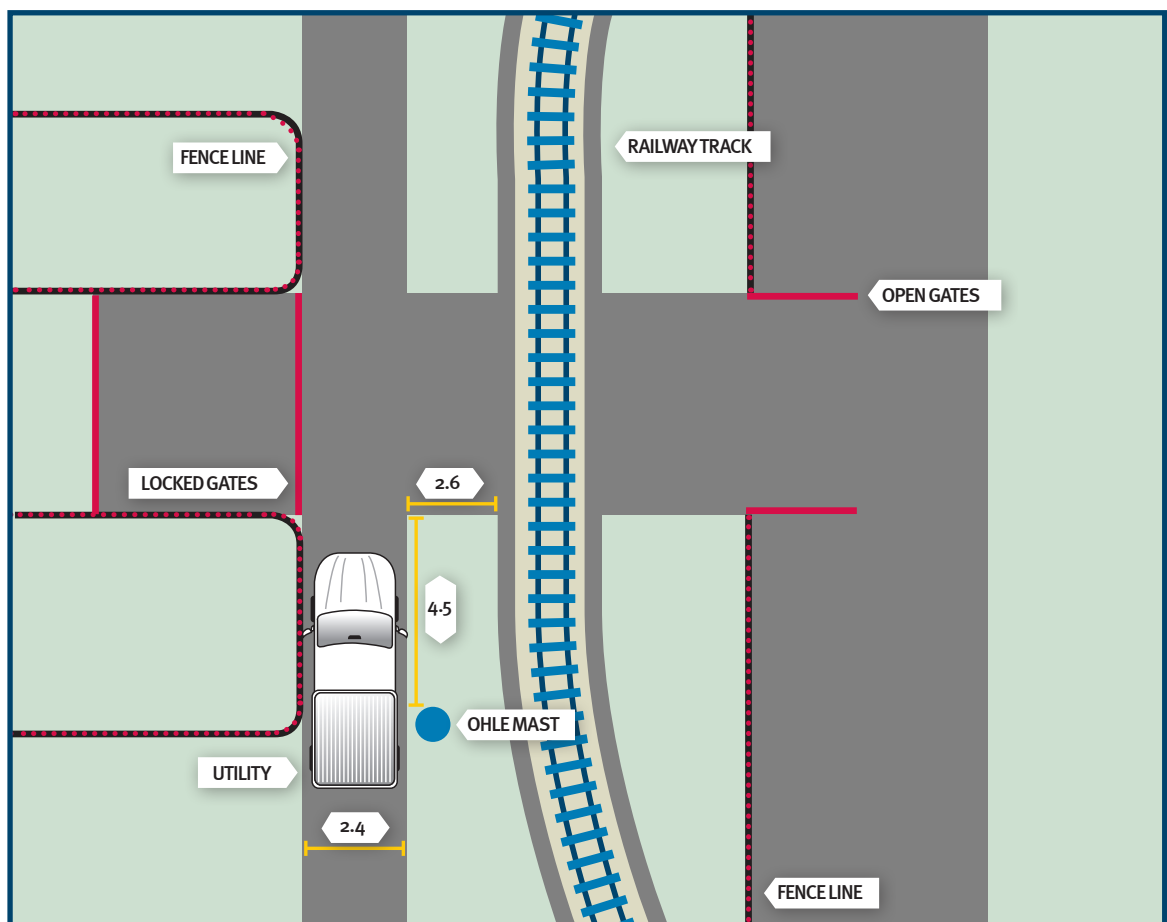
Figure 7: Placement of vehicle (distances are shown in metres)

An inspection was made of the corridor access road at the intersection of Occupational Crossing 5805. Figure 7 depicts the layout of the crossing and the approximate position of the utility prior to the collision.

The driver of the road vehicle had limited opportunity to move left to improve visibility of the track or improve his approach to the crossing because of the closed gates and the narrow track. The driver also had limited opportunity to turn early because of the obstruction of the OHLE mast near the intersection on the vehicles right hand side.

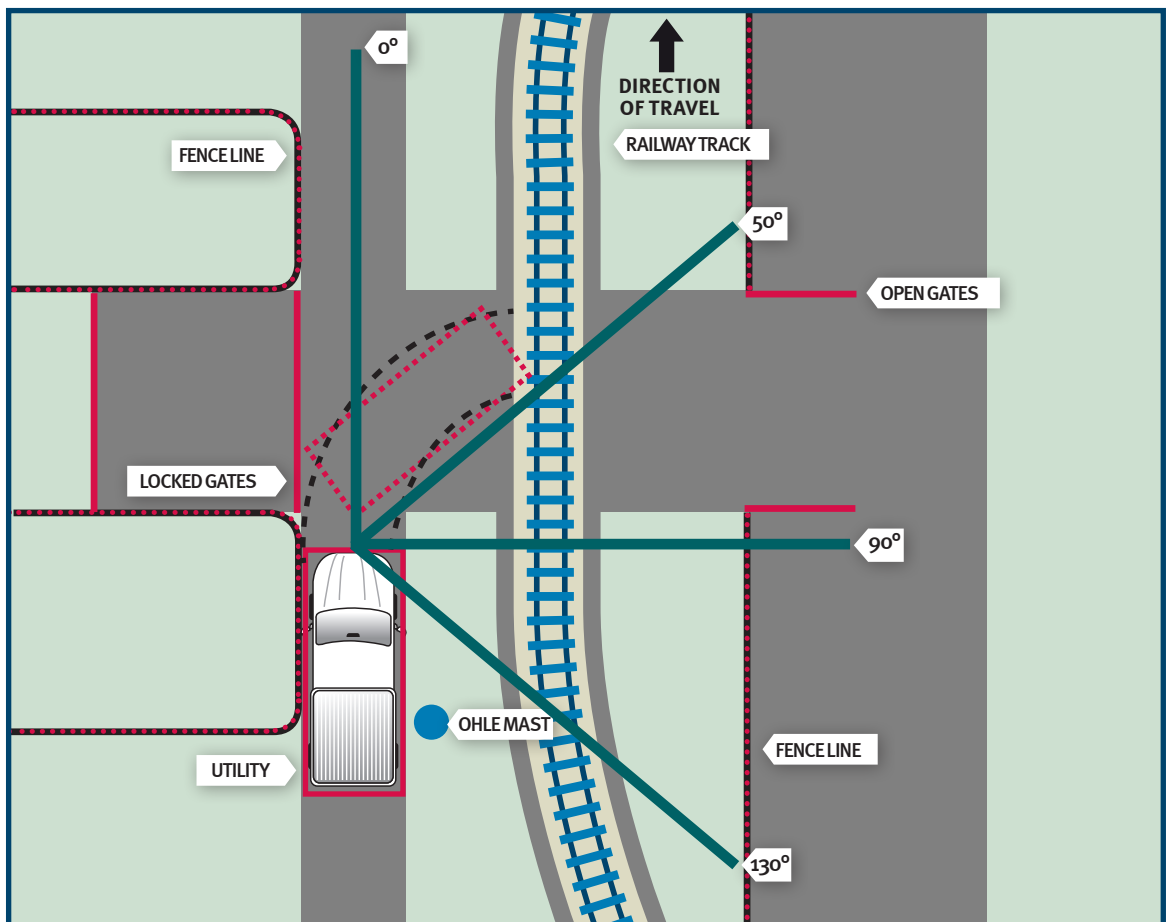
Figure 8: Turning circle of vehicle

Using measurements of the scene and the known turning circle of the utility it is possible to approximate the path of the vehicle. The manufacturer of the vehicle advises that the utility had a turning circle of 12.5 metres.

While it was not possible for the departmental investigation team to determine the exact path the utility took turning onto the crossing, Figure 8 depicts the best possible approach the driver of the utility could have made in turning towards the crossing.
