TECHNICAL REPORT

Subject: Analysis of Blakefield South Mine (BSM)
Explosion

Date: First Draft 16 Feb 2012
Revised 20 Feb 2012; 29 Feb 2012

Report Prepared By: Drs Hsin Wei Wu and Stewart Gillies

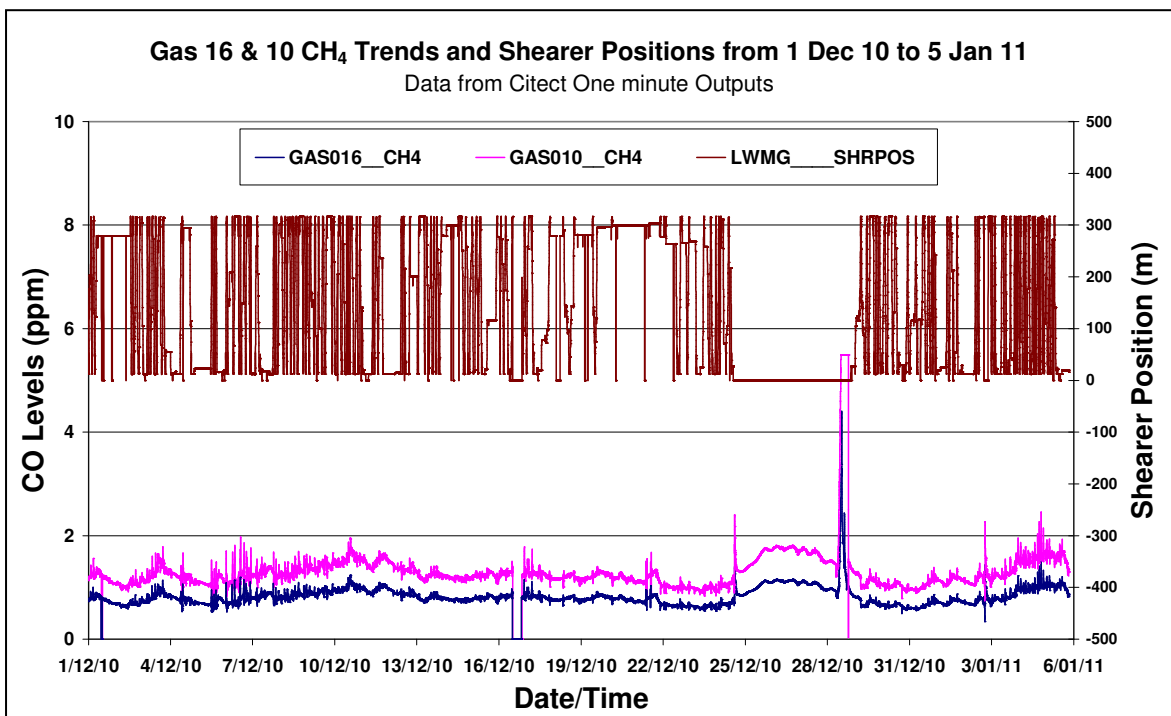
Figure 2.1 Methane gas trend recorded at Gas 16 & 10 Stations (1/12/10 – 05/01/11) and position of LW Shearer.

During the non production period from 24/12/10 to 28/12/10, CH₄ readings recorded at Gas Stations 16 and 10 gradually increased and stabilised. CH₄ readings shot up during the planned fan shut down on 28/12/10 but CH₄ levels decreased very quickly when fans were turned back on and the general trends of CH₄ levels were downward.

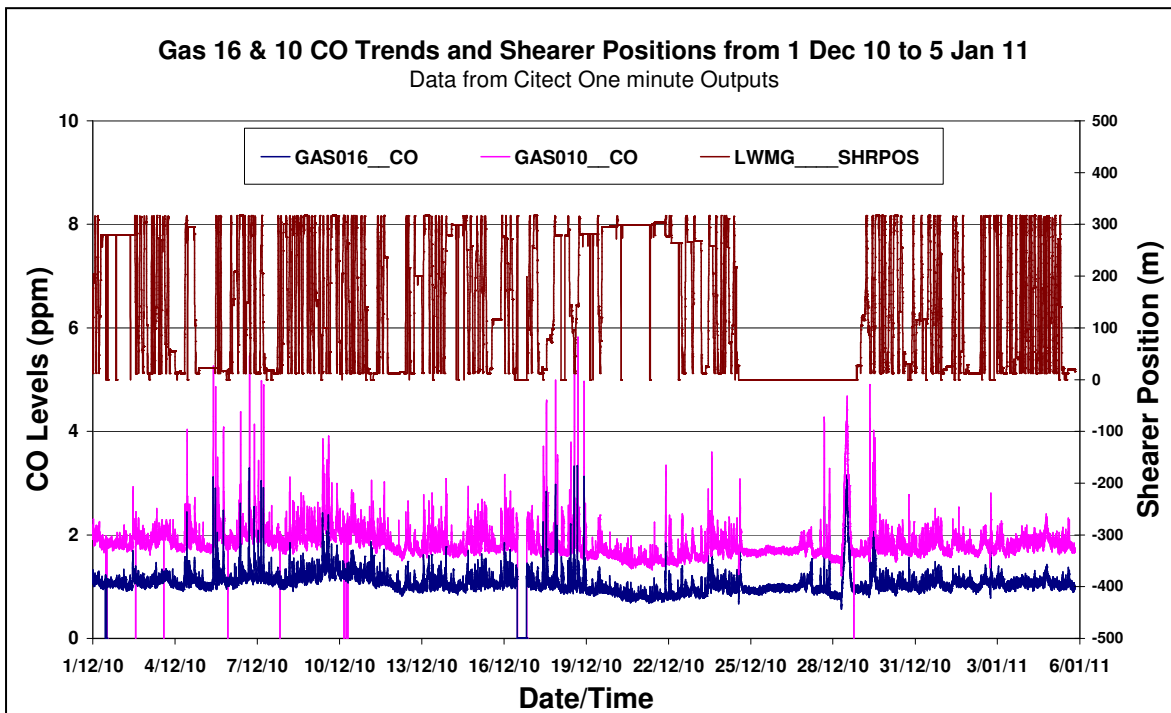
CO levels at both stations on the other hand remained steady during the Christmas shut down period. Correlation between CO levels at both stations and LW production was not as obviously as CH₄. However, the general trends of CO levels from 1 Dec 2010 to 5 January 2011 were steady and slightly downward in the second half the period.

Figure 2.2 CO gas trend recorded at Gas 16 & 10 Stations (1/12/10 – 05/01/11) and position of LW Shearer.

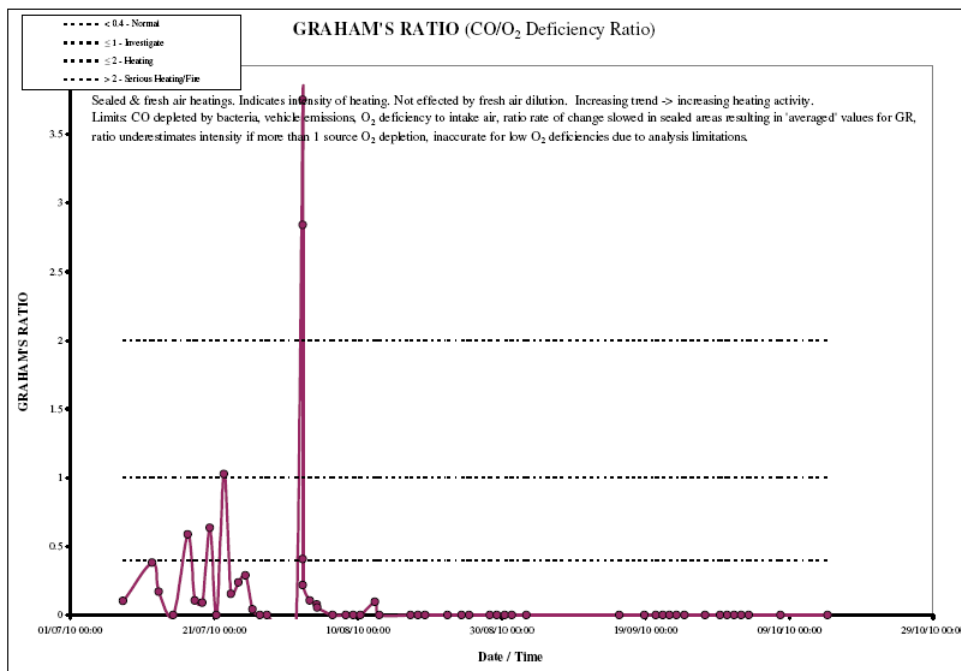
Figure 2.3 Graham's ratio trend from LW goaf bag samples.

It can be seen that from these two figures that LW goaf gas environment after initial unstable period in July 2010 and by early August 2010 LW goaf gas environment had settled and stabilized.

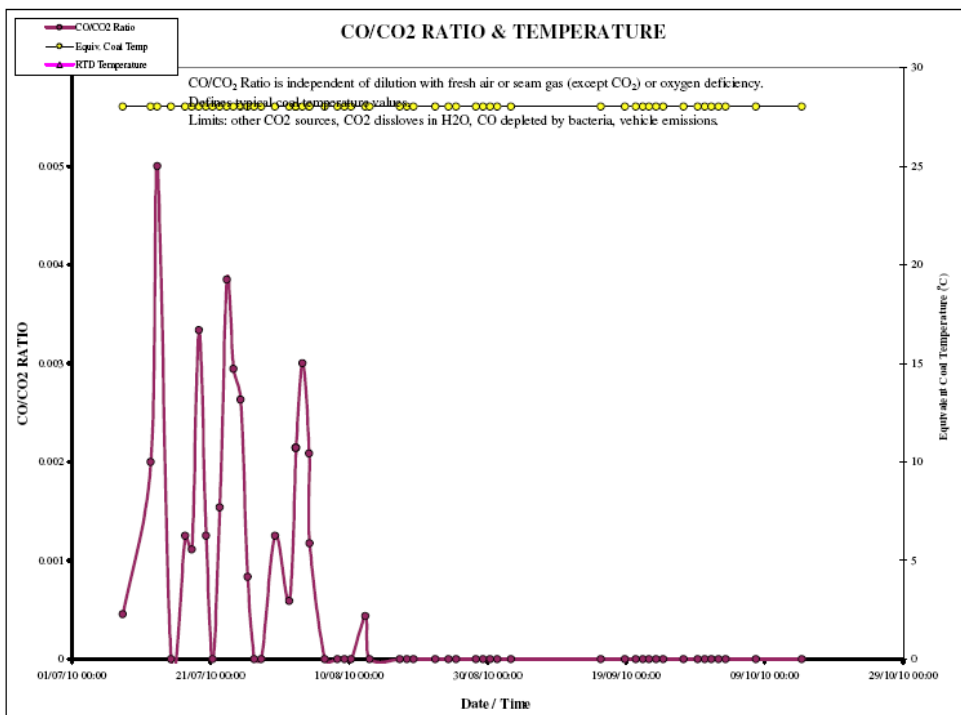
Figure 2.4 CO/CO₂ ratio and temperature trends from LW goaf bag samples.

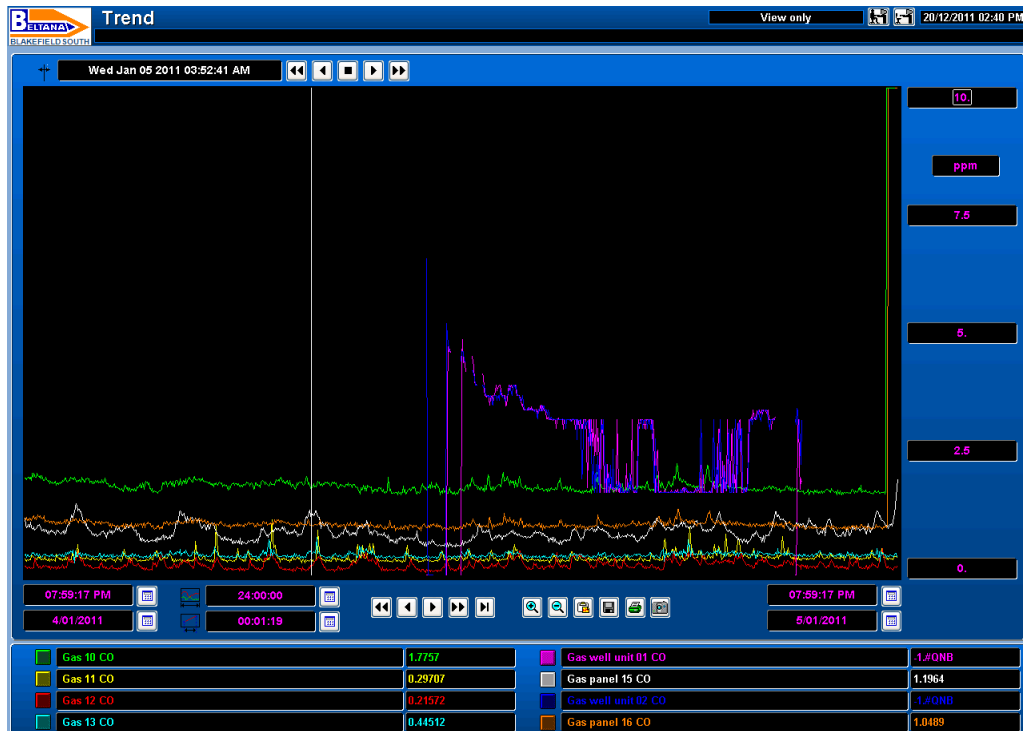
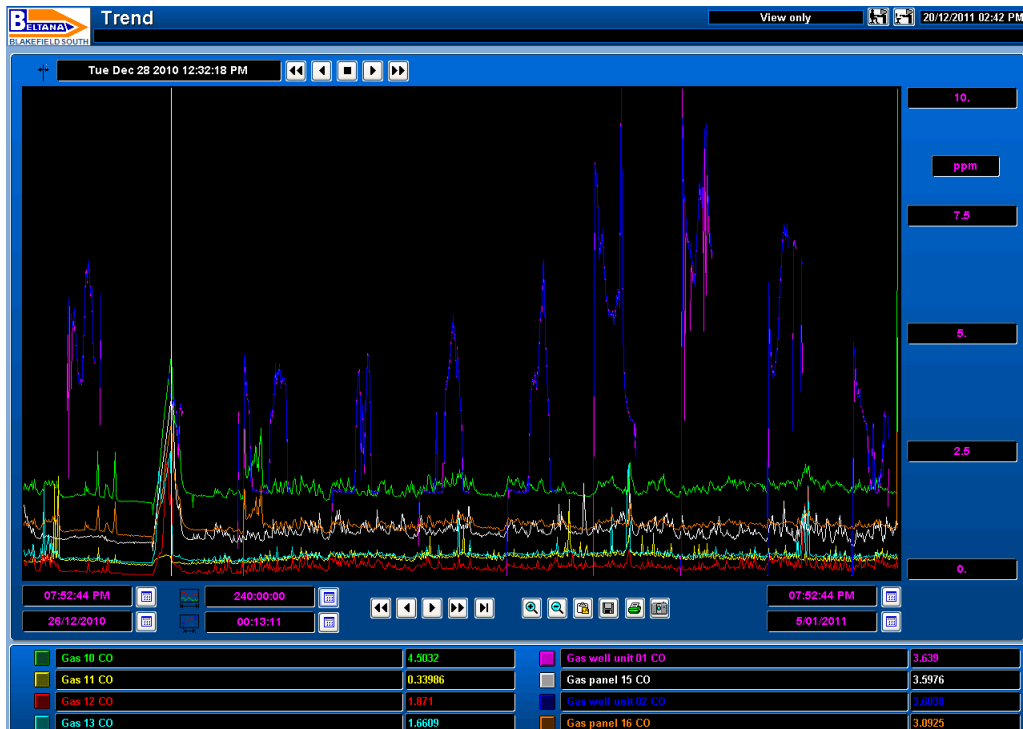
Figure 3.4 CO in the returns plus gas wells approximately 24 hours before incident

Figure 3.5 CO in the returns plus gas wells approximately 10 days before incident

Figure 3.6 CO in the returns plus gas wells approximately 10 weeks before incident

Figure 3.7 CO in the returns plus gas wells for the life of LW panel

The indications of "high" CO levels in the range of 7 to 10 ppm from gas drainage wells recorded by the Citect gas monitoring system could come from a number of sources.

- Vehicular traffic working hard sporadically in the Main Gate that ventilated across the face and around the goaf to the TG could have been the cause.

- Also slow oxidation of coal in the goaf will cause some low level CO. As the goaf forming roof fell air would have pushed into the face area and across CO sensors. These wind blasts would have altered the normal air gas concentration near the sensor for a short period (an inrush possibly followed by a suck back).

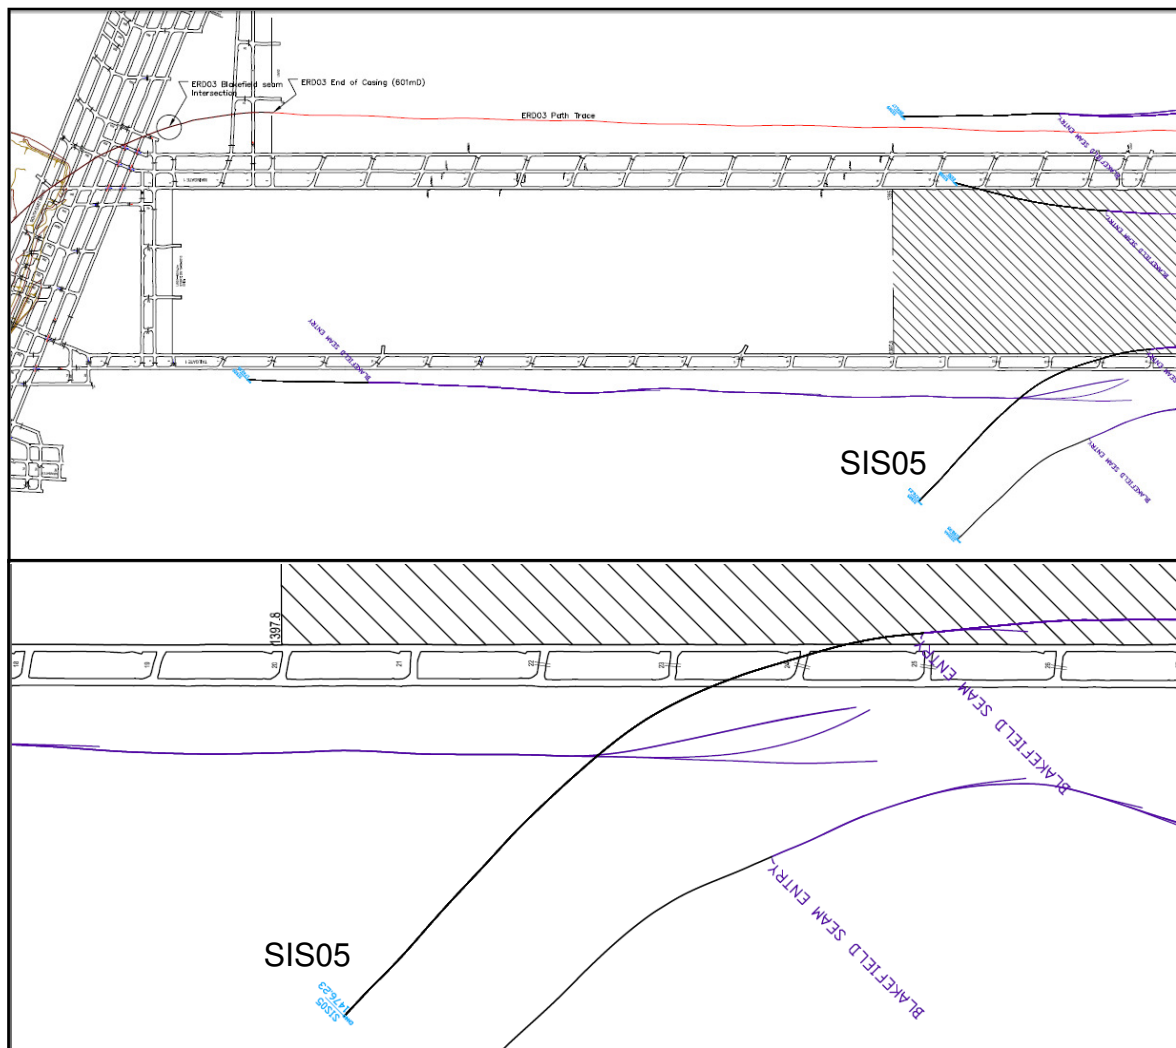
Figure 7.1 Extract from mine plan showing SIS 05 hole intercept LW TG at about 4 to 5 CTs inbye of the LW face line at the time of incident.

- (iv) Undertake Ventgraph modelling with an ignition assumed to originate where a borehole intersects the worked seam in the TG about 4 CT back or inbye the LW face. In this modelling assume that ignition is caused by lightening and model to parallel the observations and re-actions of the LW shift Deputy and the Maintenance Supervisor from the moment of lightening strike recorded on the surface above the borehole position.

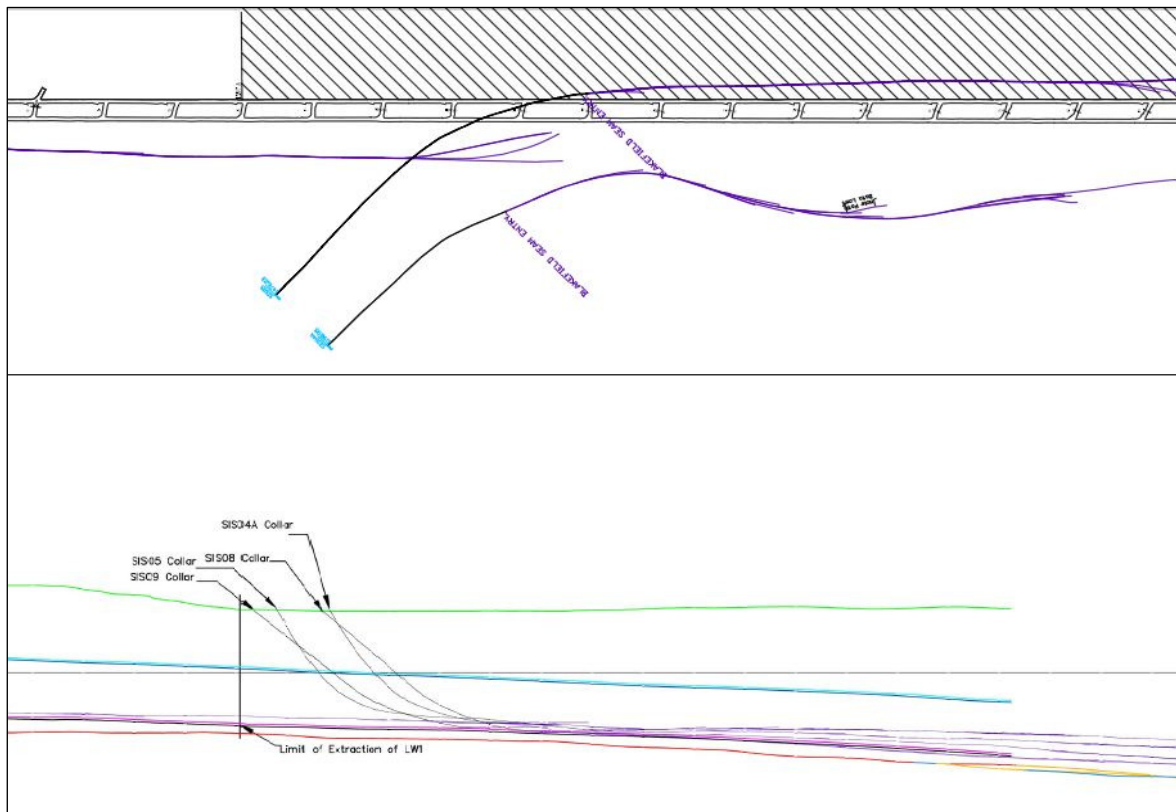
Figure 7.2 shows a plan and elevation view of the boreholes intersecting the upper and lower seams being worked in the vicinity of the TG on 5 January 2011. These demonstrate that there were a number of borehole connections between upper Wybrow and lower Blakefield South coal seams that could have held gassy atmospheres that possibly played a part in allowing CH₄ to pass from the upper seam to replenish CH₄ gas concentration levels immediately after dilution with ventilation as the longwall mined through a particular part of the coal seam being worked and goaf formation occurred.

Figure 7.2 Plan and Elevation view of the boreholes intersecting the upper and lower seams being worked in the vicinity of the TG on 5 January 2011.

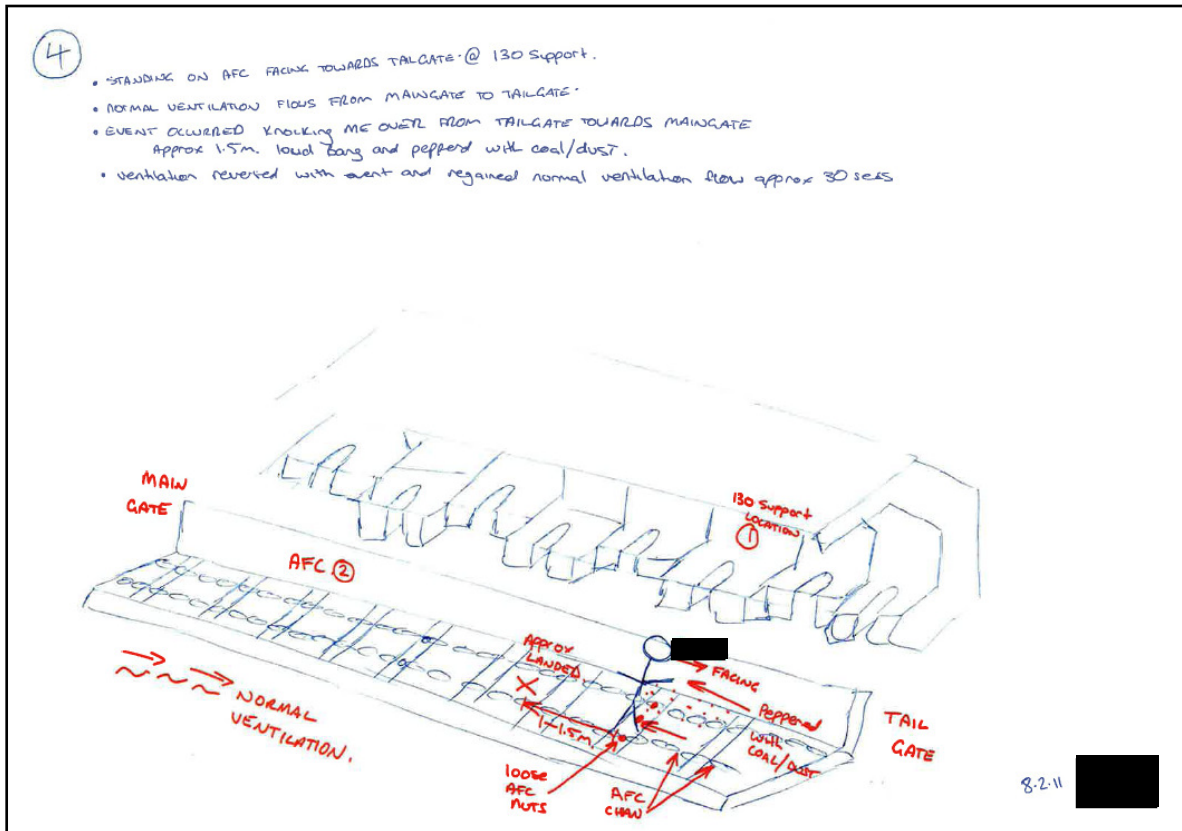
Figure 8.2 LW Maintenance Supervisor, [REDACTED], hand drawing indicating his position on LW face at Chock 130 at time of incident.

being knocked over. He noted when he was at Chock 130 a cloud of dust and he was peppered by dust. He recorded in the verbal interview that “something that was really different was the smell....it smelt like gunpowder.....like cordite....after you shoot....it’s got a real distinctive smell and I’ll never forget that smell”. ██████████ stated that he was aware of the mine’s spontaneous combustion management plan and expected to note signs of “...sweating of, of steel, heat, haze and.....” if this existed. He did not recall any of these effects at the time of the incident.
