Learnings from Middlemount Mine Highwall Fatality 26 June 2019

Presented by:
Dave Champion
Operations Manager / SSE

Incident Overview

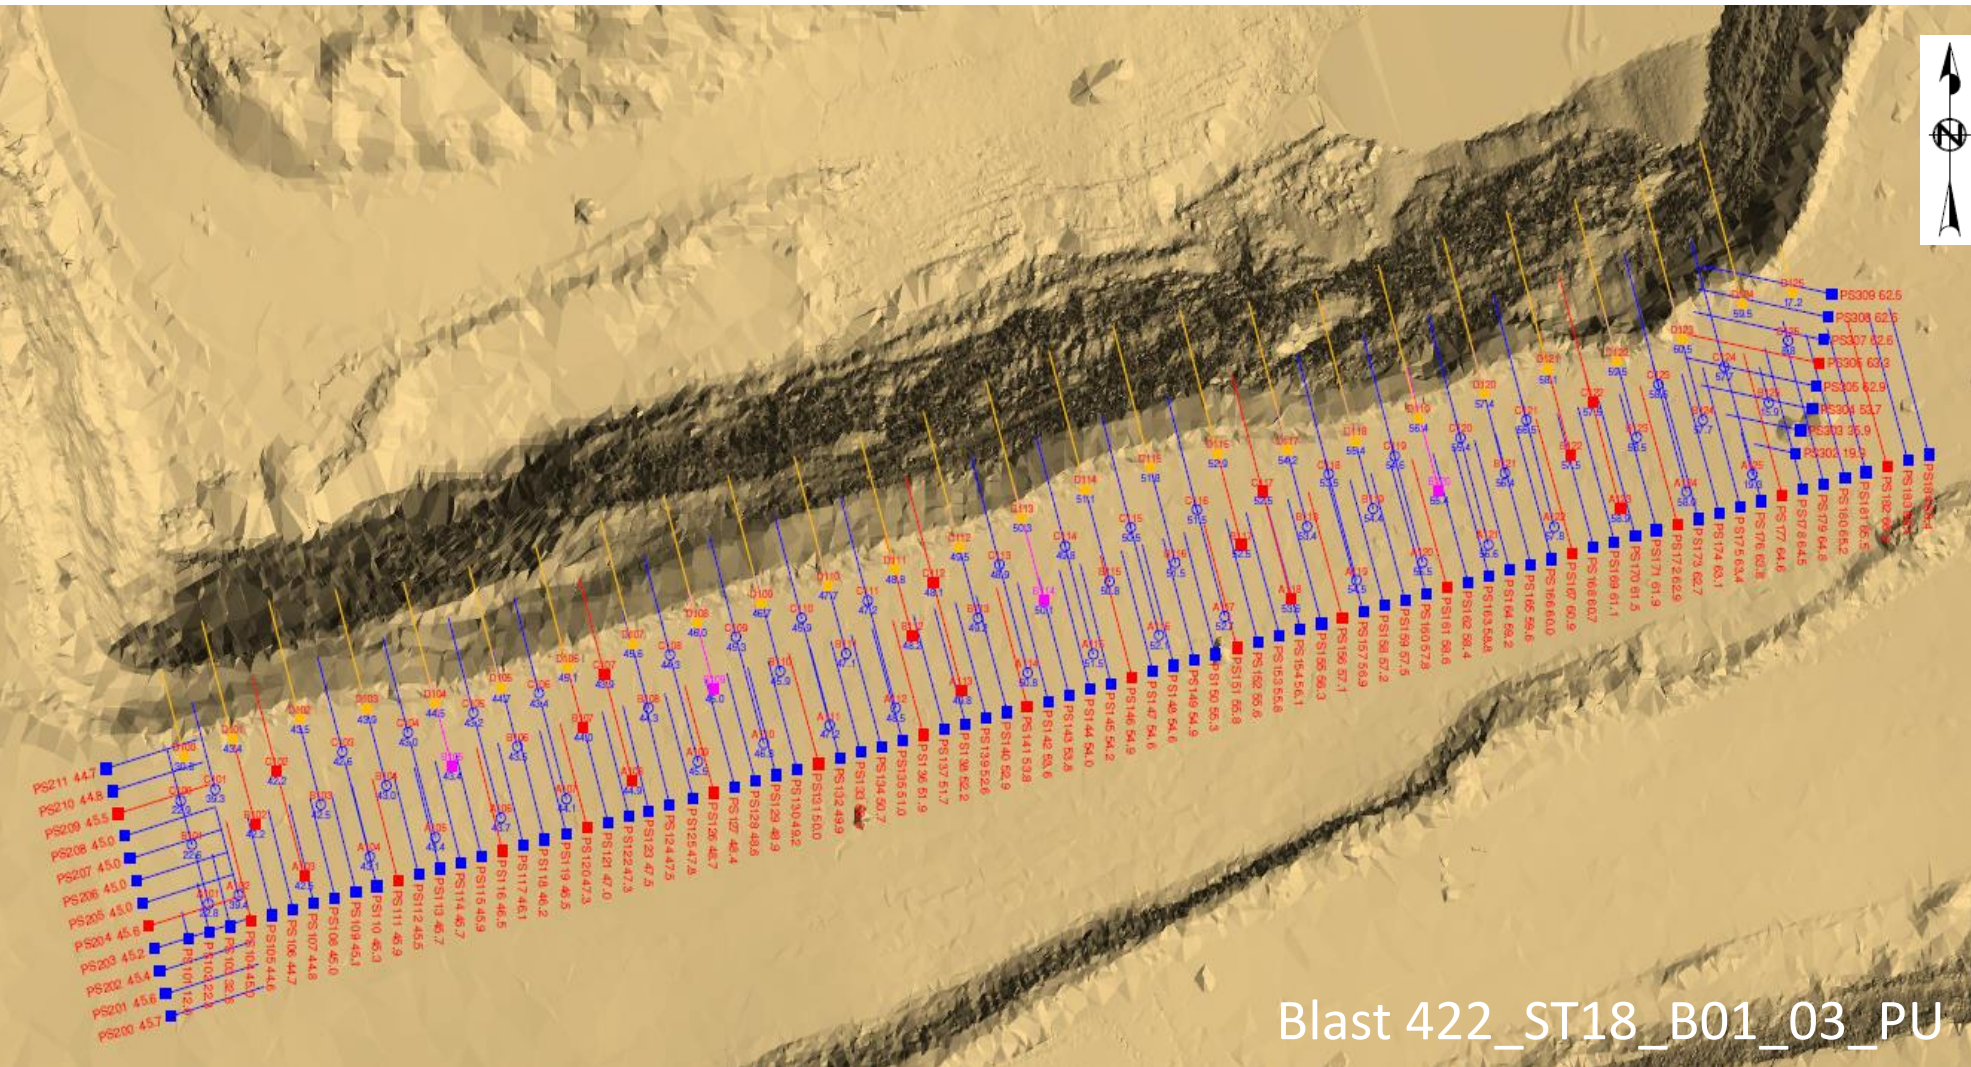
Timeline - 05/06/2019

Strip 19 drill design was approved and released. An adjusted version was later released without the appropriate authorization with minor changes to hole alignment and angle.

The eastern echelon design included a presplit to provide a cleaner, straighter wall to expose additional coal at the toe of the pit wall, which was not common practice at Middlemount Mine.

The previous Strip 18 did not include a presplit and subsequently the coal recovery was reduced.

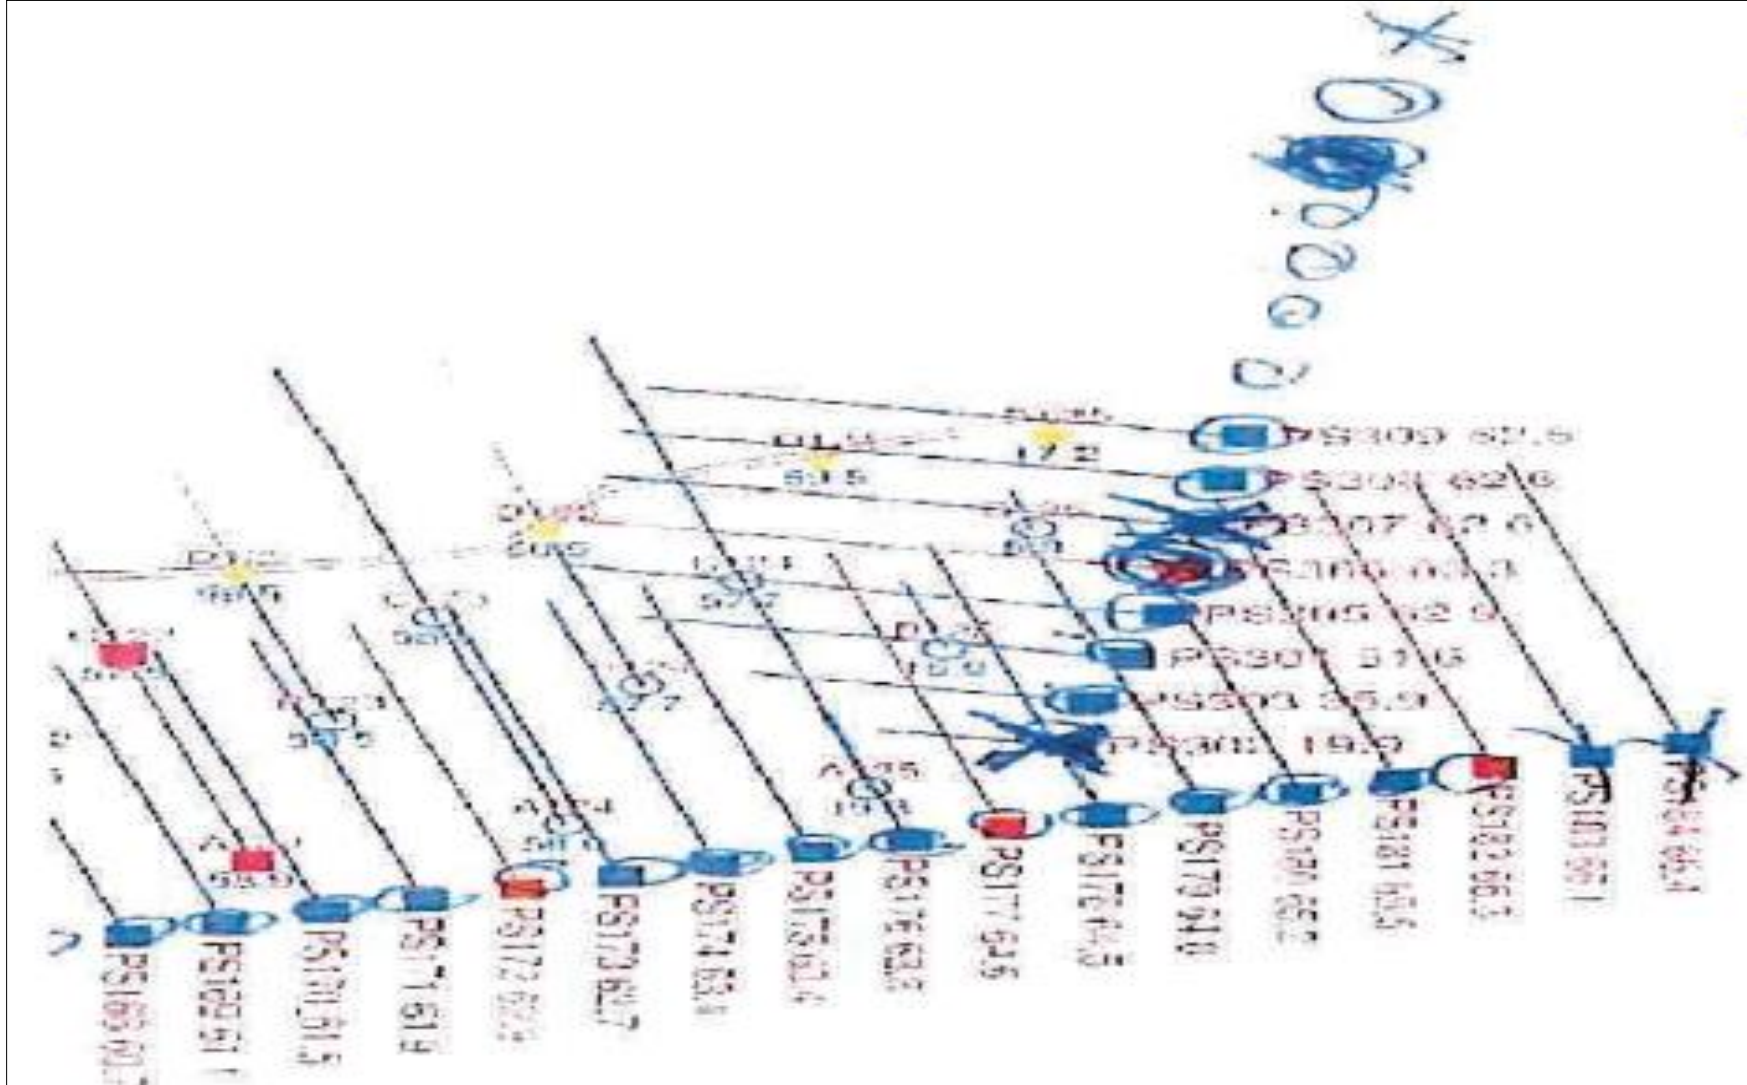
Timeline - 16/06/2019

The initial drill design for BL422 (03/06/19) had 14 presplit holes drilled across the eastern echelon wall. The approved drill design showed that there was only 8 presplit holes.

The loading map used by the blast crew was an adjusted version of the original drill design, which indicated that there were 15 holes drilled across the echelon wall.

The loading map also indicated that 4 presplit holes were not loaded with explosives, reducing the powder factor and presplit energy in the immediate area above the incident site.

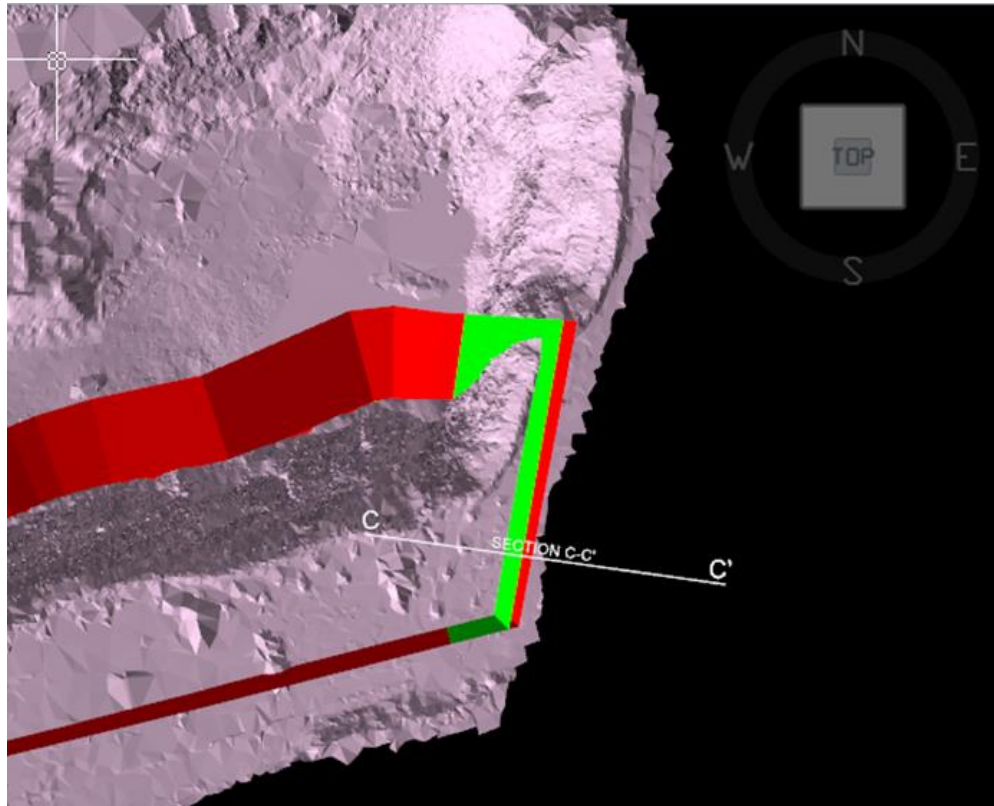
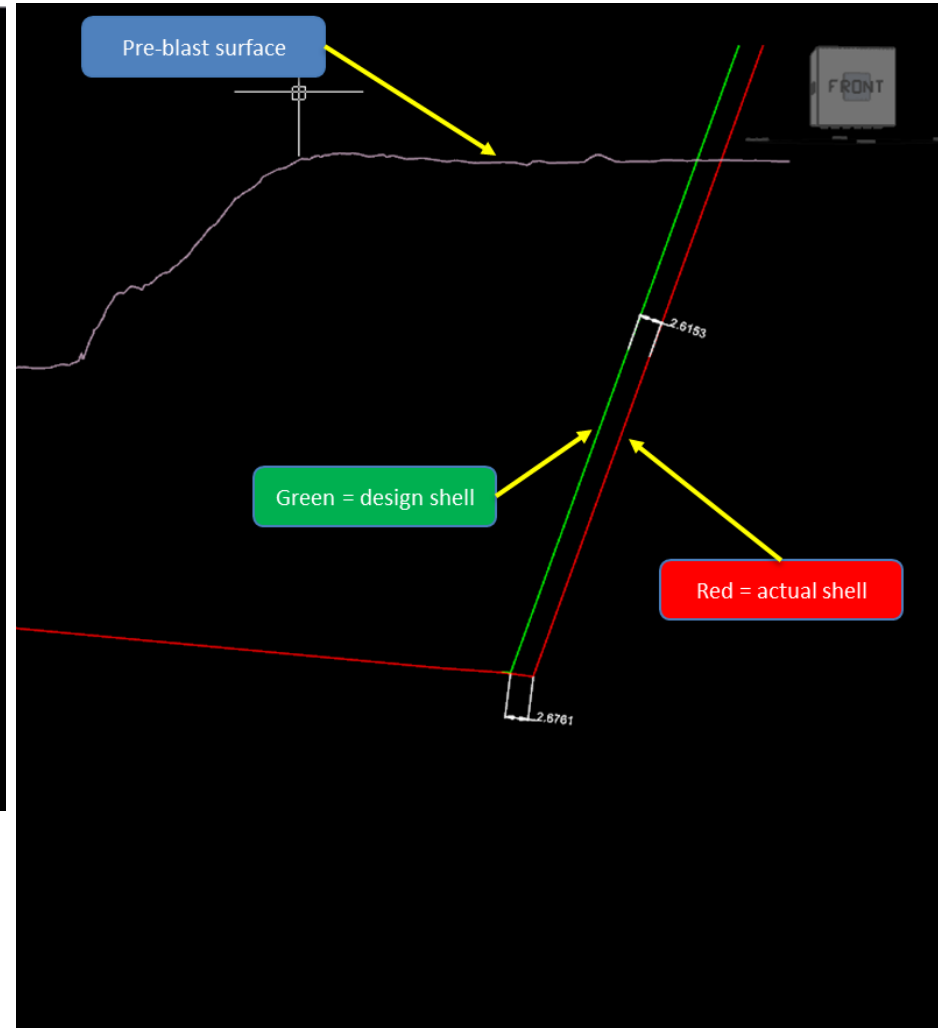
Pre-Blast Shell

The amended drill design was stepped back behind the original design shell, which was further compounded by the echelon presplit holes being drilled outside the original design parameters increasing the burden spacing and design variance.

Distance between presplit line and production holes was approx. 4.5m to 5.0m (site standard was 2.5m). The A Row burden spacing from the presplit had increased to 9.5m (site standard was 7.0m).

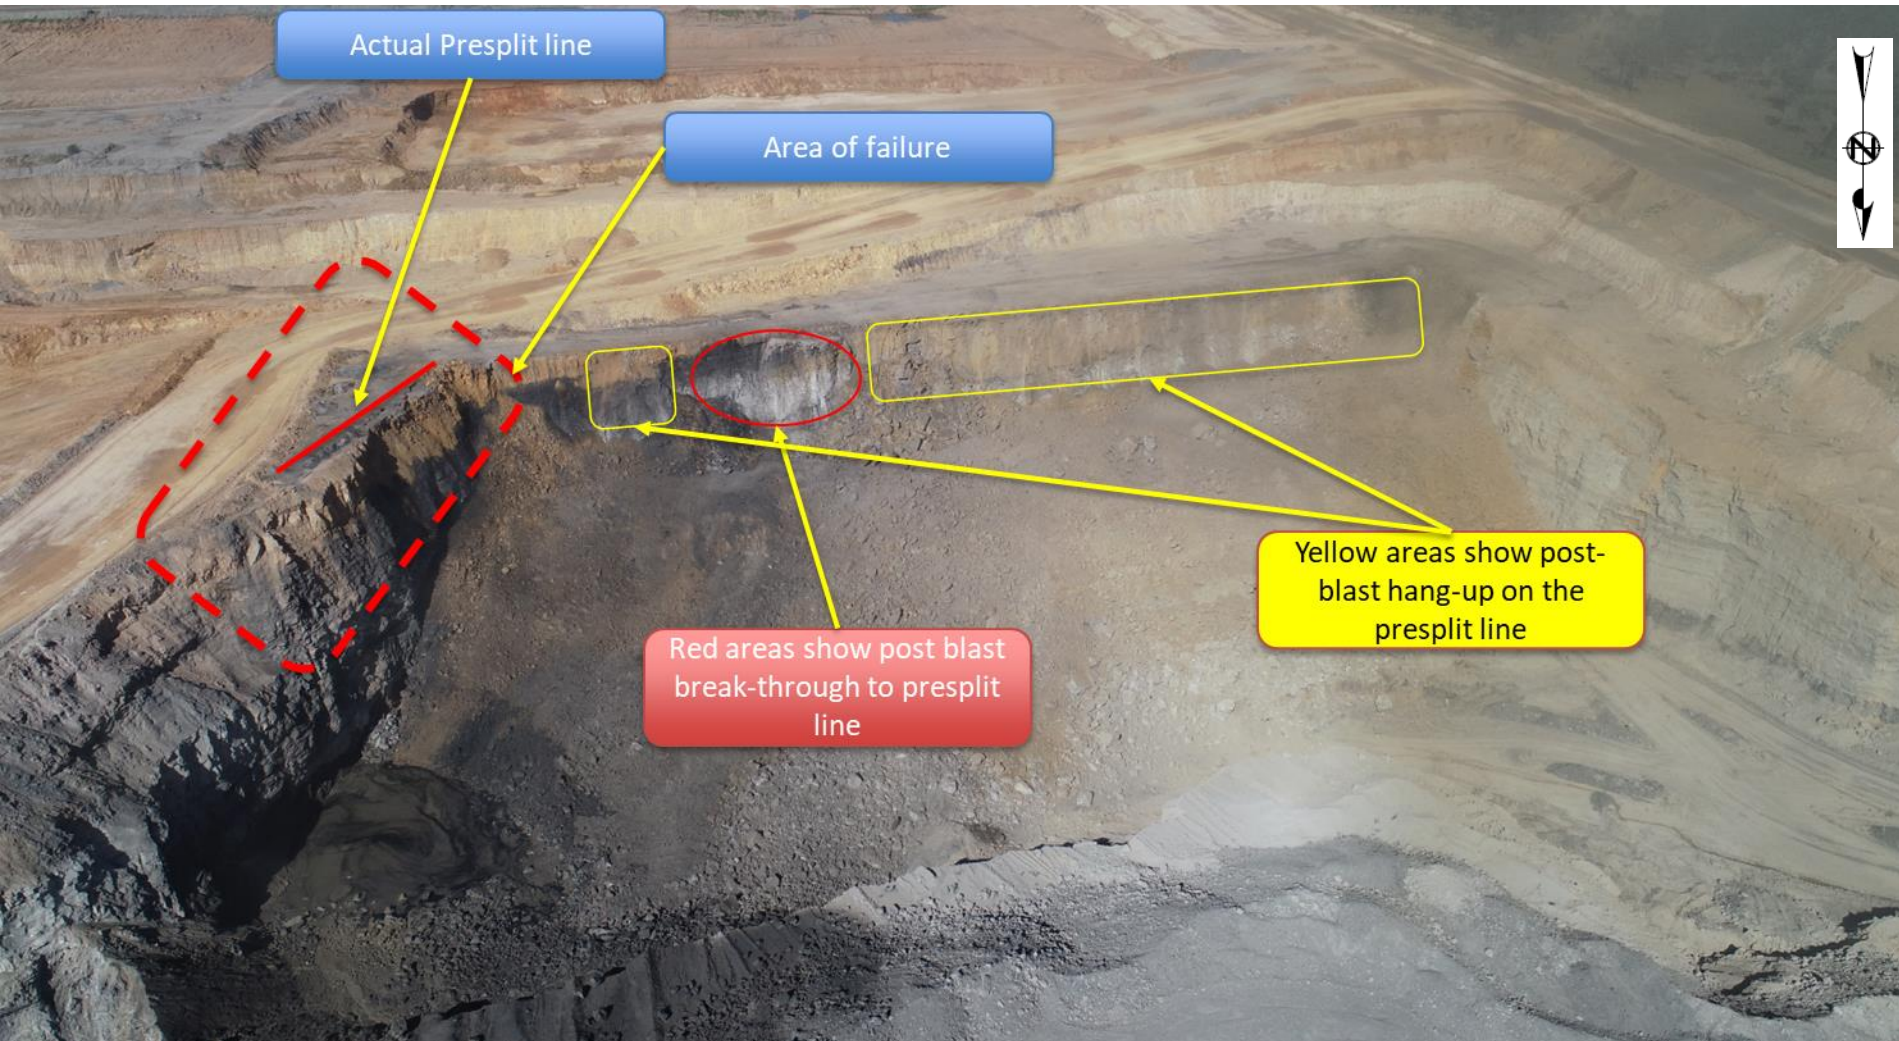
Timeline - 16/06/2019

Significant hang-up material evident on southern highwall post blast.

Mining to commence West to East.

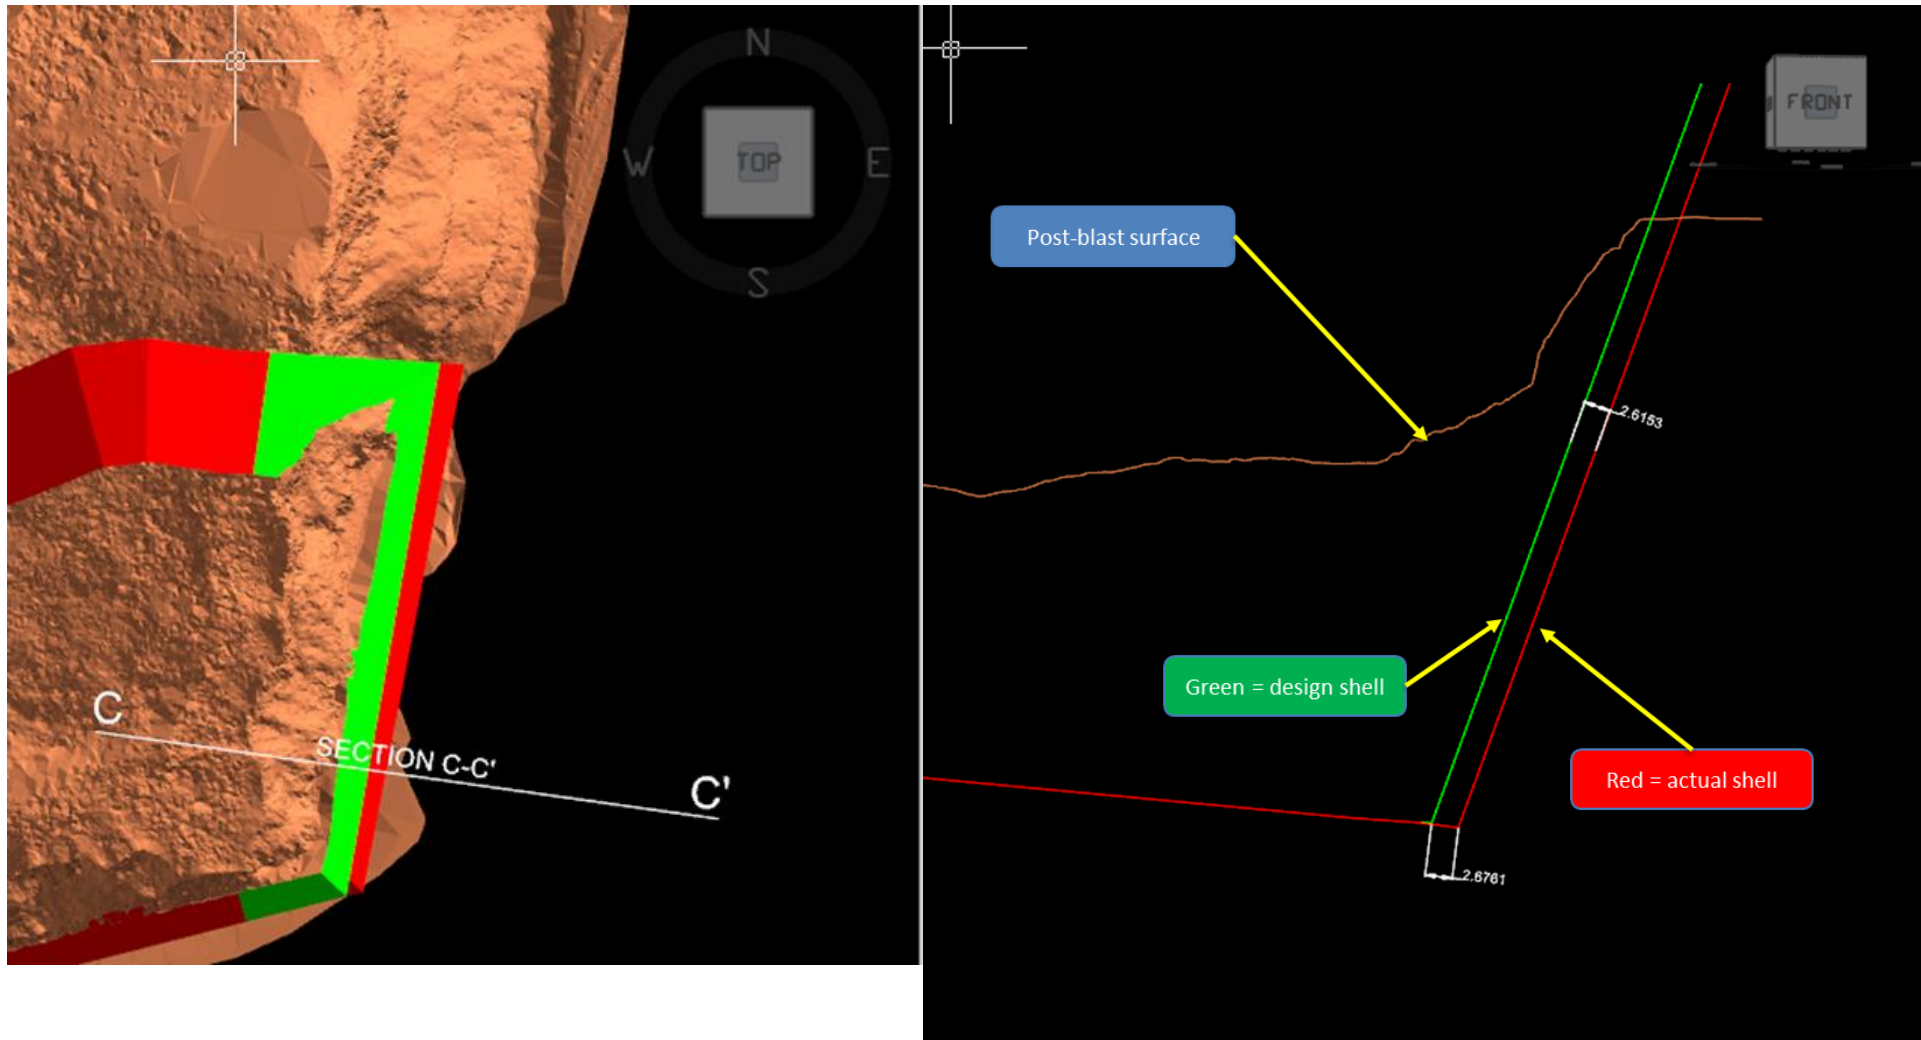
Post-Blast Shell

Post blast scan of eastern endwal shows significant amount of material in front of pre-split barrels.

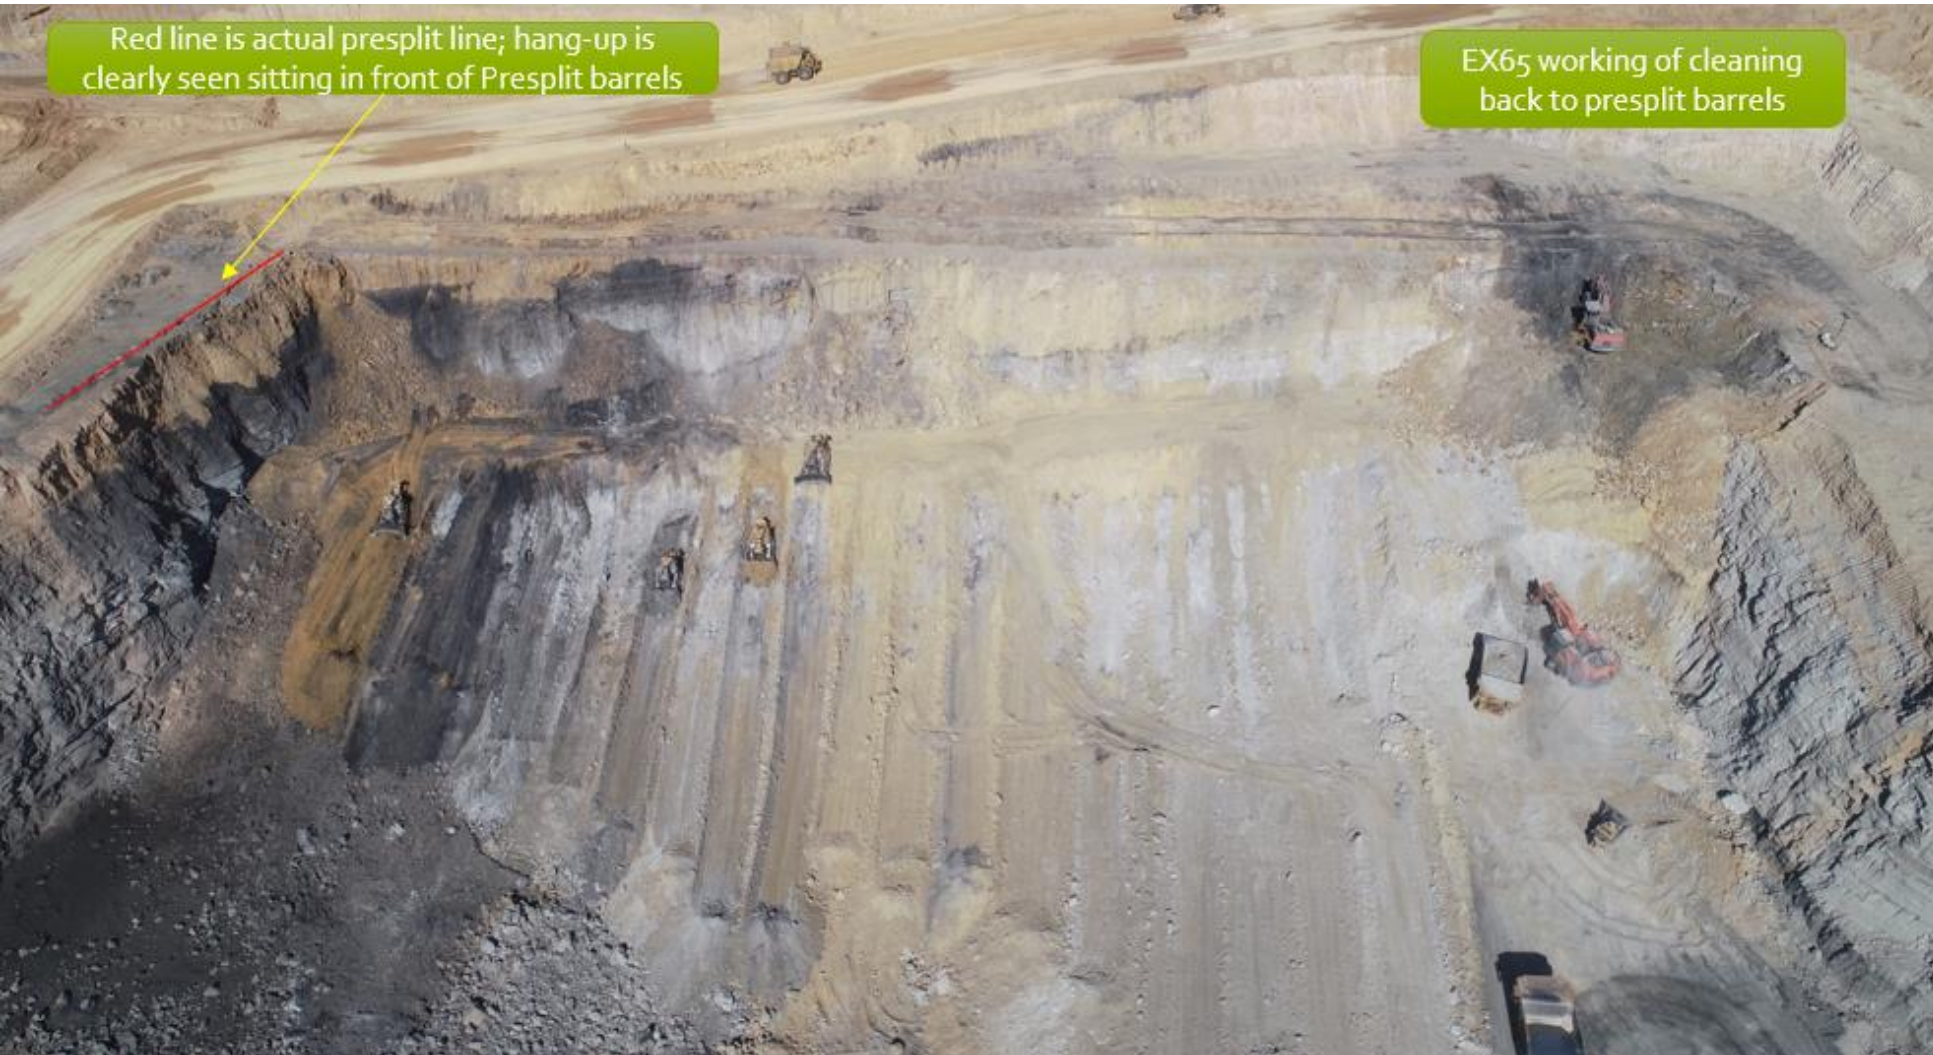
Timeline - 17/06/2019

Red line is actual presplit line; hang-up is clearly seen sitting in front of Presplit barrels

EX65 working of cleaning back to presplit barrels

EX65 created a bench to safely access the crest of the excavation due to narrower than normal strip width of 35m (site standard 60m) due to previous strip being 80m.

EX65 to work east on this level remediating highwall presplit holes and cracking visible on crest of east end wall.

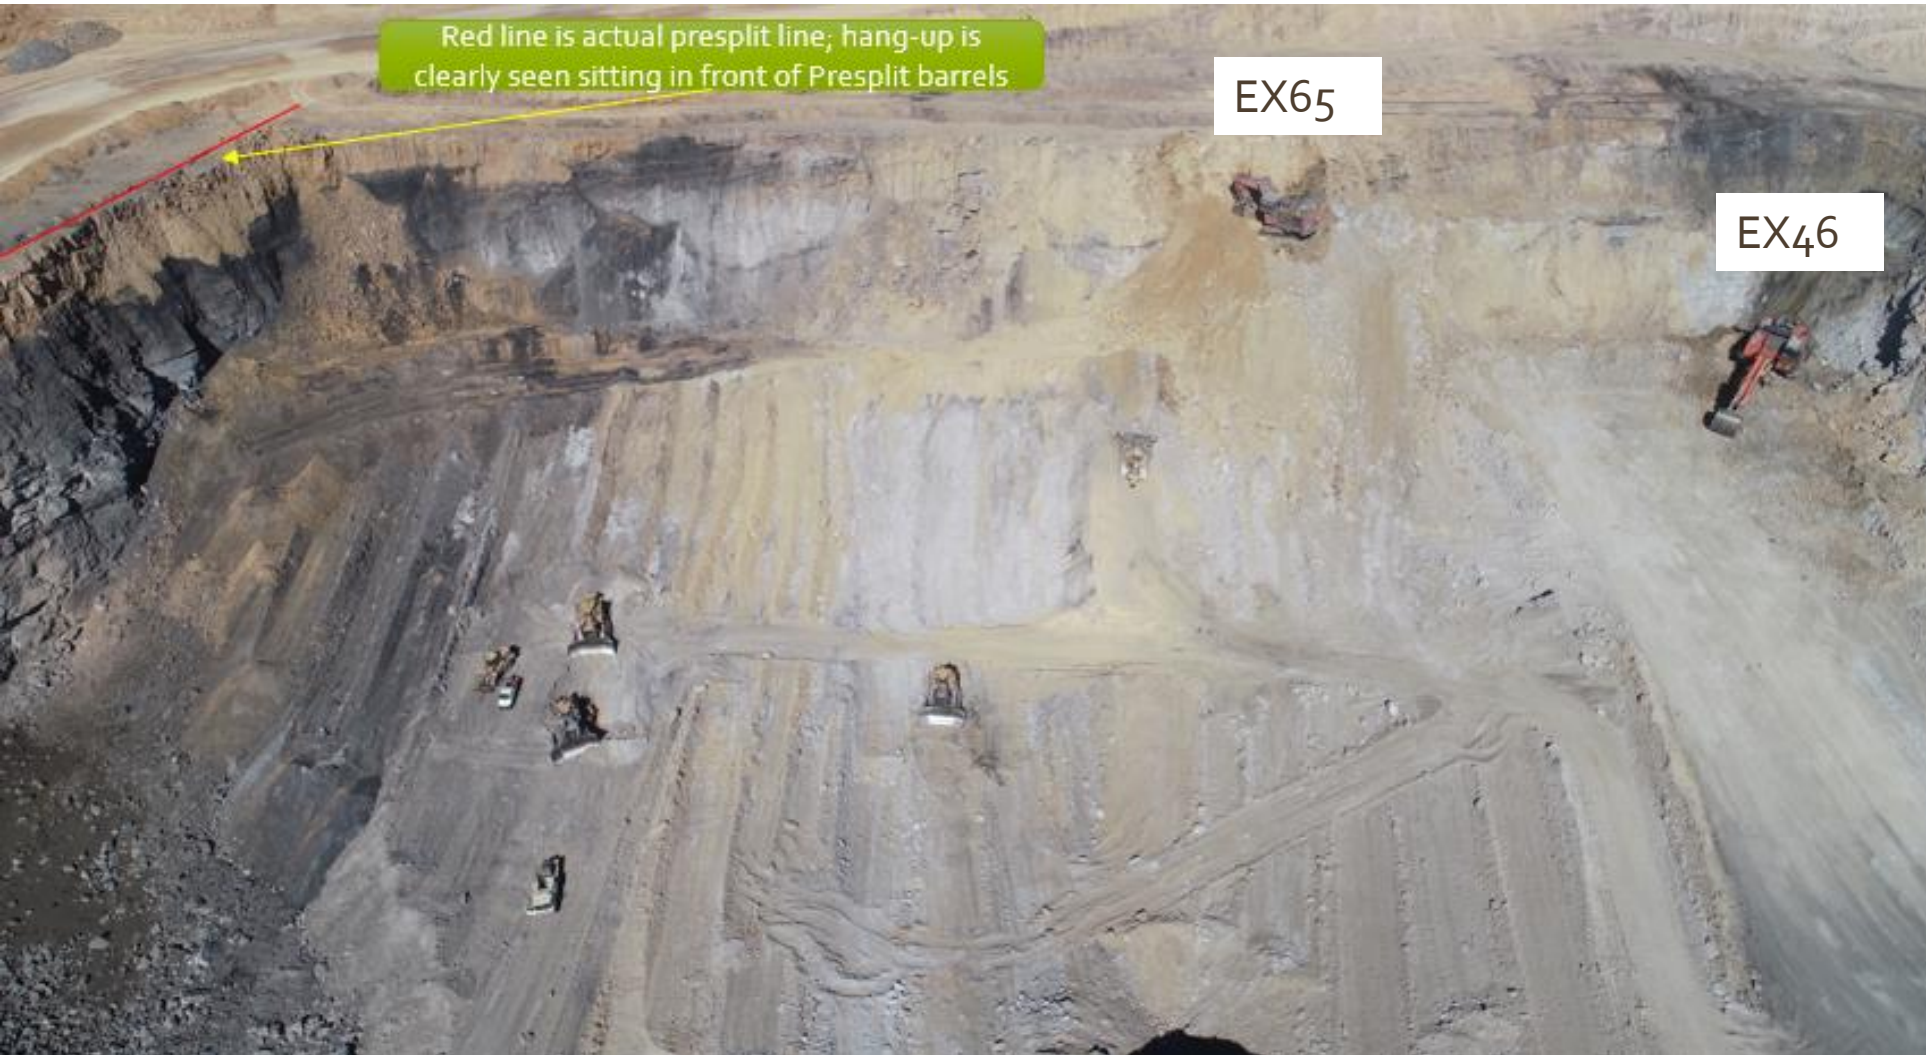
Timeline - 18/06/2019

EX65 continuing to remediate highwall from west to east.

EX46 mining towards the south and benching back towards the east.

EX46 identified hard dig on highwall and reported to Supervisor.

Dozer mining team working from west to east.

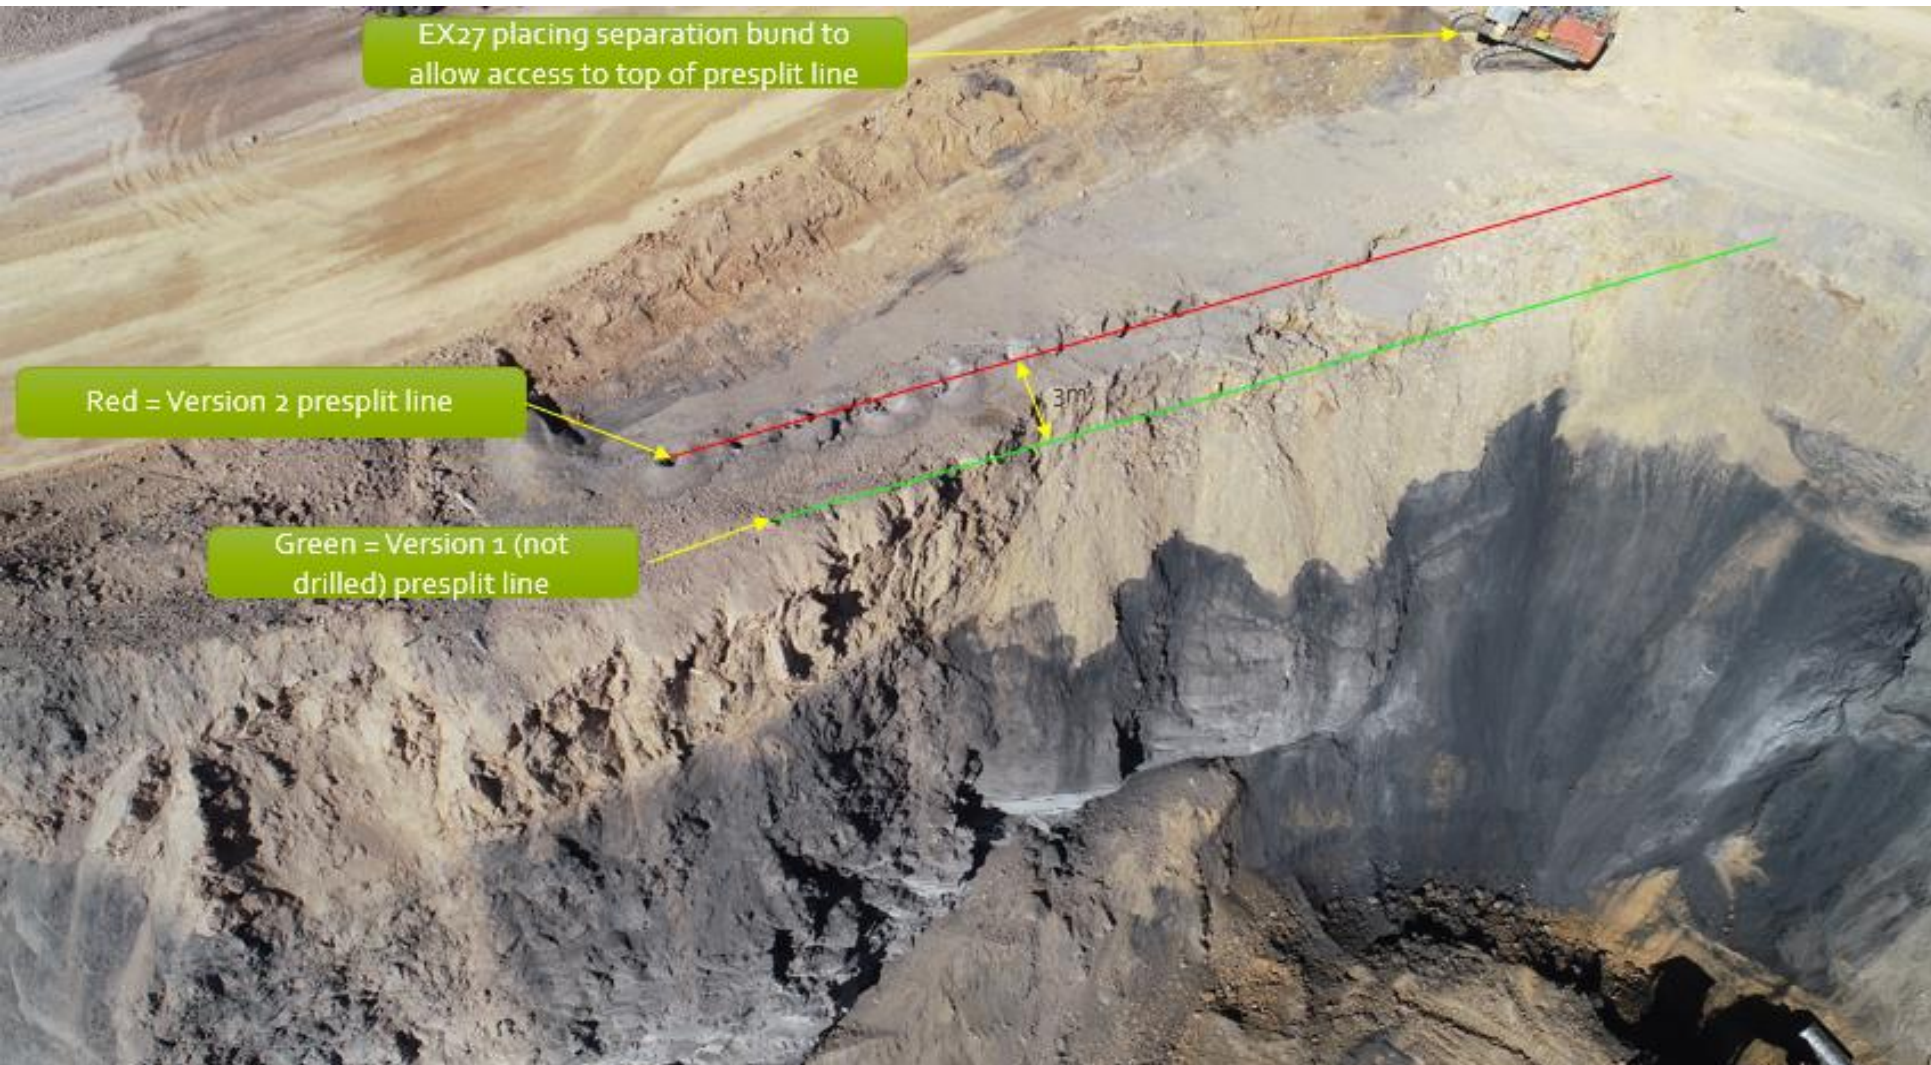
Timeline - 20/06/2019

EX27 increasing height of separation bund along edge of haul road near east endwall.

Evidence of pre-split and cracking identified.

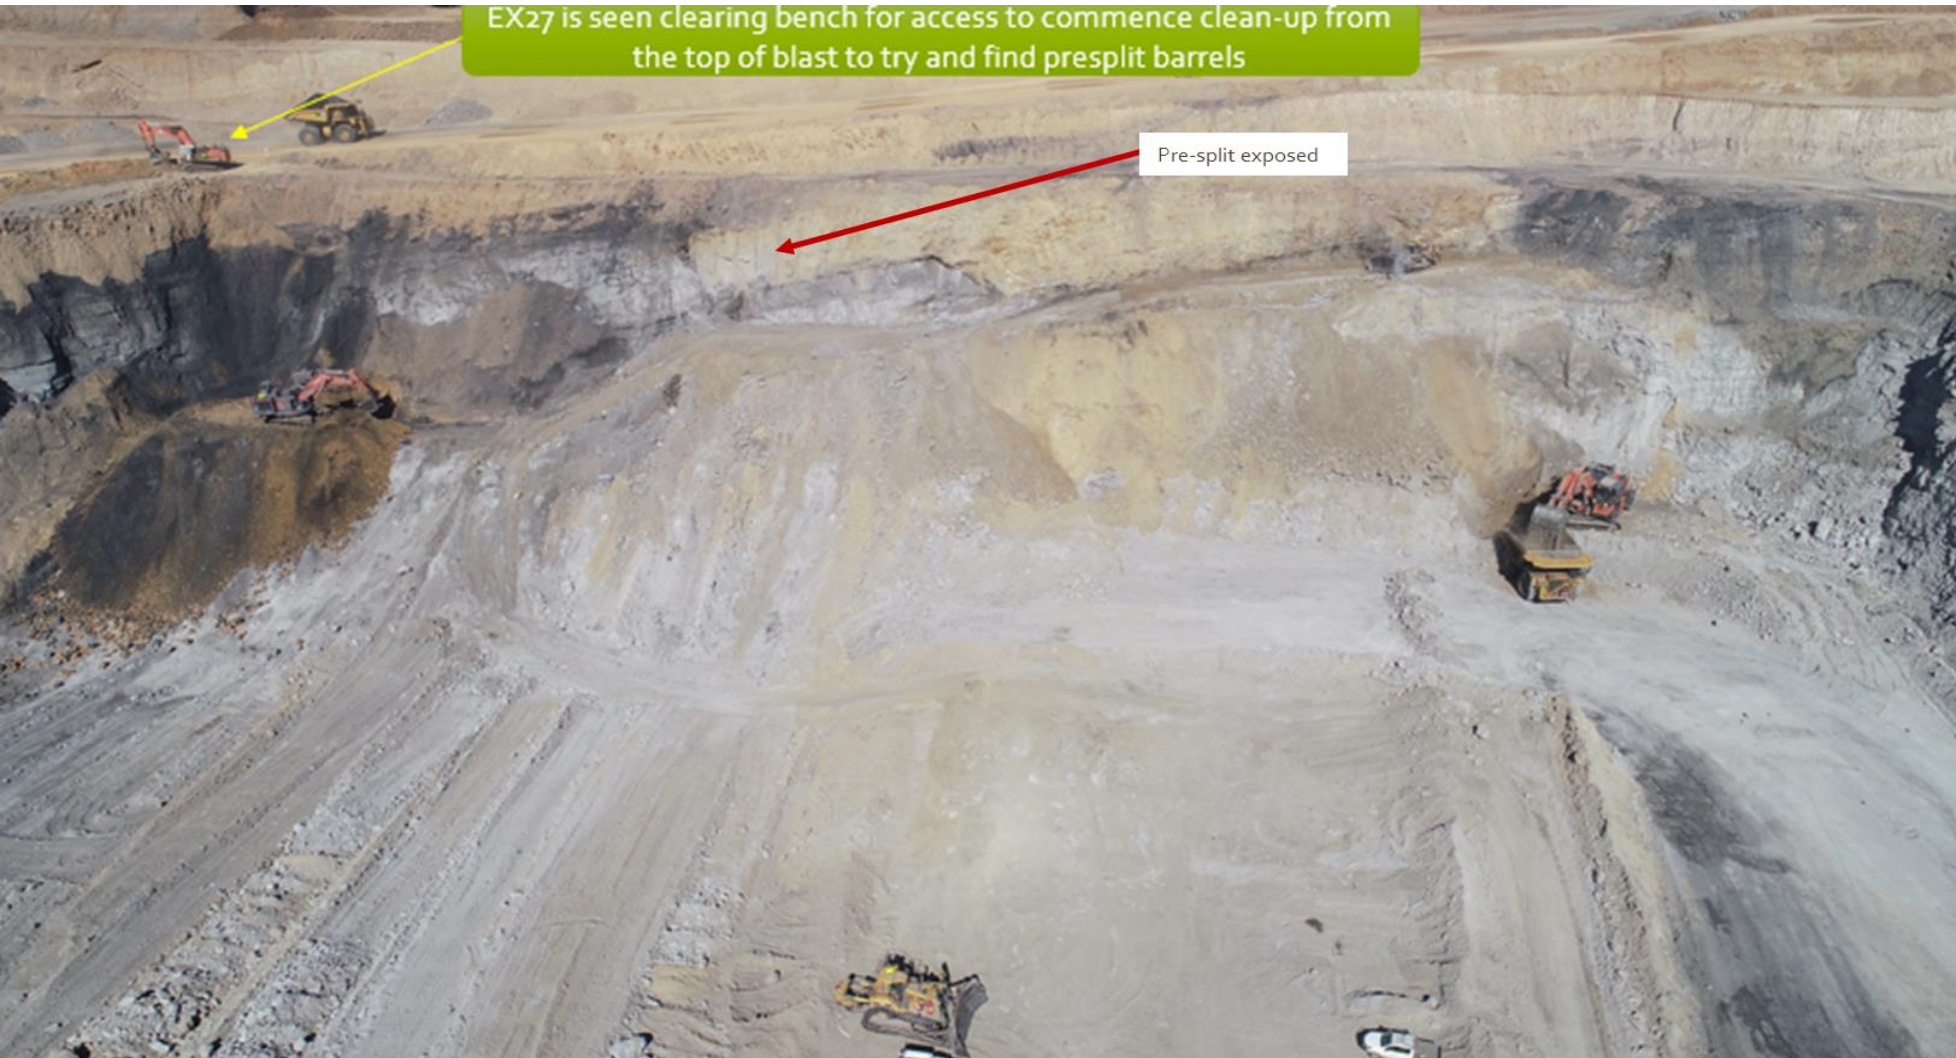
Timeline - 20/06/2019

EX27 is seen clearing bench for access to commence clean-up from the top of blast to try and find presplit barrels

Pre-split exposed

Majority of Southern Highwall presplits barrels now exposed.

EX65 full reach removing echelon hang up.

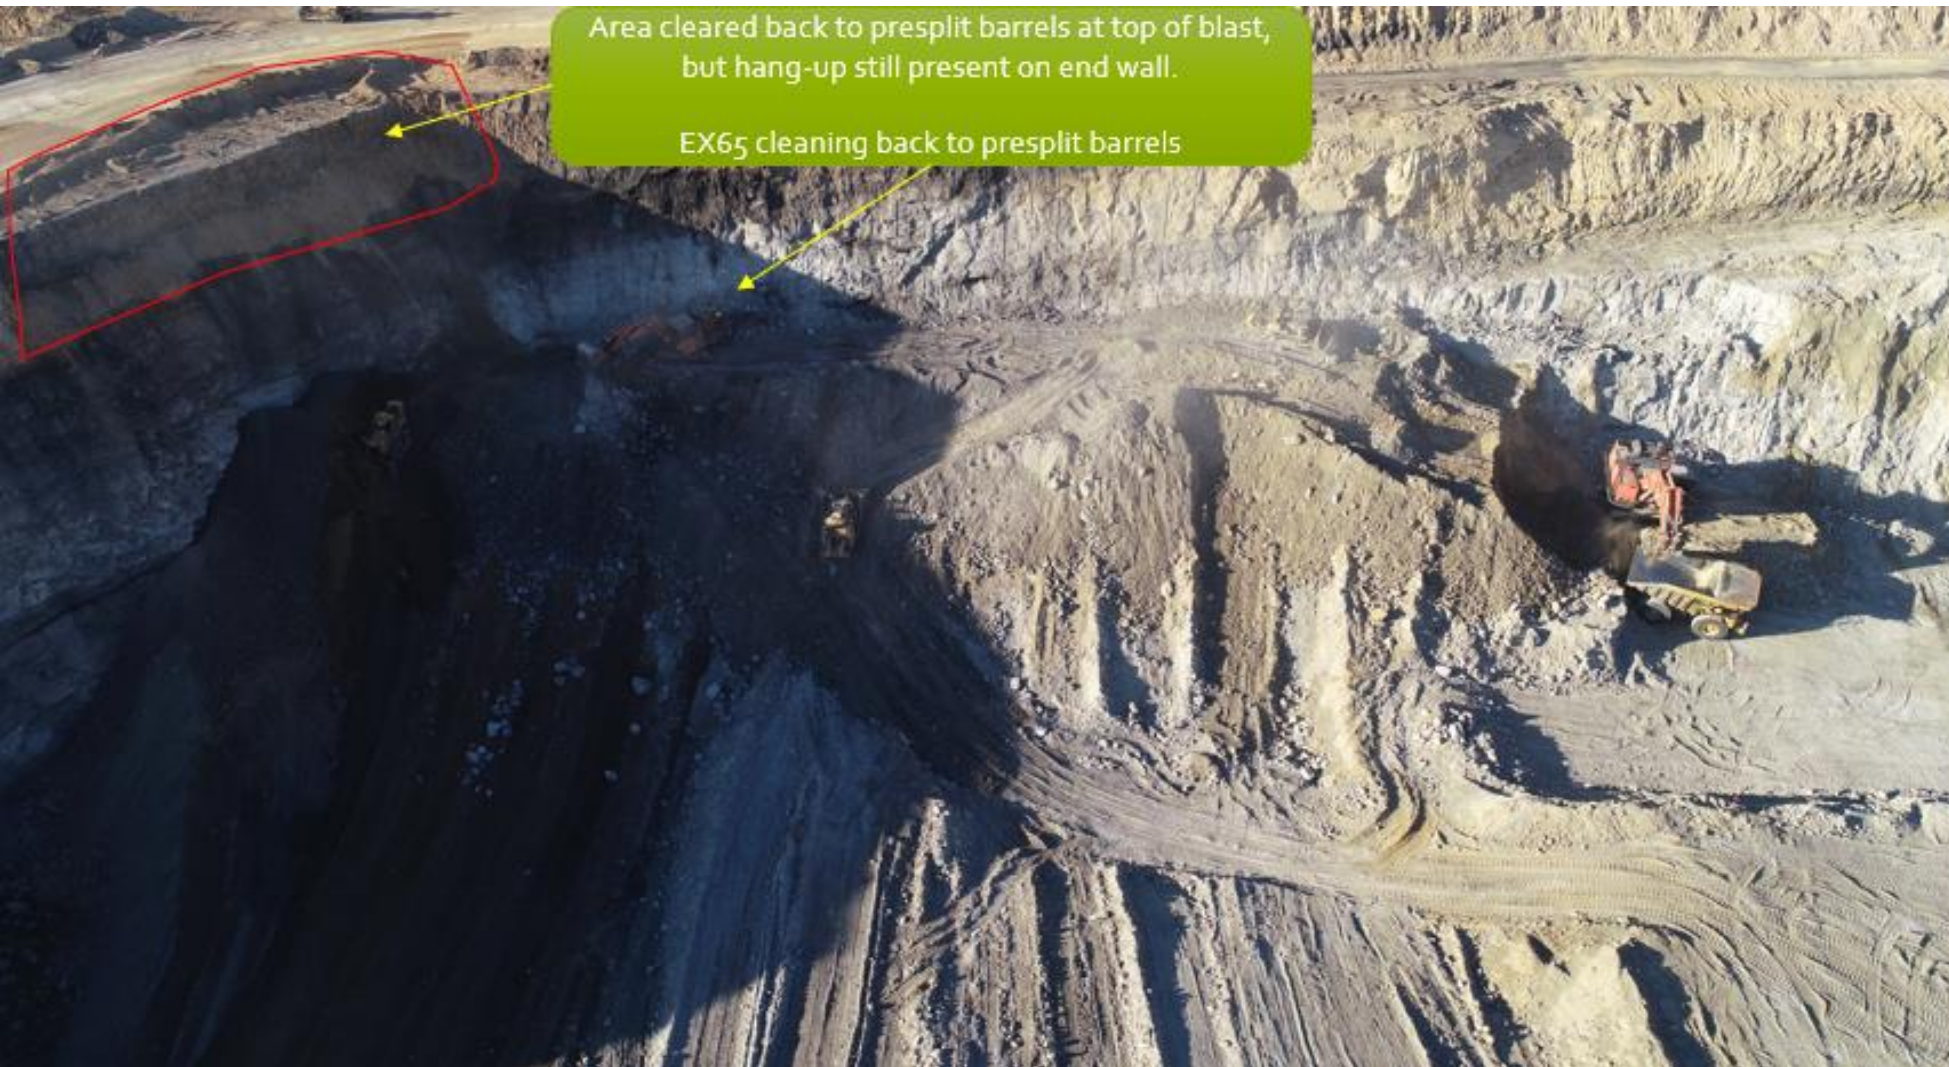
Timeline - 21/06/2019

EX65 finished cleaning highwall back to pre-split on upper level.

EX46 was digging back to hard on highwall west to east.

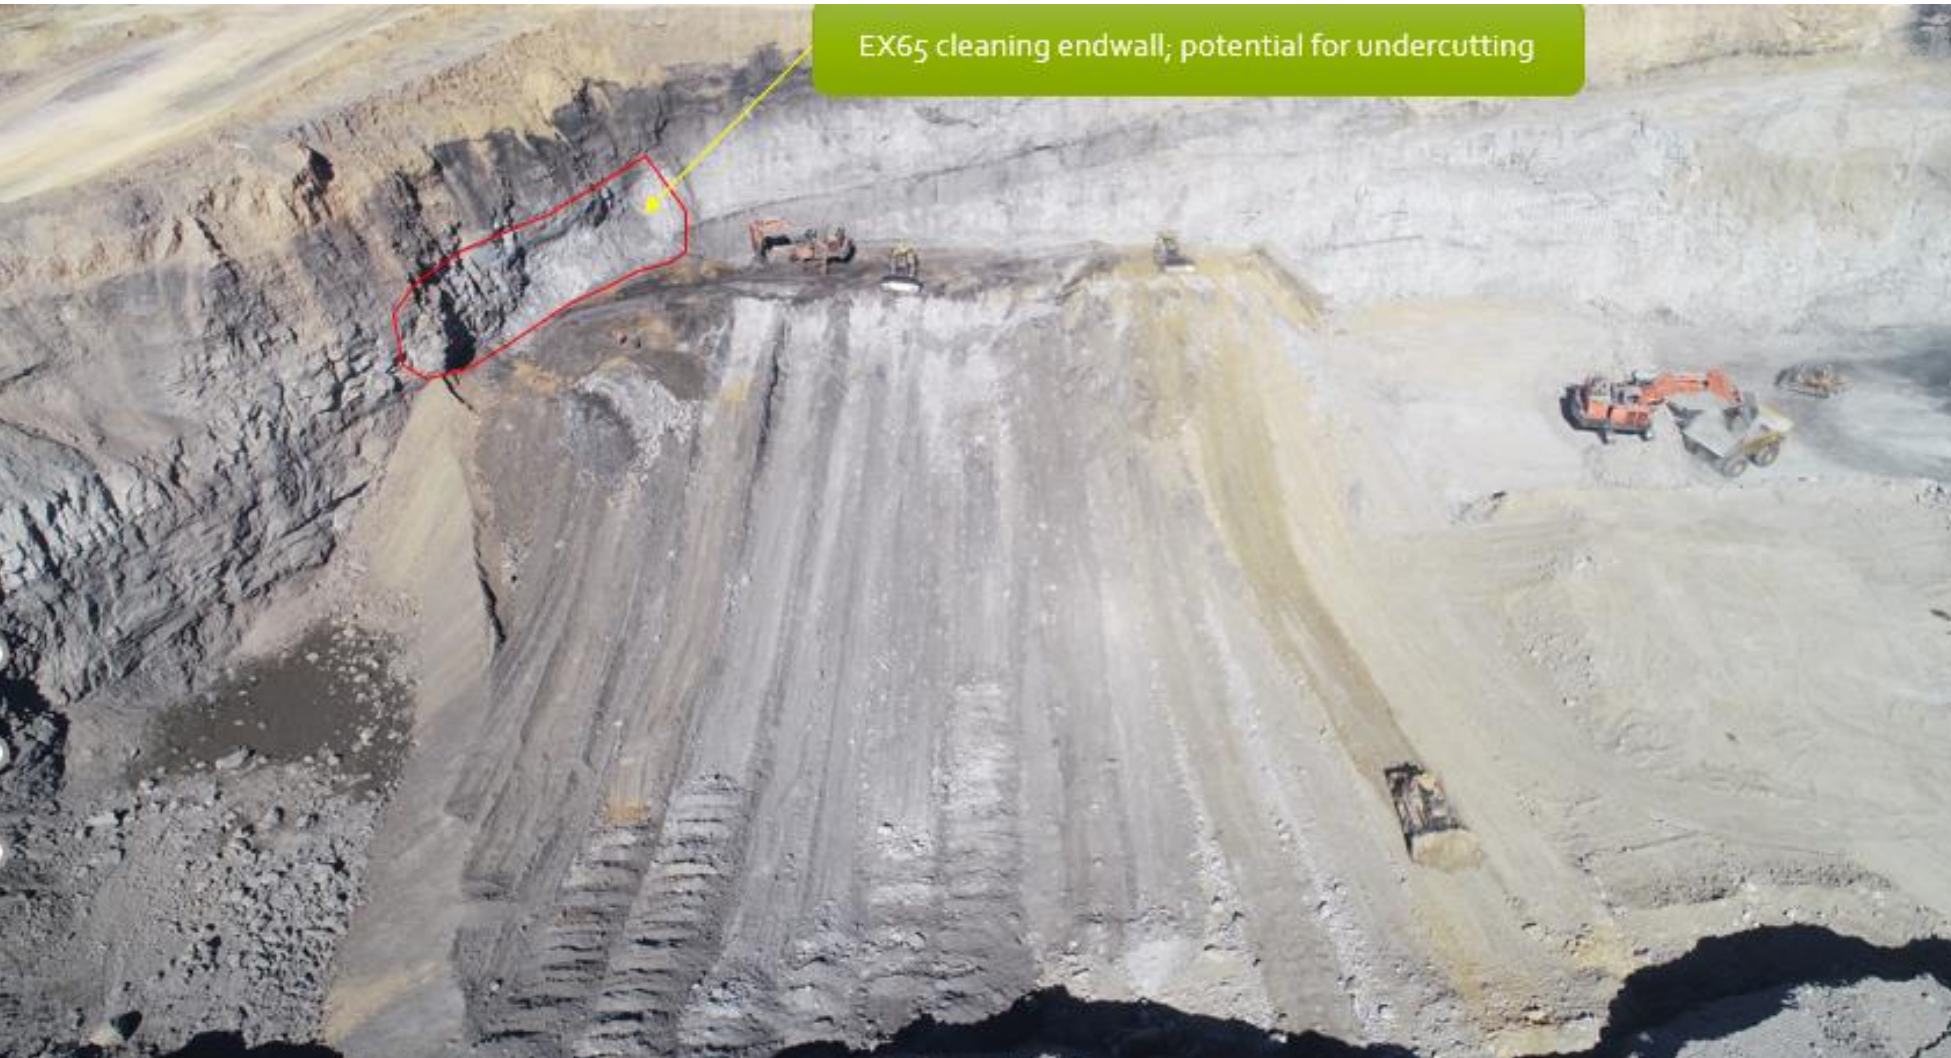
Timeline - 22/06/2019

EX65 cleaning endwall; potential for undercutting

EX46 relocated back towards the west and faced up conventional mine to the east.

EX65 removed loose material at toe of eastern endwall.

Note: Under cutting of east endwall.
