Learnings from Middlemount Mine Highwall Fatality 26 June 2019

Presented by:
Dave Champion
Operations Manager / SSE

Incident Overview

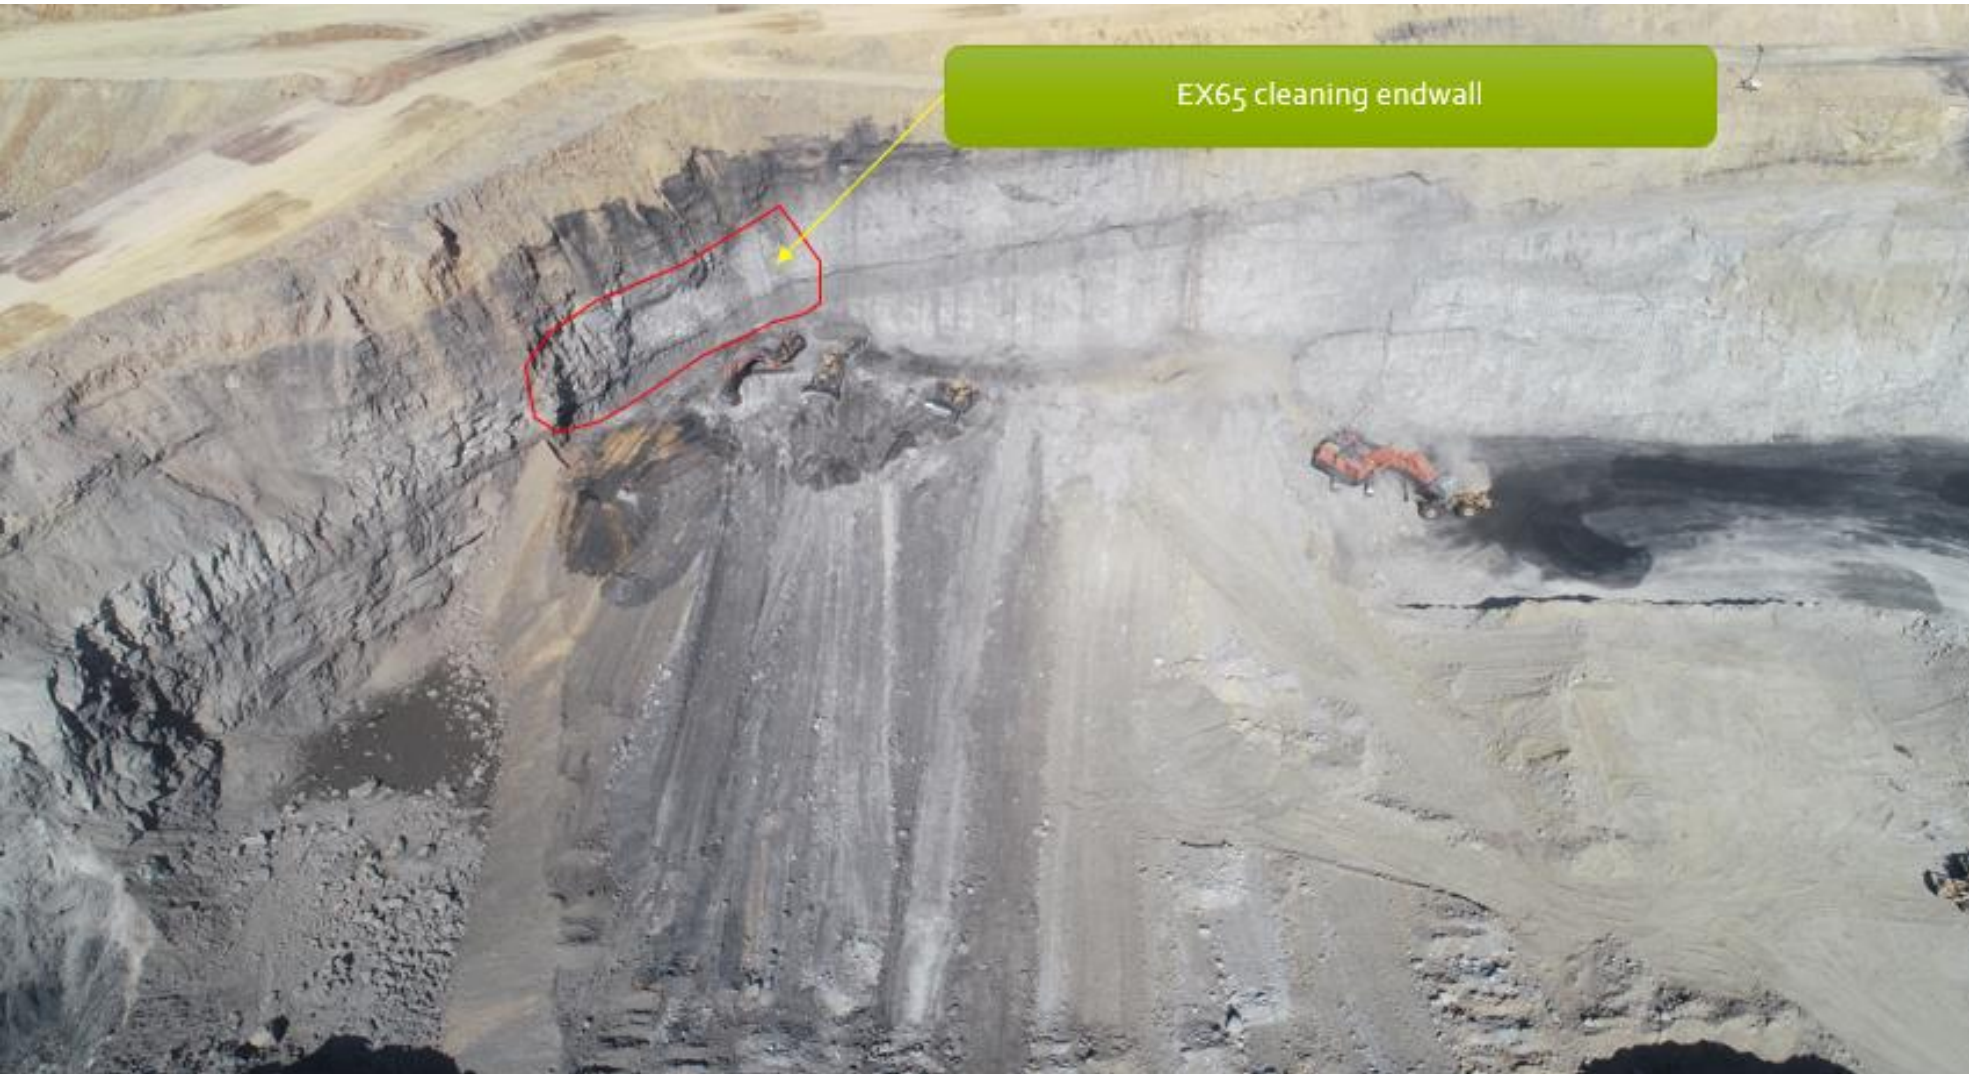
Timeline - 23/06/2019

EX46 mining
overburden to the
east.

Note: There was no
significant attempt to
dig to the barrels in
the eastern endwall
echelon or remove
the hung-up material.

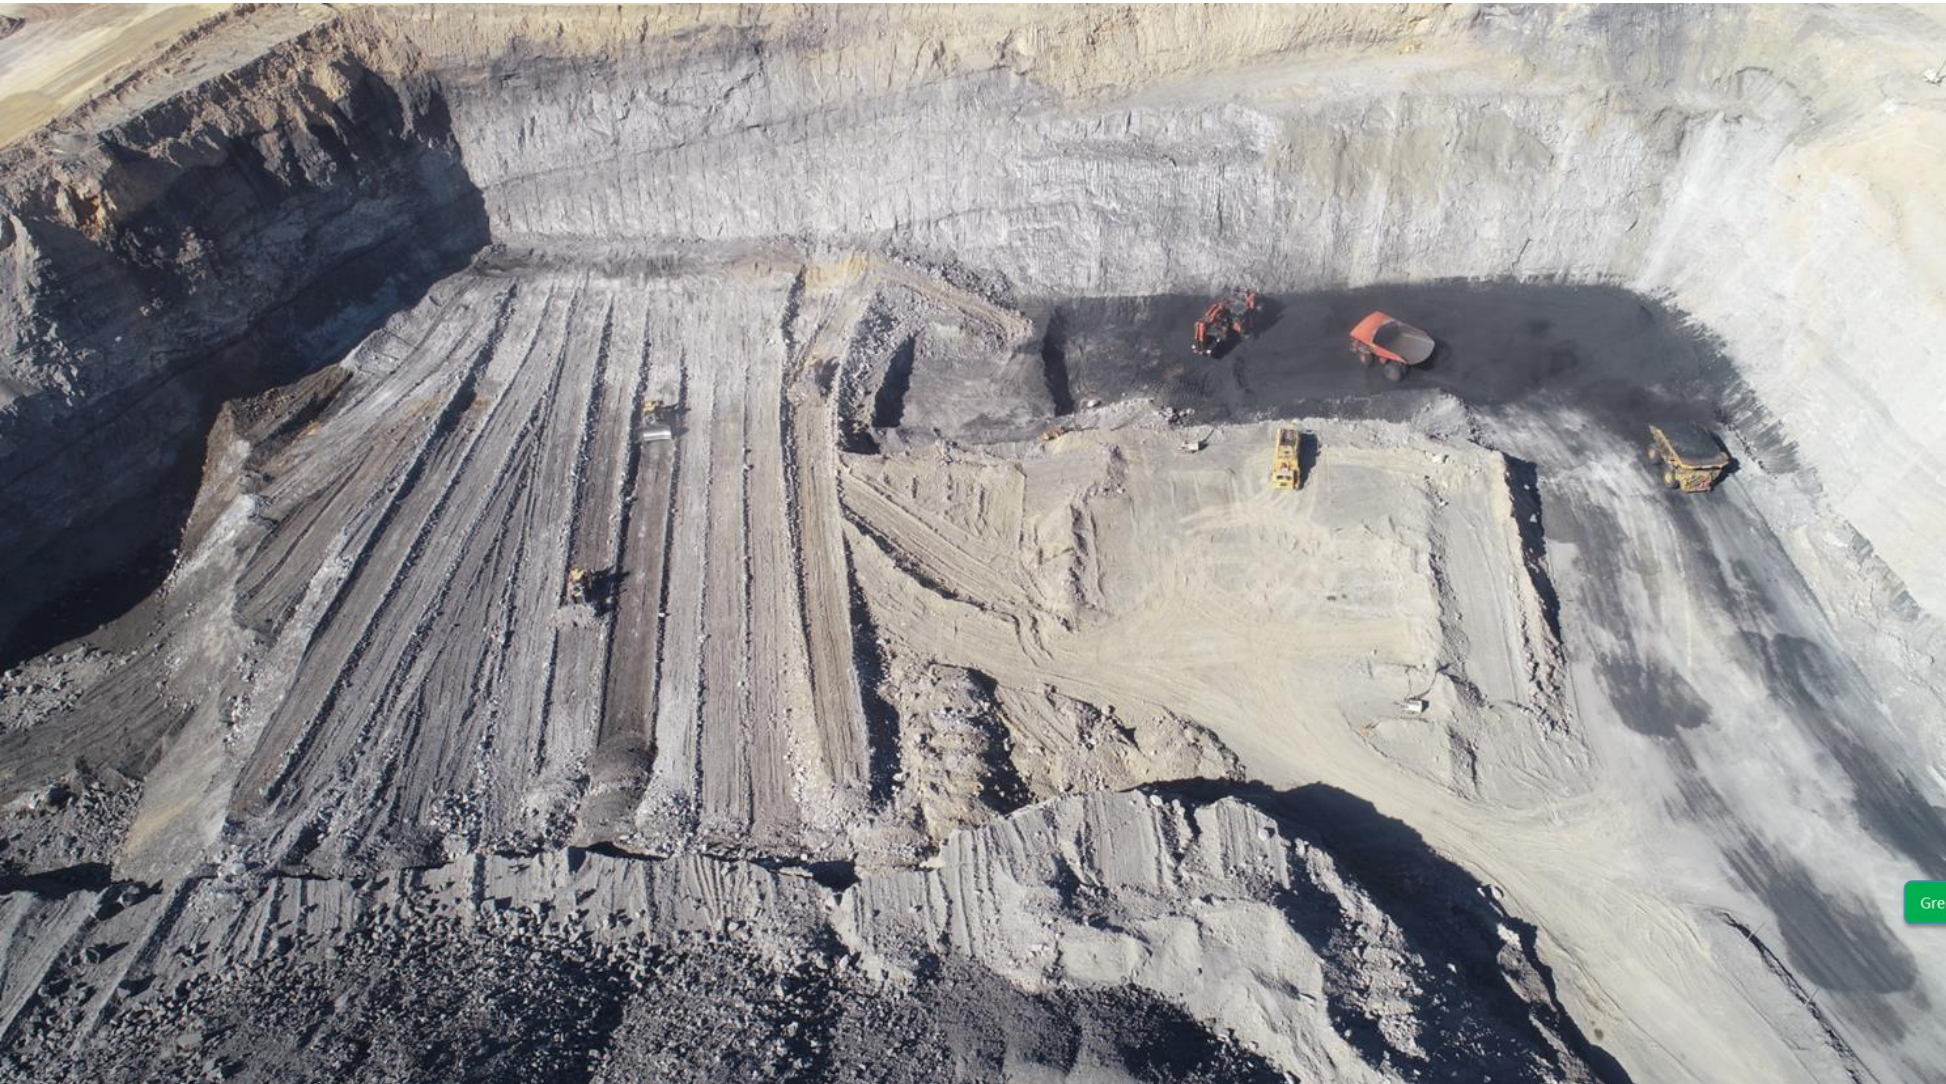
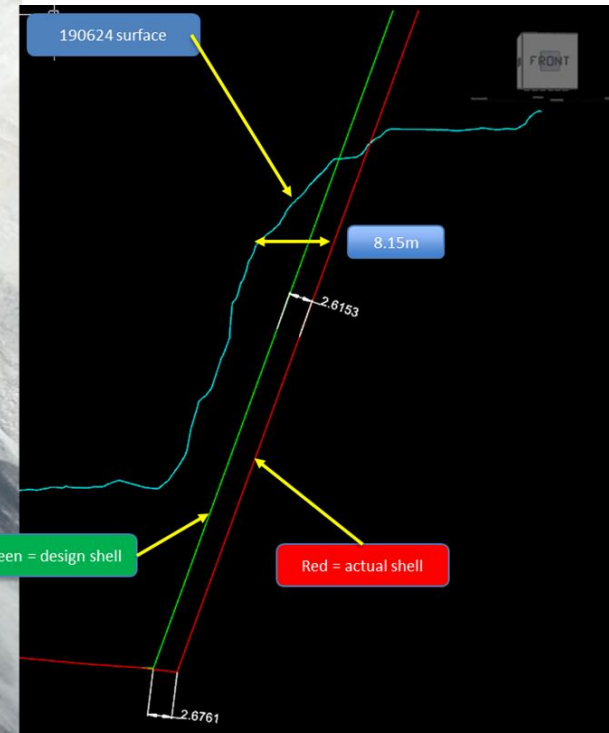
Timeline - 24/06/2019

Remediation work completed and EX46 mining pisces coal.

Dozer push scan shows 8.15m of material in front of pre-split barrels.

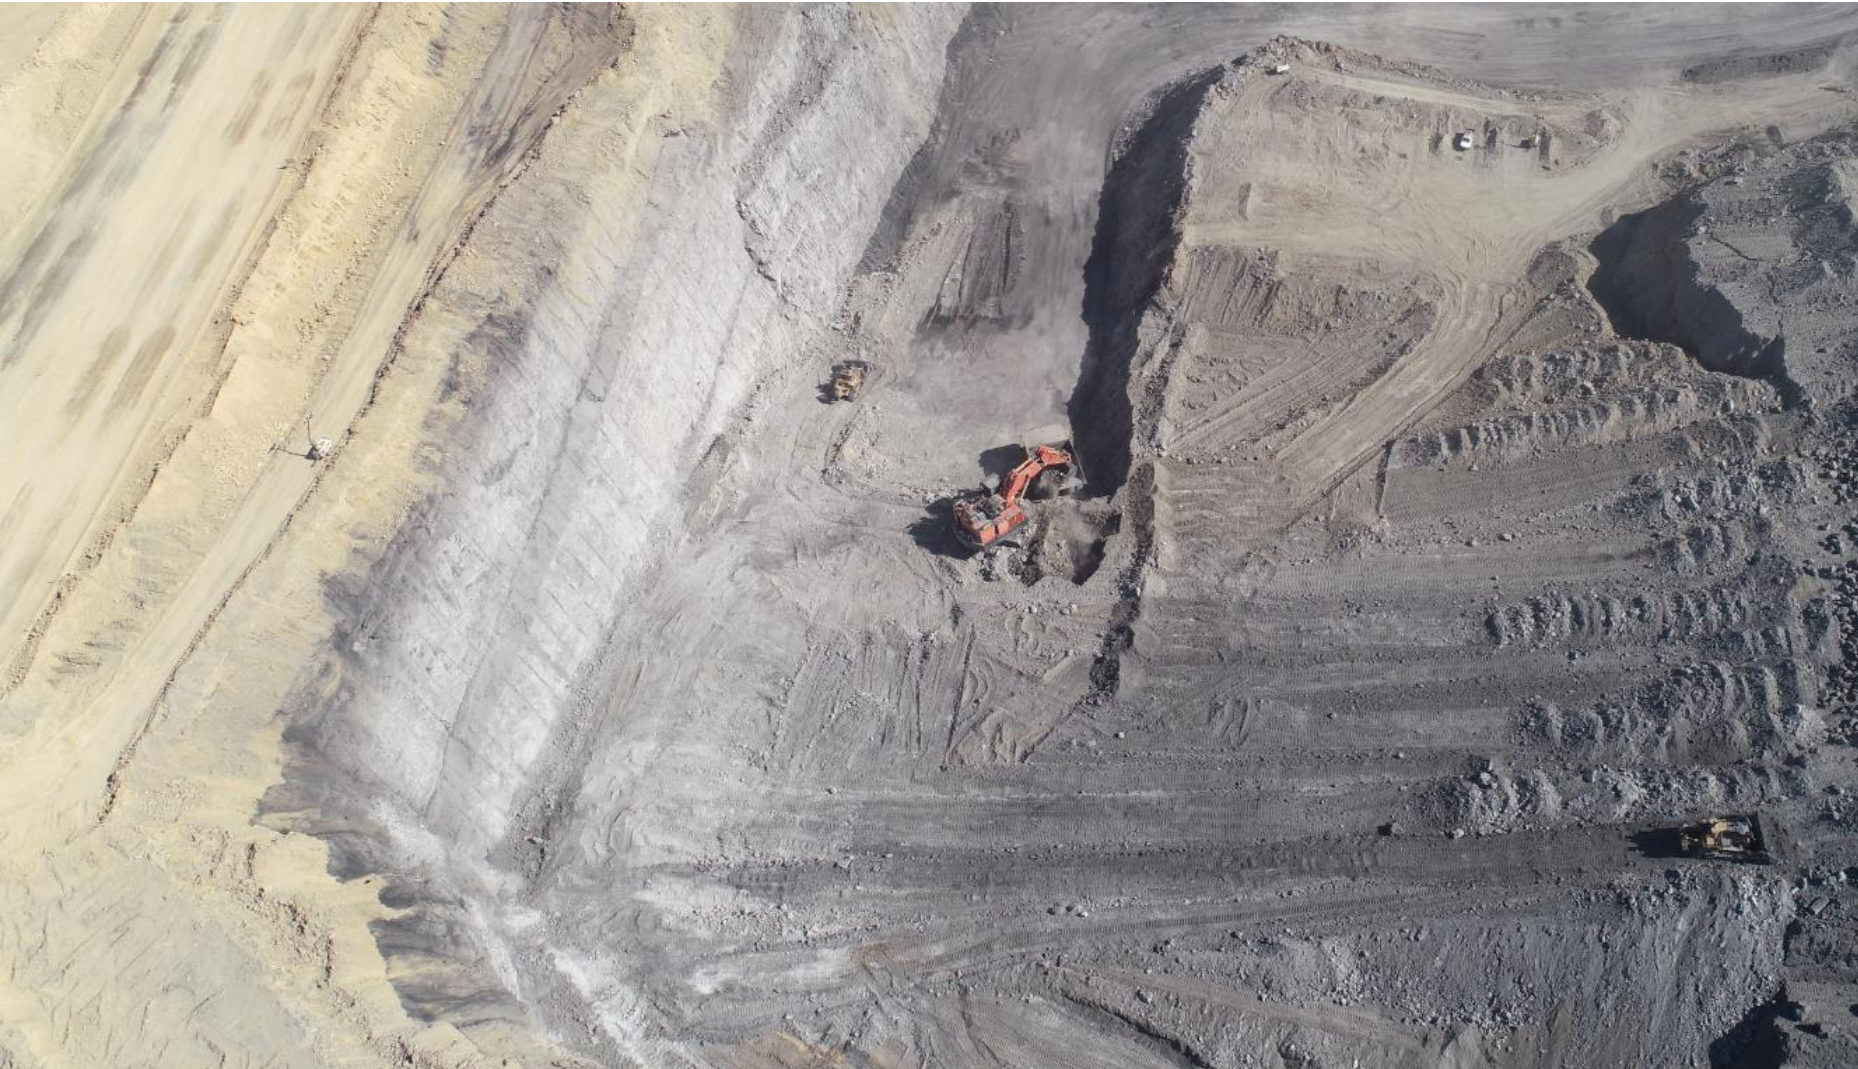
Timeline - 25/06/2019

EX46 is ramping back into overburden working to the east after coal mining completed

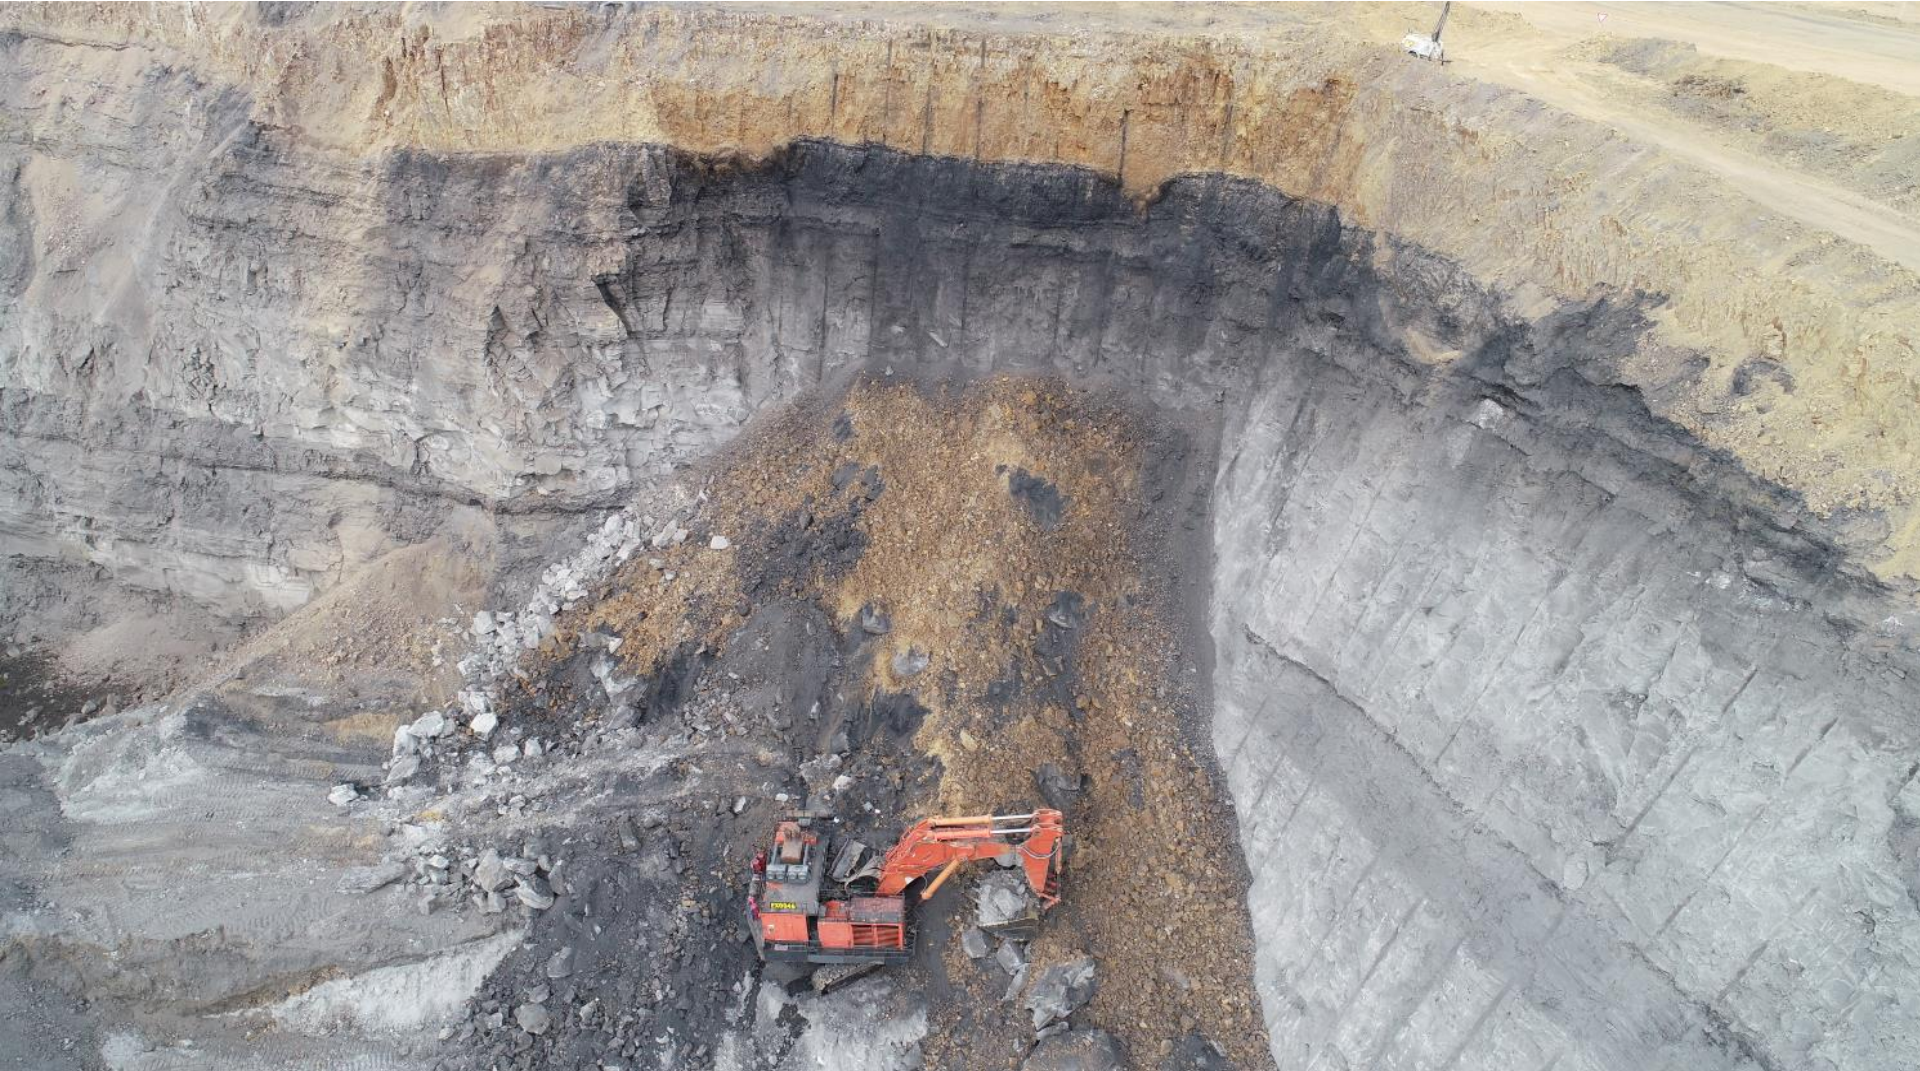
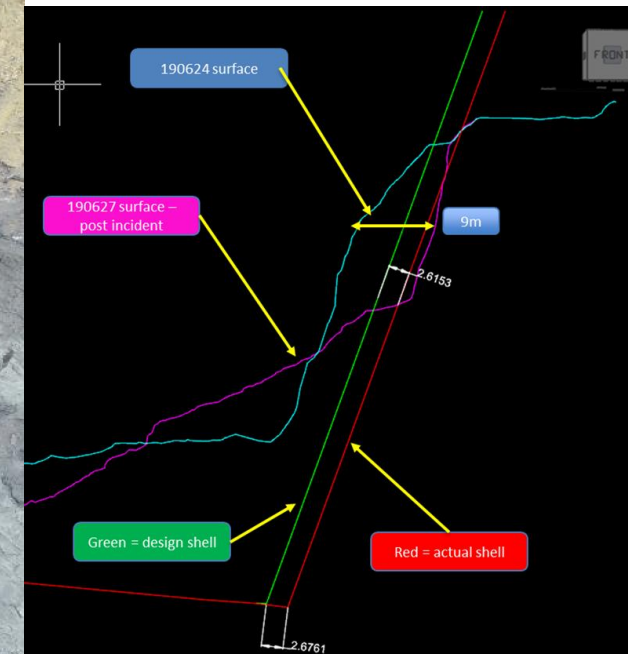
Timeline - 26/06/2019

EX46 engulfed by highwall material.

Post incident scan shows approx. 9m of material fell from in front of presplit barrels.
