Mines Inspectorate Report

Stephen Cave Fatality & Serious Injury to

Dawson Mine - 16 February 2015

File GCAN-9TT7GF

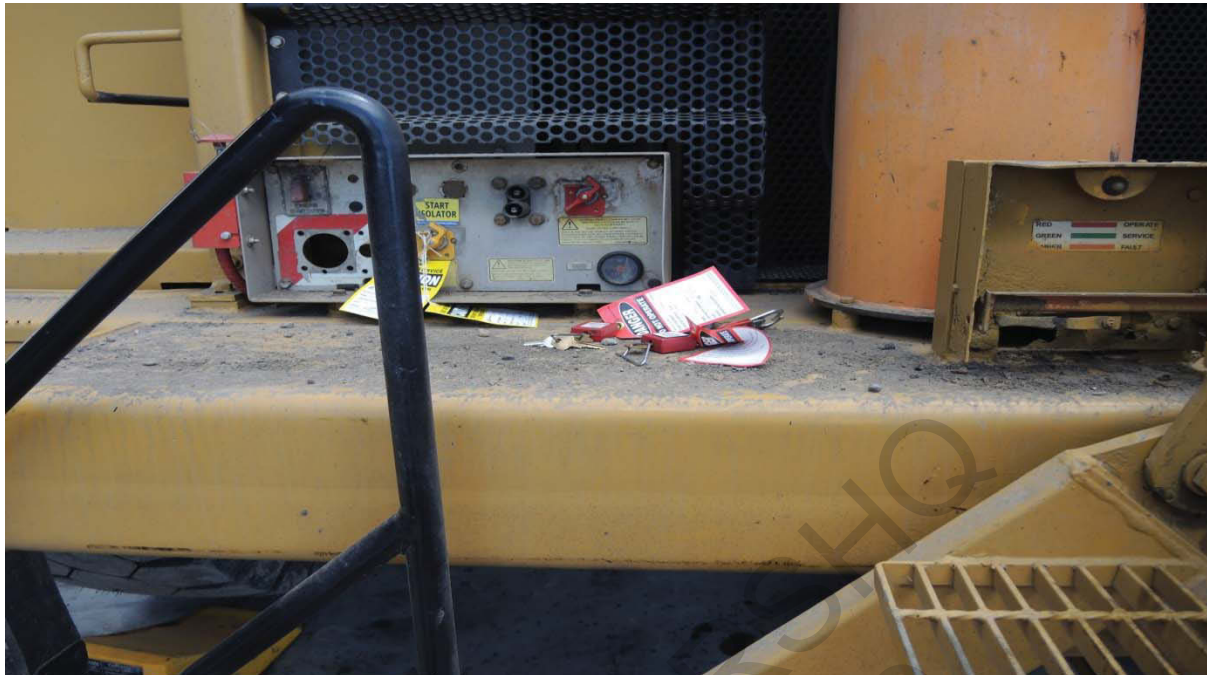
The first task is isolation of the truck but it does not appear that sch4p4(6) Personal information sch4p4(6) isolated the truck correctly, as neither of their danger tags or personnel locks were locked onto the isolation point. Figure 4 shows both sch4p4(6) Personal information danger tags and personal locks not applied to the isolation point of the truck.

Figure 4 sch4p4(6) Personal information danger tags and personal locks not applied to the isolation point of the truck (DNRM photo taken at the incident scene).

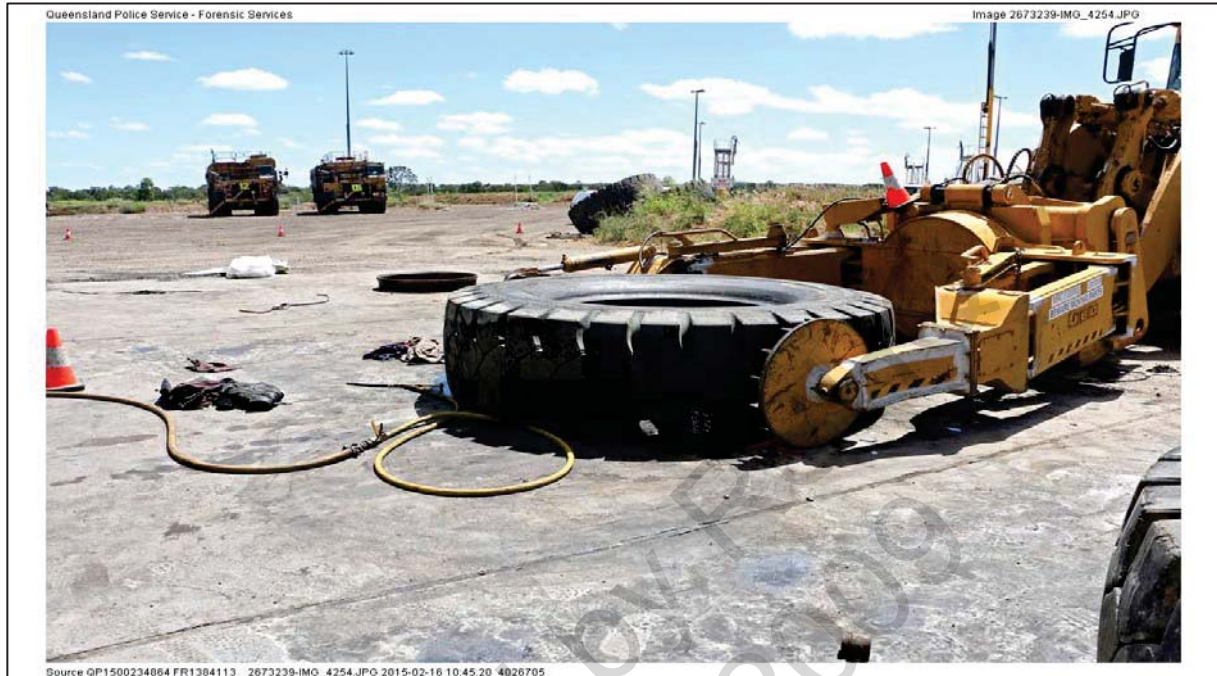
Figure 6: Photo of the Position 1 tyre placed back where it was found at the time of the incident. It had to be moved initially to retrieve the deceased (taken by QPS prior to site release).

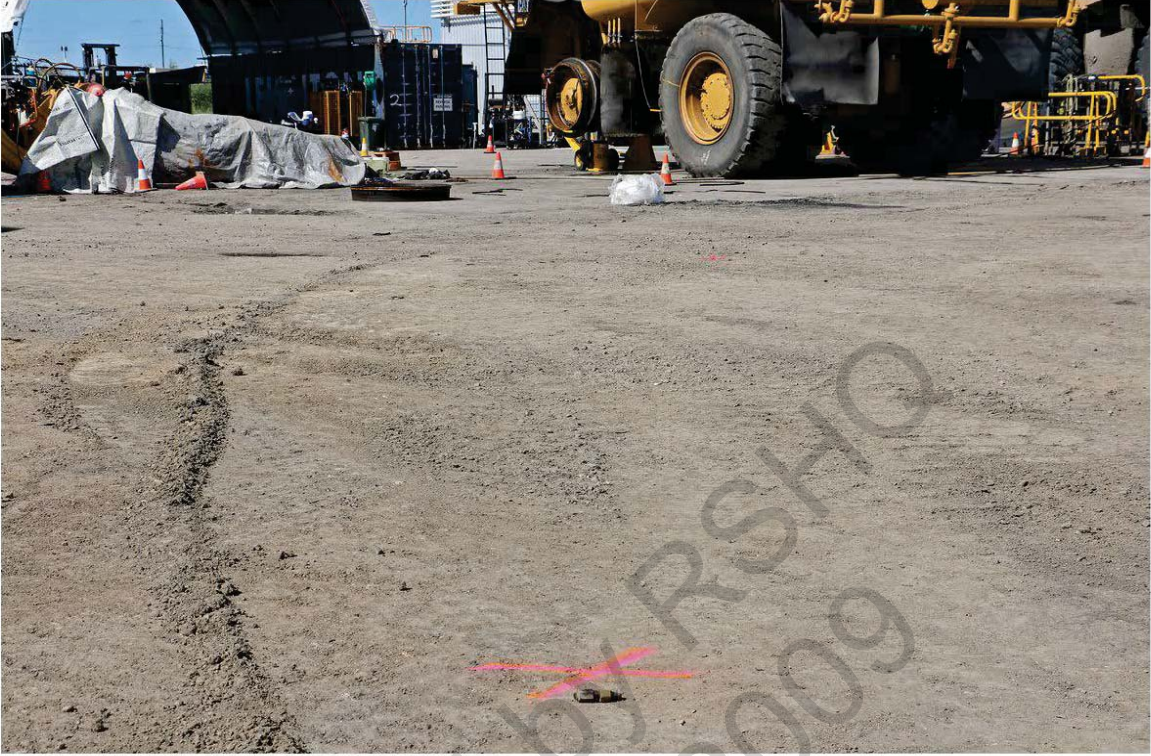
Figure 7: Metal fitting, believed to be part of the Norbar Assembly (*taken by QPS prior to site release*).

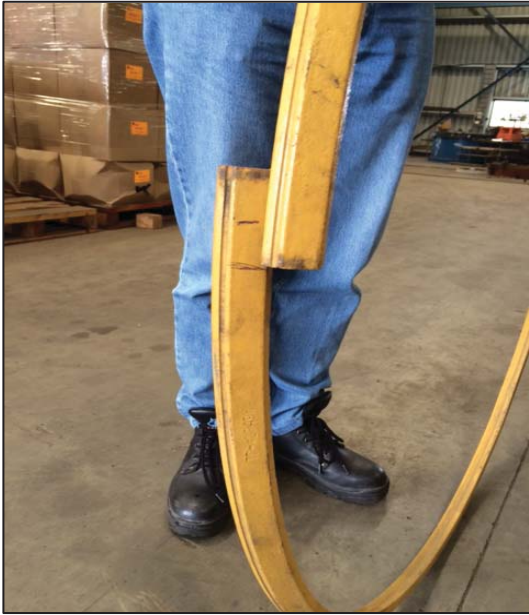
4. Rimex Field Inspection Handbook (page 18) and Topy Industries Manual (sections 3.1, 8.1 - step 4 and 8.3 - step 5) state that lock rings should not be used if the ends of the lock ring do not touch as an unassembled component (Appendix 28). The lock ring is required to have sufficient tension so that it sits into the rim groove, and is in contact with the groove for the full 360 degrees, with the exception of the gap between the ends of the lock ring when assembled. It should be noted that both Topy Industries and Rimex do not clearly indicate how the confirmation of the overlap is to be checked. For example, if an EV lock ring is checked in the vertical position with the gap at '12 o'clock', there may be no overlap, however, if the gap is rolled around to the '9 o'clock' position, then due to the lock ring weight, an overlap of approximately 25mm can be observed. Figure 10 shows a 49 inch EV lock ring end overlap of 50mm when measured at the 9 o'clock position. Figure 11 shows the same 49 inch EV lock ring overlap of 25mm when measured at the 12 o'clock position.

Figure 10: 49 inch EV lock ring end overlap of 50mm measured at the 9 o'clock position (taken by DNRM Inspectors at Rimex Mackay).

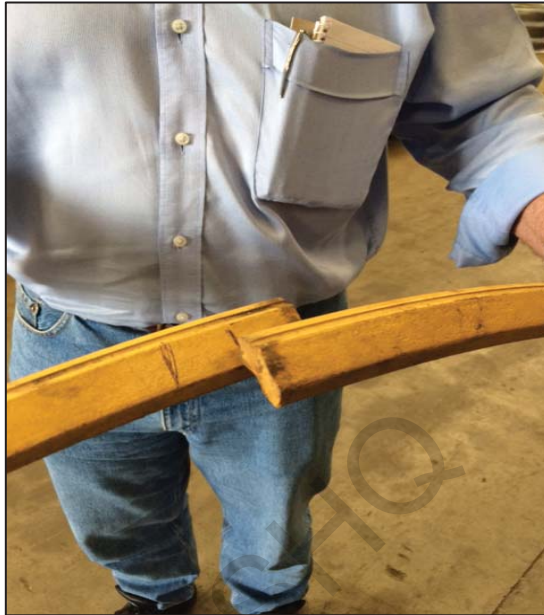
Figure 11: 49 inch EV lock ring end overlap of 25mm measured at the 12 o'clock position (taken by DNRM Inspectors at Rimex Mackay).

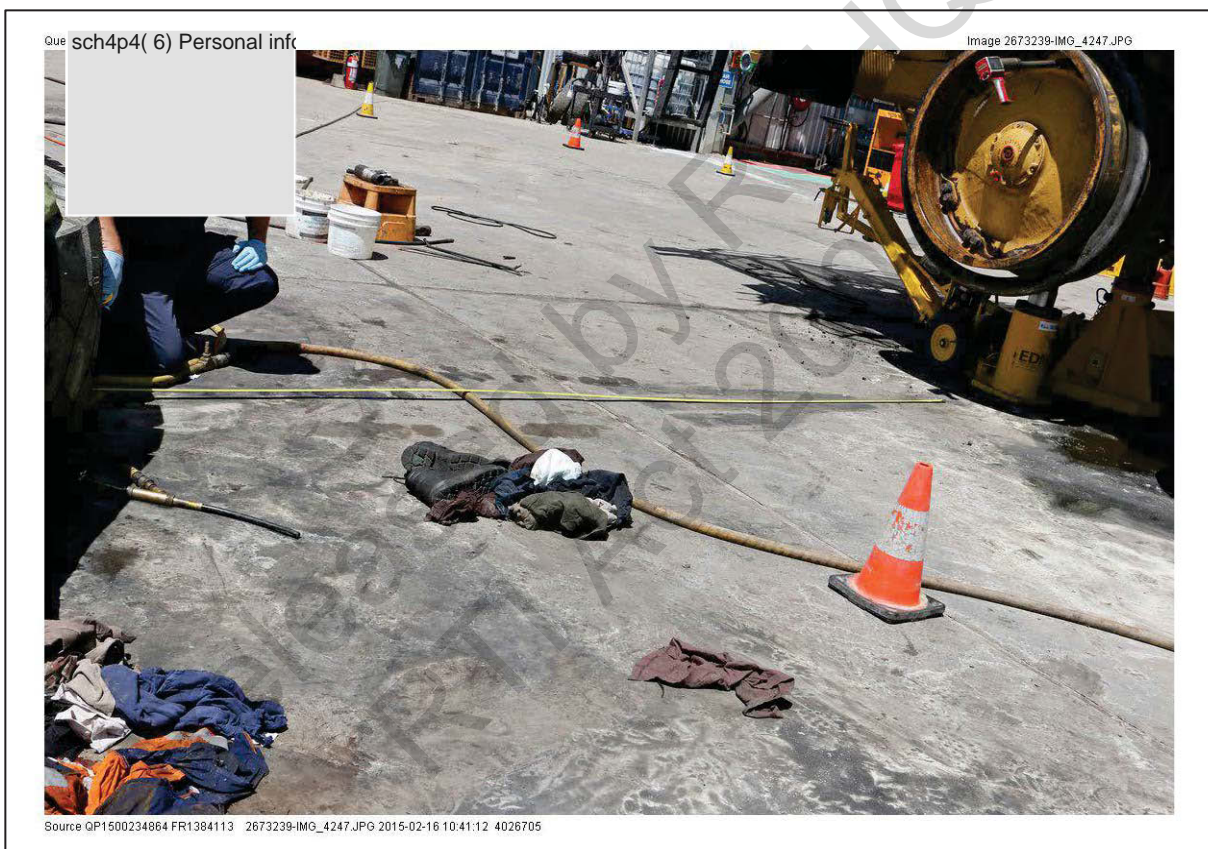
The tyre is a new Bridgestone 2700R 49 earthmover. It was the correct size and type for a front wheel steer tyre. There was no failure of the tyre that contributed to the incident. Its part in the incident was as a pressure vessel that contained the energy that was suddenly released, causing the tyre and other rim components to become projectiles. Figure 14 shows the distance that it was ejected off the rim before it contacted the Tyre Handler. The skid mark on the ground begins close to the truck, and is where the tyre has made initial contact with the ground after leaving the rim. The skid mark continues until the tyre has fallen horizontally onto the ground. The initial trajectory from rim to ground is very short (less than a metre), where a fully inflated tyre would be at least several metres.

Figure 14: Distance tyre ejected before contacting Tyre Handler (taken by QPS prior to site release).

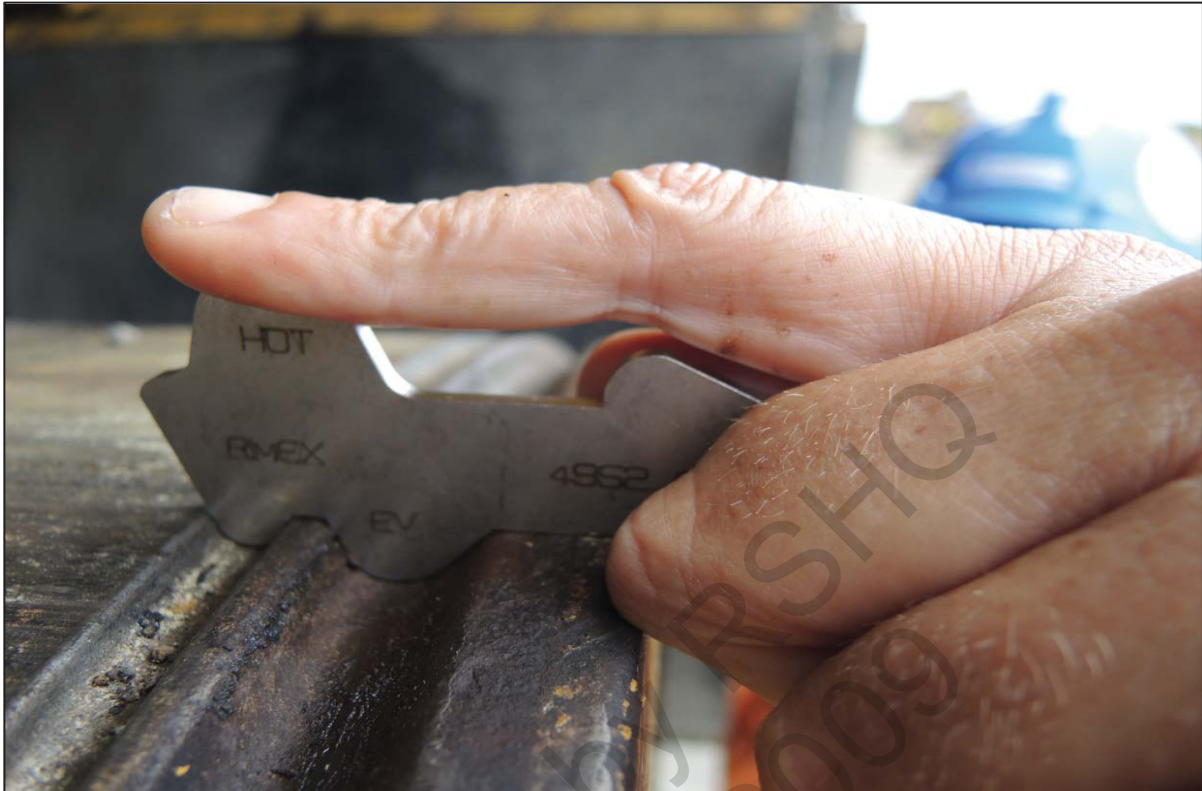
Figure 15: Profile gauge checks (taken by DNRM at incident scene).

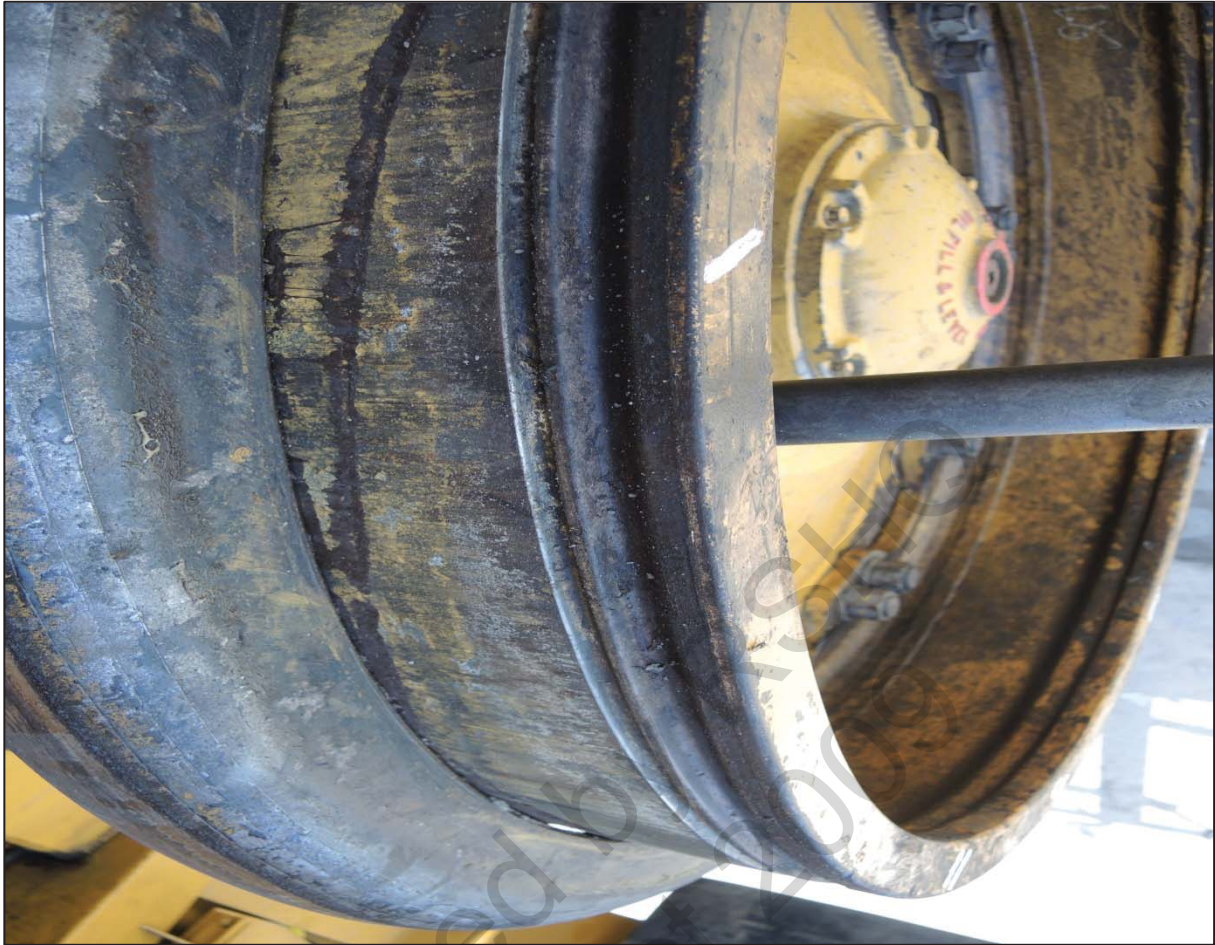
Figure 16: Standard of cleaning of rim (from DNRM photos taken at incident scene).

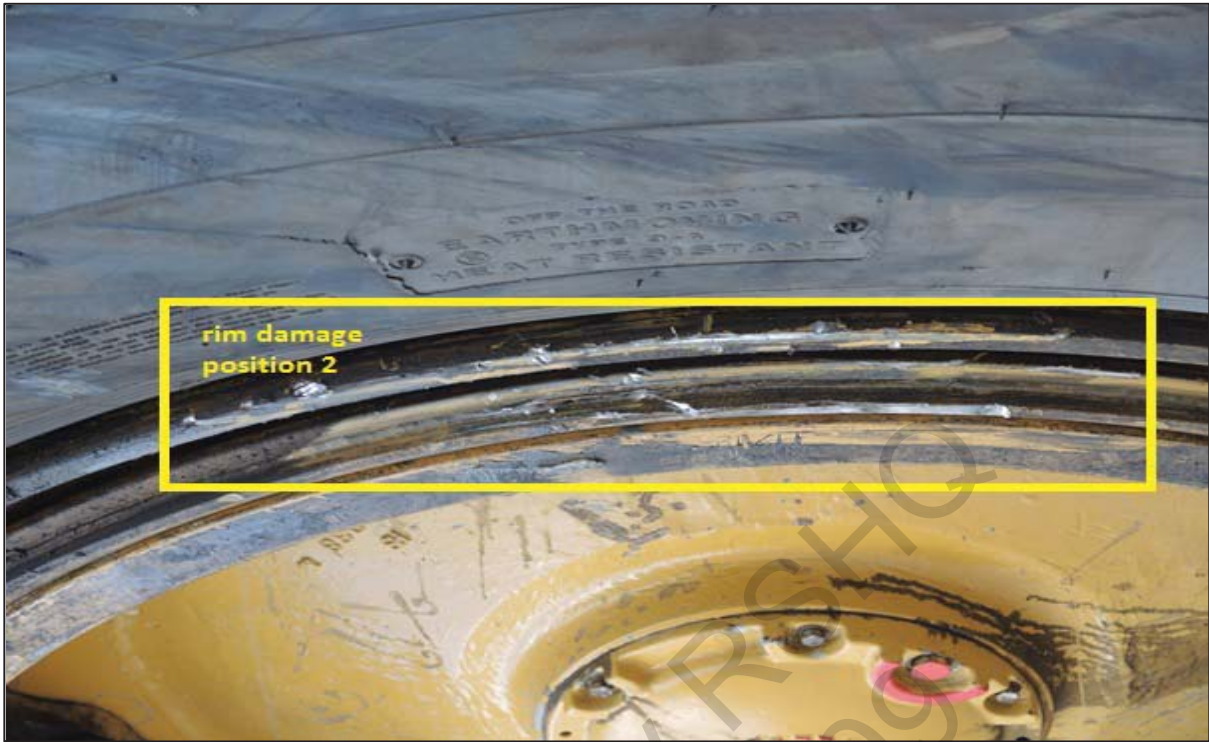
Figure 17 below, shows damage to Position 2 assembly.

Figure 17: Damage to Position 2 assembly (from DNRM photos taken at incident scene).

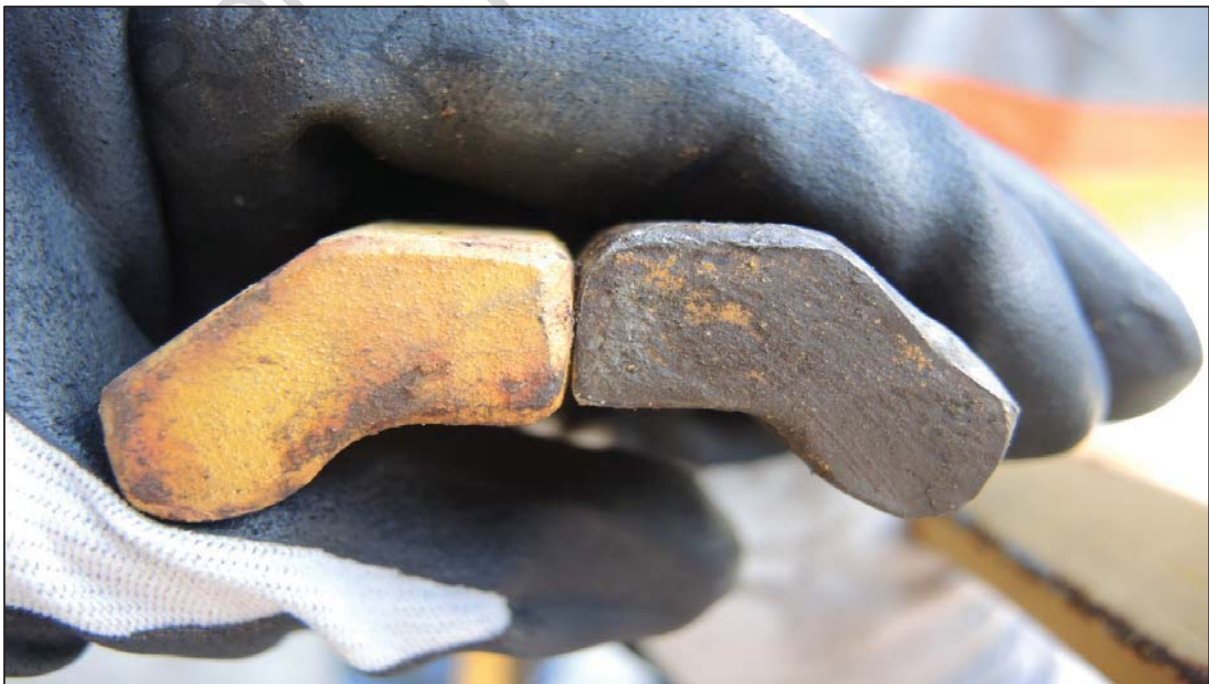
The lock ring in the incident was manufactured by Topy Industries and had been distorted due to the incident. Figure 18 shows the profile comparison to a new lock ring of the same part number.

Figure 18: Profile comparison to a new lock ring of the same part number (from DNRM photos taken at incident scene).

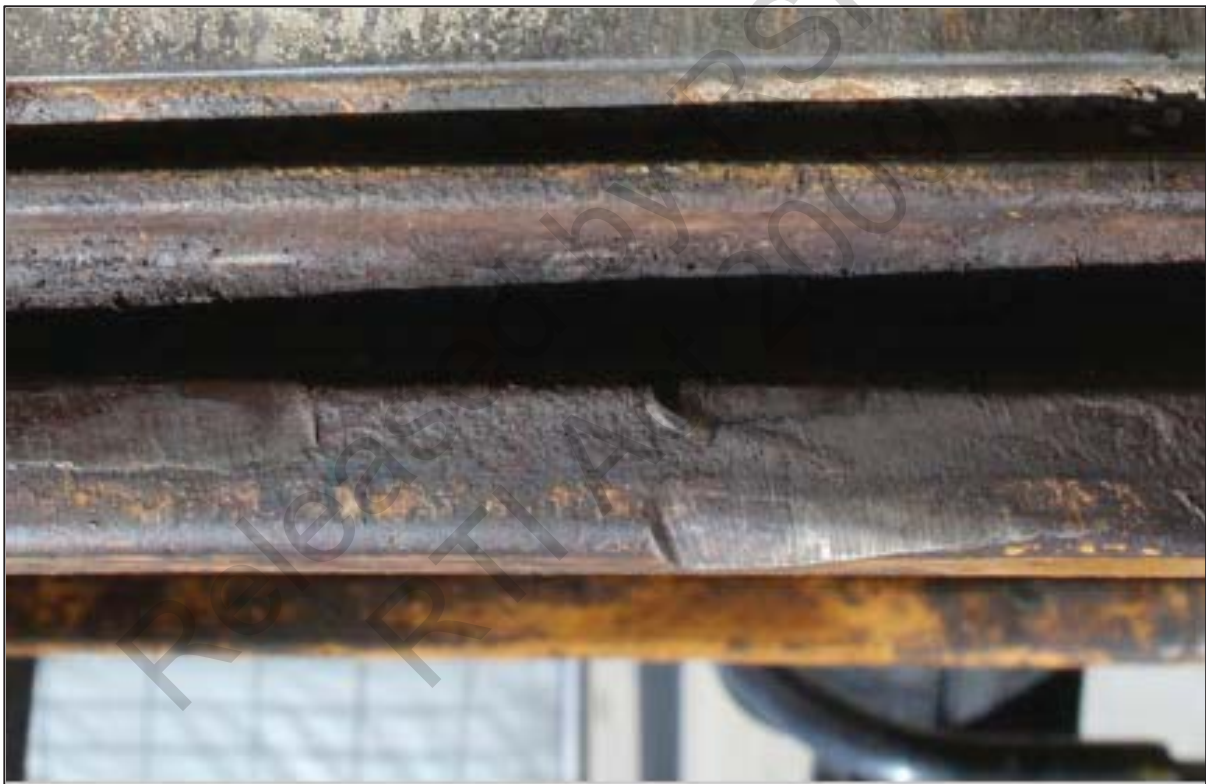
It is important to note, that witness marks left on the rim and bead seat band after the incident, may indicate that the gap in the lock ring ends when it was installed into the groove, was 38mm. Further testing is being conducted to determine if this measurement is indicative of the installation gap, which is the most probable reason, or that it could have been caused by the lock ring movement as it ejected from the rim groove. The OEM specifications state that the correct lock ring fitment should have a lock ring gap of between 16 and 27mm. With a deviation of this magnitude, there would be sections of the lock ring that will not have any contact, or less than adequate contact with the rim groove. Figure 19 shows the witness marks left on the rim by the lock ring.

Figure 19: Witness marks left on rim by lock ring (from DNRM photos taken at incident scene).

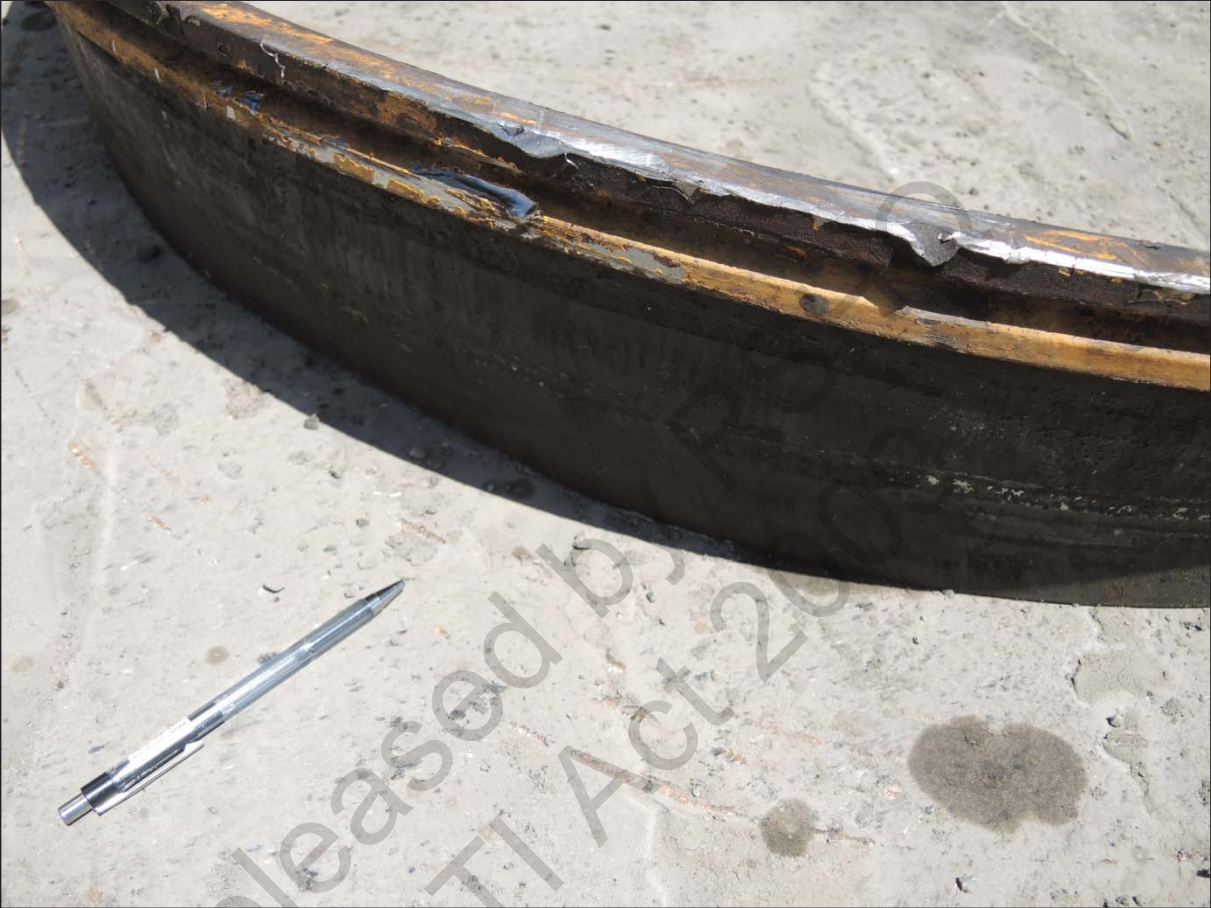
The Rimex bead seat band was manufactured in September 2010 and shows signs of general wear. It was poorly cleaned and similar to the rim condition. Surface damage to the outer lip and scoring of the components was evident, and has mostly likely been caused during tyre fitting, when the Tyre Handler tyre grippers are compressing the tyre to allow fitting of the 'O' ring and lock ring, shown in Figure 20.

Figure 20: Rimex bead set band (from DNRM photos taken at incident scene).

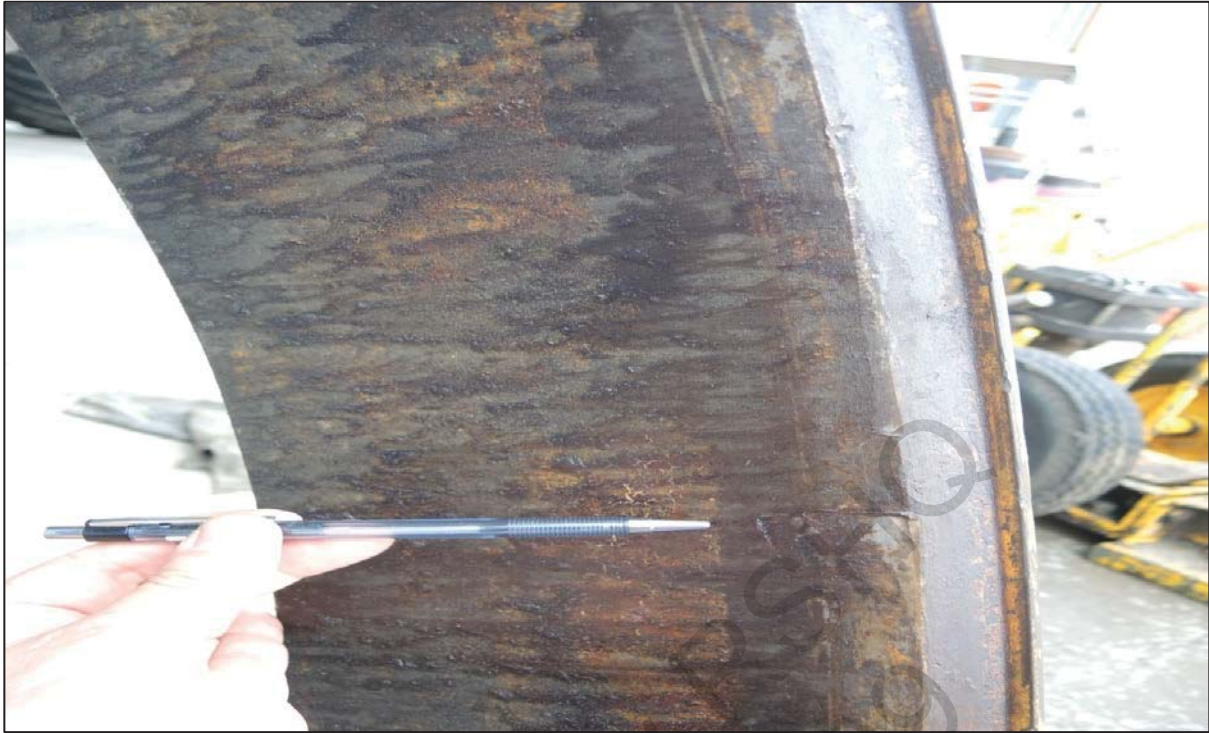
The marks shown in Figure 21 are the witness marks that occurred during the 'peeling' of the lock ring, that resulted in the explosive disassembly of the rim components in the incident. These marks match with those on the rim.

Figure 21: Witness marks that occurred during the peeling of the lock ring (from DNRM photos taken at incident scene).

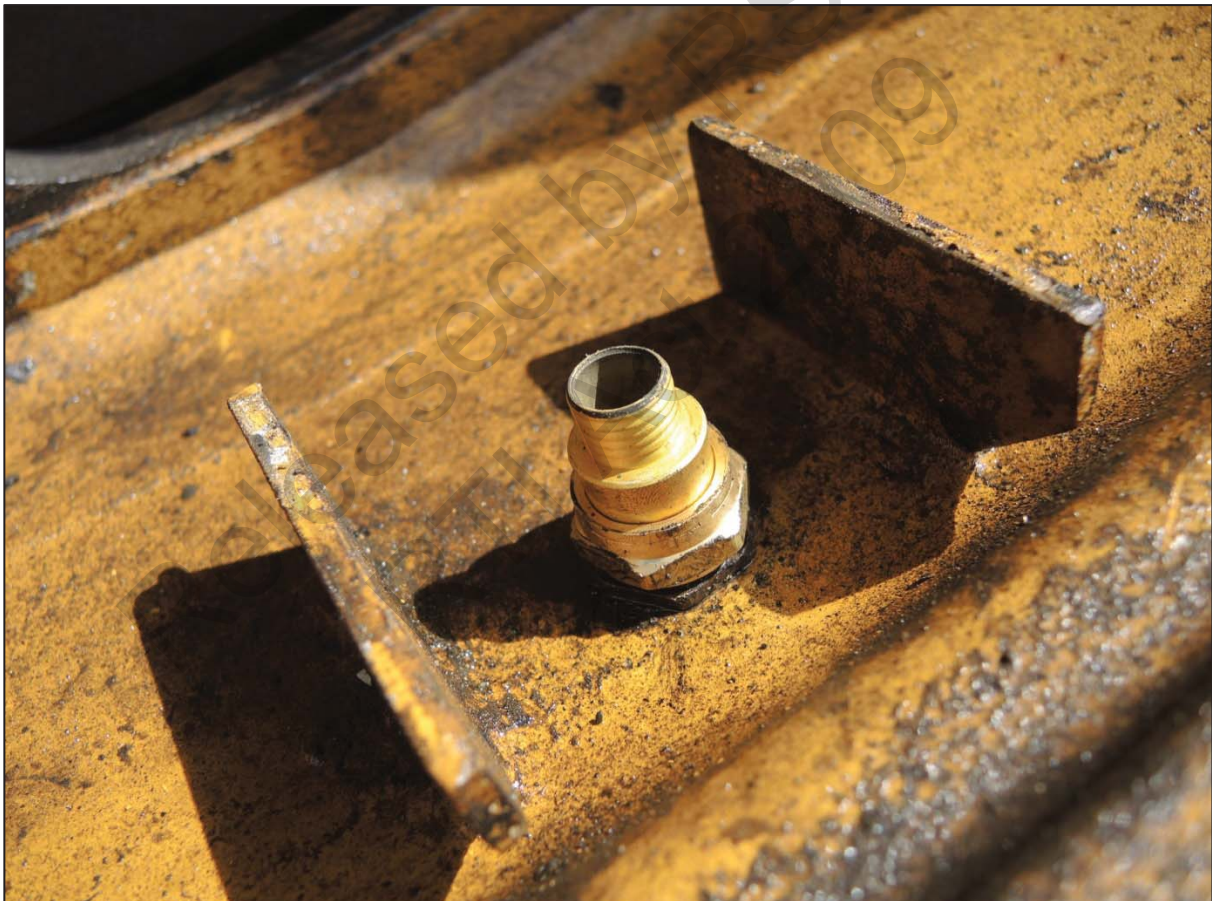
Figure 25: Part of the valve stem (from DNRM photos taken at incident scene).

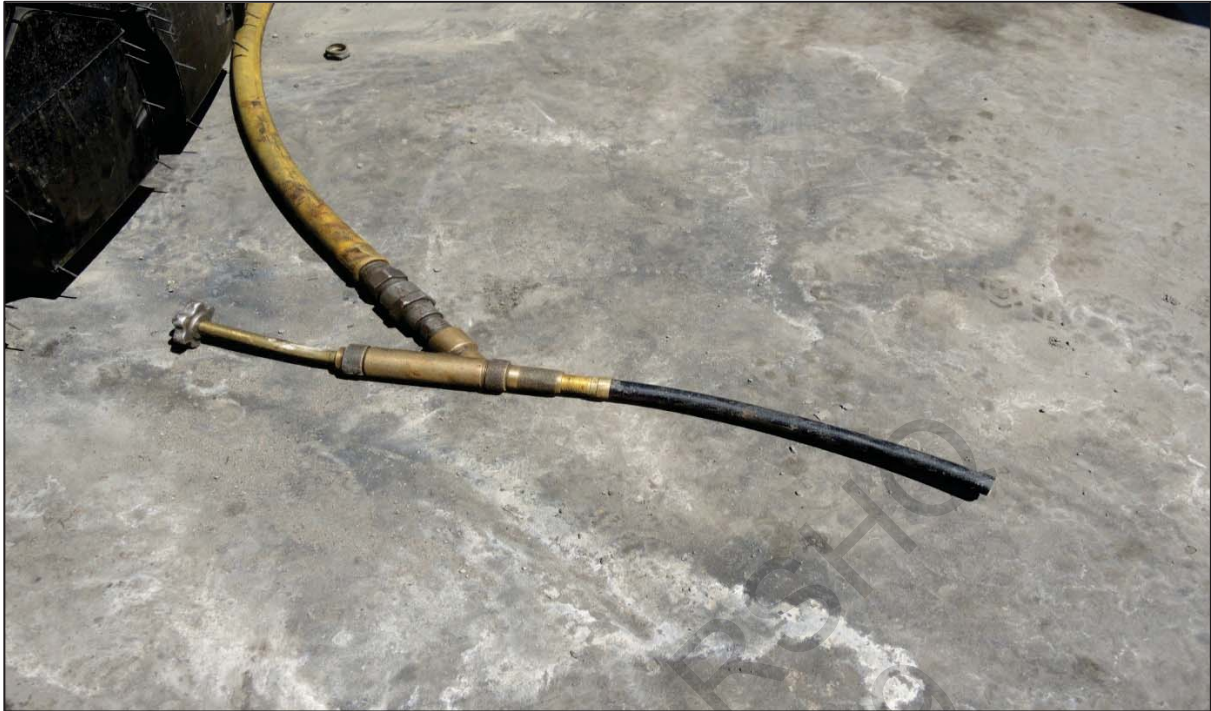
Figure 26: Part of the valve stem (from DNRM photos taken at incident scene).

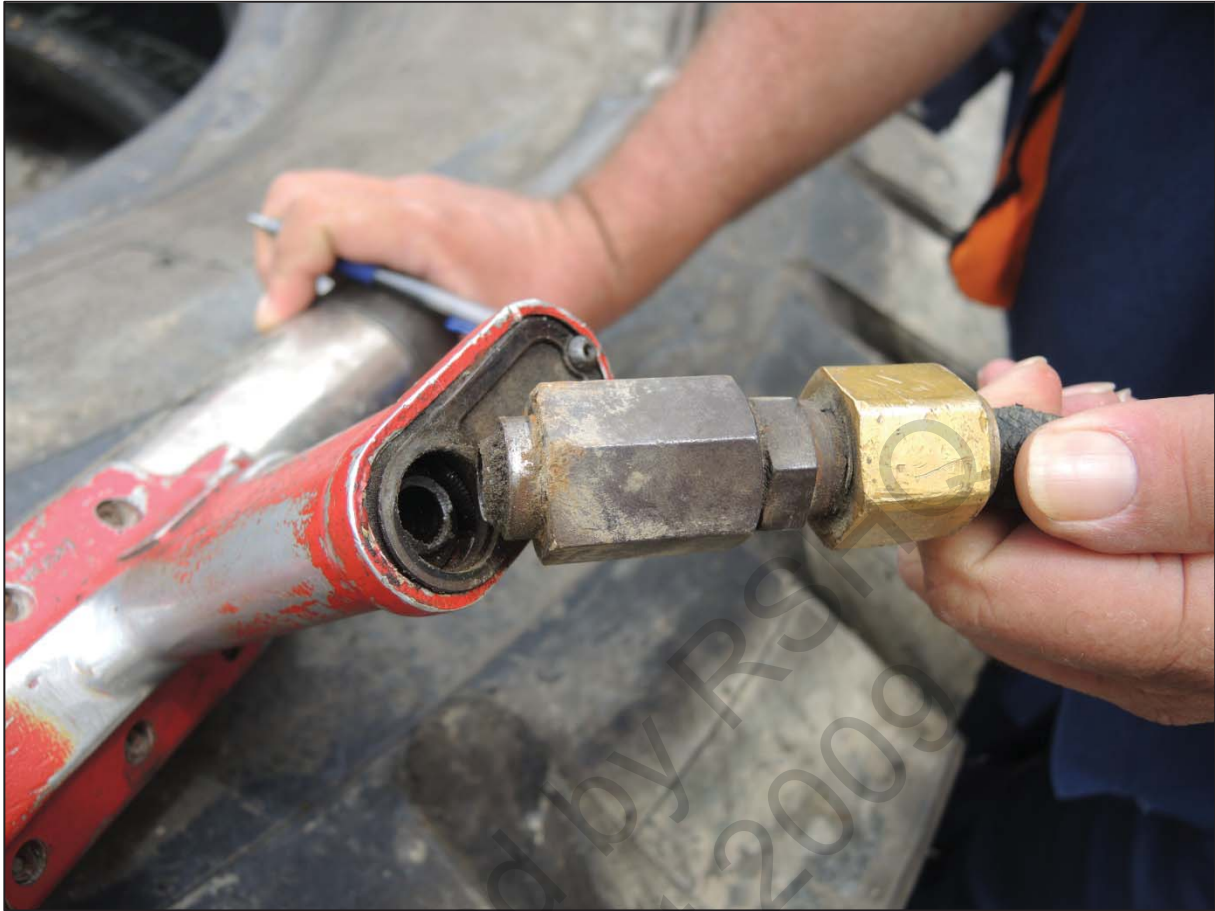
Figure 32 shows the broken fitting in the Norbar and the end of the airline.

Figure 32: Broken fitting in the Norbar and the end of the airline (from DNRM photos taken at incident scene).

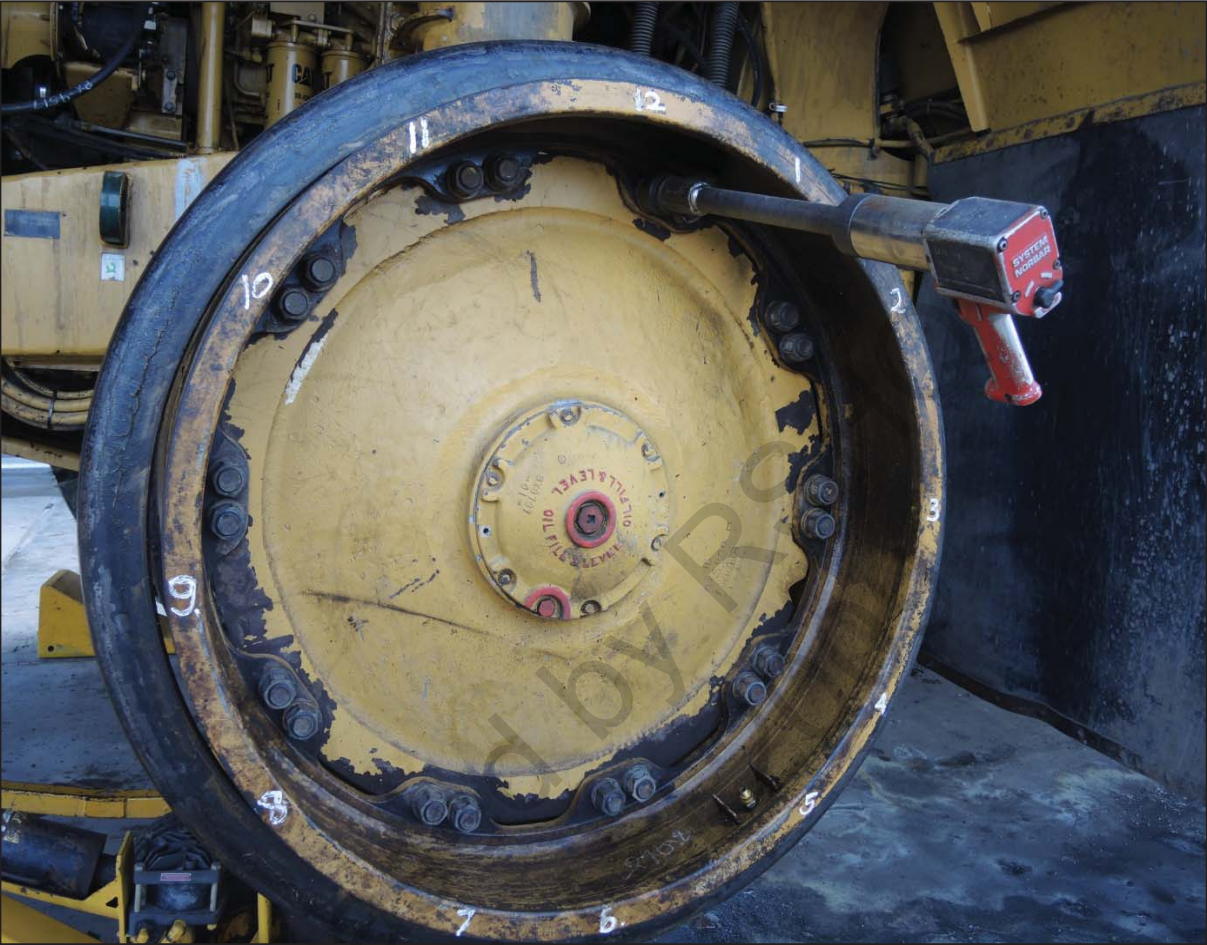
nut number 1, fifteen nuts fully torqued. Five nuts at location numbers 2 to 6 were not fully torqued (refer Figure 35).

Figure 35: Five nuts at location numbers 2 to 6 (from DNRM photos taken at incident scene).

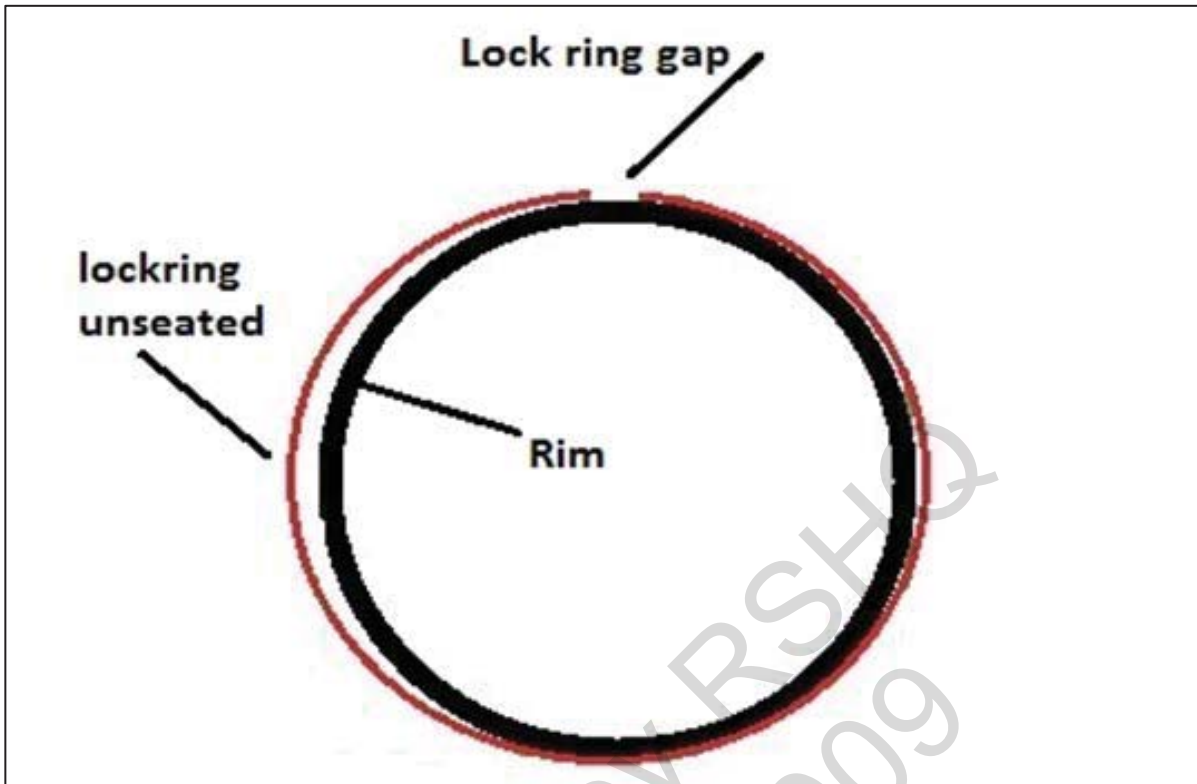
Further testing is being conducted by the Inspectorate to determine if this measurement is indicative of the installation gap. Figure 36 is a diagram showing an open lock ring (excessive gap end).

Figure 36: Diagram showing an open lock ring (excessive gap end).

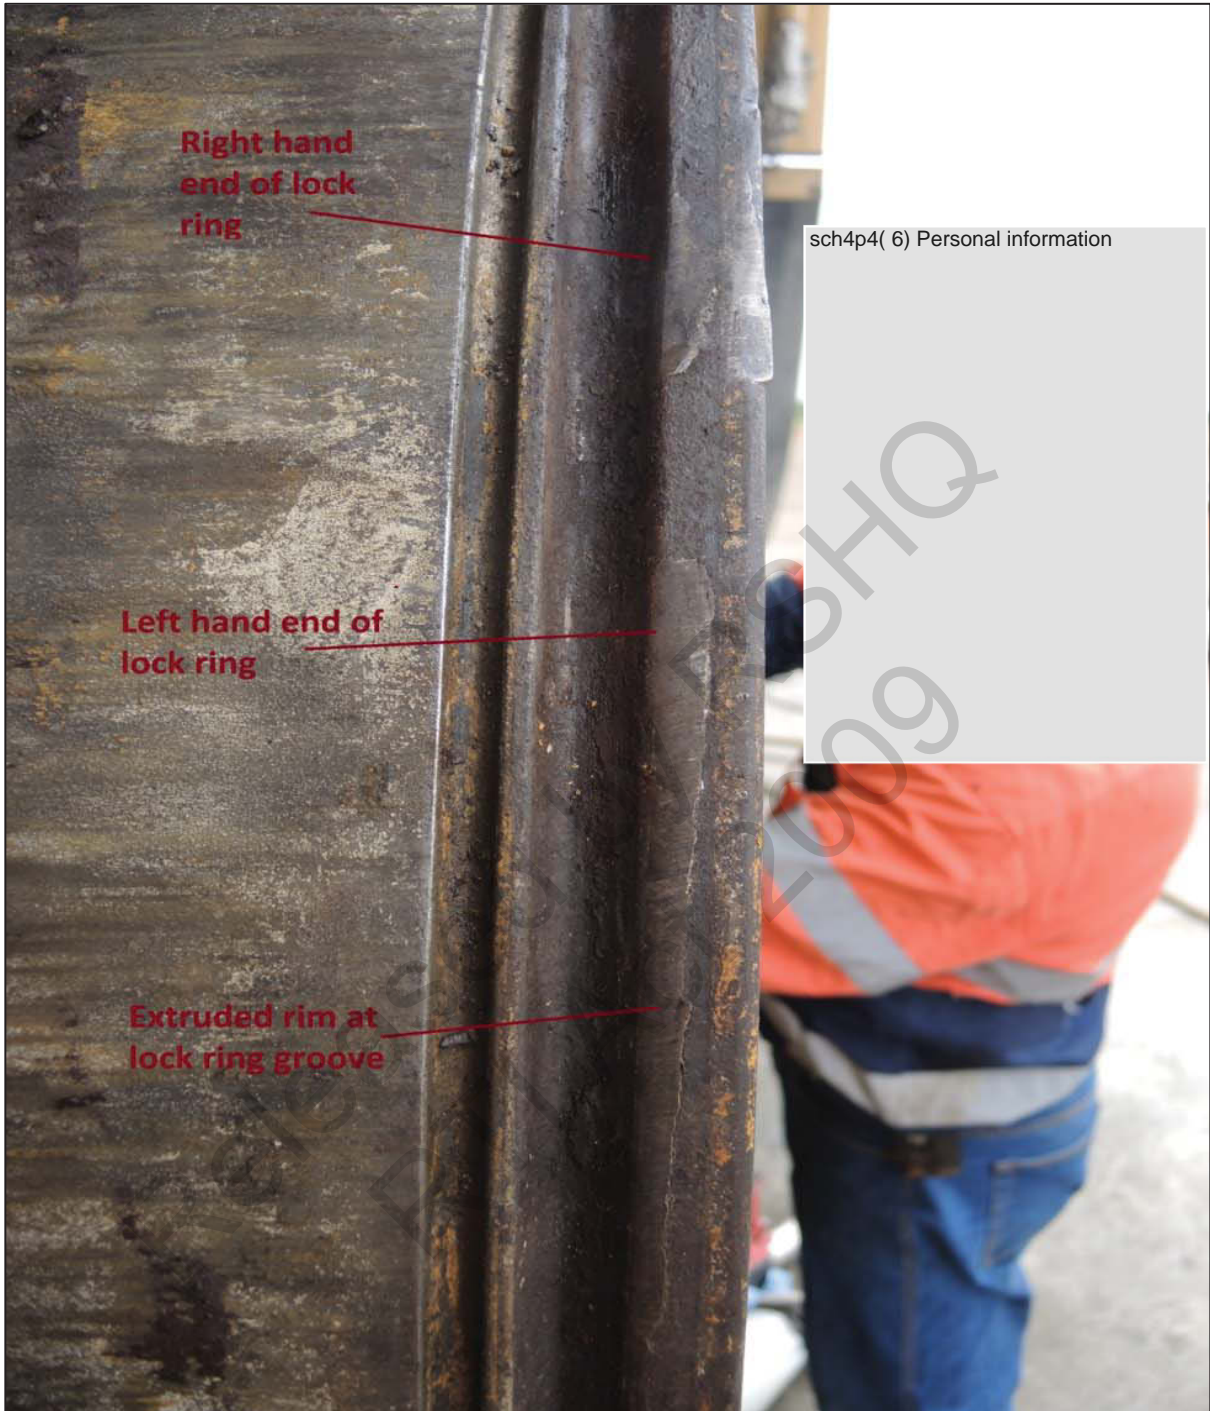
Figure 37: Right and left hand ends of lock ring and extruded rim at lock ring groove (from DNRM photos taken at incident scene).

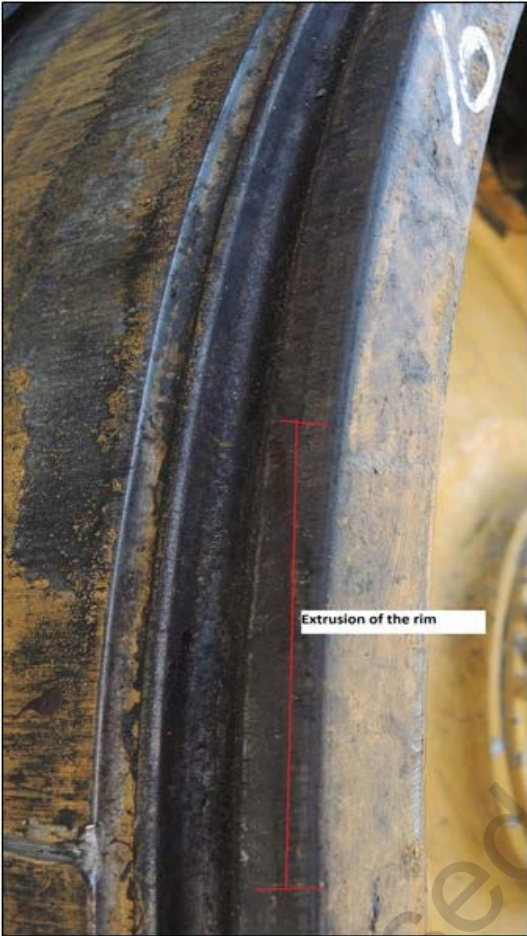
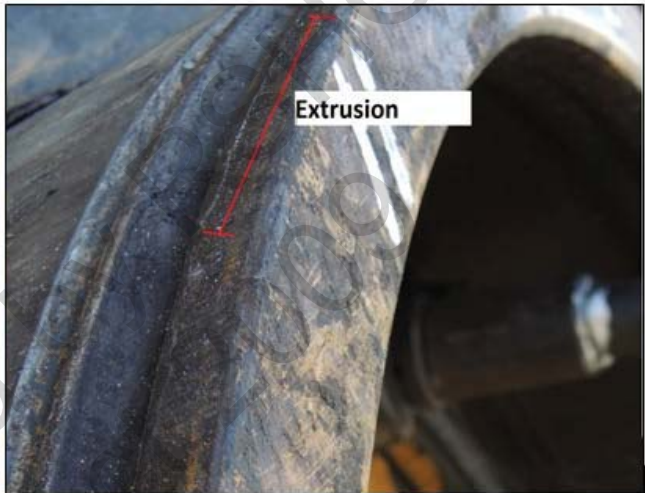
Figure 38 and 39: Extrusion of rim (from DNRM photos taken at incident scene).

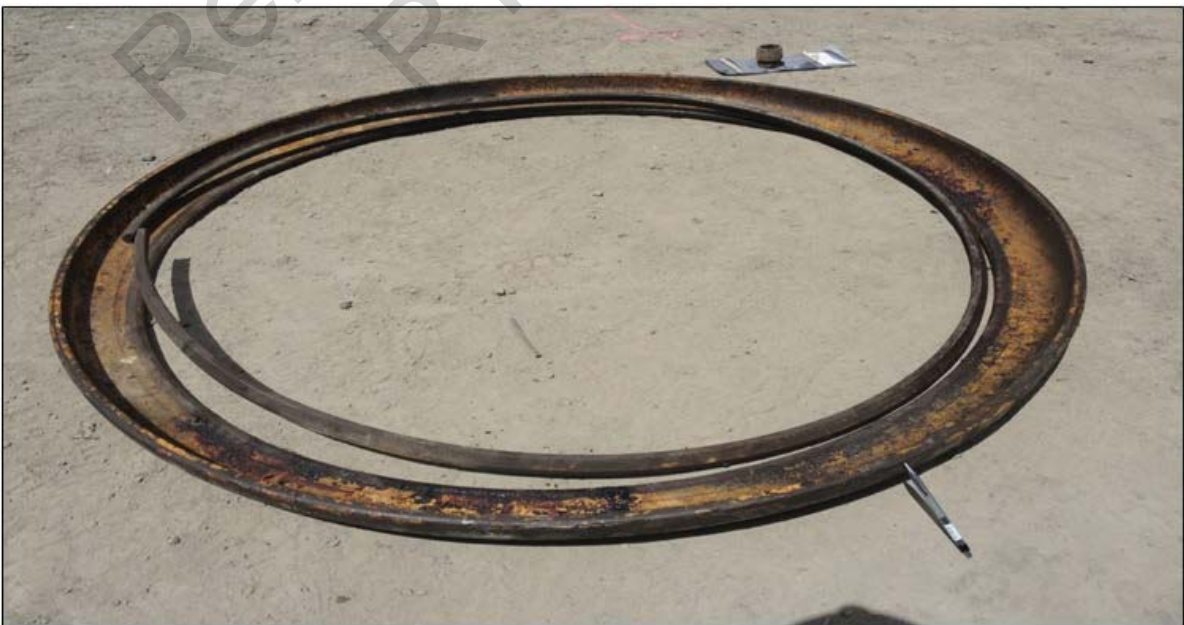
In Figure 40 below, the lock ring has a distinctive spiral shape, typical of a lock ring 'peeling' out of the lock ring groove.

Figure 40: Distinctive spiral shape of lock ring (from DNRM photos taken at incident scene).

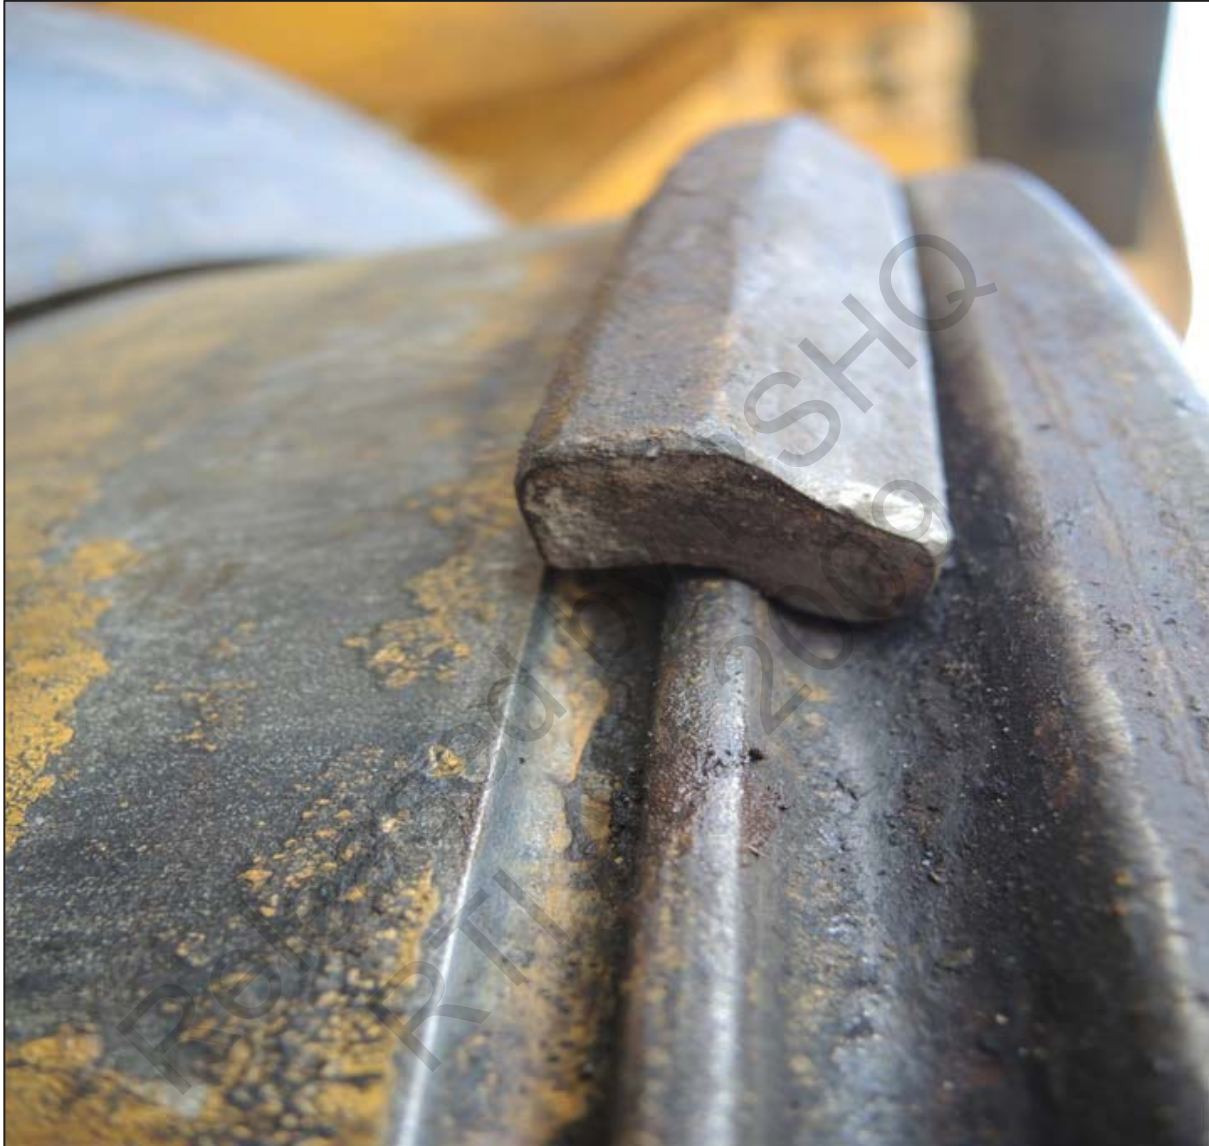
Figure 41 shows interference with the 'O' ring by the lock ring if fitted in reverse. Inflation of the tyre would not be possible as the bead seat band would not seal against the 'O' ring.

Figure 41: Interference with the 'O' ring by the lock ring if fitted in reverse (from DNRM photos taken at incident scene).
