Royal Commission on the Pike River Coal Mine Tragedy

Volume 2

Date of Publication: October 2012

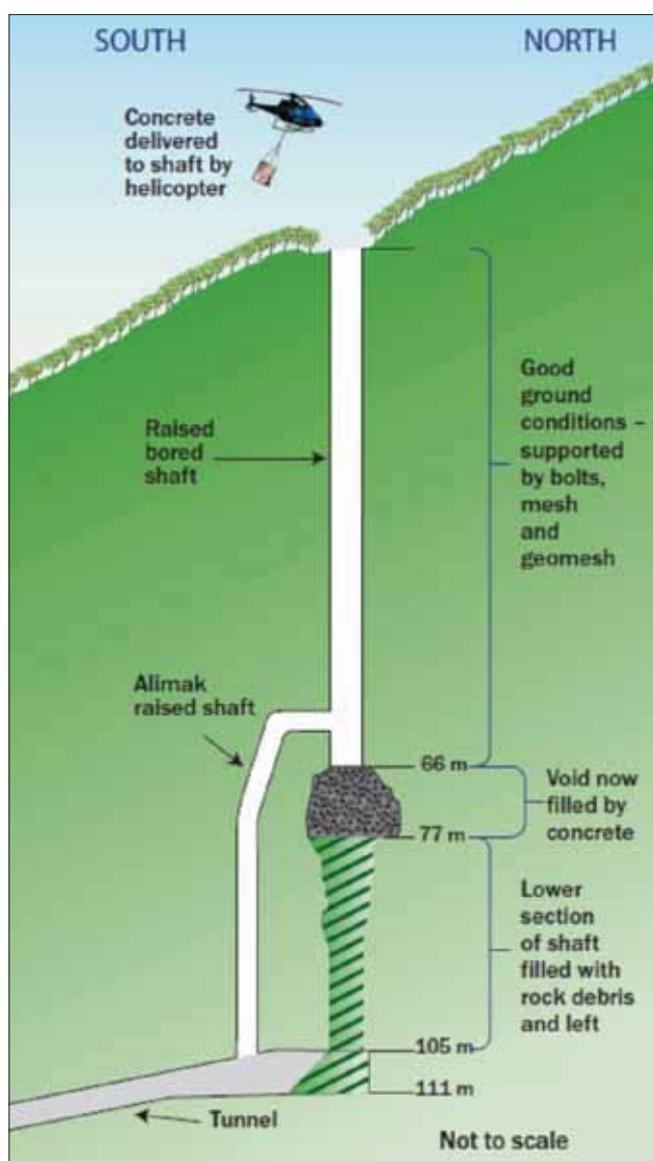
Figure 3.7: Ventilation shaft and Alimak raise³⁸

49. Following investigation the company decided to abandon the bottom 35m, cap it with concrete and construct a bypass to reconnect to the upper 70m of the shaft, as shown in the diagram.

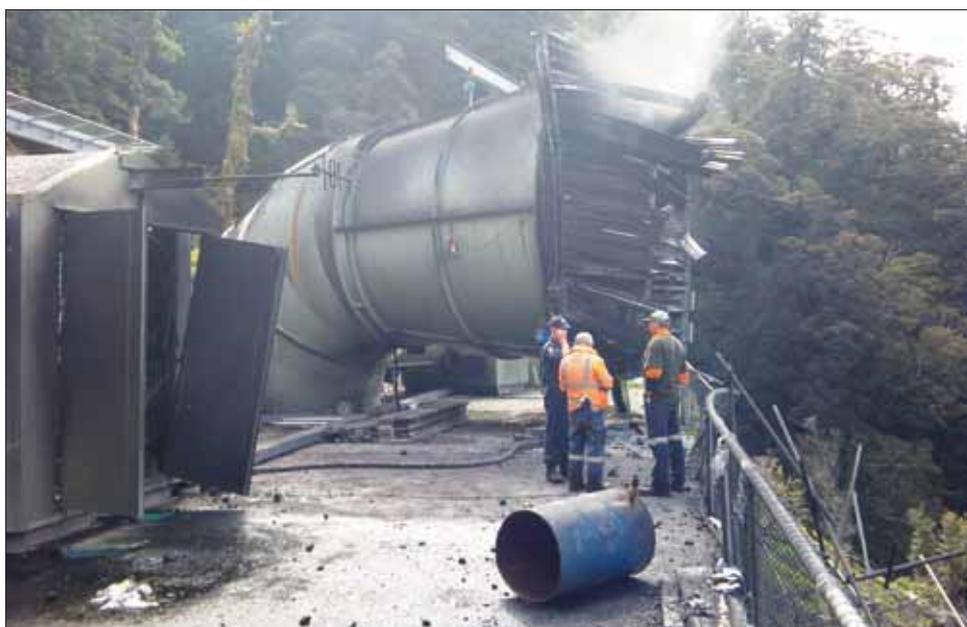
Figure 8.10: The surface fan after the first explosion

82. The surface fan failed in its vital back-up role. As shown in the photograph below, the explosion panels failed to divert the explosive air flow and debris from the first explosion, which damaged the fan, fan housing, shaft access doors, power generator and control infrastructure. Subsequent explosions propelled the fan and housing from their fixed positions.¹¹⁸

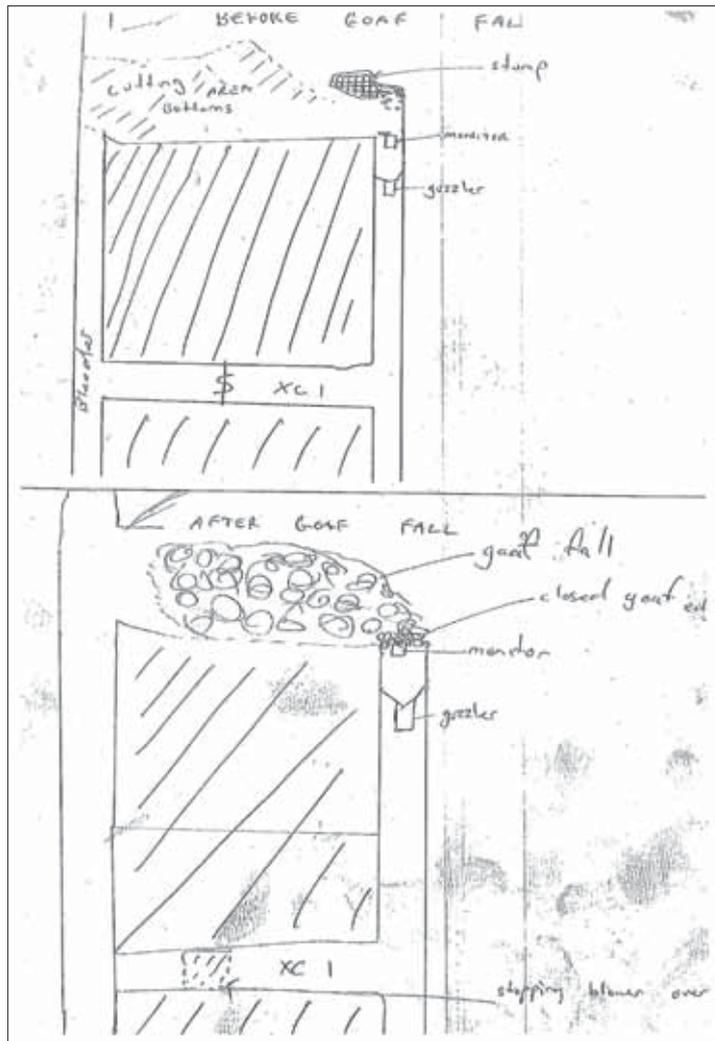
Figure 8.15: Effects of roof fall on 30 October 2010¹⁷¹

119. Mr Wylie completed an incident report.¹⁷⁰ He attached a hand-drawn diagram showing the effects of the roof fall, including the blocked heading at the entry to the goaf and the damaged stopping in cross-cut one, with the words 'stopping blown over'.

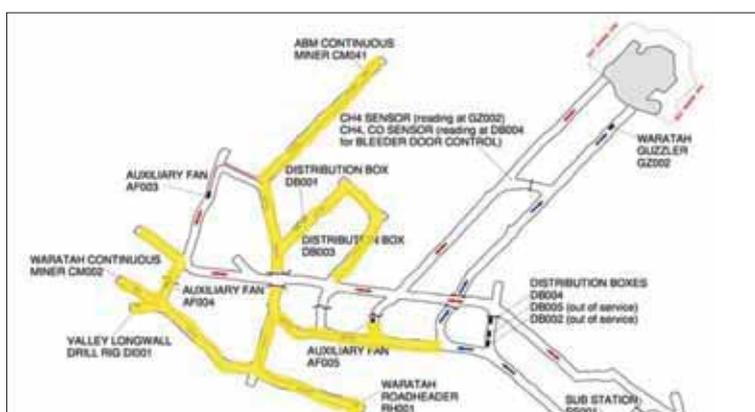
Figure 8.17: Ventilation inbye of the monitor panel¹⁹⁸

135. Ventilation inbye of the monitor panel was particularly fragile and struggling to cope with the extent of mining operations and gas load in the mine.¹⁹⁷ Those areas had a small amount of pressure (14Pa) and quantity (49m³/s) available to ventilate the three working places and two standing places inbye of panel 1. That area is shaded yellow in the following diagram.

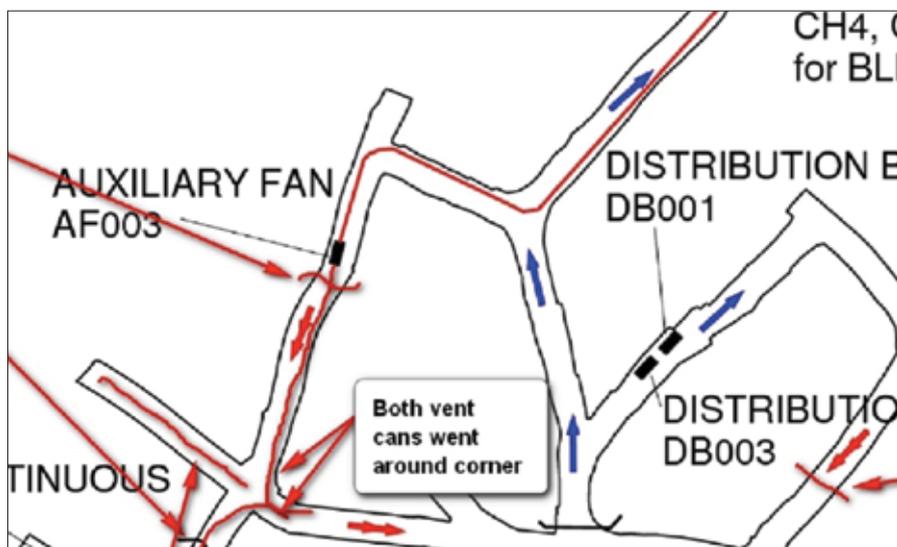
Figure 8.18: Location of the auxiliary fan²⁰¹

136. DOL concluded that, given the gas make in the mine and the number of faces being worked, it should have been apparent that the ventilation system was stretched to its limit. Pike's approach allowed no factor of safety to deal with predictable hazards.¹⁹⁹
137. Mr Reece also noted other deficiencies with the ventilation system, for example, the placement of an auxiliary fan (AF003) immediately next to a stopping,²⁰⁰ which meant the fan did not have the necessary 30% of fresh air passing over it to ensure it did not overheat. The fan can be seen towards the left-hand side of the following diagram.

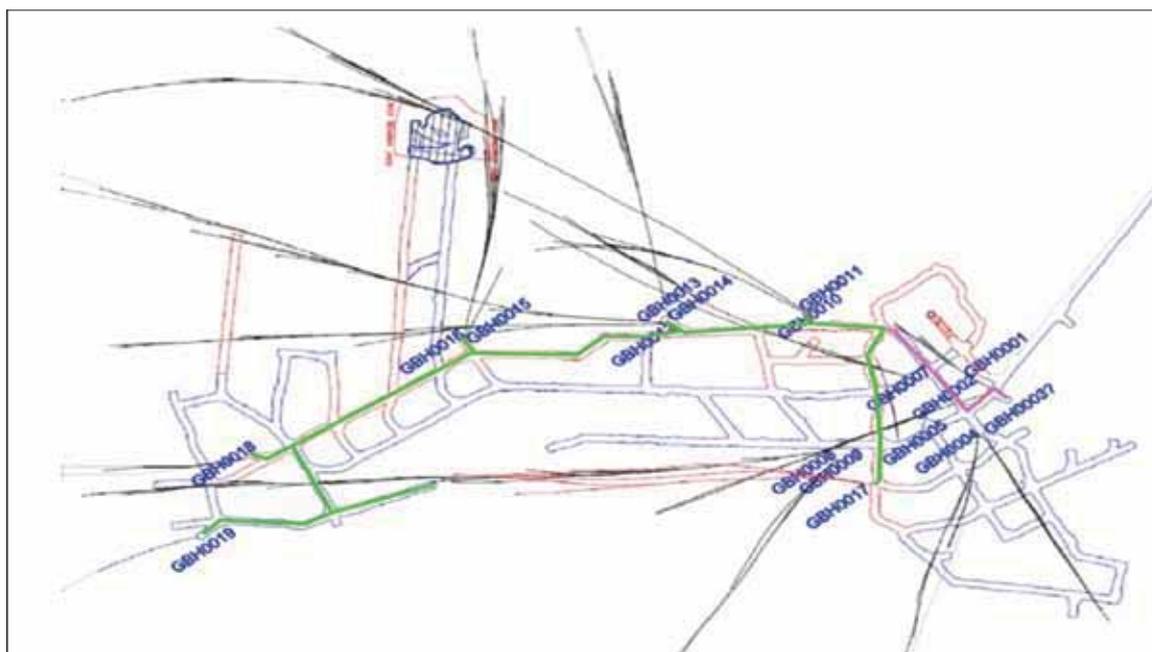
Figure 9.7: Gas drainage line and in-seam boreholes⁶⁷

70. The pipeline was installed primarily in the return airways leading from connected boreholes outbye to the riser (as shown below in green), but it also ran for about 100m in the intake airway (shown in pink) from the overcast near the underground fan through Spaghetti Junction before turning left and then right to the gas riser located at the entrance to the slimline shaft/FAB. This created a significant hazard.

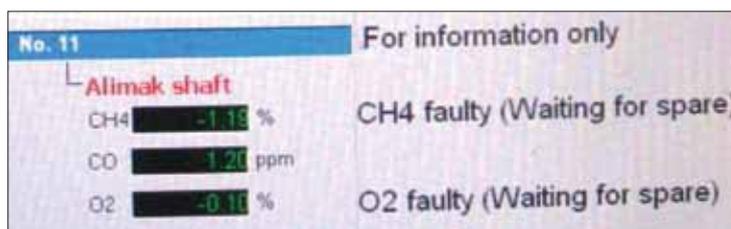
Figure 10.4: Control room operator's screen on the Safegas system³²

19. There were several problems with the gas sensors in the ventilation shaft. First, the sensor at the bottom of the ventilation shaft stopped working on 4 September 2010, nearly 11 weeks before the explosion, and was never repaired or replaced.³¹ Indeed, the control room operator's screen on the Safegas system was permanently annotated to say the sensor was 'faulty' and 'waiting for spare'.

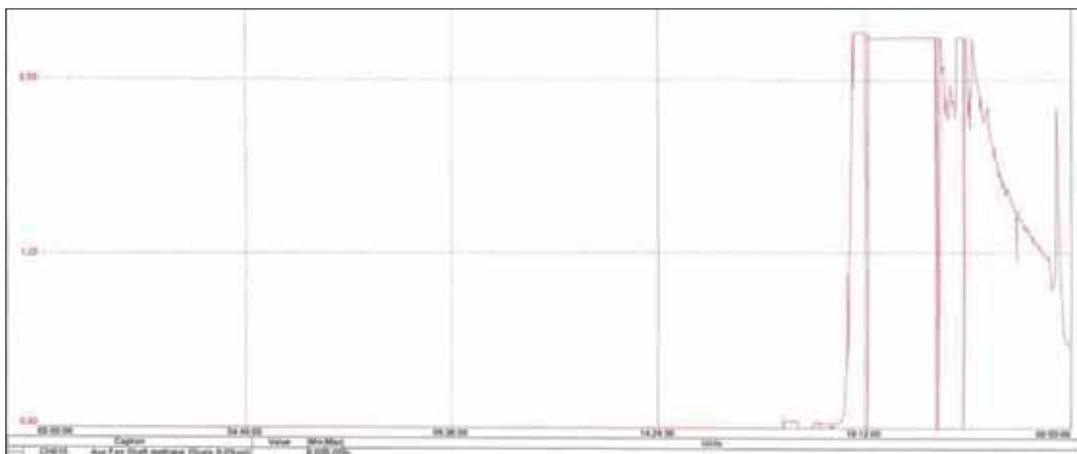
Figure 10.5: Auxiliary fan shaft methane – 6 October 2010⁴³

24. The ventilation shaft sensor also 'latched' or was poisoned on a number of occasions, causing a flat line to show on the surface controller's system. The flat line phenomenon indicated the sensor had been exposed to greater than 5% methane. This occurred during the 'gassing out' of the mine on Wednesday 6 October 2010, after the failure of the surface fan.

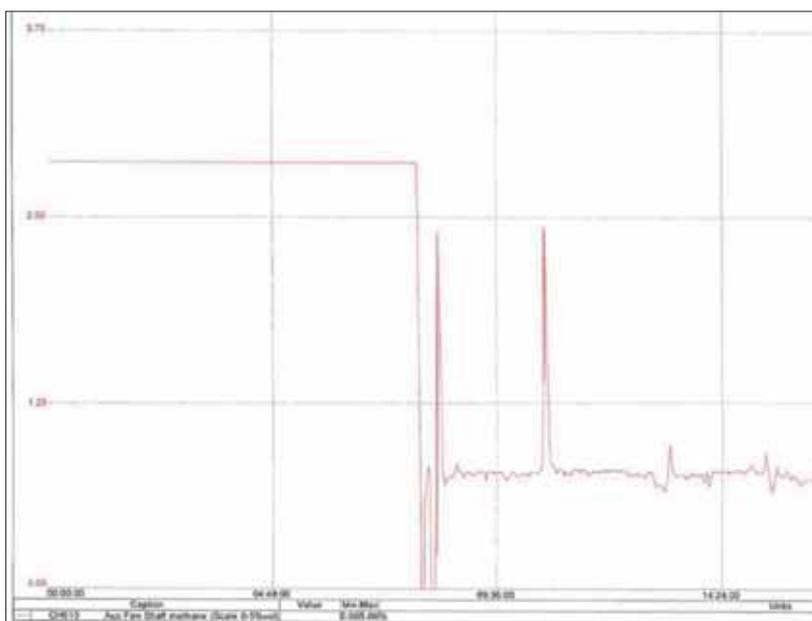
Figure 10.6: Auxiliary fan shaft methane – 8 October 2010⁴⁴

25. There was no data from the sensor from the time of the fan failure on 5 October. The control room system then showed a flat line around 2.5% during the evening of 6 October. Despite a review and a notification to the Department of Labour (DOL) about the incident, nothing was done about the flat line issue.
26. There was then a second flat line that started late on Thursday 7 October and continued through to Friday 8 October 2010 during the degassing procedures.

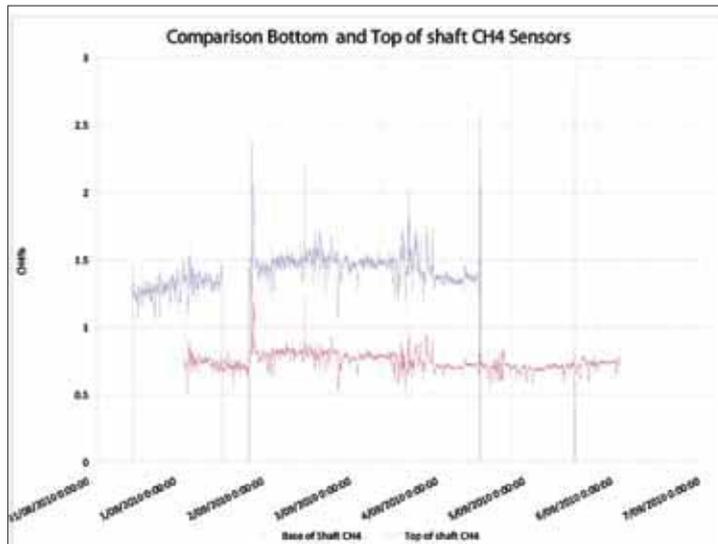
Figure 10.7: Comparison bottom and top of shaft CH₄ sensors⁴⁷

27. Mr White told the commission he was not aware of any flat lines, and if he had been, it would have been a cause for investigation.⁴⁵ However, he accepted that he signed a ventilation survey dated 7 October 2010 that said in red capital letters 'Had a spike of 2.8% at vent shaft – monitor stuck on this reading.'⁴⁶
28. Third, while the sensor at the bottom of the shaft was operational, there was an obvious discrepancy between the readings at the top and bottom of the shaft. The discrepancy is shown in the following graph prepared by DOL, which shows the reading from the top of the shaft in red, and the reading from the bottom of the shaft in blue.

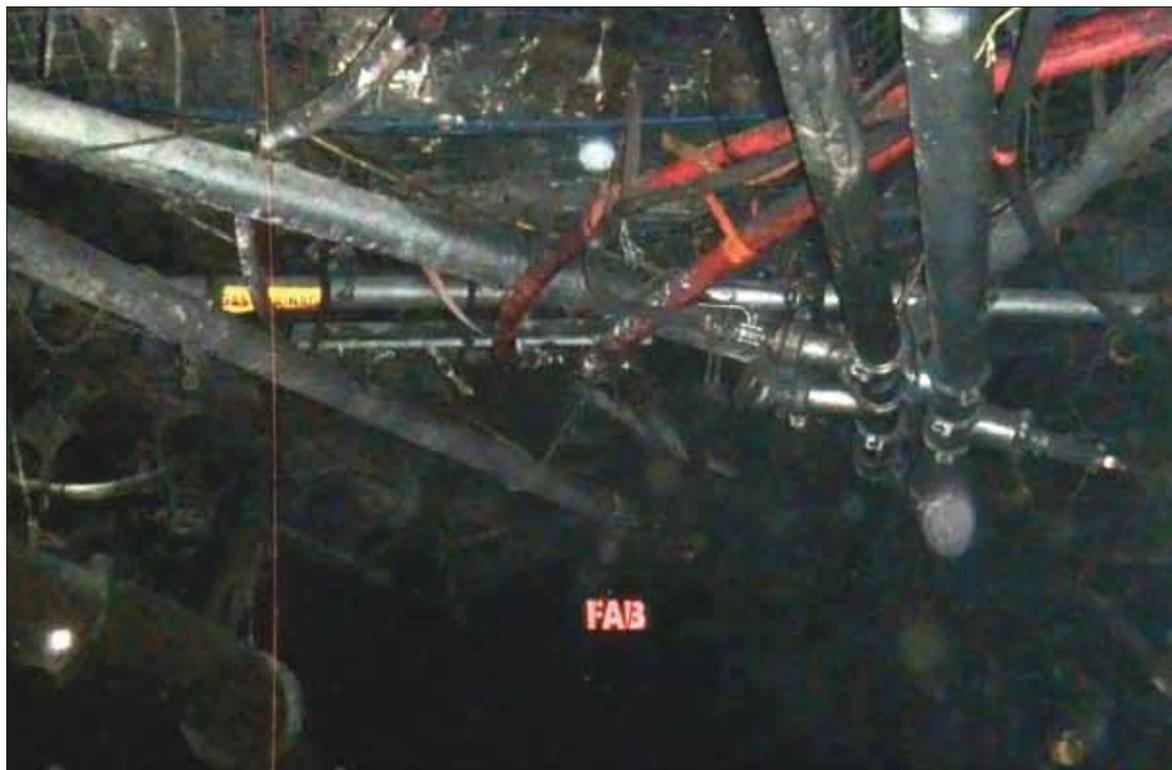
Figure 11.2: Spaghetti Junction¹⁸

24. Of that configuration mining consultant David Reece said:
- This is quite unusual to have pipes like this, this sort of configuration in a mining situation. The other thing is the high-tension cables that are also interspersed with all these services in that particular area. So this is potentially an area where these could be hit by a diesel vehicle or something of that nature ... it's certainly hazardous and the combination of services that you've got there with high-tension cables, and we're talking about 11,000 volts in those cables, if you damaged that at the same time as the pipeline, it is highly likely that you would get an ignition at that point.*¹⁷
