Section 89. Coal Mines Regulation Act, 1982.

Report of an investigation into the Notification of a Dangerous Occurrence.

A Fire Occurred on Longwall 7 Coalface at 12-45 a.m. on 13th December, 1986, when a block of polyurethane foam being used to fill a roof cavity self ignited.

WEST CLIFF MINE -

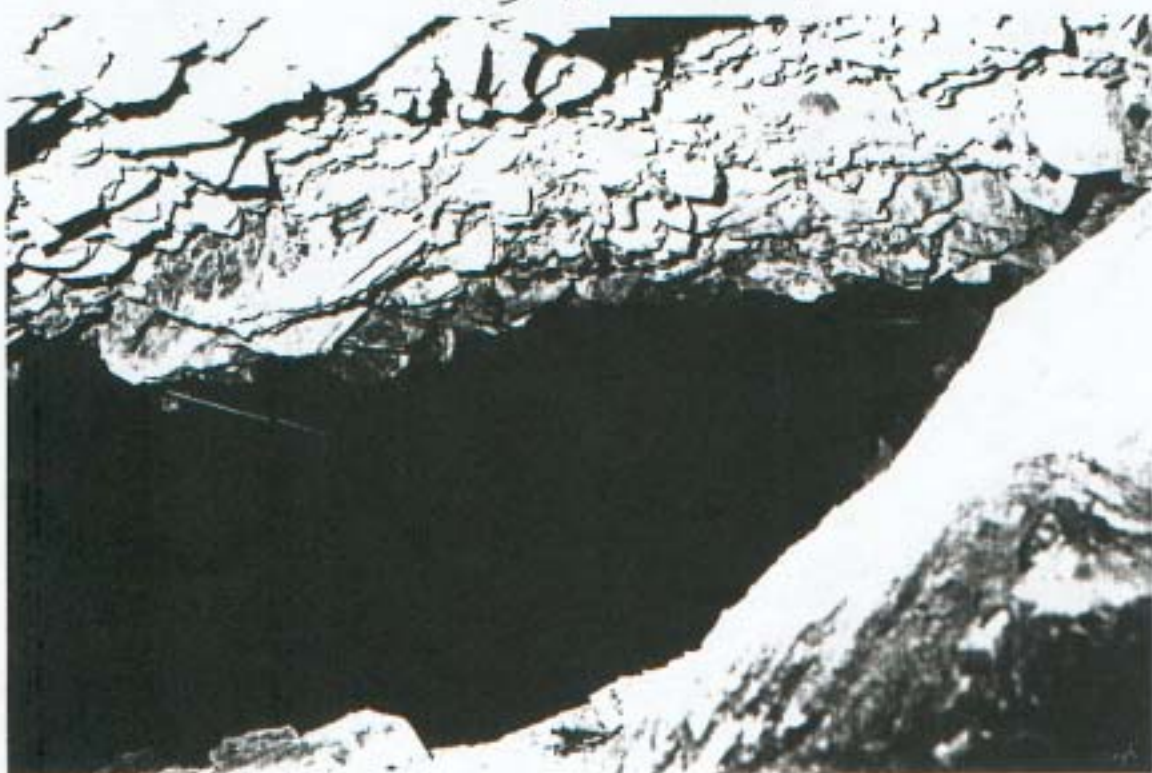
The roof fall material was cleaned up and the conveyor was then run. The height of the cavity formed by the fallen roof was estimated as being approximately 18 to 20 metres from the seam floor level. Above the powered roof supports (chocks) the fallen stone was broken and laying on the chocks at a 45° angle of repose. Due to the friability of the roof strata and coal adjacent to the dyke, the material had 'fretted' away to the extent that the distance between the coal face and the front extension roof support bar of the chock was 3.5 metres (See figure 1). Attempts were made to

View Looking into Cavity Showing Extent
of Roof Fall.
Location 7 Face

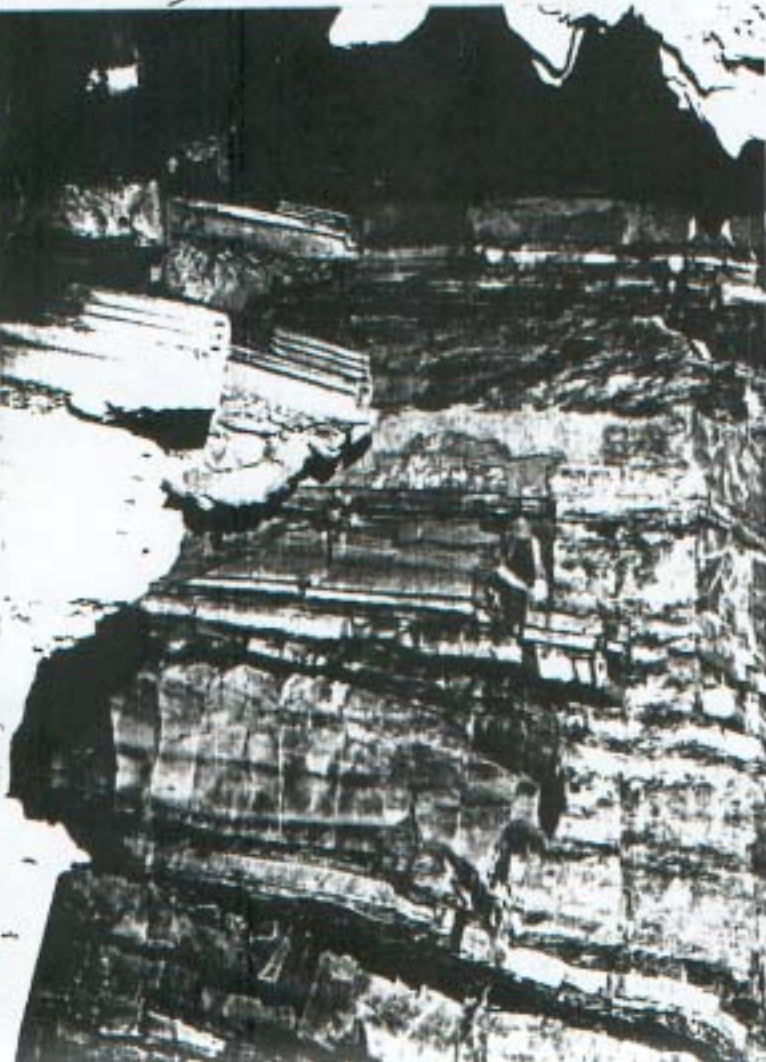
Location 7 Coal Face
View Looking Towards Tail Gate
Showing Fracture Roof Strata and
Structure

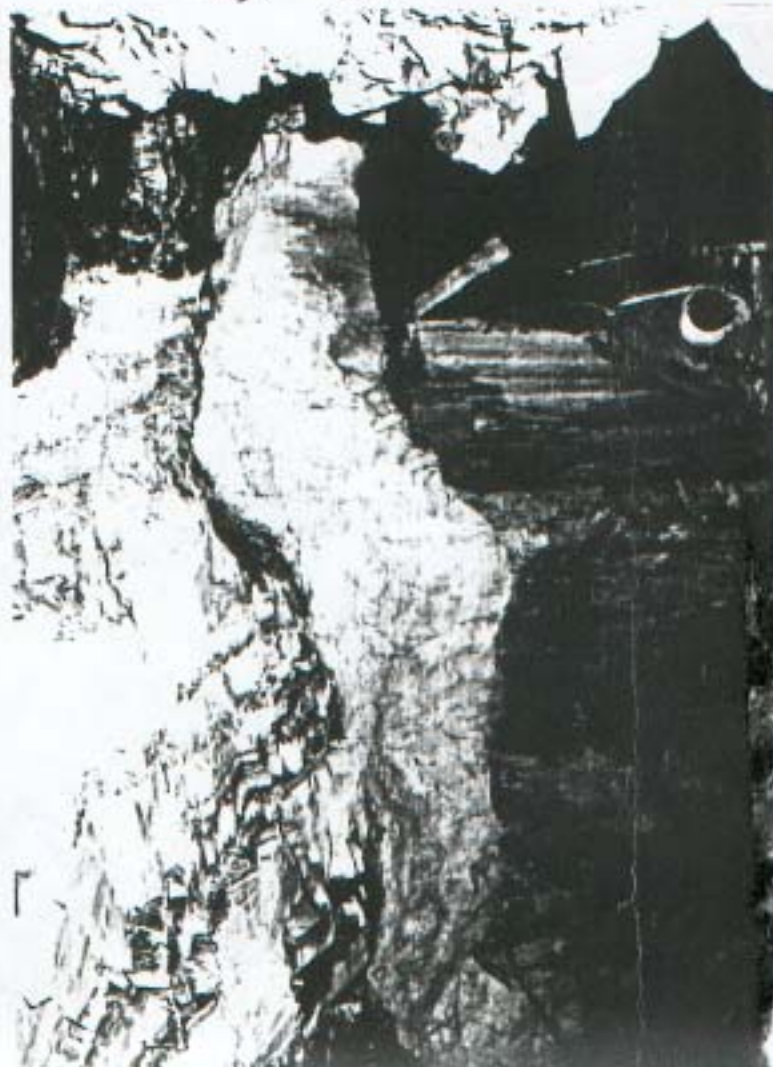
Location 7 Coal Face
View Looking Towards Main Gate Showing
Dike Intrusion into Coal Seam and Roof
Structure

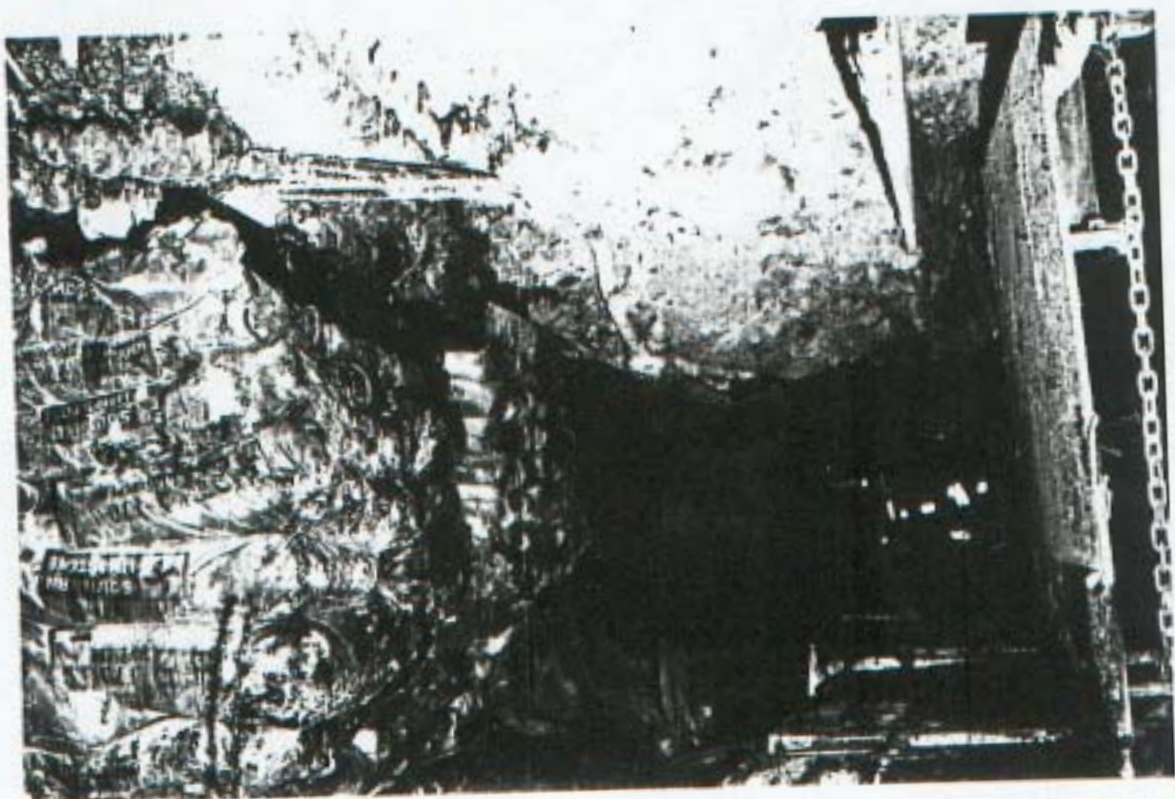
PHOTOGRAPH 4

Showing METHOD USED TO ERECT

STAKEPOST WALL BY USE OF BACKS OF STAKEPOST

ON WOOD PALLET

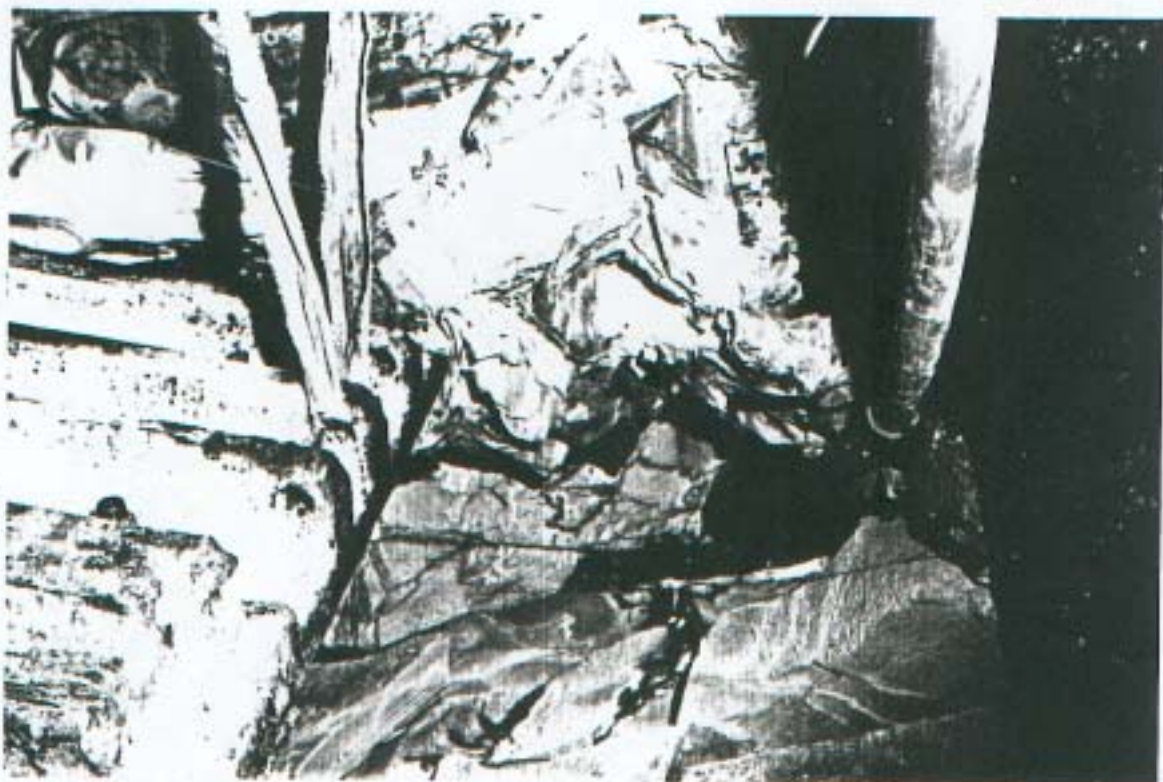
On arrival at the site it was observed the stone dust bag wall built on the coal face side of the conveyor from the floor to the underside of the chock beams (Photograph 1). At the upper left hand corner of the wall was a hole which had afforded observation into the cavity and the inside of the stonedust wall. Due to fallen roof stone very little could be seen except the roof of the cavity (Photograph 2).

View of Observation (Peg) Hole into
Cavity - Fallen Roof Stone Obscured
Clear View of Polyurethane Block

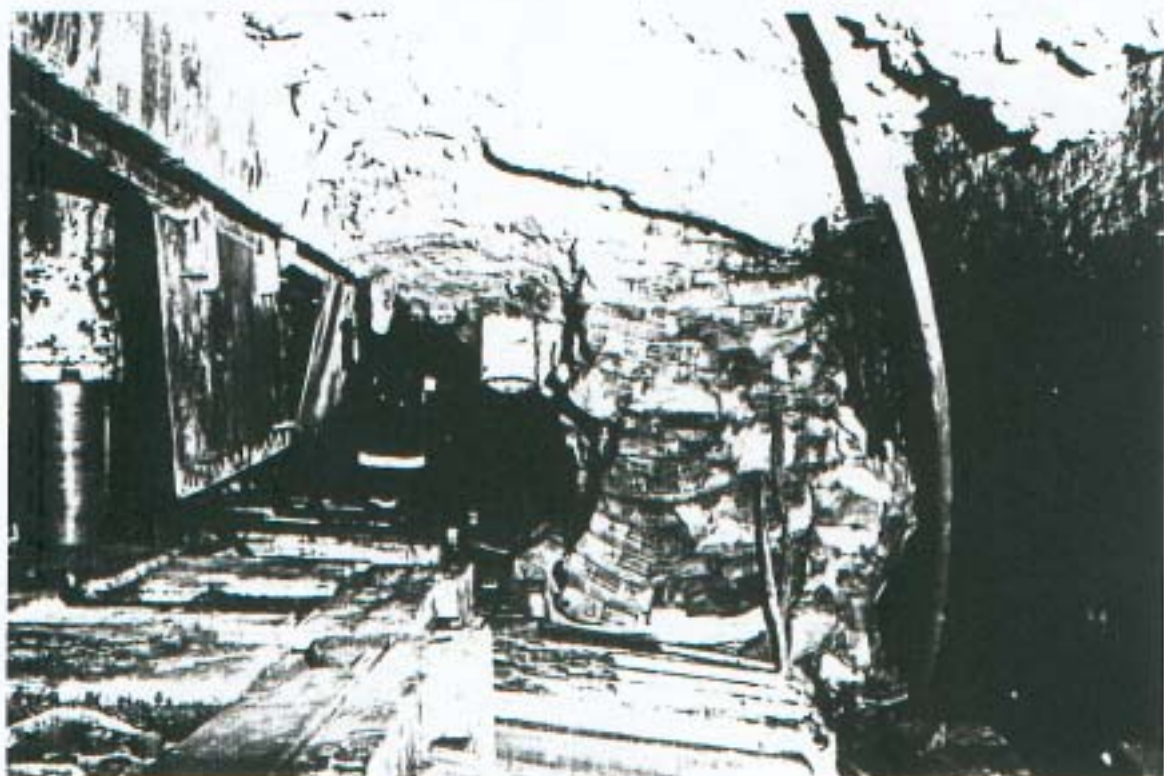
View of Stalagmite Bag Wall
When Approaching from Main Gate

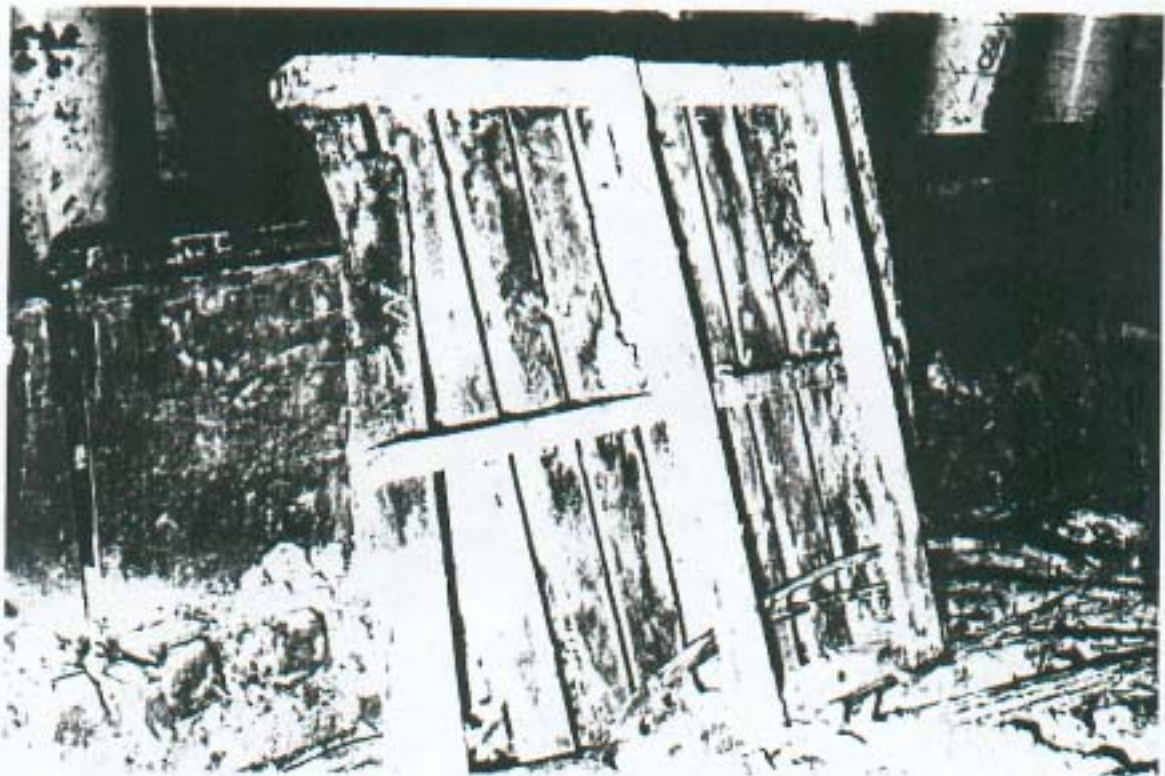
3

SHOWS EXTENT OF BURNING OF WOOD PALLETS

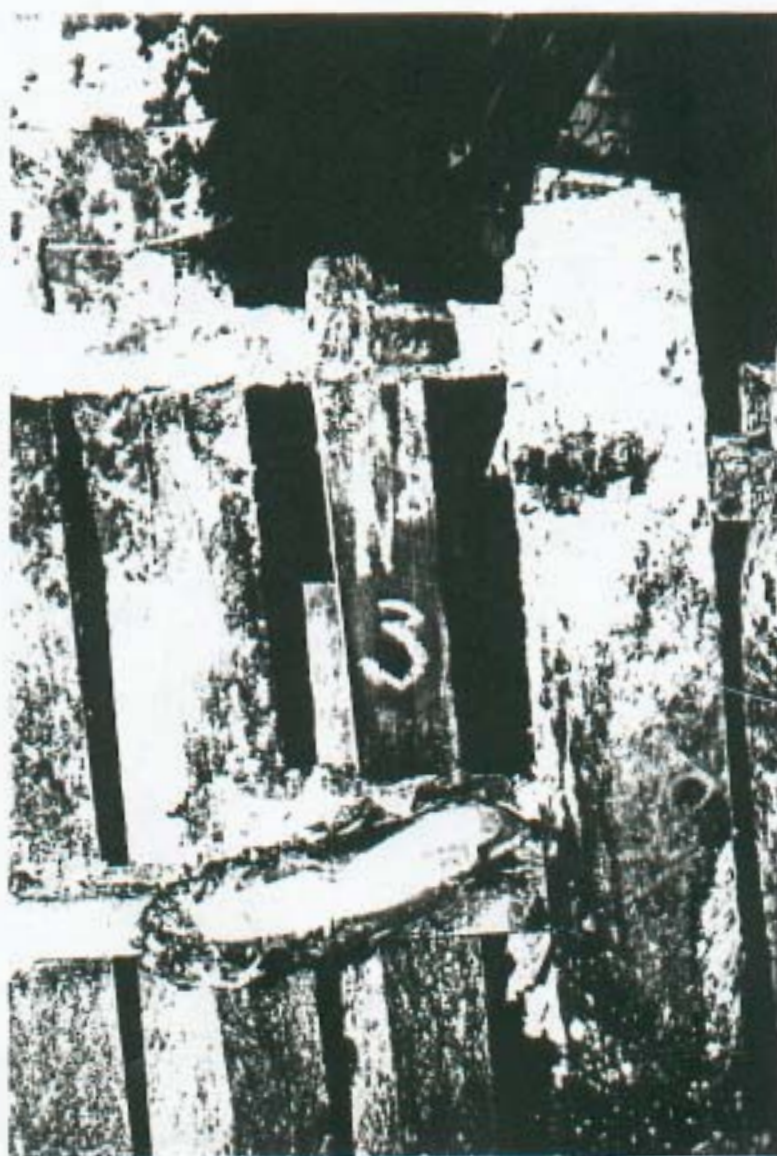
SHOWS BURNT WOOD PALLET AND STONEDUST
BAG PAPER

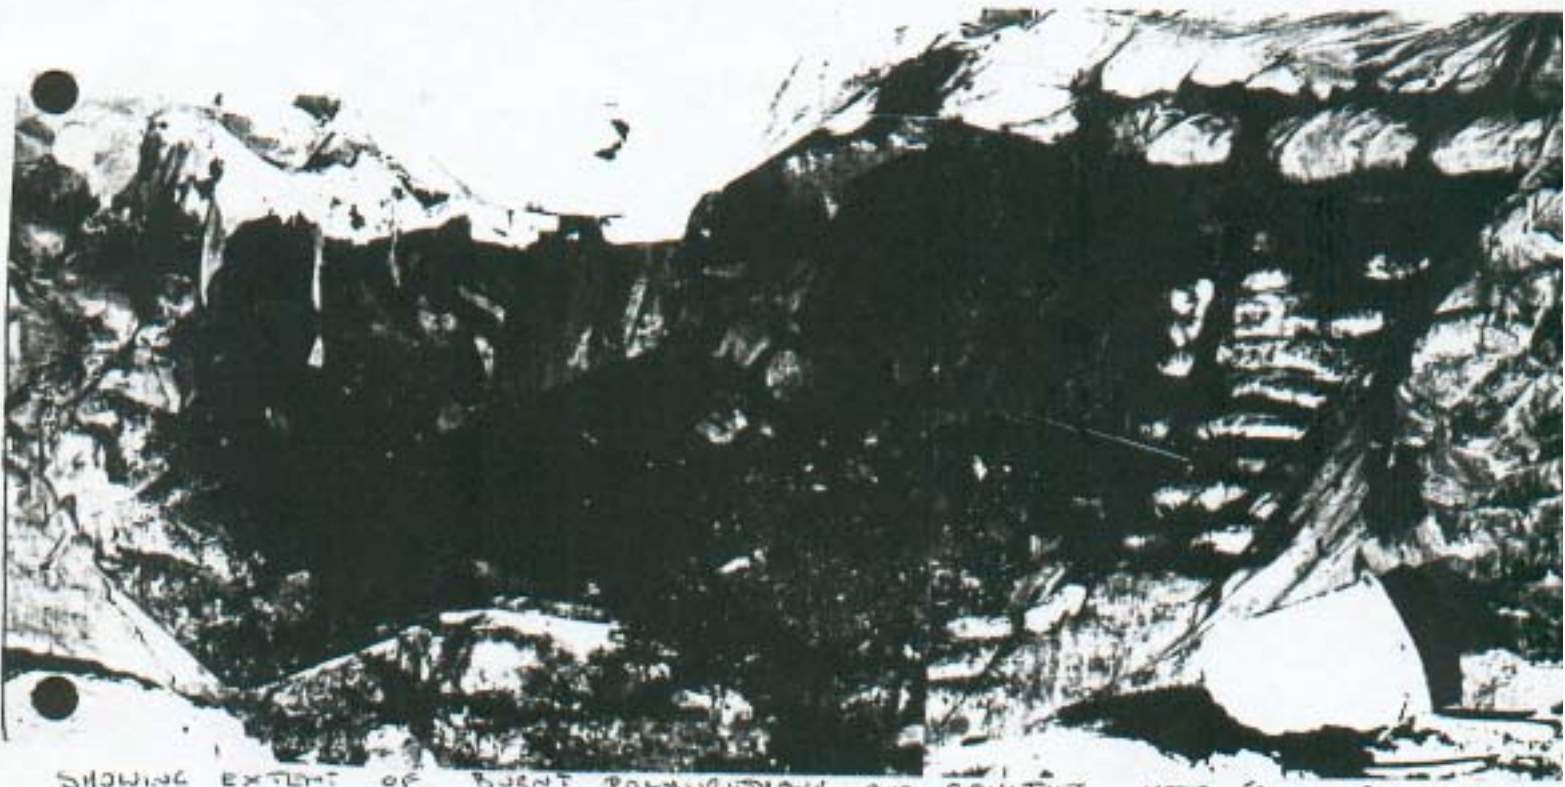
7

Opposite Chocks 86-87-88 the stonedust bag wall had been demolished and the burnt polyurethane was exposed (Photographs 7-10). At the extremities of the cavity exposed was evidence of the brattice cloth lining having been subject to intense heat which melted the brattice adhering it to the stonedust bag wall. A closer inspection of the polyurethane showed cavities of varying sizes in which there was evidence of burning whilst parts of the urethane were in a cindered or ash condition (Photograph 11-12). Also penetrating through the polyurethane were large pieces of roof stone which appeared to have fallen after the placement of the polyurethane and had punctured the shell of the urethane block. (Photograph 13).

VIEW LOOKING TOWARDS MAIN GATE END OF STONE DUST WALL

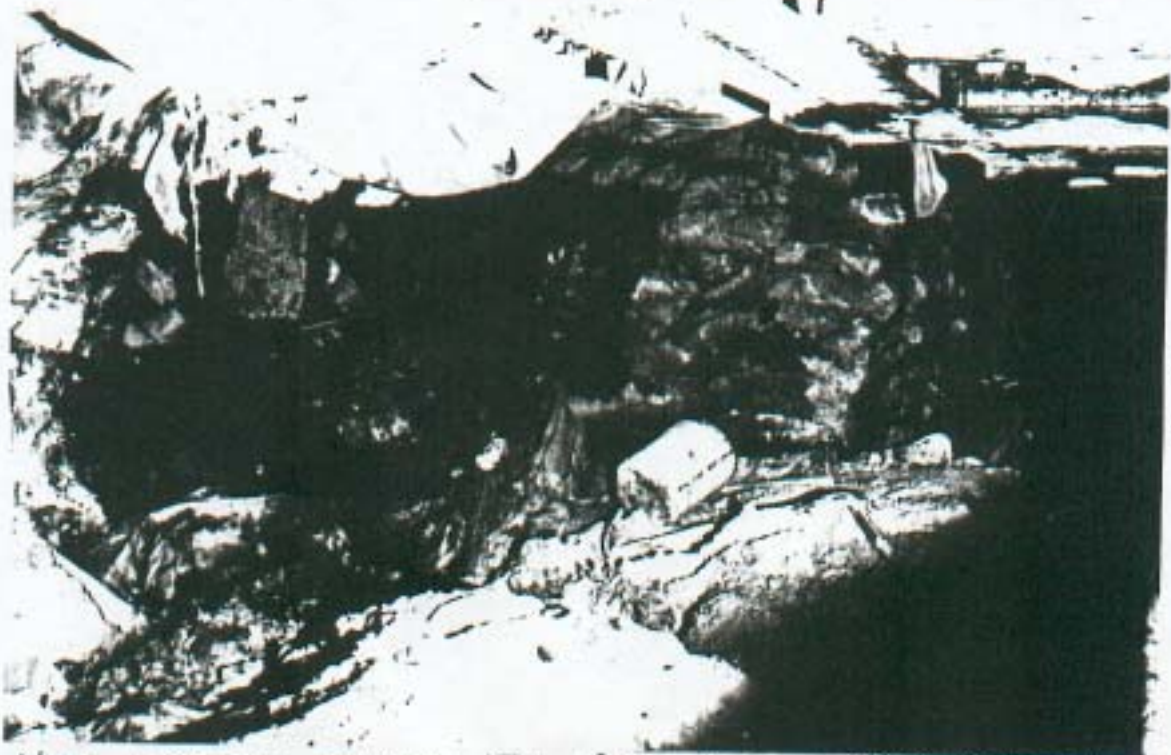
SHOWING EXTENT OF BURNT POLYURETHANE AND CAVITIES - NOTE FALLEN ROOF STONE

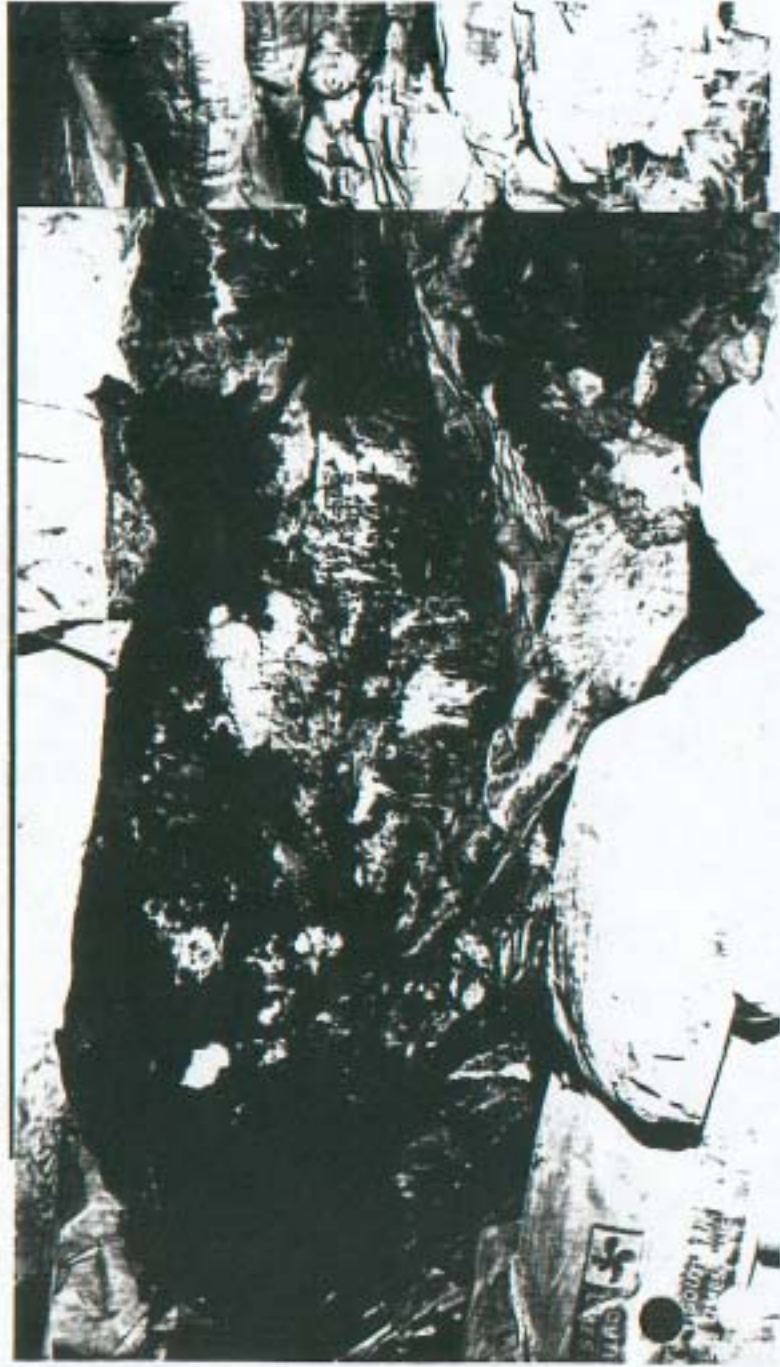
10

VIEW LOOKING TOWARDS TAIL GATE END OF STONE DUST WALL

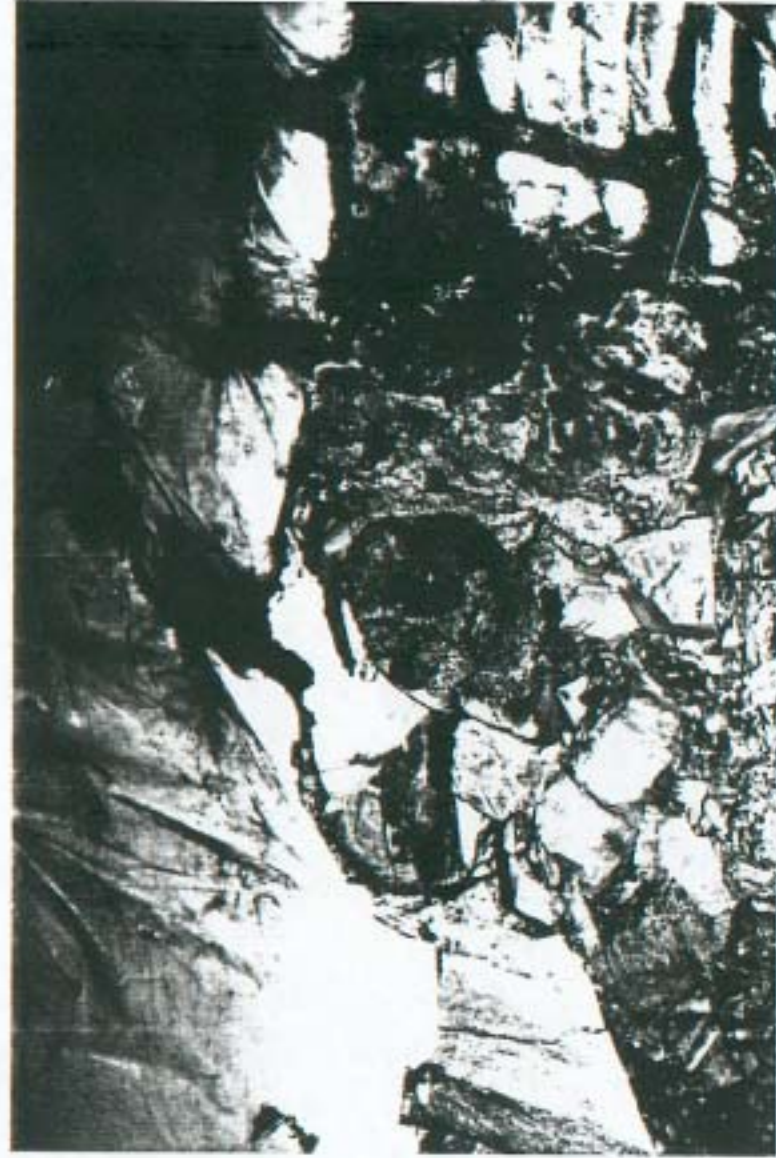
11

SHOWS CAVITIES IN URETHANE CAUSED BY OUTBURSTING
OF FILL - NOT STONECAST IN MIDDLE OF
CHUNKED POLYURETHANE

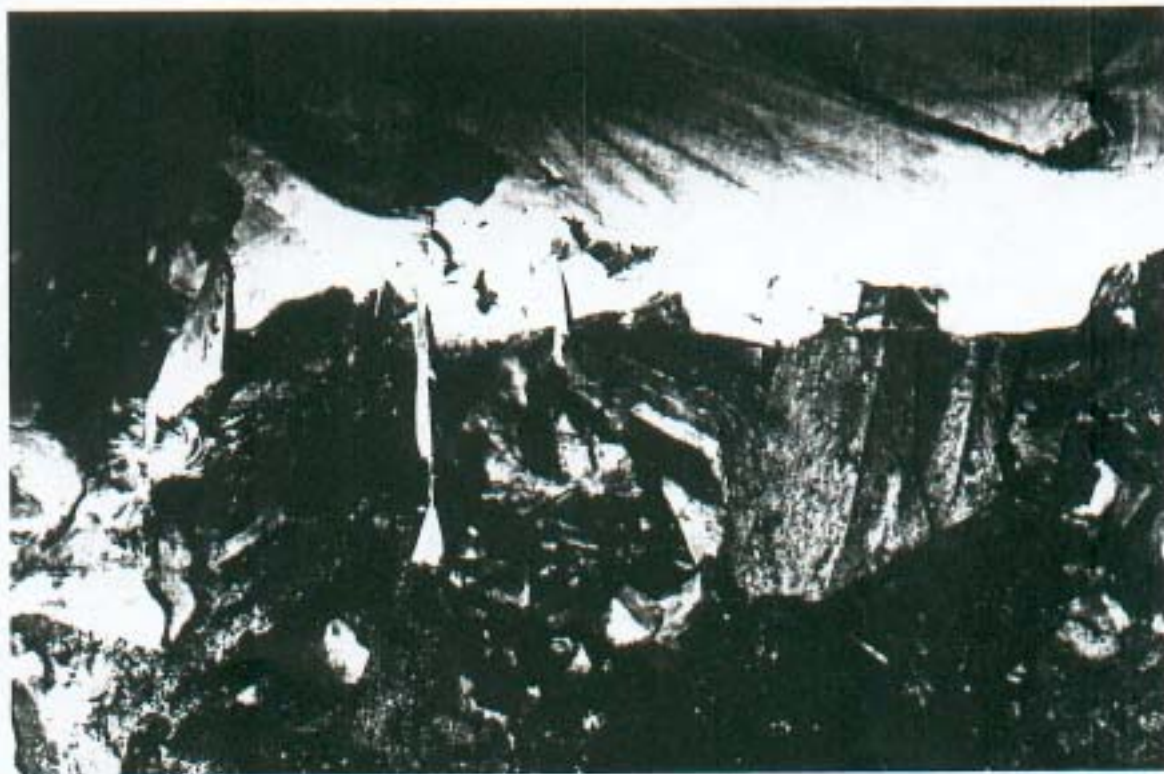
12

SHOWS BASE: AND CHUNKED POLYURETHANE AND
RIGHT OF PHOTO CENTRE UNIT: CENTRE
PICTURE SHOWS URETHANE AND PORT STONE

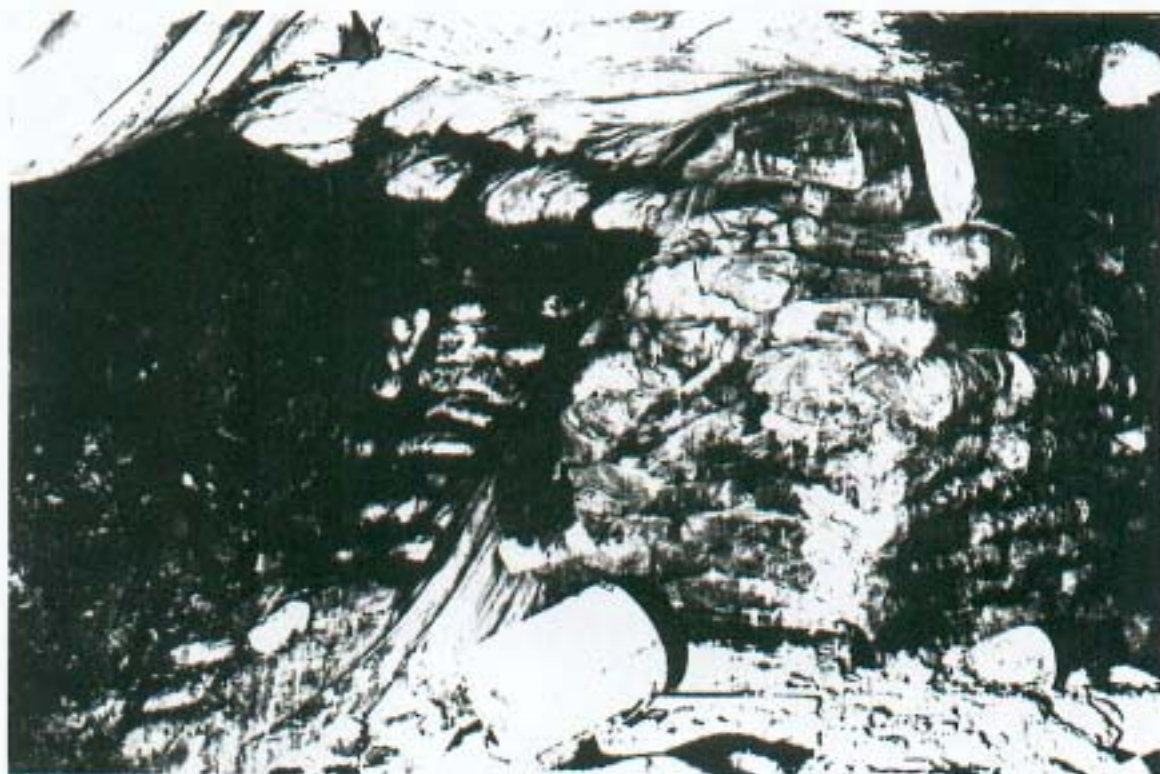
13

Fallen Roof Stone Protruding Through
Polyurethane Block

A further inspection of the burnt area of the polyurethane plug showed that large pieces of roof stone had fallen and penetrated the polyurethane plug. The rock extended into the first pumped block and was adjacent to the brattice and the position of the wood pallets.

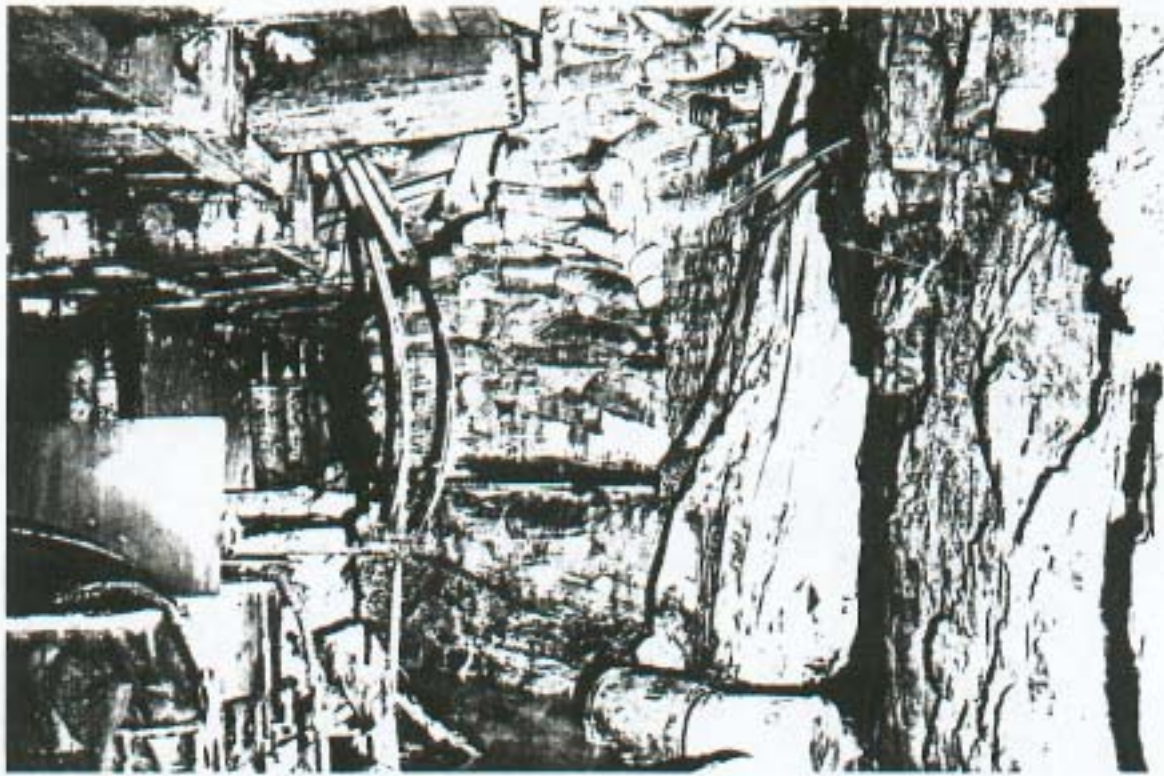
14

Show Position of Wood Pallets
Within Stone Dust Wall

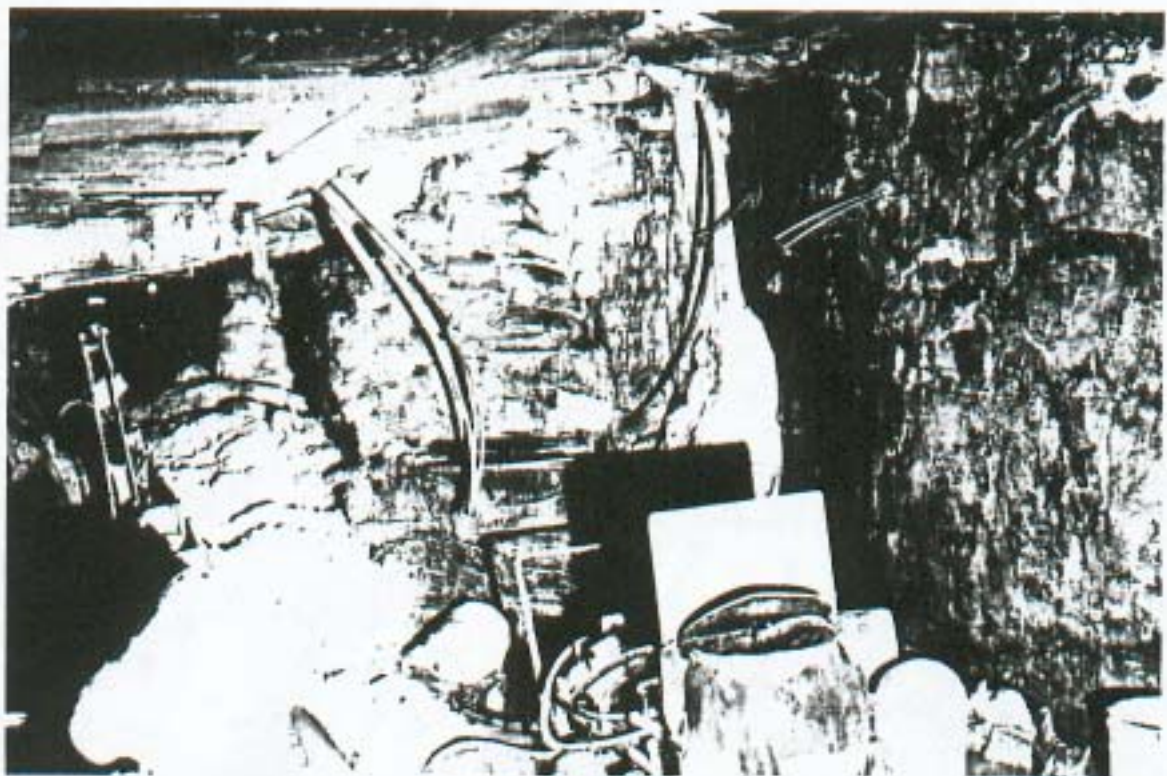
15

SHOWS SYSTEM USED TO INJECT POLYURETHANE

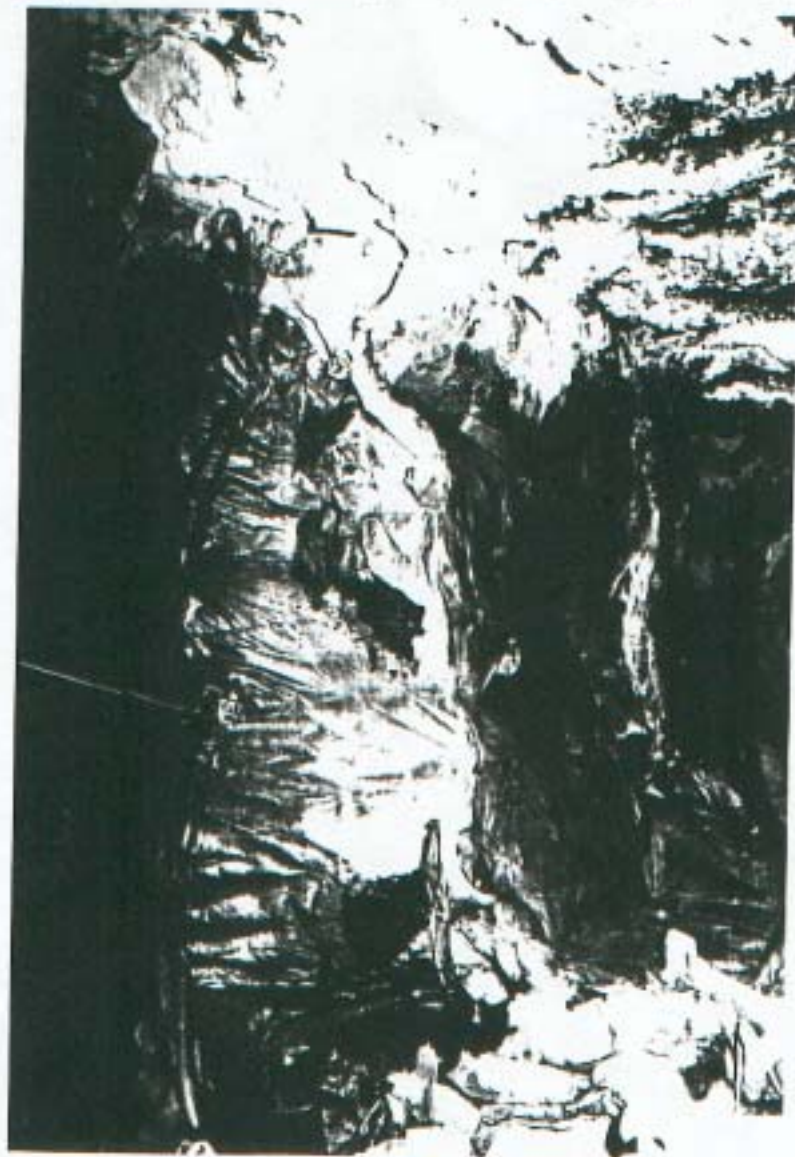
On completion of the initial investigation the wall around the polyurethane was dismantled and Photographs 17 and 18 were taken looking from the tailgate towards the maingate. These show the extent of the polyurethane wall which had been affected by the self ignition caused by the exothermic reaction within the polyurethane. Despite this incident it did appear that the intent of the trial to form a false roof for the protection of workmen was successful.

Shows tail end of polyesthane wall
with cavities formed when burning occurred

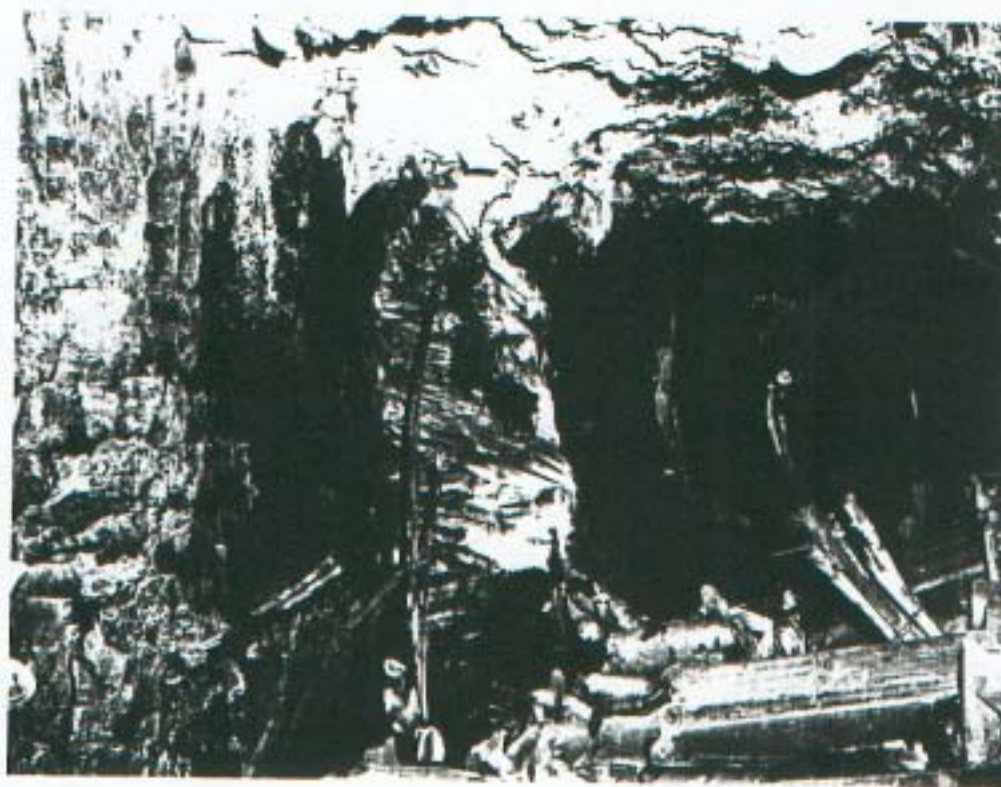
17

Shows extent of polyesthane wall
Affected by fire - view from tail gate

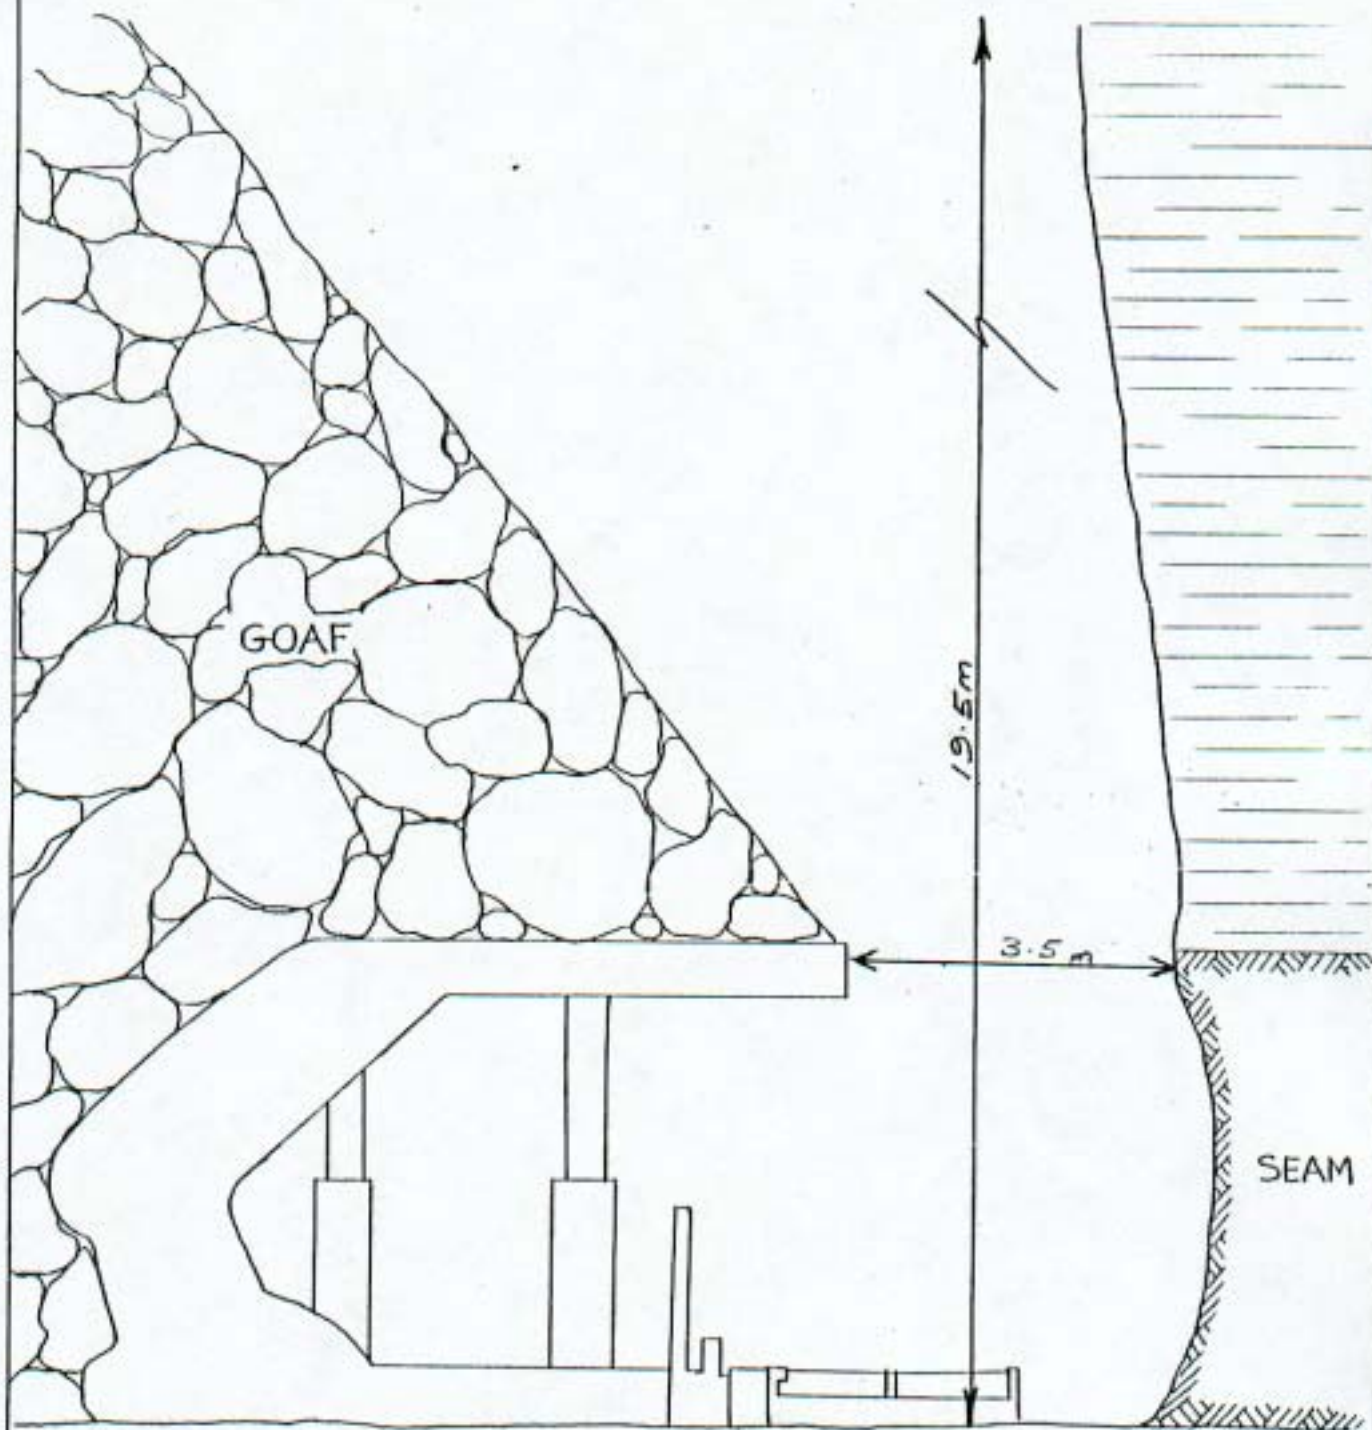
FIGURE 1

SKETCH SHOWING FALL IN L.W.7 FACE.

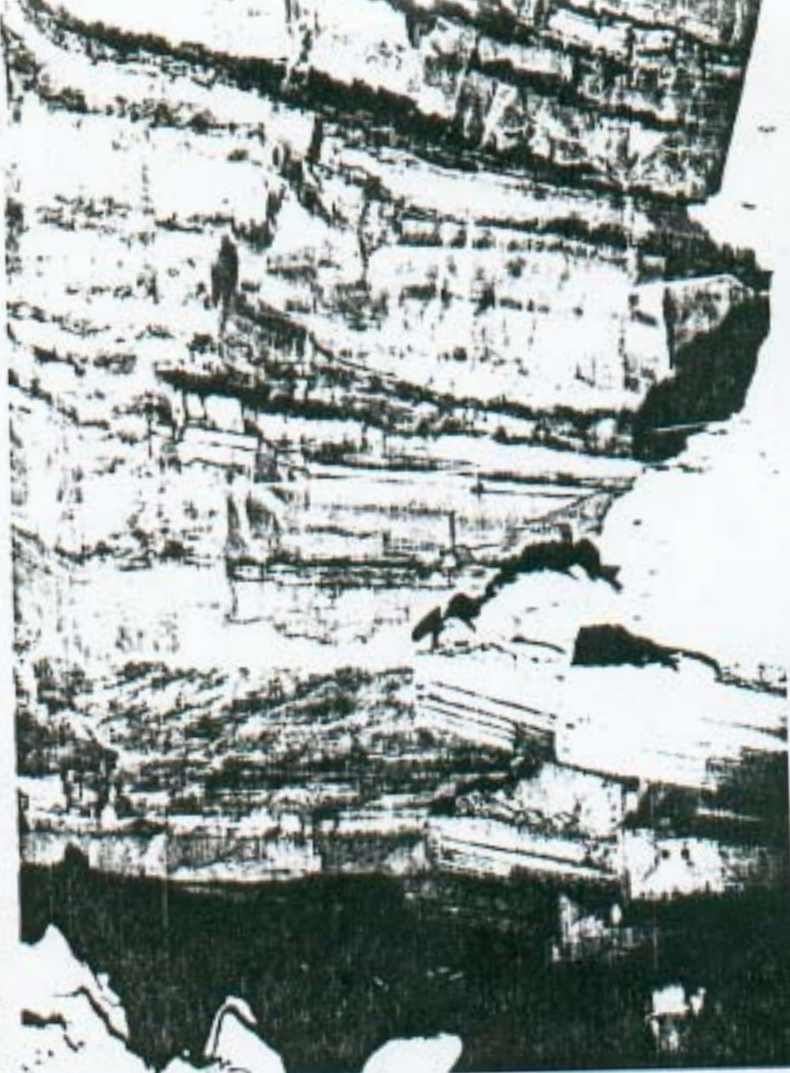
LONGWALL 7 COAL FACE

VIEW LOOKING TOWARDS TAIL GATE SHOWING
SKEW INTRODUCTION INTO COAL SEAM AND ROOF
STRUCTURE

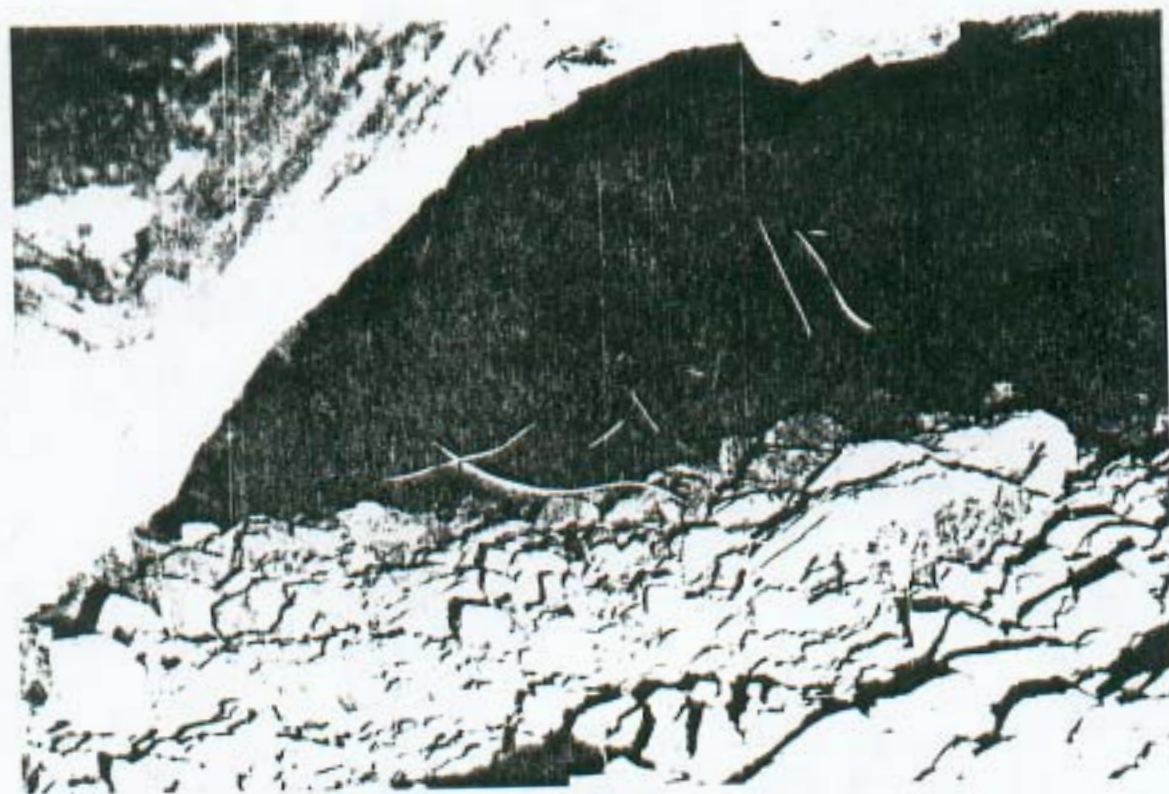
LONGWALL 7 COAL FACE

VIEW LOOKING TOWARDS TAIL GATE
SHOWING FRAGILE ROOF STRATA AND
STRUCTURE
