Section 89. Coal Mines Regulation Act, 1982.

Report of an investigation into the Notification of a Dangerous Occurrence.

A Fire Occurred on Longwall 7 Coalface at 12-45 a.m. on 13th December, 1986, when a block of polyurethane foam being used to fill a roof cavity self ignited.

WEST CLIFF MINE -

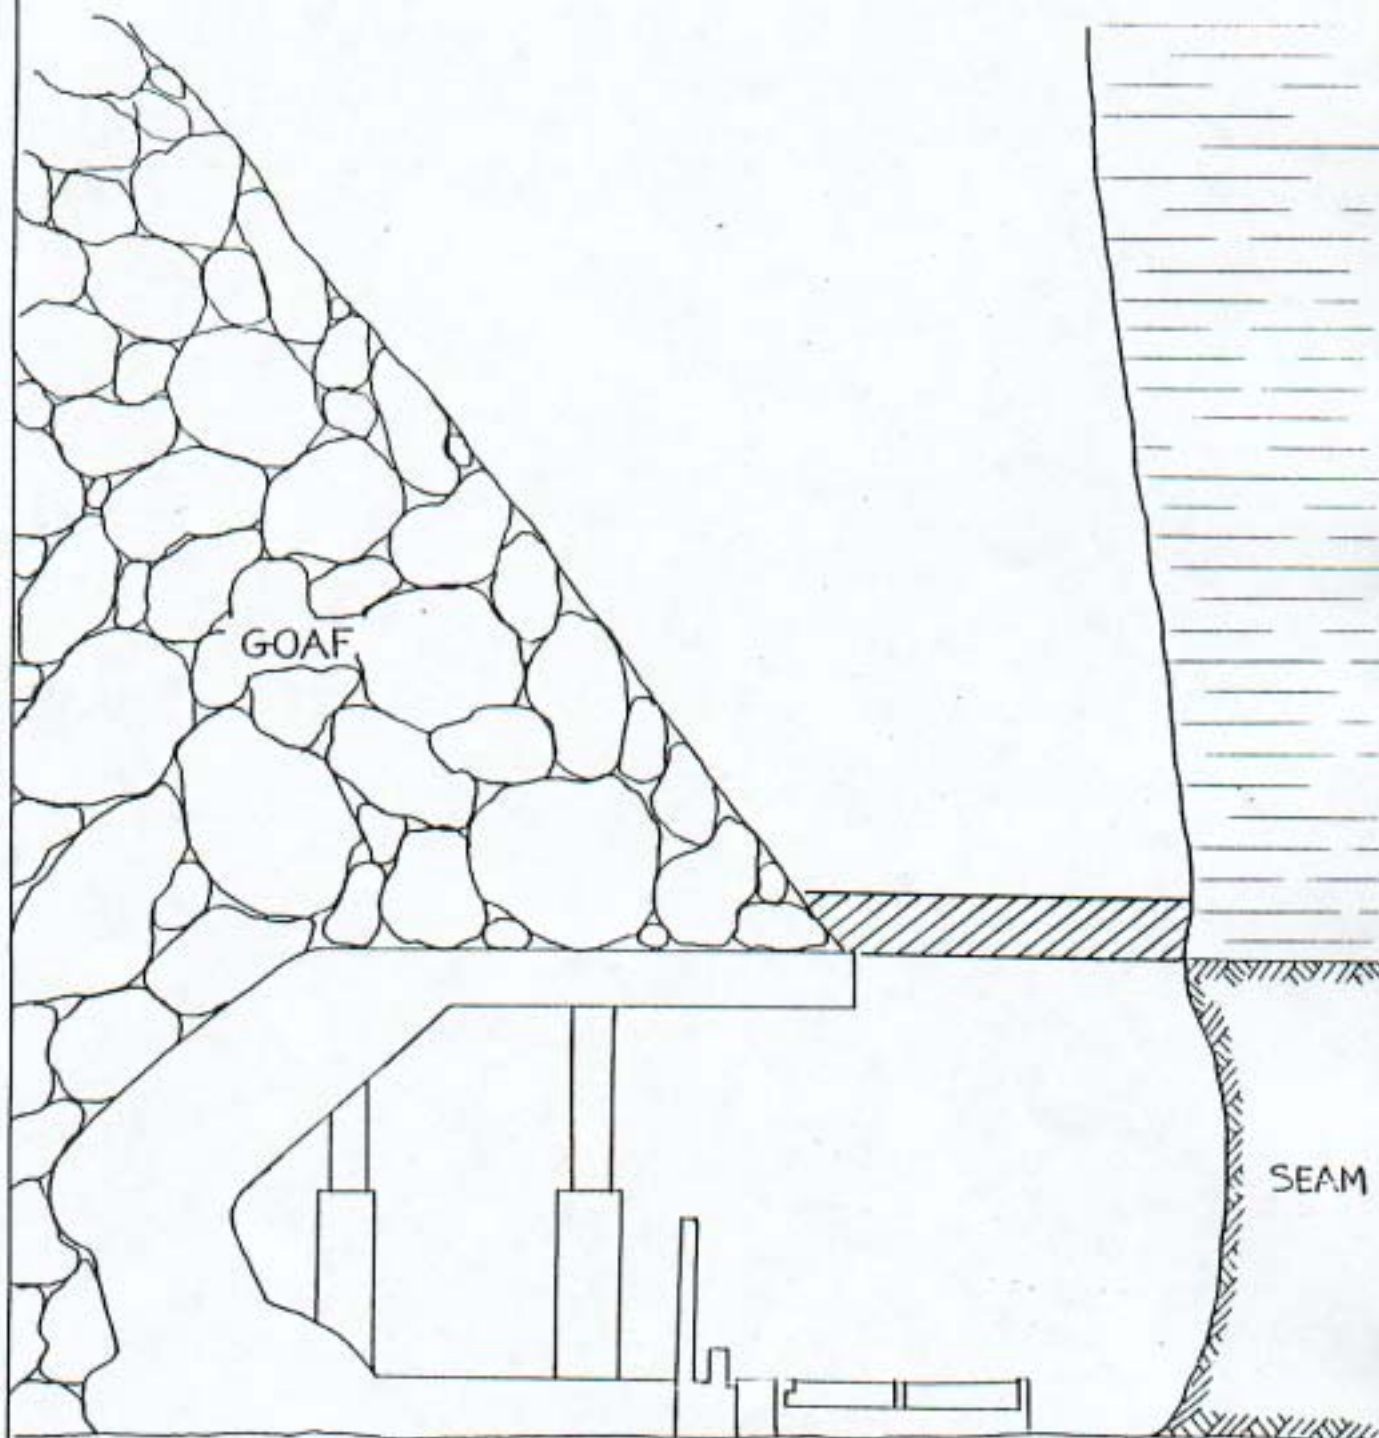
FIGURE 2.

SKETCH SHOWING PROPOSED FALSE ROOF

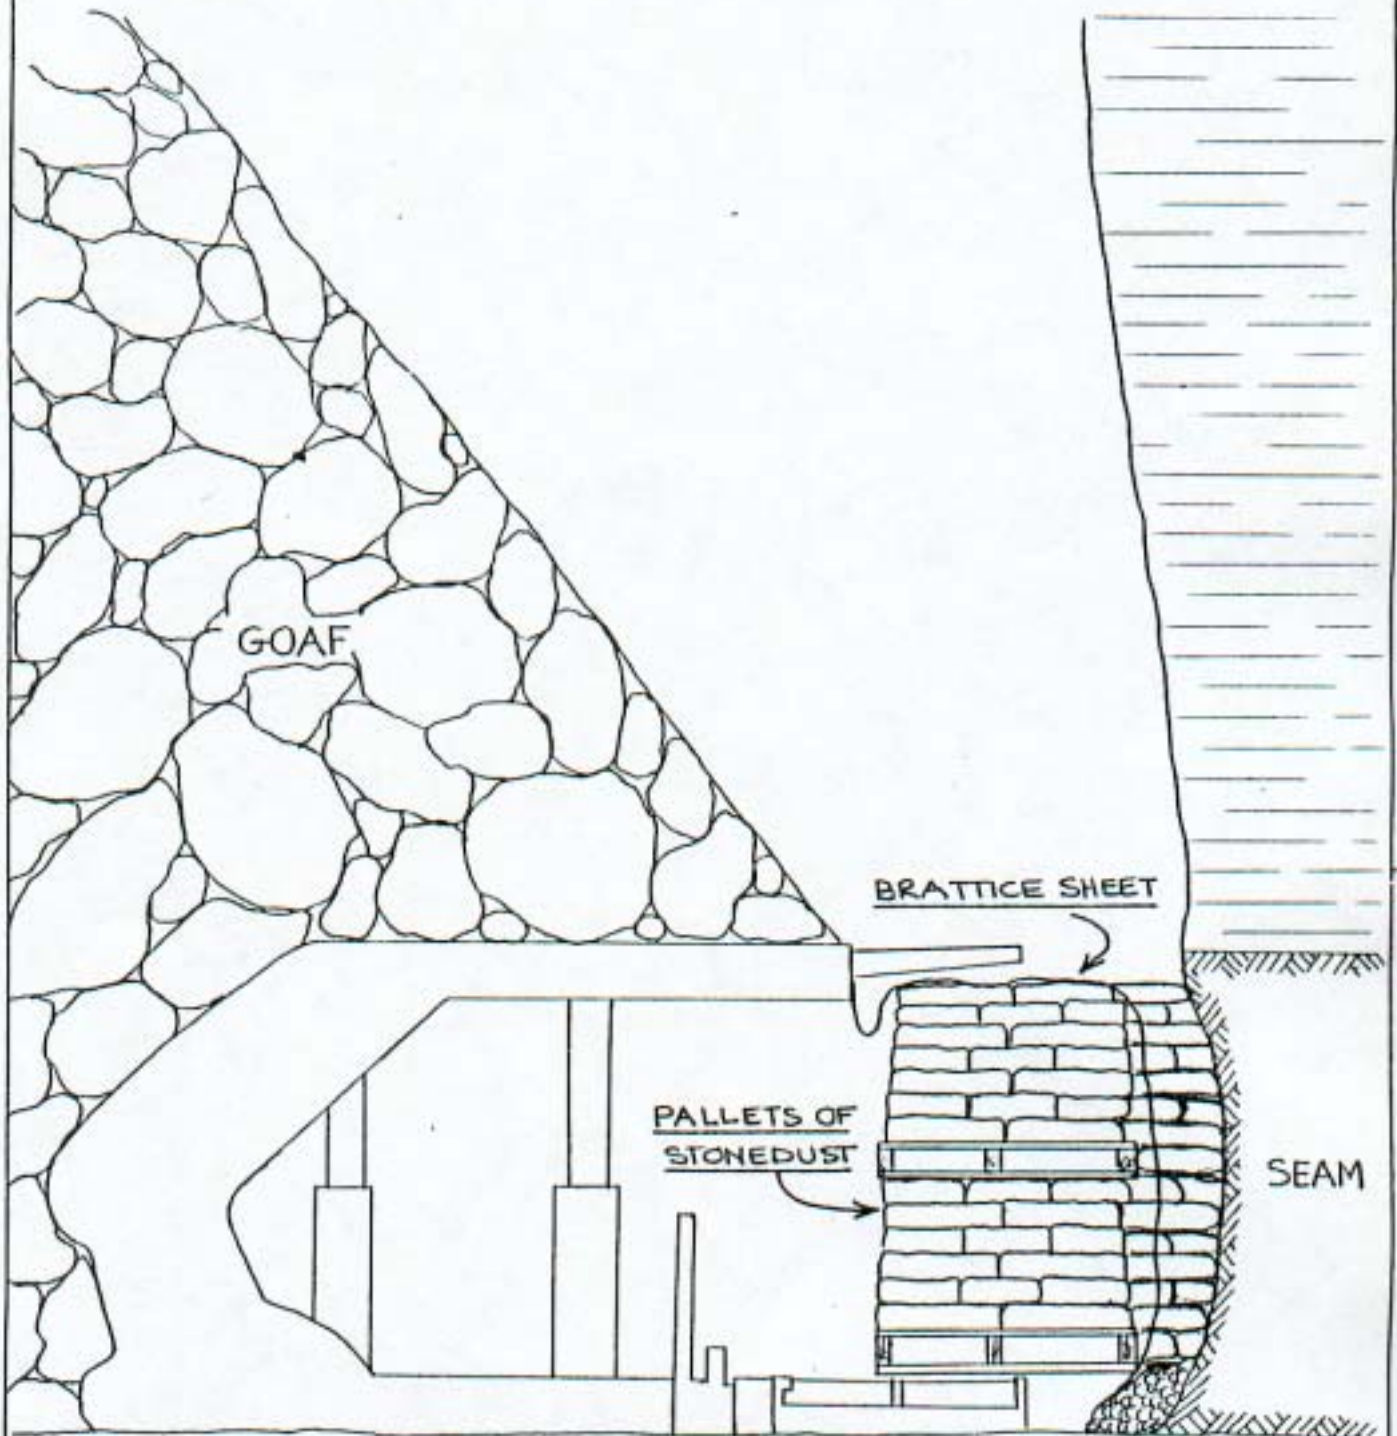
FIGURE 4.

This advice was discussed at the management meeting and it was decided on advice received to form a plug of polyurethane material to make an artificial roof. To contain the polyurethane which was primarily in a fluid state and had to be pumped into the cavity, pallets containing bags of stonedust were placed to form a wall on three sides and underneath the chock beam on the coal face. These also formed a barrier between the face and the chocks. Brattice cloth was then draped down the inside wall of the stonedust bags thus sealing each end of the fall from floor level to the underside of the chock roof support beams (See Figure 4 and Photograph).

SKETCH SHOWING POSITION OF STONEDUST BAGS
AND BRATTICE SHEET PRIOR TO INSTALLATION OF
POLYURETHANE.

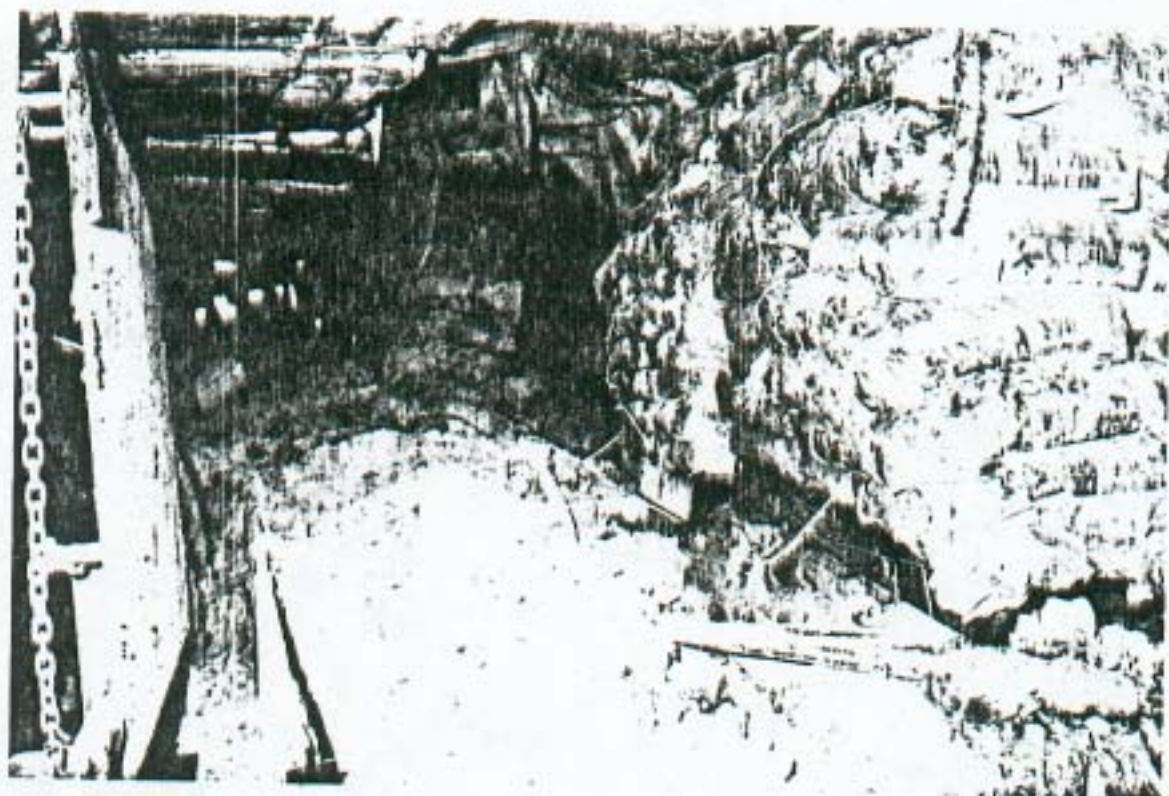
PHOTOGRAPH 4

SHOWING METHOD USED TO ERECT
STONE DUST WALL BY USE OF BAGS OF STONE DUST
ON WOOD PALLETS

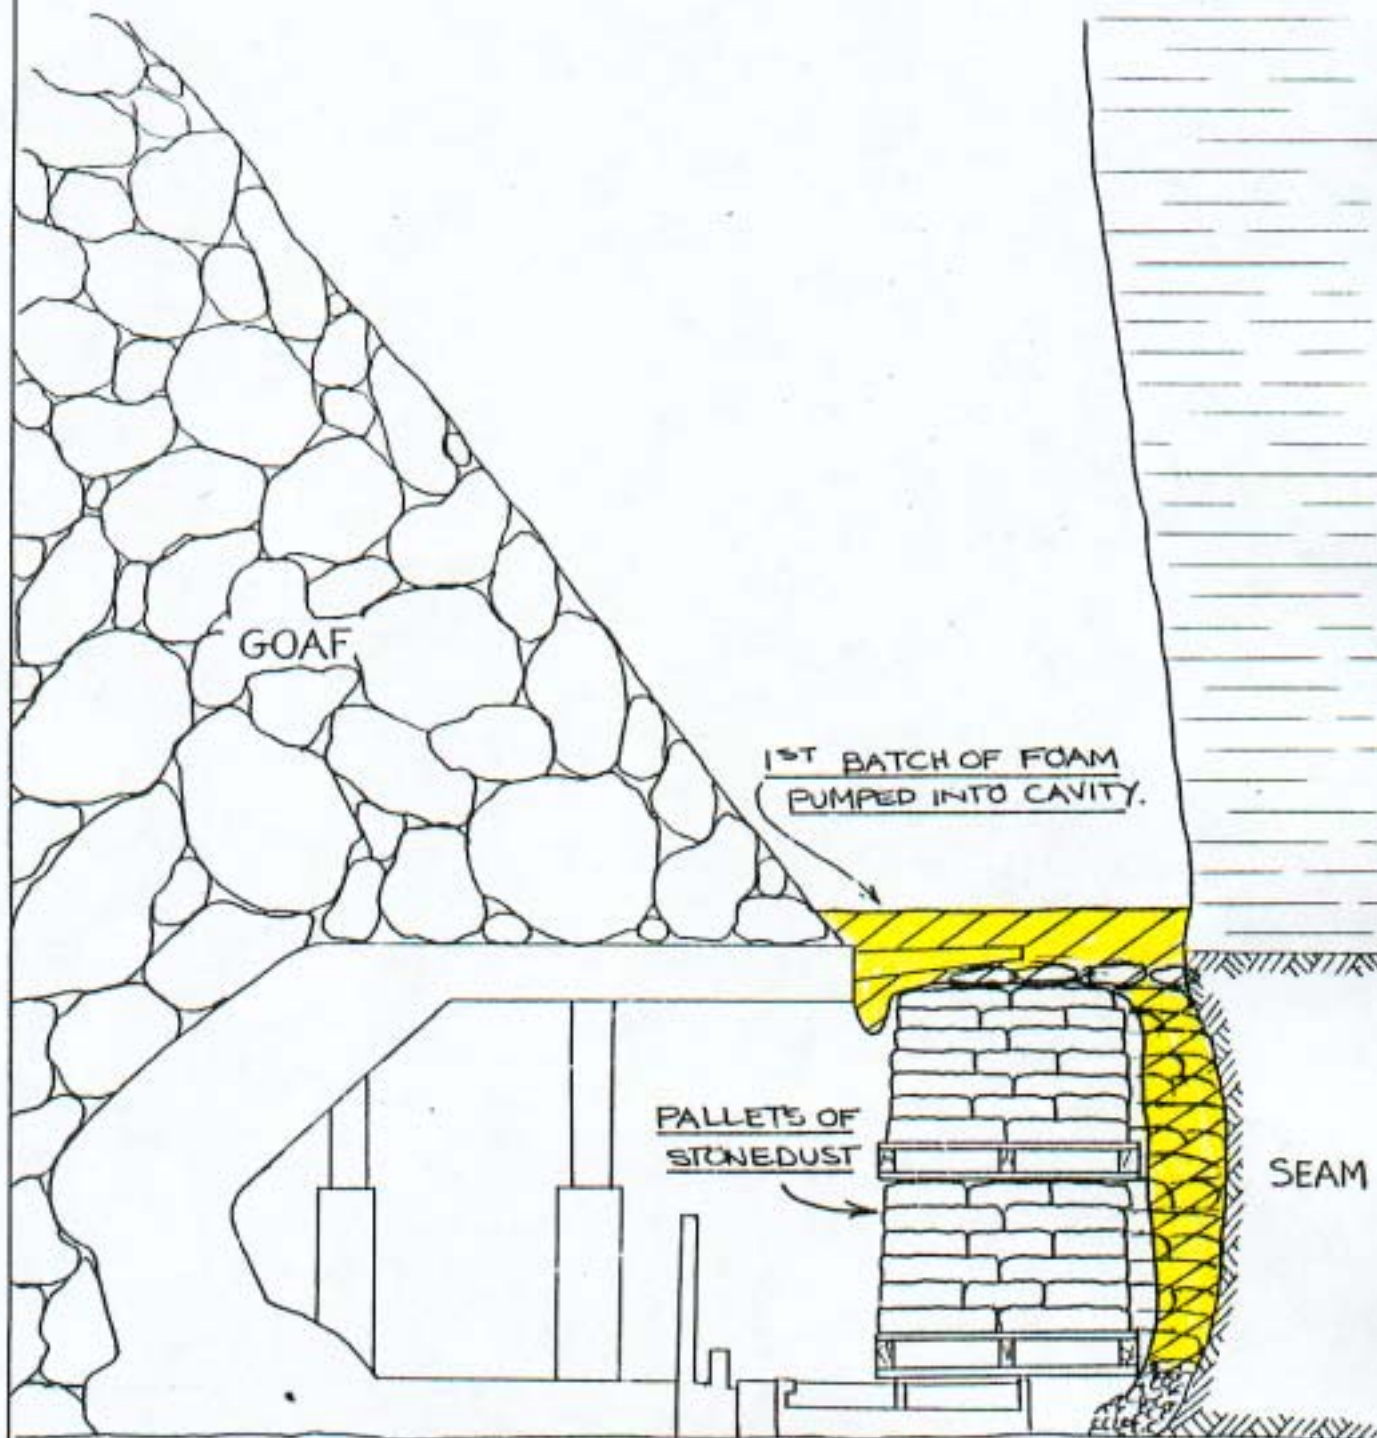
FIGURE 5.

SKETCH SHOWING FIRST BATCH OF FOAM
PUMPED INTO CAVITY.

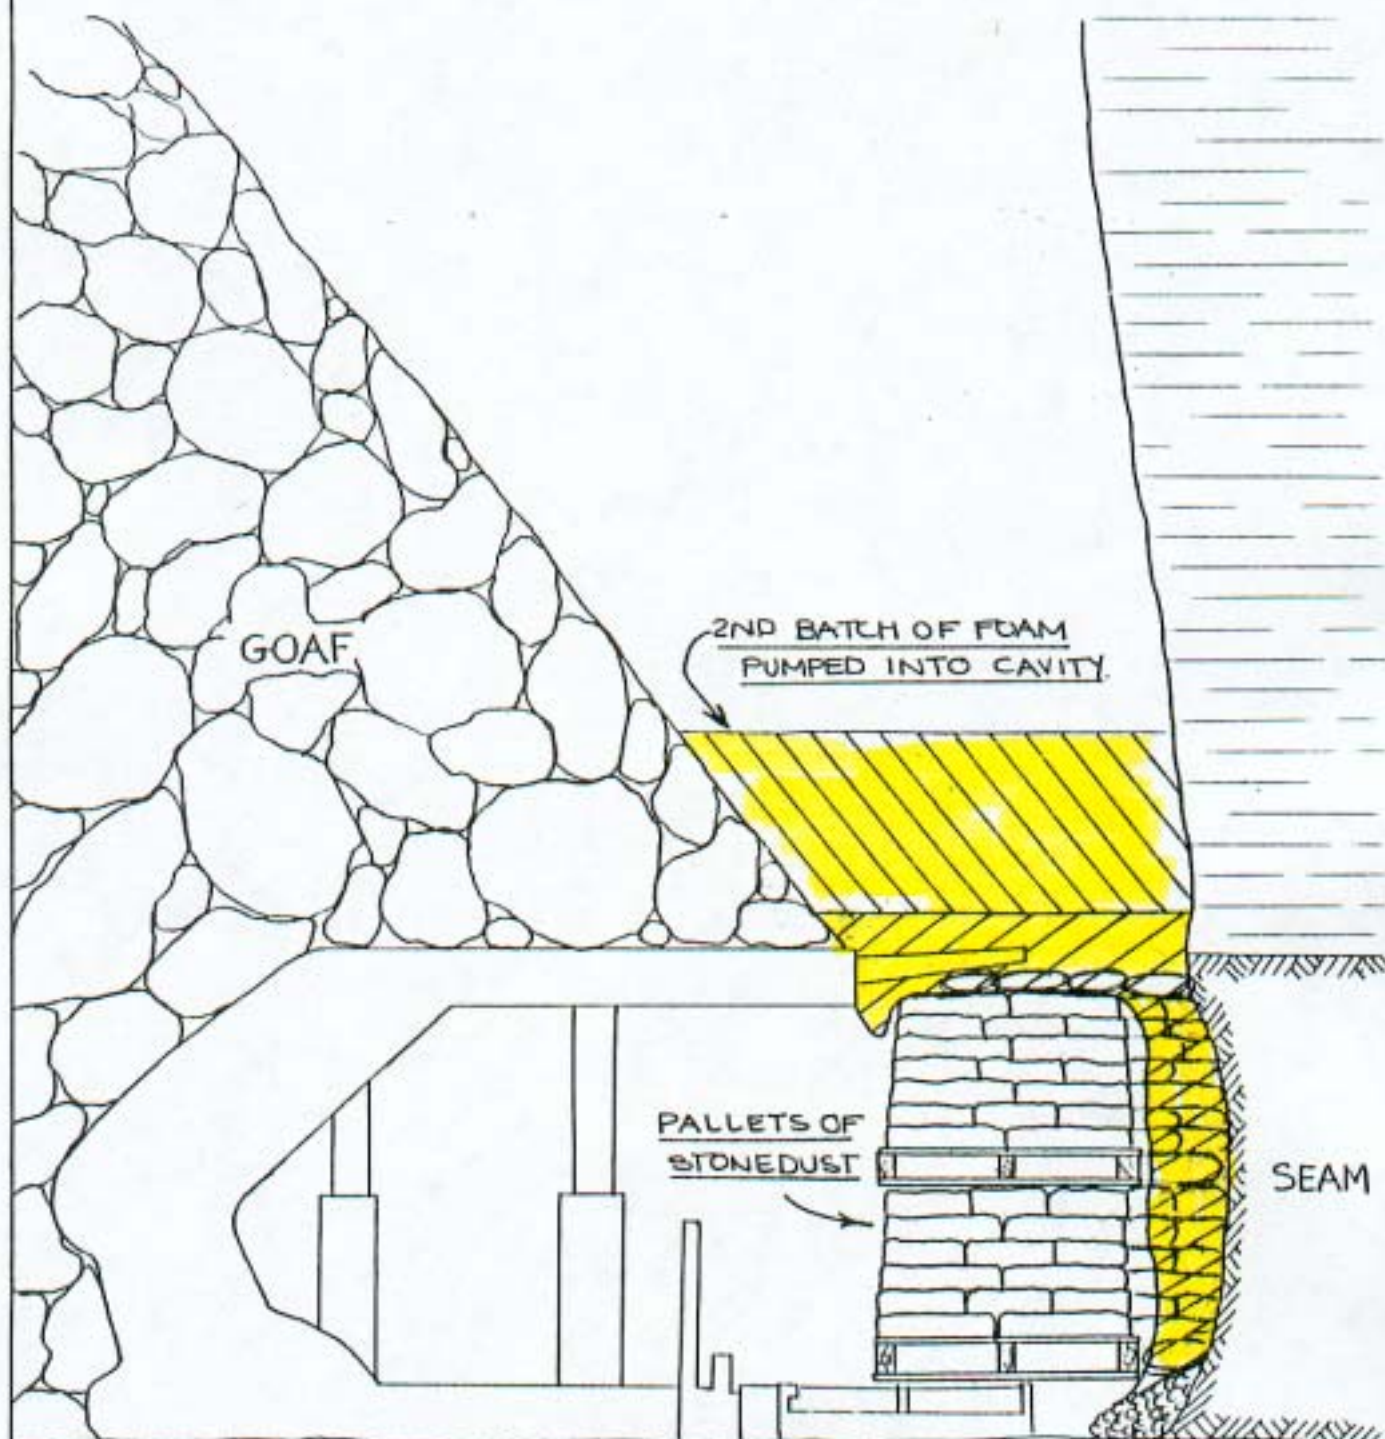
FIGURE 6.

SKETCH SHOWING SECOND BATCH OF FOAM
PUMPED INTO CAVITY,

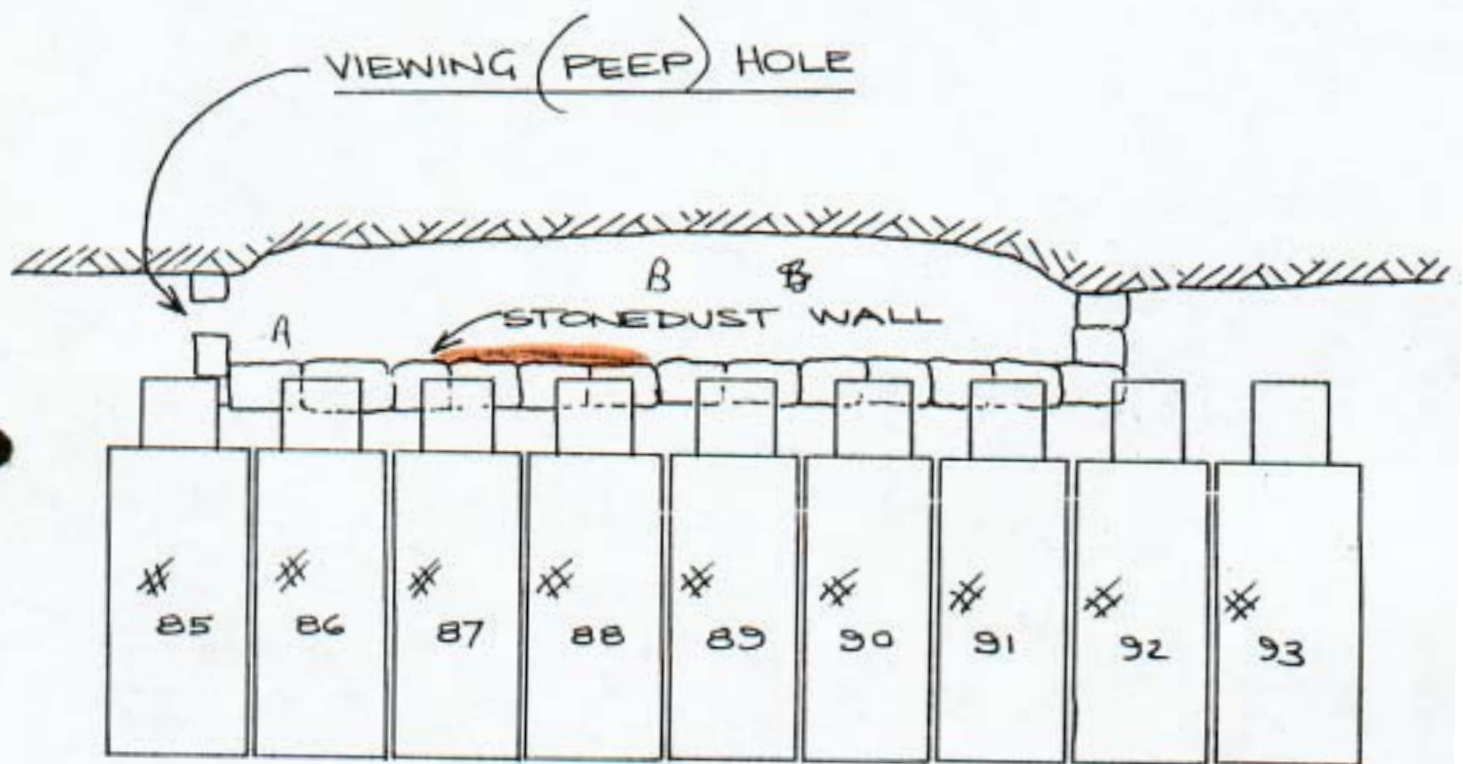
FIGURE 7

SKETCH SHOWING LOCALITY OF
VIEWING (PEEP) HOLE.

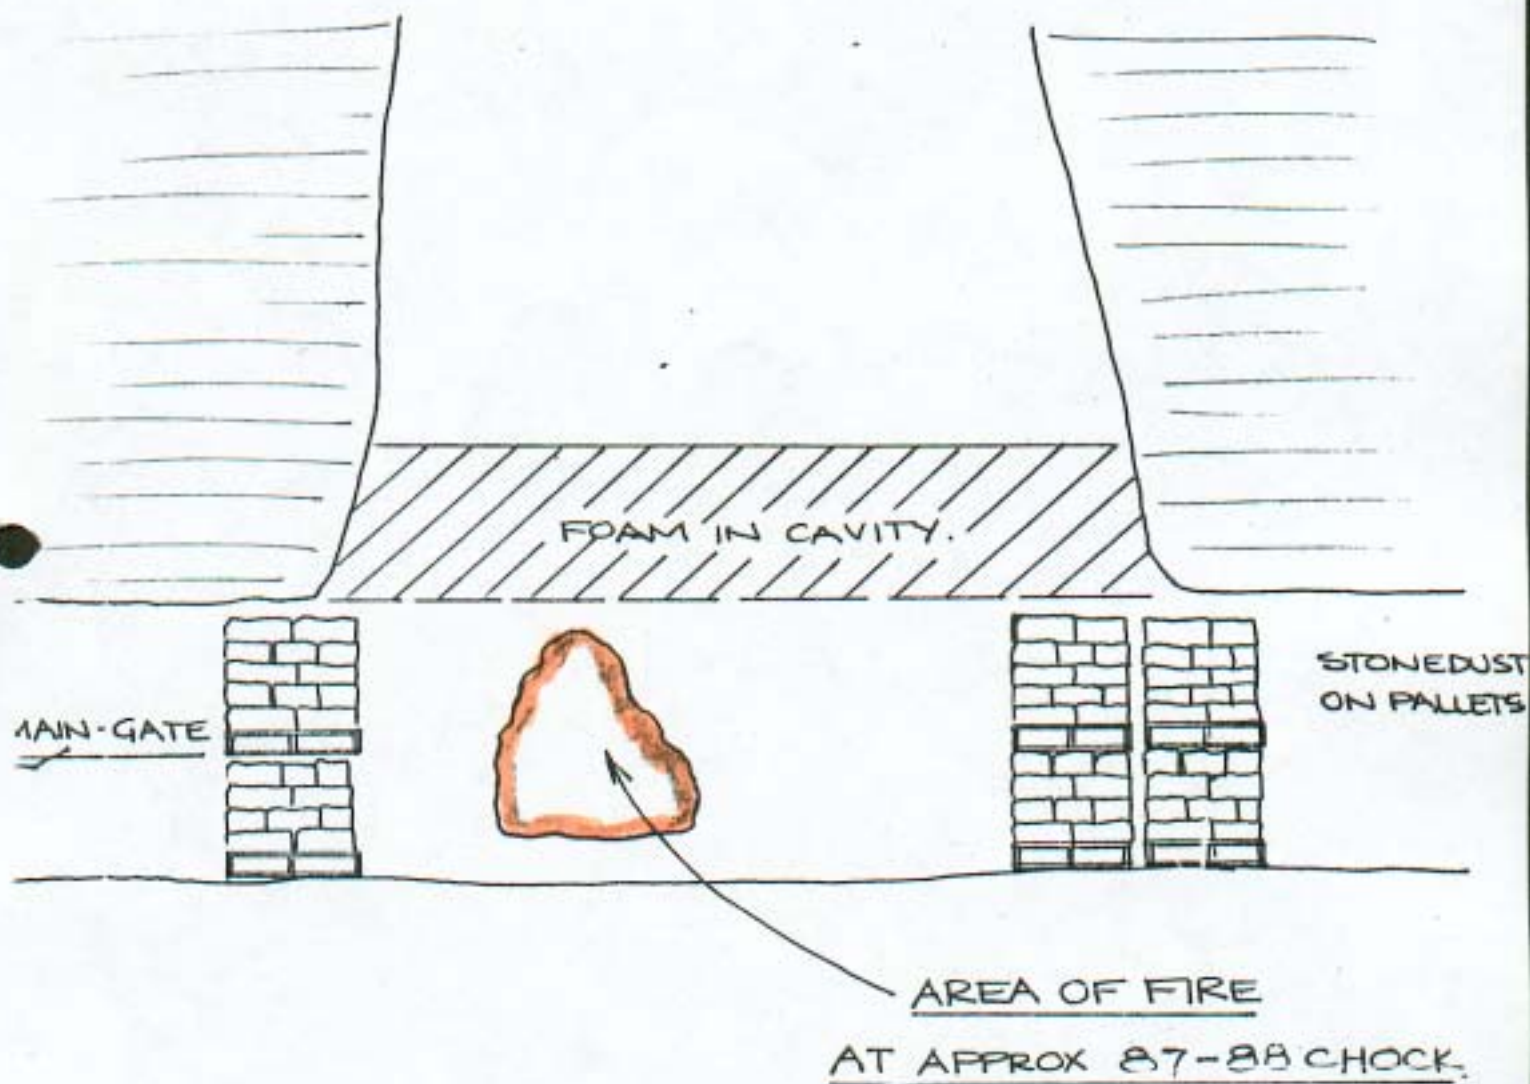
FIGURE 7

SKETCH SHOWING LOCALITY OF FIRE.

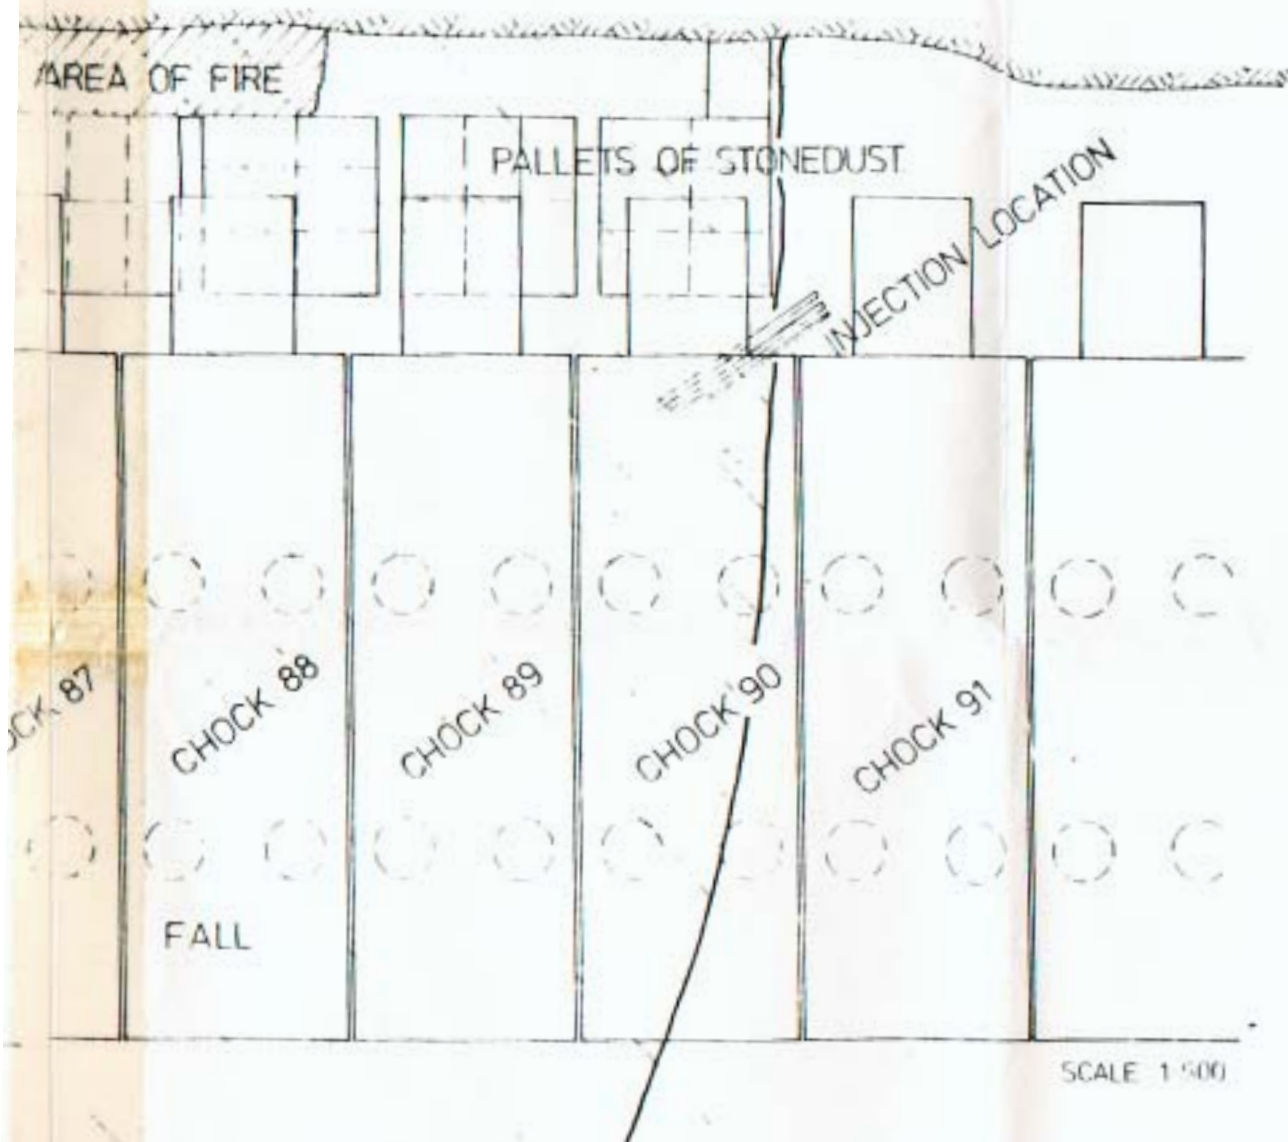
DIMENSIONS OF SECTION DUG OUT
DURING INITIAL FIRE.

SHOWING POSITION OF FIRE
