Resources Safety and Health Newsflash

CMW Hit in Face by Springing Steel Plate

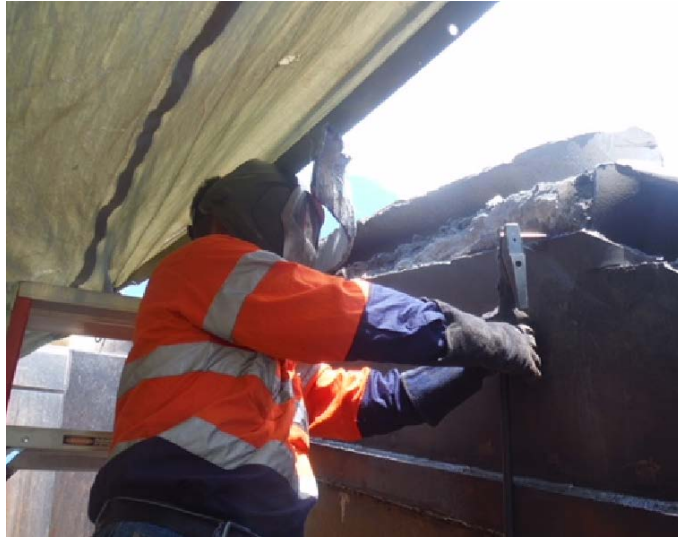
A coal mine worker was removing a steel plate from a rear dump truck tray using air arc gouging tools. The plate (approx. 100mm wide by 1800mm long) has released in an uncontrolled manner, springing approximately 500mm hitting the coal mine worker in the face.

Re-enactment of incident showing sprung plate

- Mines review all Safety and Health Management System procedures related to the removal and / or replacement of liner / wear plates on earthmoving equipment to ensure the level of risk is at an acceptable level.
- In reviewing the SHMS items such as supervision, recognition and understanding of the task risks and the implementation of appropriate stop and hold points in procedures should be considered.

This incident appears to have many similarities to that which resulted in a fatality in August 2017. At that time all coal mines were issued with a directive to review aspects of the SHMS related to this type of work. Mines should review the adequacy of procedures and their effectiveness in controlling risk.
