MAJOR INVESTIGATIONS AND EMERGENCY RESPONSE UNIT

INFORMATION RELEASE

Fatality

Incident date	13 December 2016
Event	Worker dies after being struck by truck tailgate
Location	Rix's Creek Mine, Singleton NSW

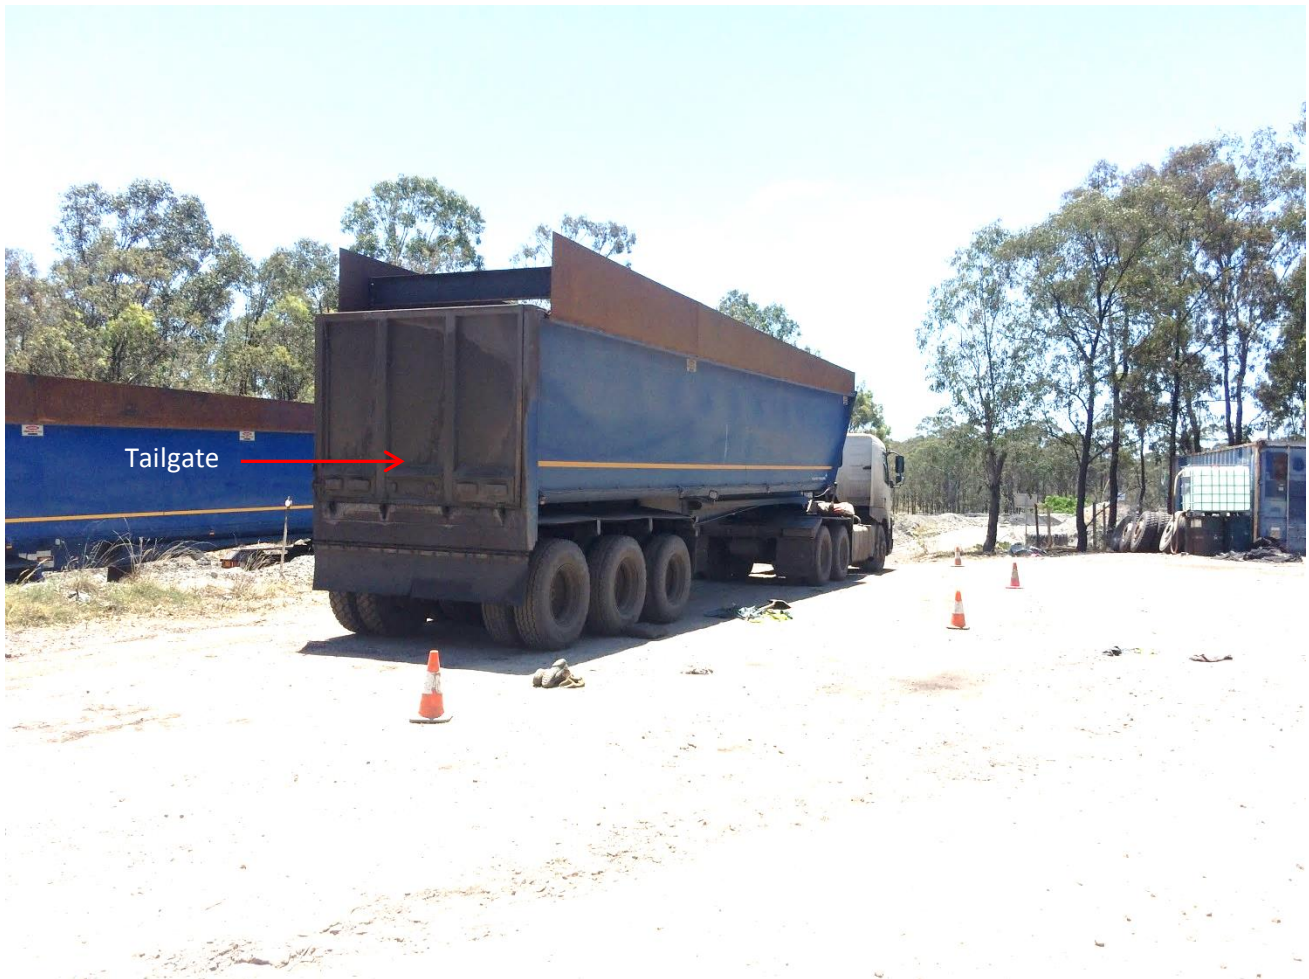
A worker was struck by the steel tailgate of a truck when he attempted to climb into the trailer under the tailgate while it was suspended to clean out residual material. He suffered fatal head injuries.

Photograph 1: Truck showing trailer and tailgate

Workers should not undertake any work underneath suspended and unsecured plant and equipment.

Plant and equipment should be cleaned at fit-for-purpose washing facilities that eliminate the need for persons to work underneath suspended and unsecured plant and equipment.

Fit-for-purpose access and egress points should be used to access plant and equipment. Trailers and truck trays should have safe access points.

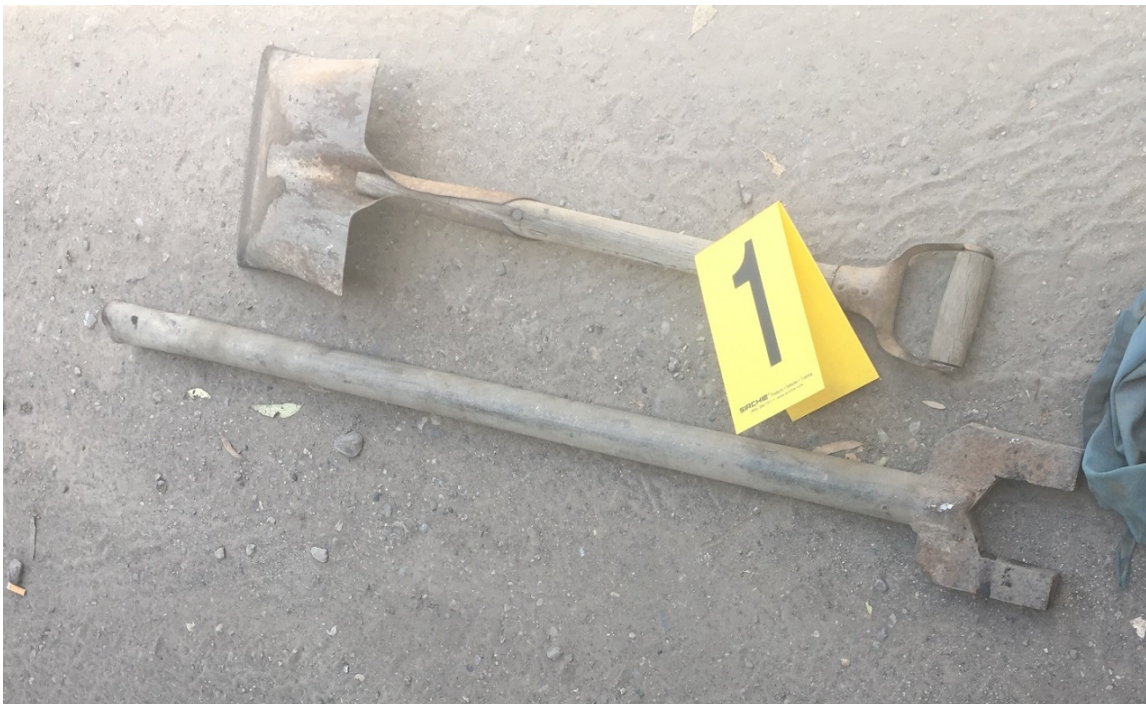
The deceased worker and two colleagues of the haulage contractor went to the rear of the trailer where the worker used a shovel to lever the tailgate open after the tailgate latching mechanism was released. The two colleagues then lifted the tailgate high enough to allow the worker to prop the tailgate open using a pipe spanner (refer Photo 2).

Photograph 2: Steel pipe spanner and shovel

The worker's colleagues lifted the tailgate and held it while the worker placed the pipe spanner in place to prop open the tailgate.

As the worker attempted to climb into the trailer, the pipe spanner moved unexpectedly allowing the tailgate to fall and strike the worker's head.

Falling plant and equipment pose a serious risk to health and safety and require appropriate control measures to prevent an object from falling.
