NATURE AND CAUSE INVESTIGATION REPORT ON
FATAL ACCIDENT

JACKS QUARRY
COLLINSVILLE
SUNDAY 29 JULY 2018

LEAD INVESTIGATING OFFICER:	Steven Firth	Inspector of Mines – Mining	Townsville
INVESTIGATING OFFICERS:	Mark Desira	Inspector of Mines – Occupational Hygiene	Townsville
	Noel Towers	Inspector of Mines – Mining	Mackay
	Alan Graham	Inspector of Mines – Mechanical	Townsville
SUPPORT OFFICER:	John Barron	Principal Investigations Officer	Brisbane
DATE of REPORT:	Tuesday 29 January 2019		
FILE REF:	MDEA-B35EZY - IR

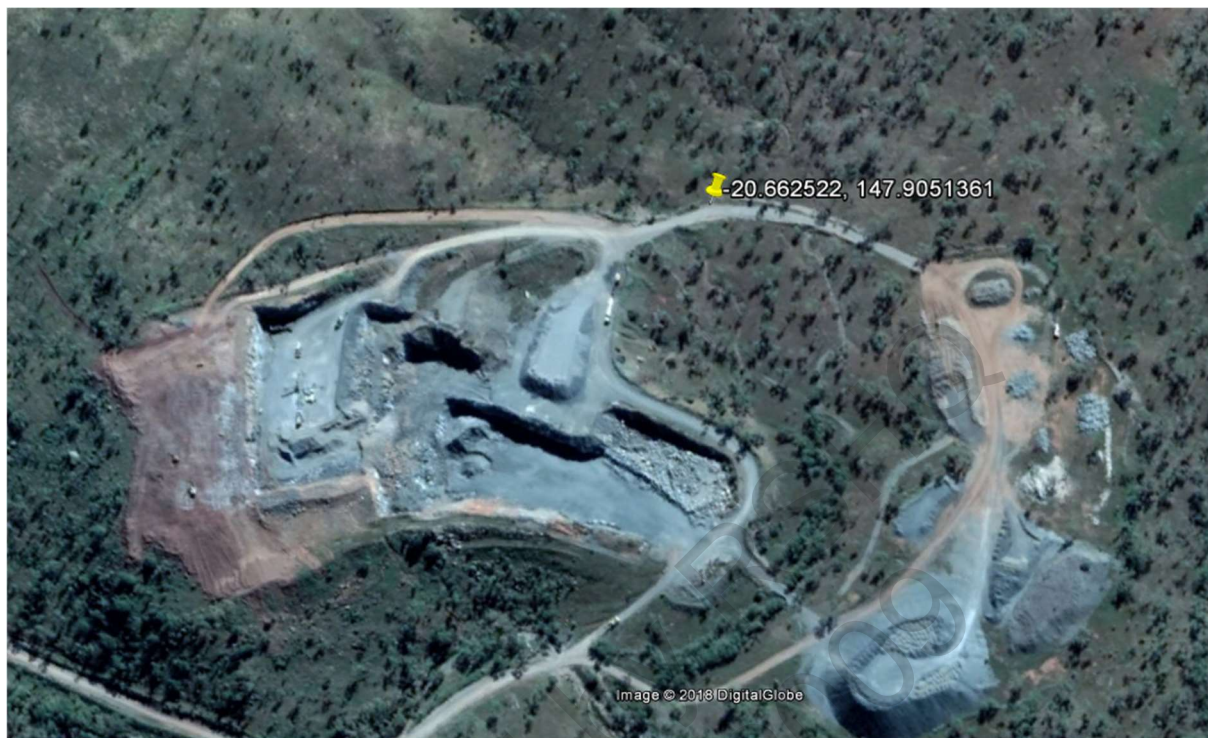
The accident occurred along an east west perimeter haul road around the main pit. The road provides access from different pit levels to an area where shot rock and mobile crushing plant is stored. The final resting place of the truck was recorded by a hand held

GPS unit. The accident occurred within the boundaries of the Quarry as defined on Lease D on SP204630.

Figure 3. Satellite image and approximate location of the accident scene

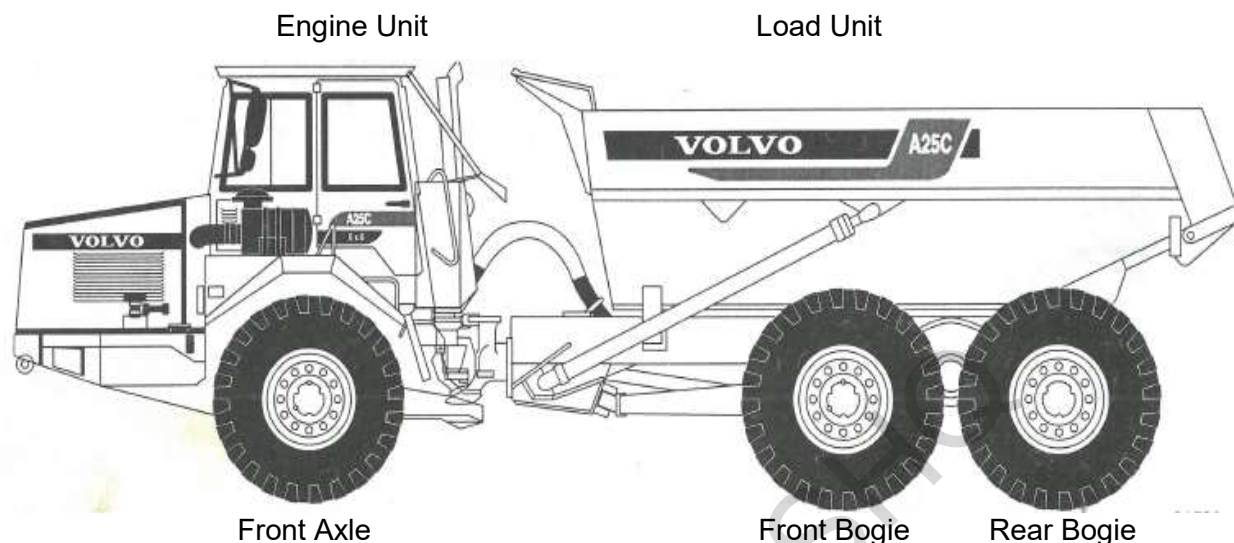
Figure 7. Volvo BM A25C articulated dump truck (6x6)
