**UNITED STATES DEPARTMENT OF LABOR
MINE SAFETY AND HEALTH ADMINISTRATION
COAL MINE SAFETY AND HEALTH**

REPORT OF INVESTIGATION

**Fatal Underground Mine Explosion
April 5, 2010**

**Upper Big Branch Mine-South, Performance Coal Company
Montcoal, Raleigh County, West Virginia, ID No. 46-08436**

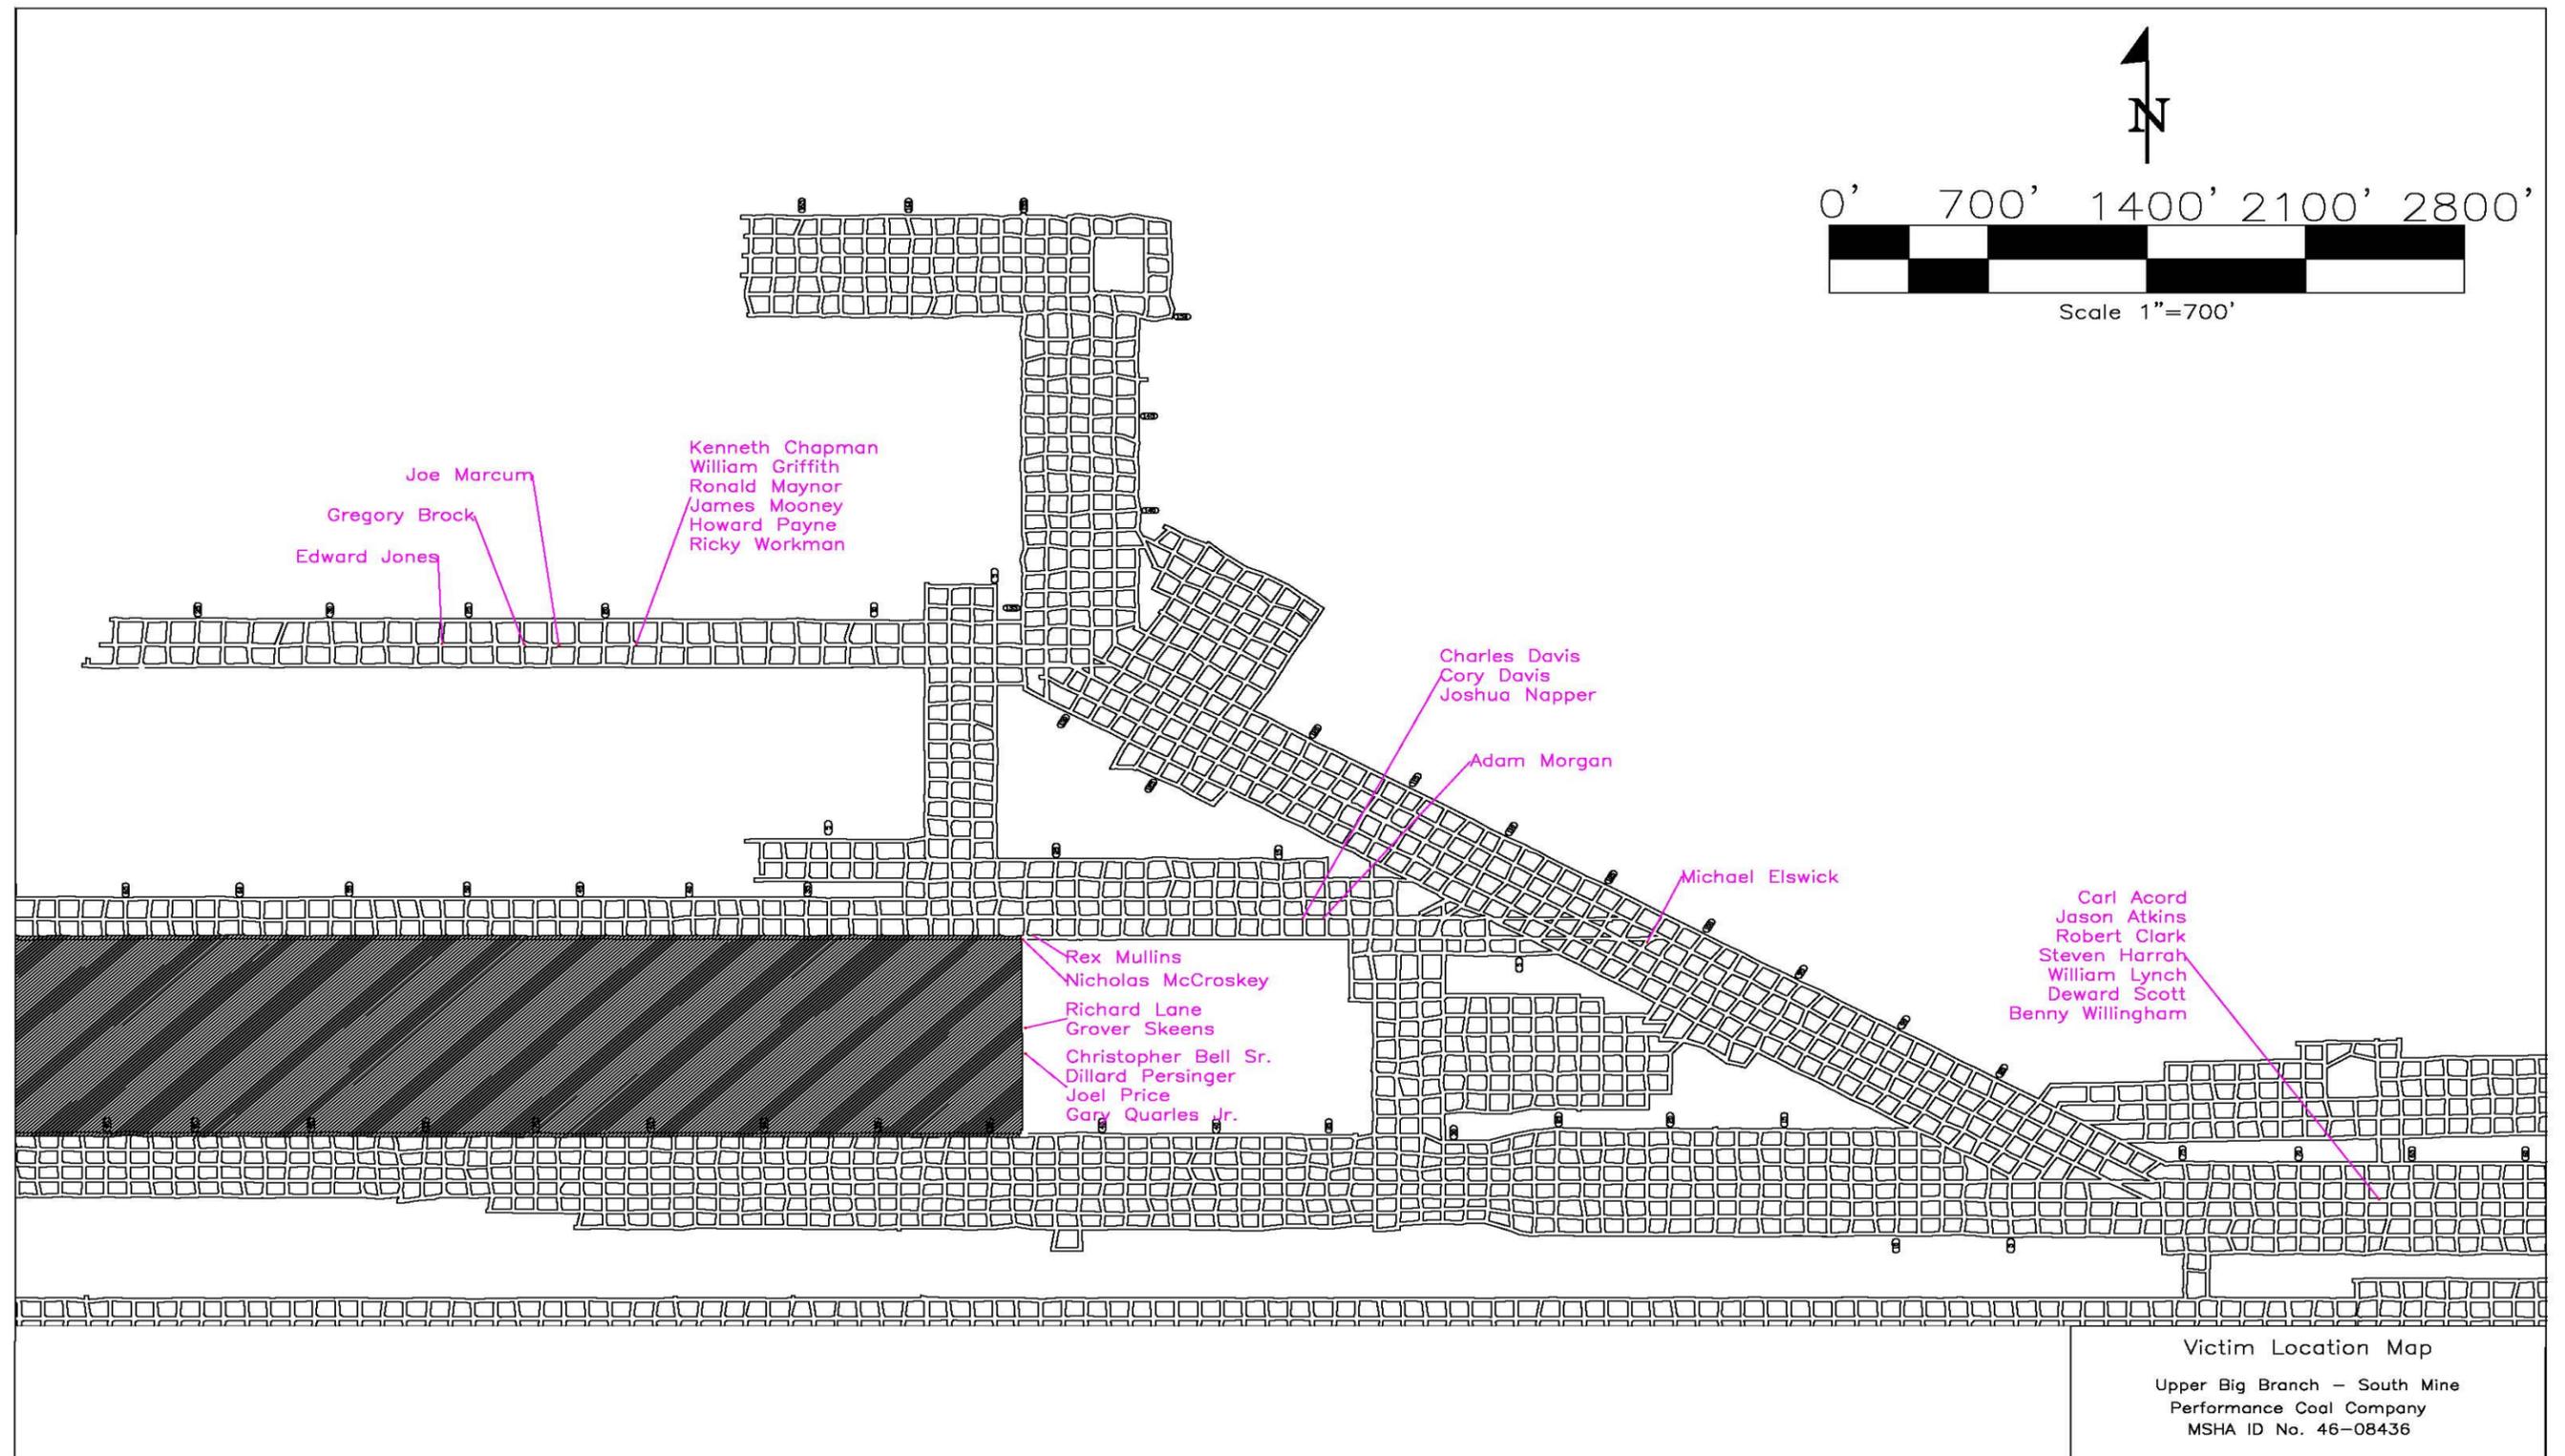
Figure 1: Victim Location Map

William Lynch, Carl Acord, Benny Willingham, Robert Clark, Jason Atkins, Steven Harrah and Deward Scott were found on the TG 22 mantrip heading out of the mine at crosscut 67.

Ricky Workman, Howard "Boone" Payne, Ronald Maynor, James "Eddie" Mooney, Kenneth Chapman, and William Griffith were found on the mantrip in the HG 22 area. Located inby the HG 22 section but away from the mantrip were Joe Marcum, Gregory Brock, and Edward "Dean" Jones.

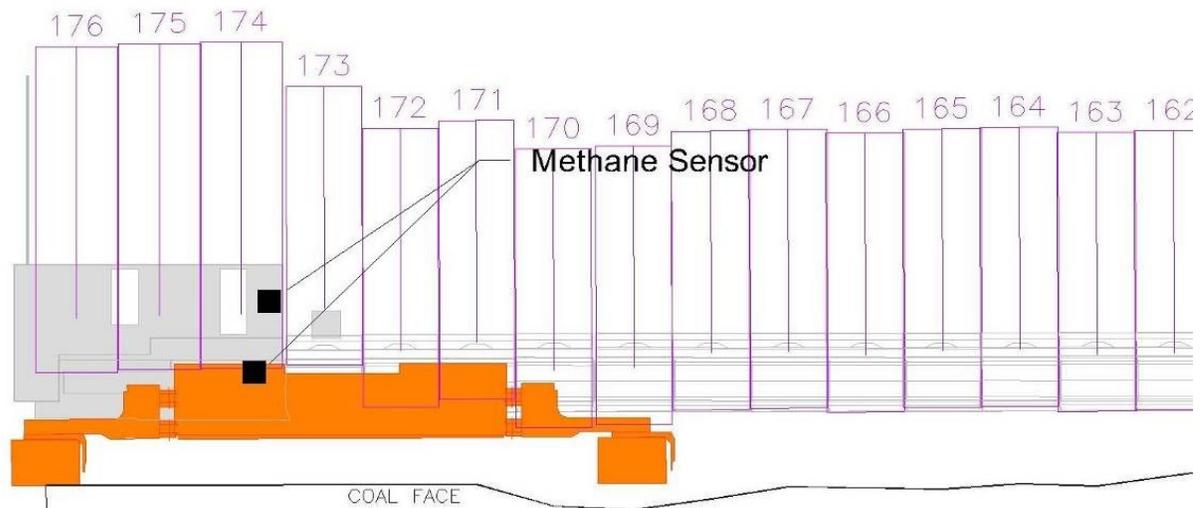
Figure 22. Diagram of UBB longwall face, showing locations of methane sensors mounted on the shearer and on the tailgate drive.
