# North Goonyella Spontaneous Combustion

September 2018

# North Goonyella

27 Sept 2018

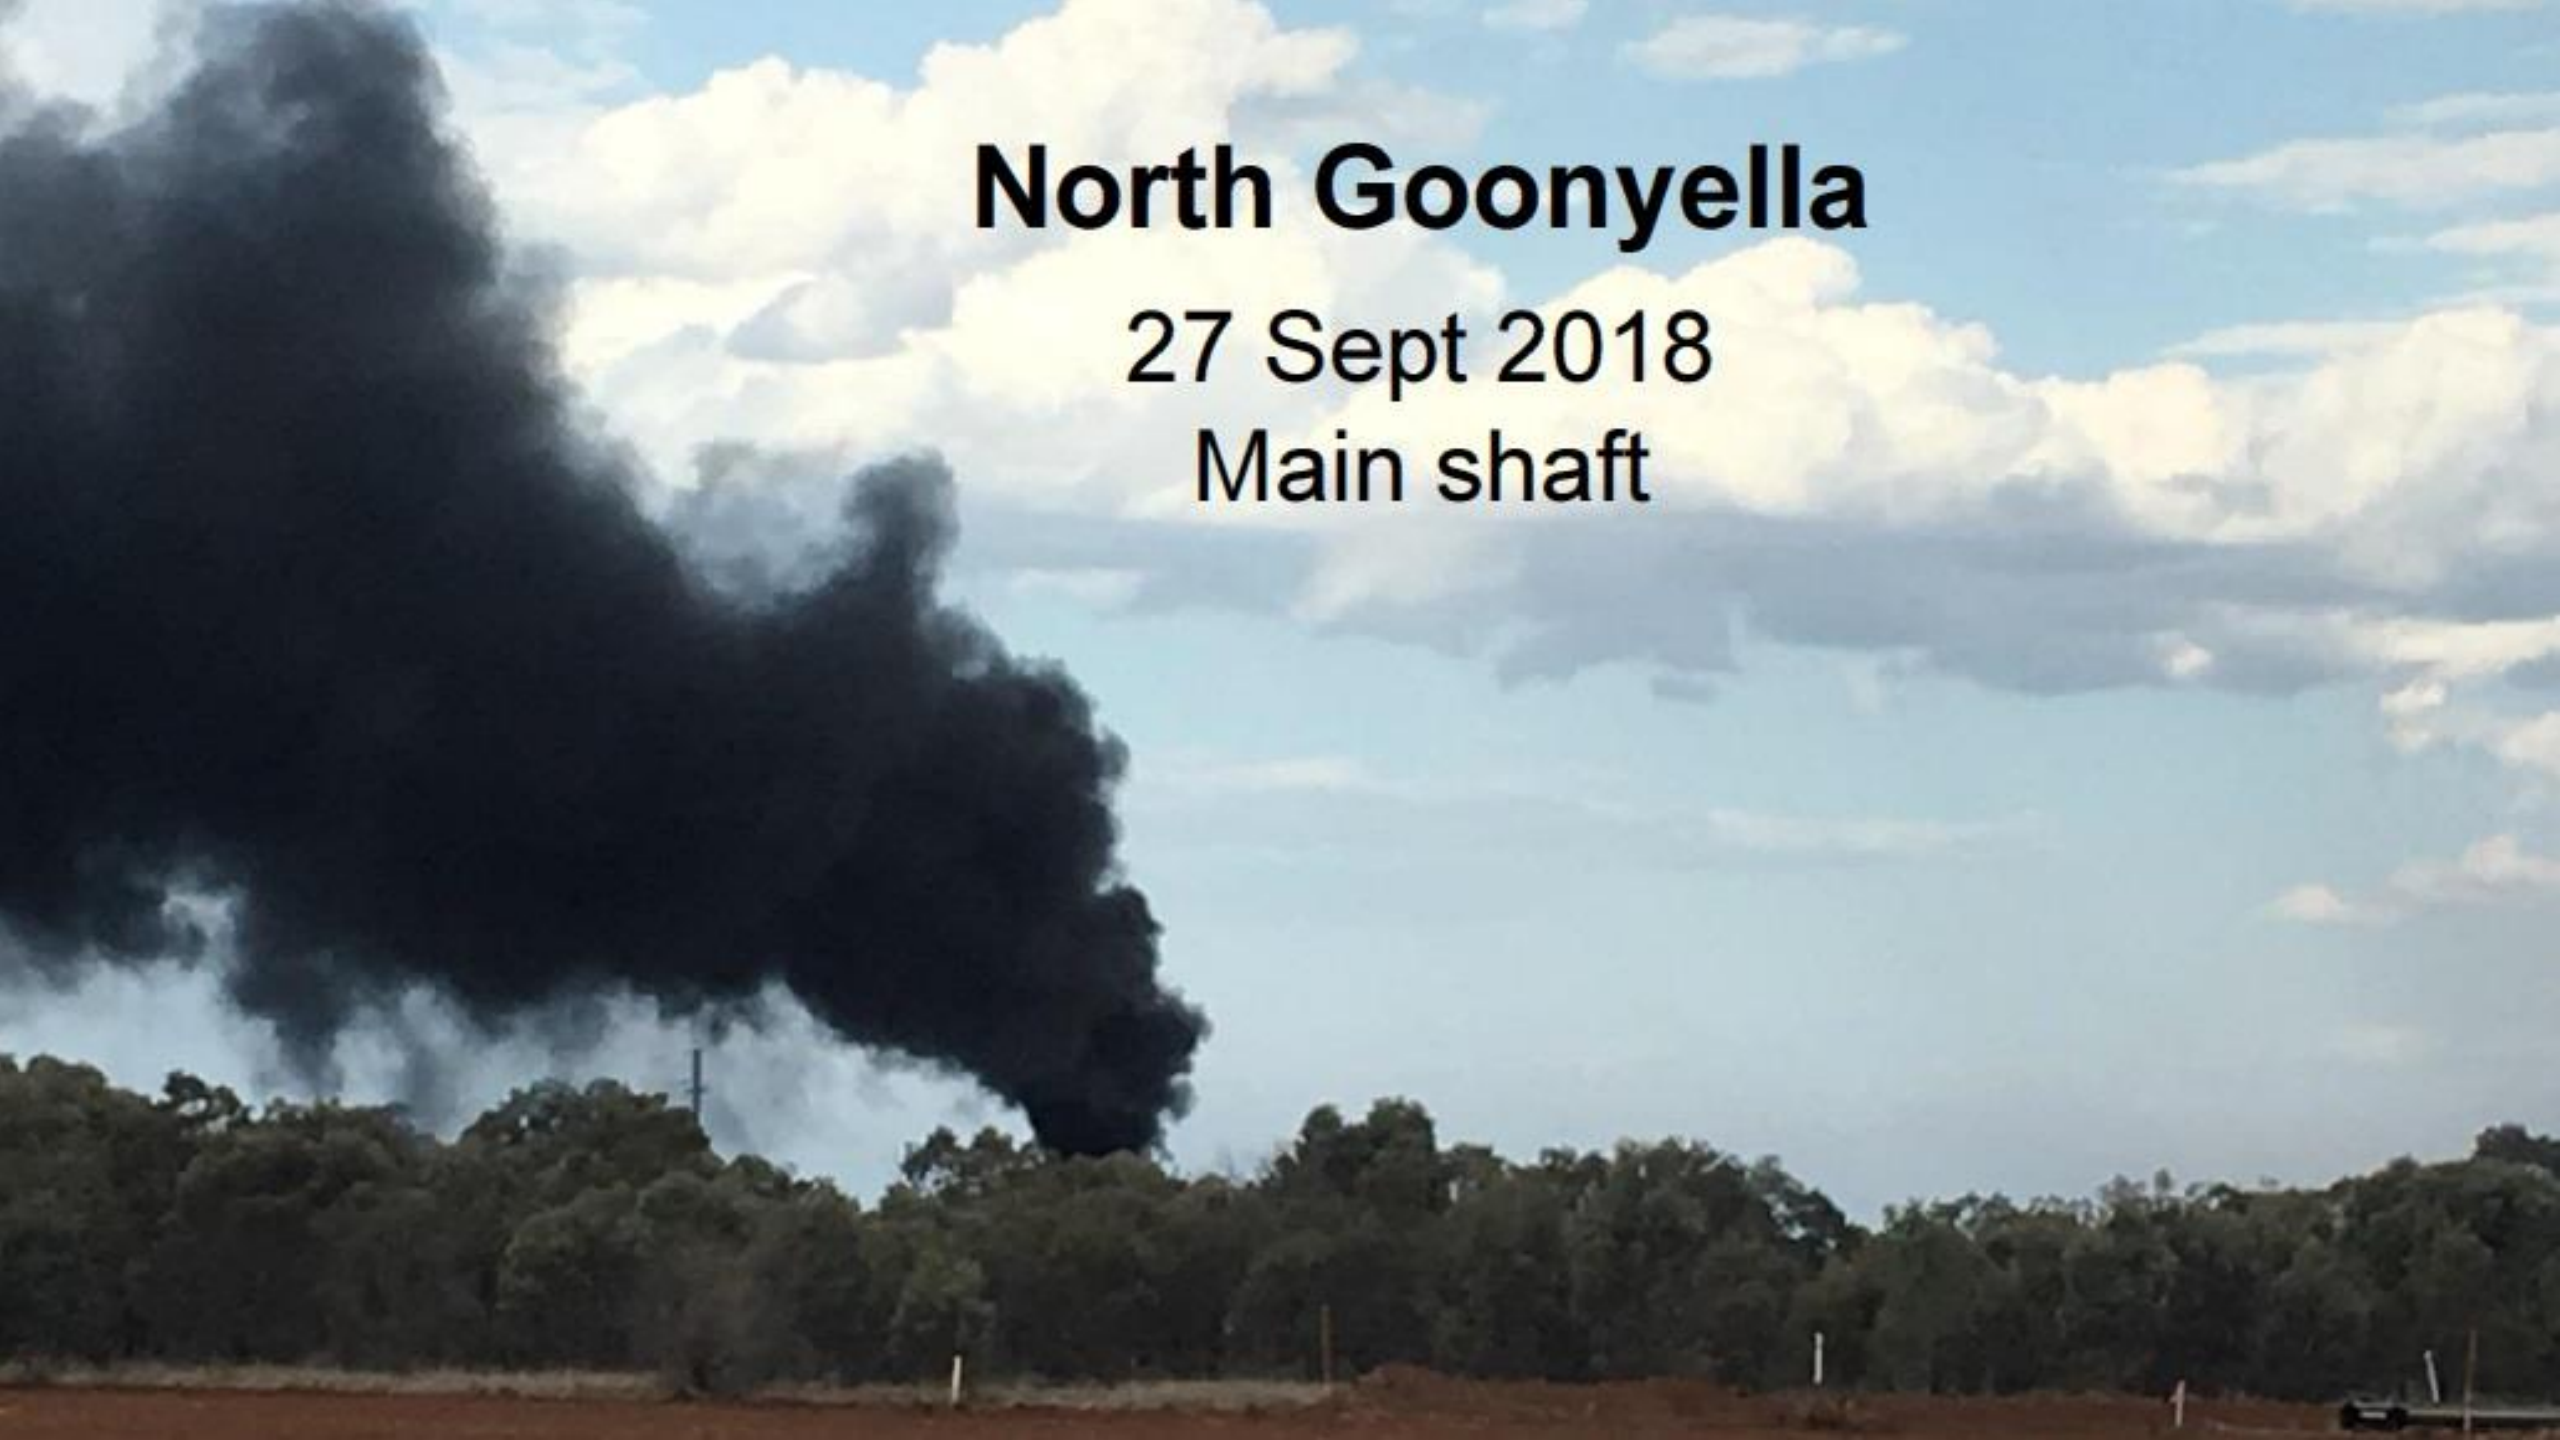
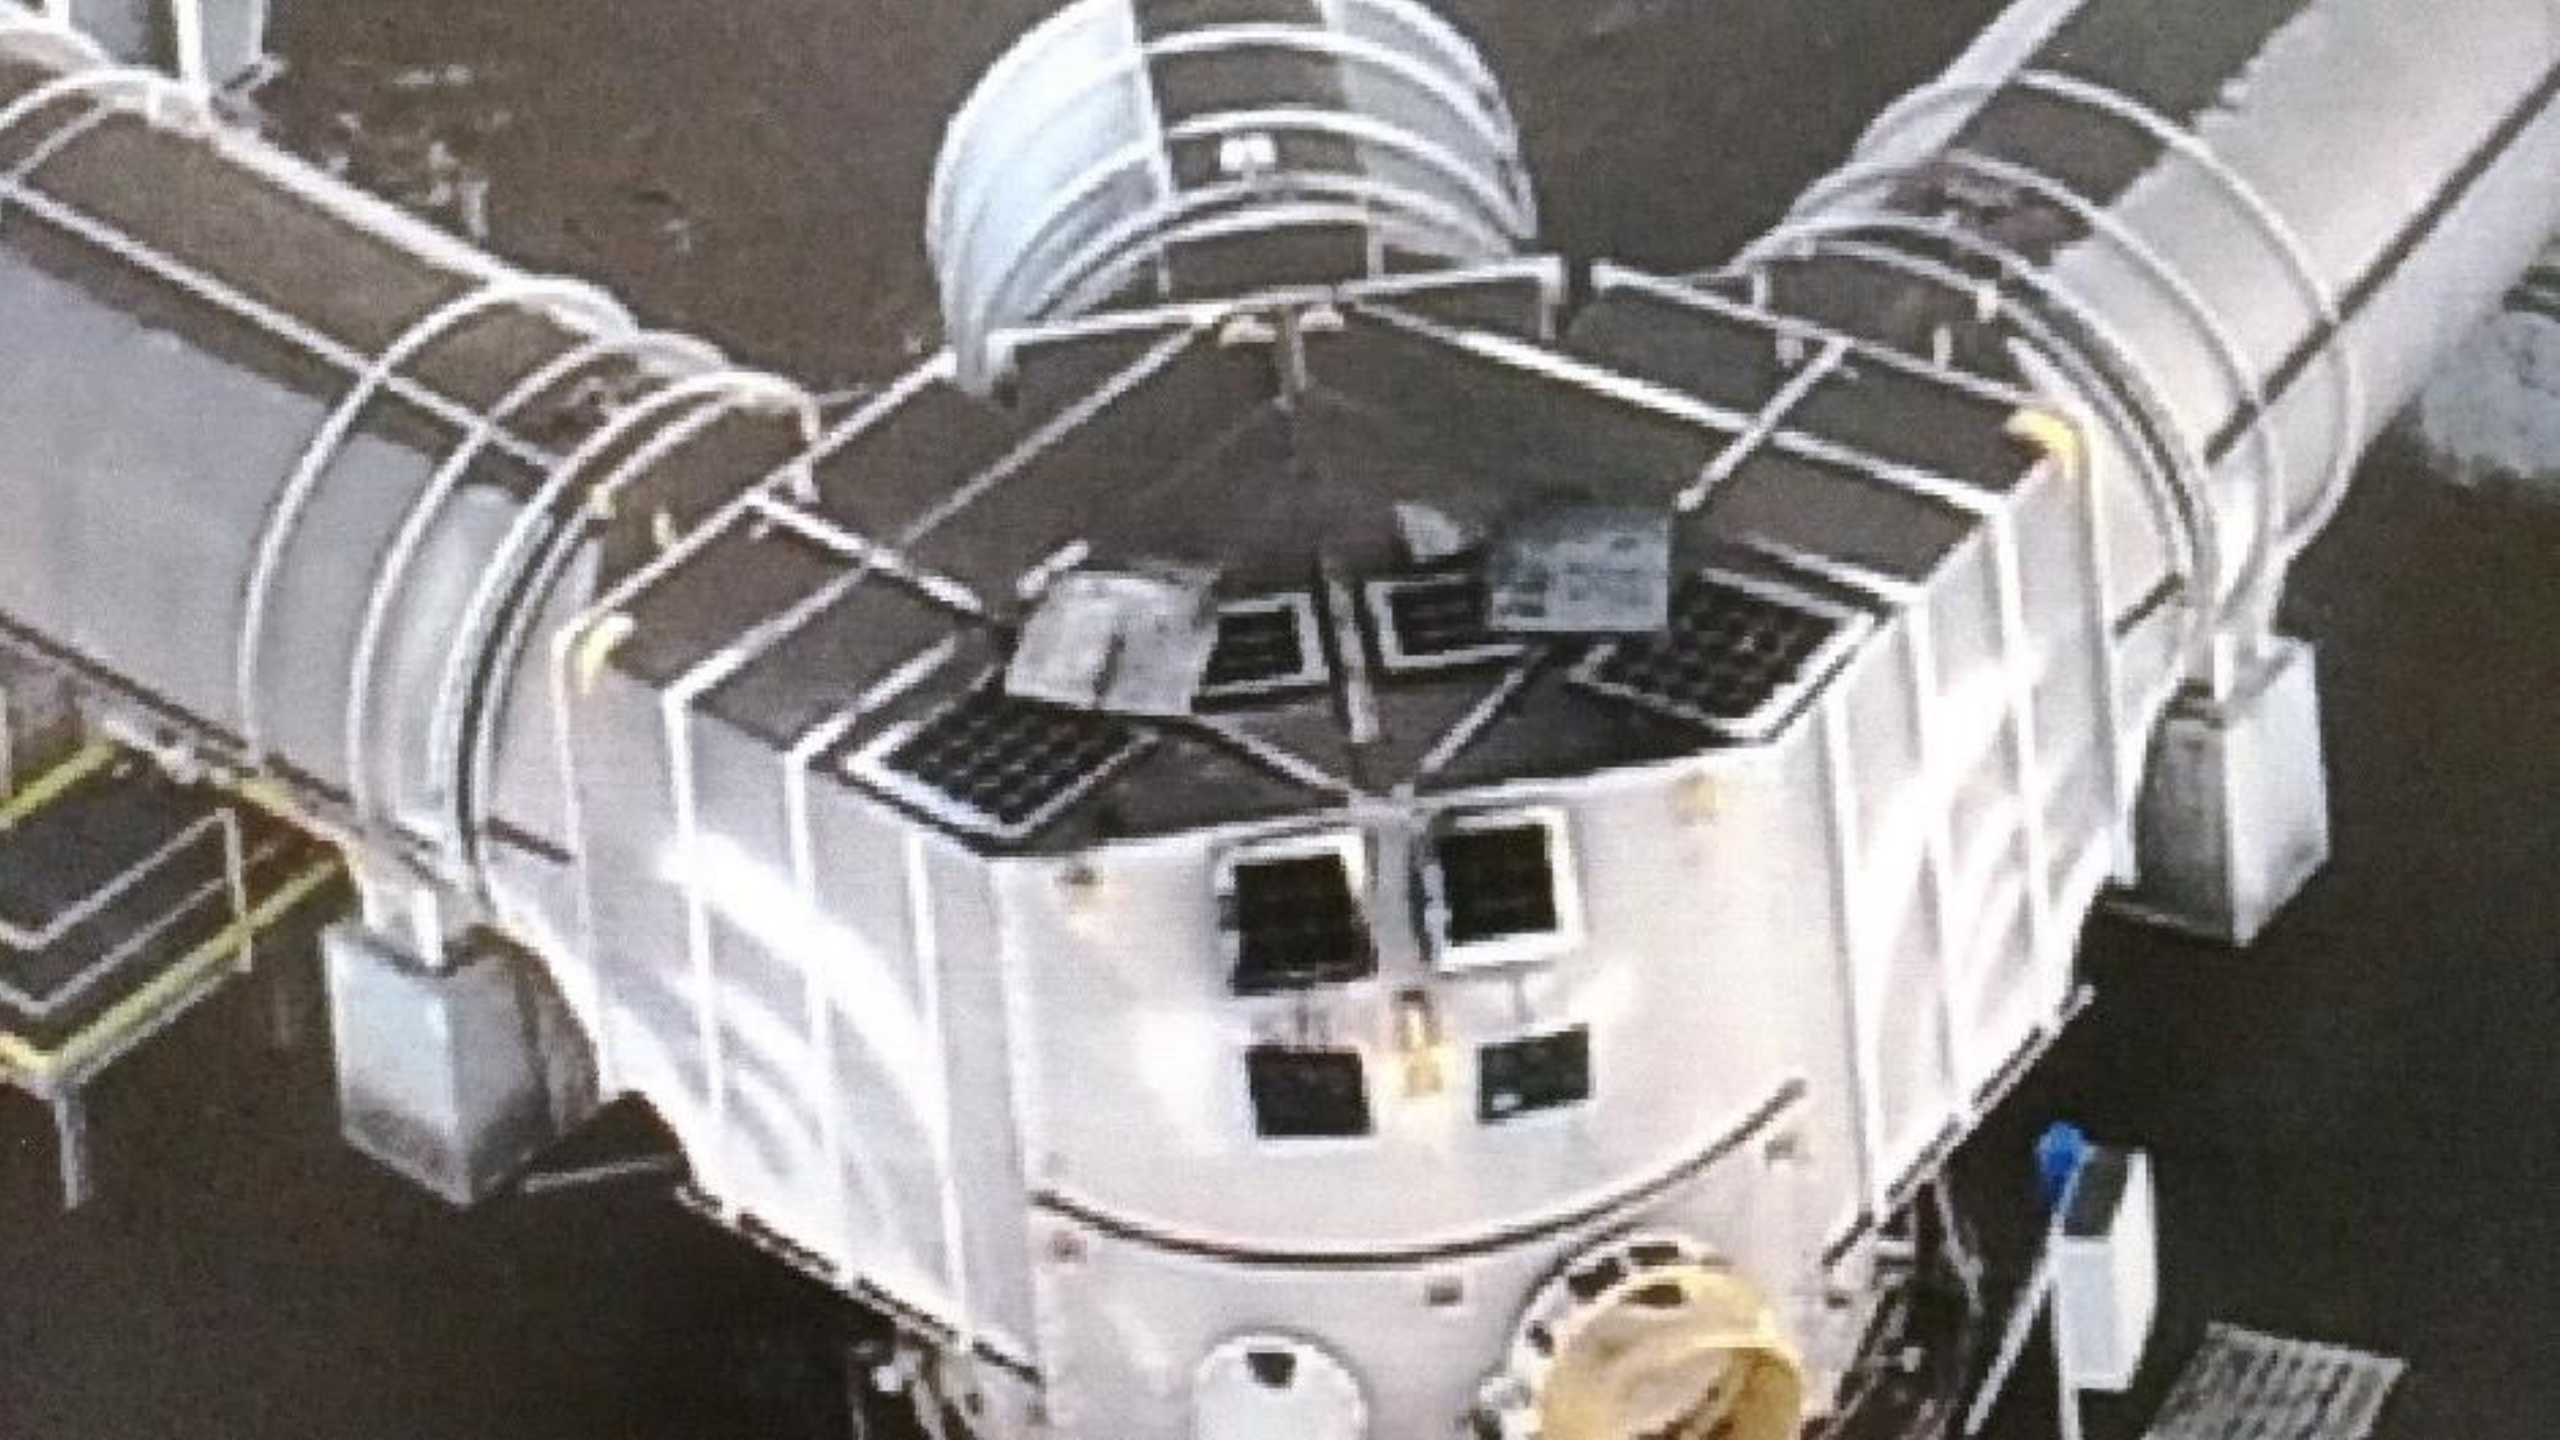
Main shaft

# Carbon monoxide increases at return shaft to over 100ppm on the 24th of September. Off scale 27th September, shaft discharging black smoke

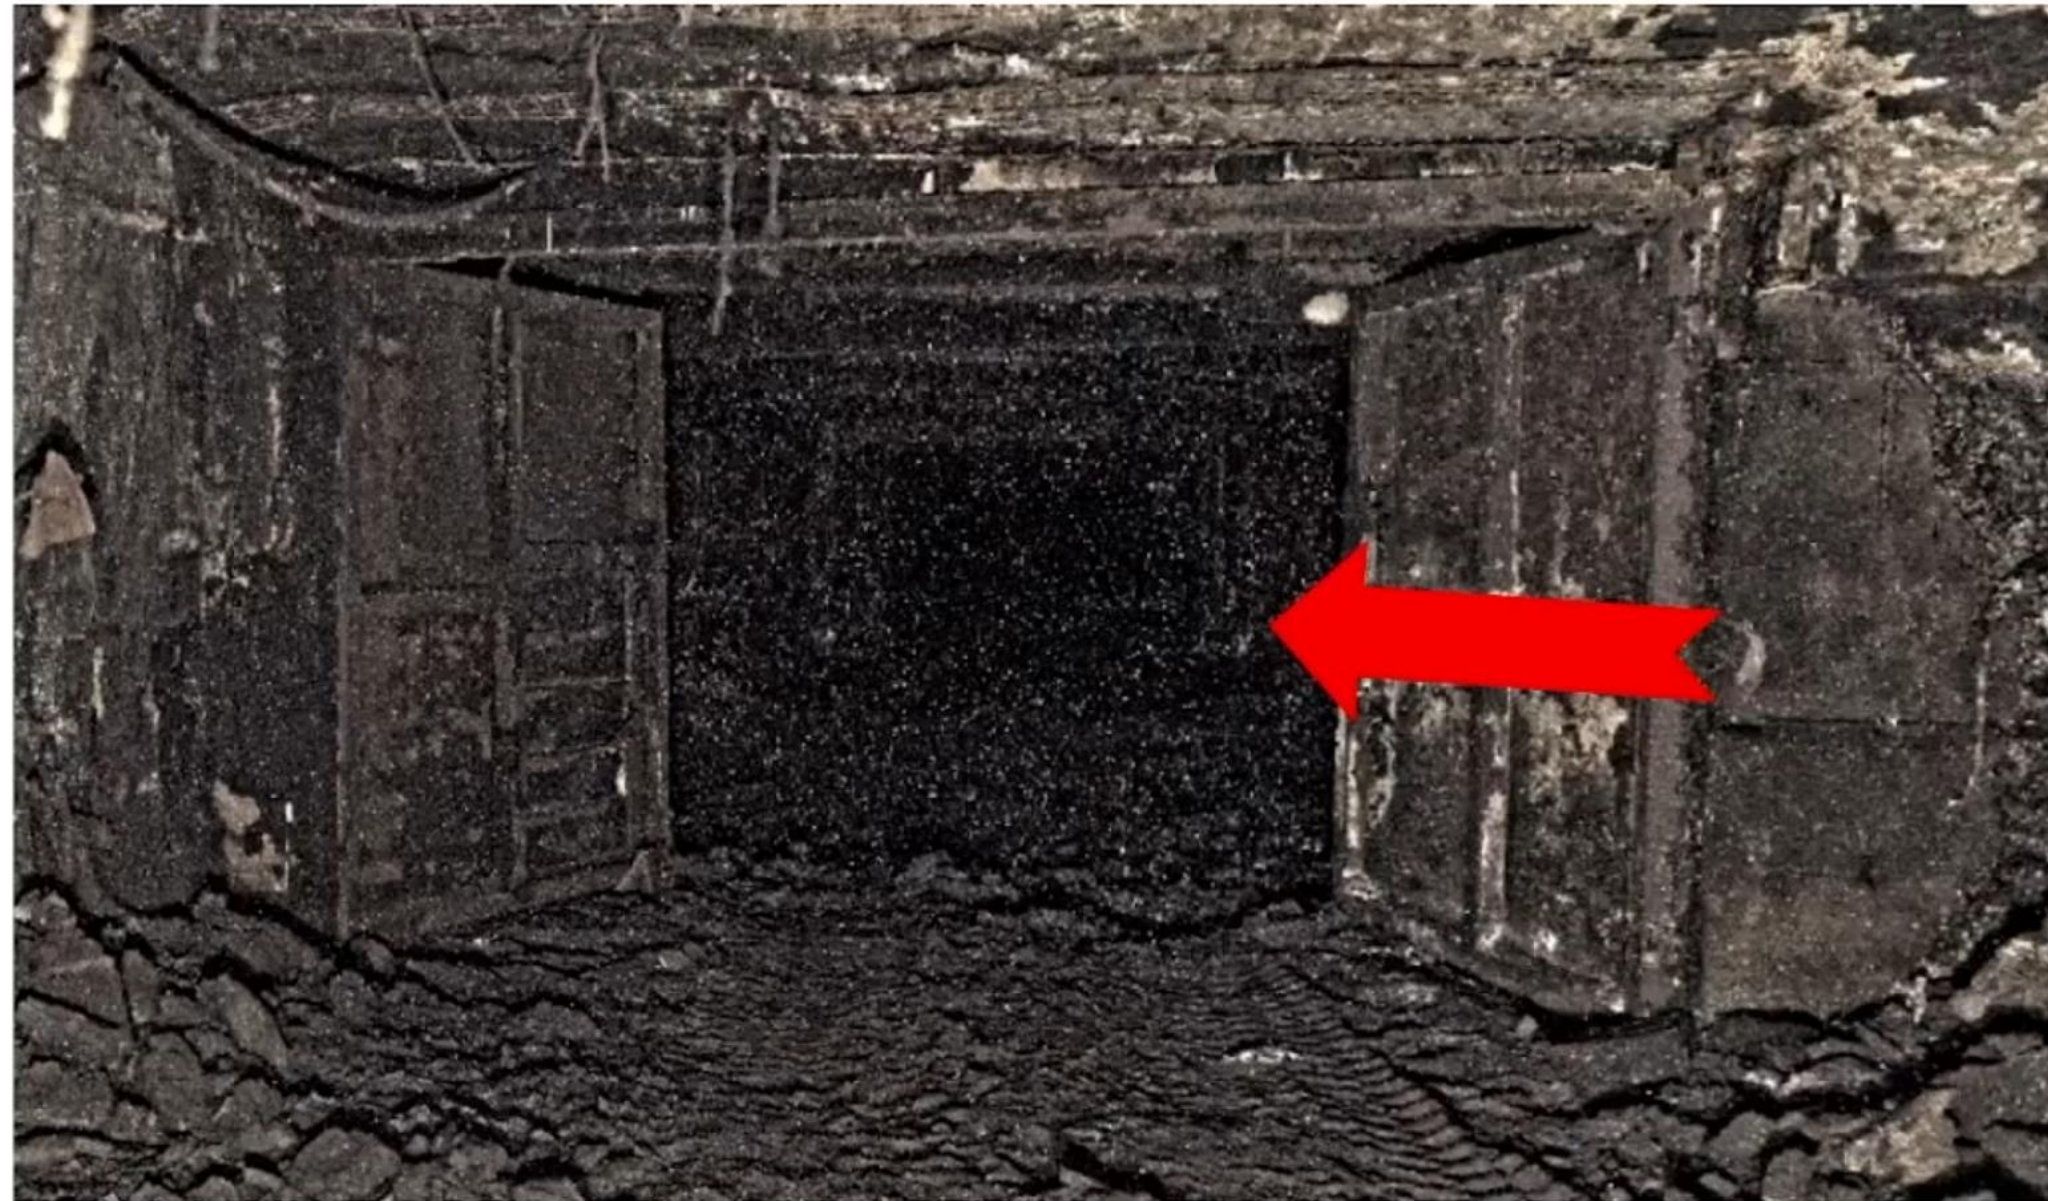
# Ventilation Doors

Intake to return  
regulator
