## Investigation report

Investigation into a fatal collision between a Caterpillar 793D haul dump truck and a Toyota Landcruiser at Ravensworth open cut mine on 30 November 2013

Report prepared by the NSW Mine Safety Investigation Unit for the Secretary of NSW Trade & Investment

March 2015

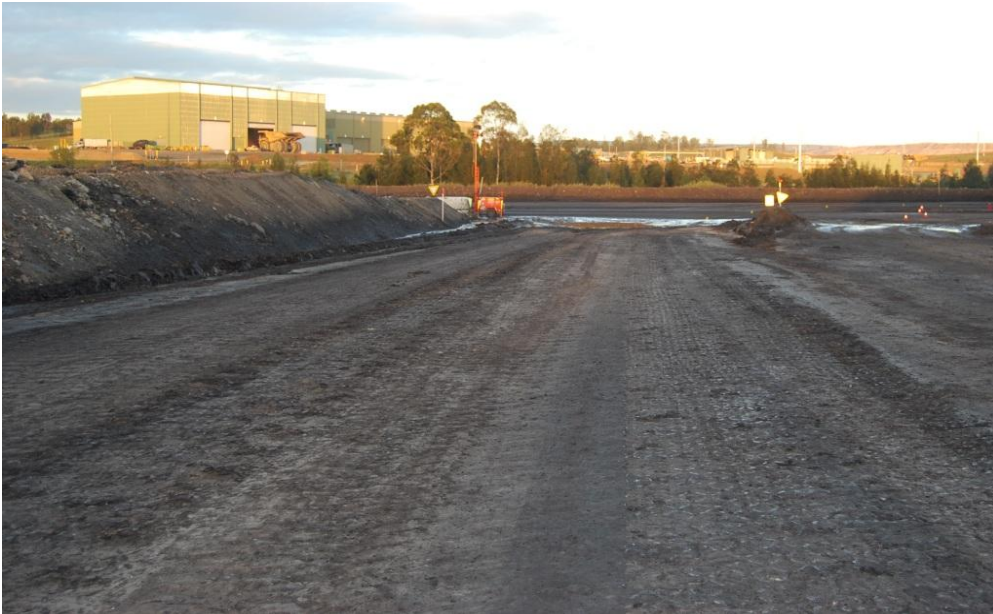
**Figure 8. Photograph of the intersection from the 8<sup>th</sup> haul road taken by investigators on 1 December 2013.**

Figures 8 and 9 are photographs of the intersection (note: the orange mobile lighting tower in Figure 8 was put in that position following the incident, there were no lighting towers near the intersection at the time of the incident).

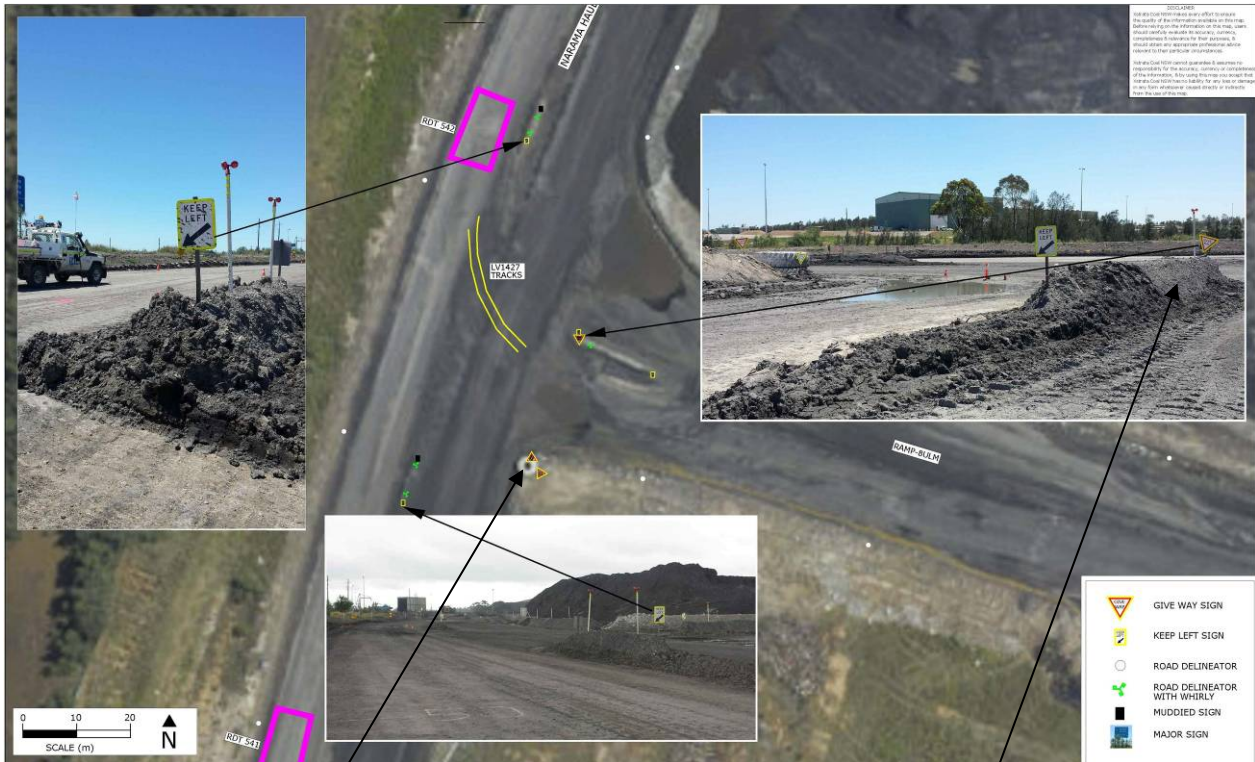
Figure 10. Plan of signs provided by Ravensworth mine (cropped for report).

The intersection was controlled by the 8<sup>th</sup> ramp having to give way to the 9<sup>th</sup> haul road. Figures 10, 11 and 12, below depict the “GIVE WAY” signs located at the intersection on the 8<sup>th</sup> ramp and “KEEP LEFT” signs in the medians on the 9<sup>th</sup> haul road and the 8<sup>th</sup> ramp.

The median windrow height (the southern median to the intersection) ranged from 0.7 - 1.05 metres (see Figure 10, above).

Figure 10 (above) shows the position of delineators (guideposts) marked with white dots along the 9<sup>th</sup> haul road and the 8<sup>th</sup> ramp.

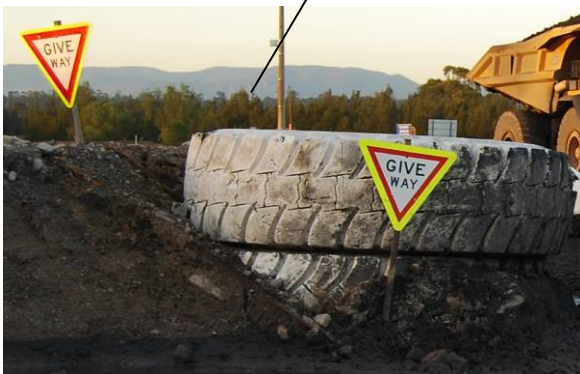
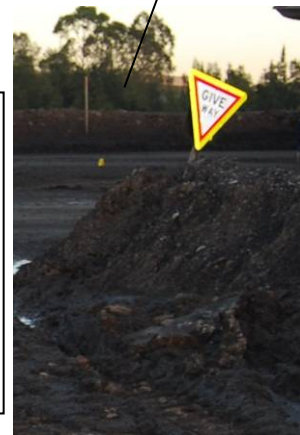
Figure 11 (left) and Figure 12 (right). Photographs taken by investigators on 1 December 2013

The centre median windrow height at the intersection on the 8<sup>th</sup> ramp ranged from 1.4 metres - 1.6 metres (see Figures 10 and 12, above).

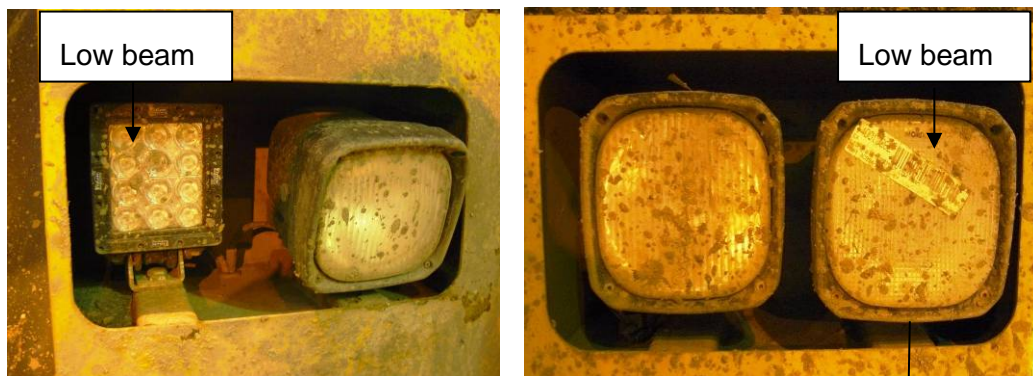
Figure 24. RHS (below left) and LHS (below right) front lighting (low beam and high beam) of truck. Photographs taken by investigators on 5 December 2013.

- There was an aftermarket (Vision Brand) LED installed to the low beam position on the RHS (offside) of the truck. It was recessed into the front fender and not flush with the front panel of the front fender (see Figure 24).

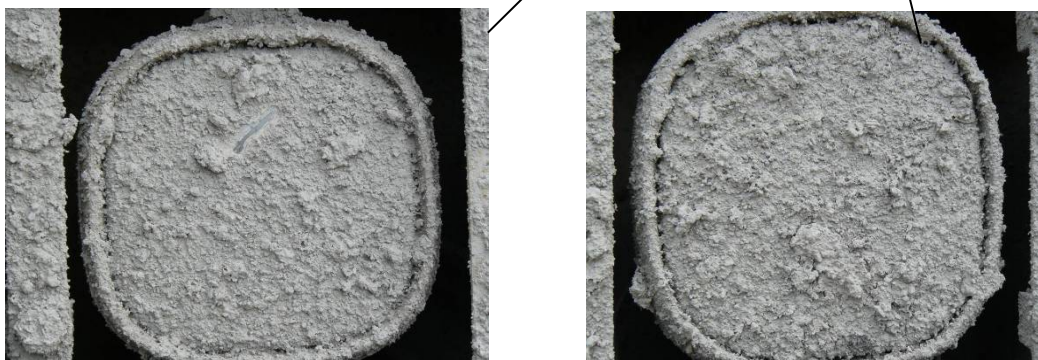
Figure 26. RHS (above left) and LHS (above right) front bumper lights of truck. Photographs taken by investigators on 2 December 2013.

The bumper lights on the truck were heavily obscured by mud (see Figure 26) at the time of the incident.

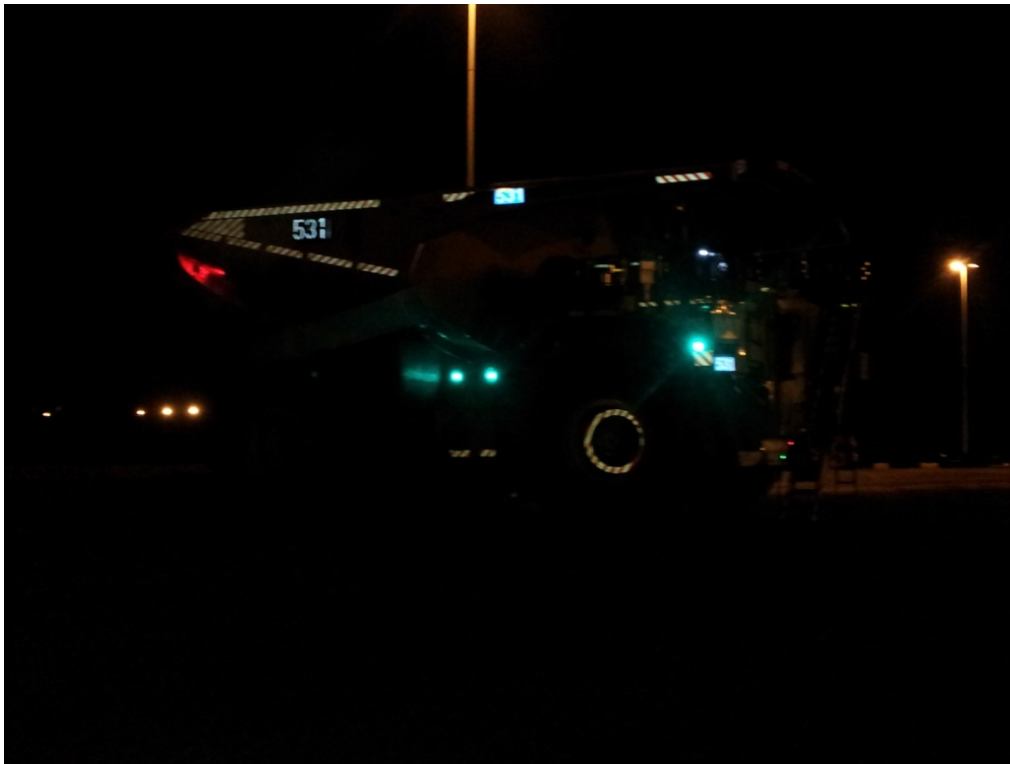
Figure 31. Dump truck visibility trial.

There was a trial of green clearance lights, luminescent paint, and reflective tape on certain haul trucks to attempt to improve truck visibility (see Figure 31, below).
