Moranbah Investigation Report

**Fatal collision - 8 July 2010 - Occupational crossing 5805
Goonyella Riverside Mine - Near Moranbah**

Final report, Rail Safety Investigation TMR3584

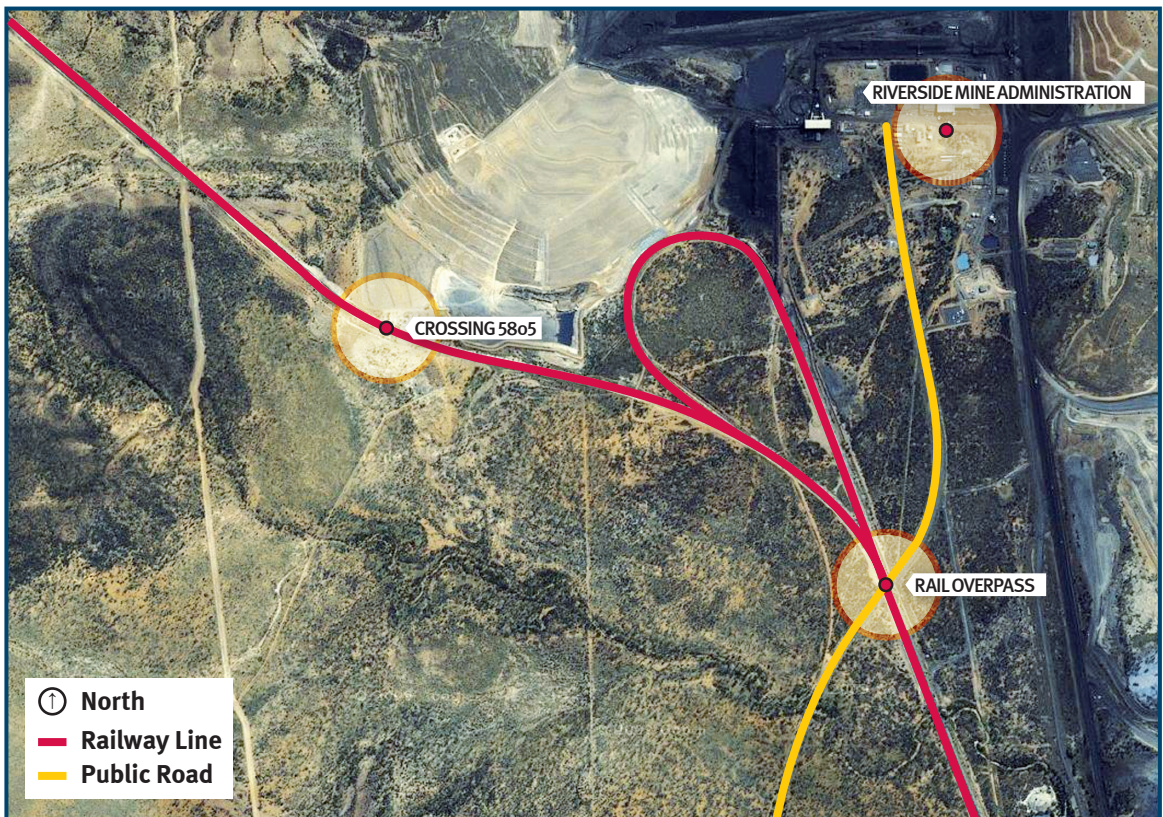
Figure 3: Overview of incident site

The collision occurred on Occupational Crossing 5805 near the Goonyella Riverside Mine (refer Figure 3). Occupational Crossing 5805 is a dirt track that crosses the rail corridor between two mining leases of the Goonyella Riverside Mine. Occupational Crossing 5805 is located at the 203.400 kilometre mark on the railway system, approximately two kilometres south east of the Goonyella Riverside Mine industrial area.

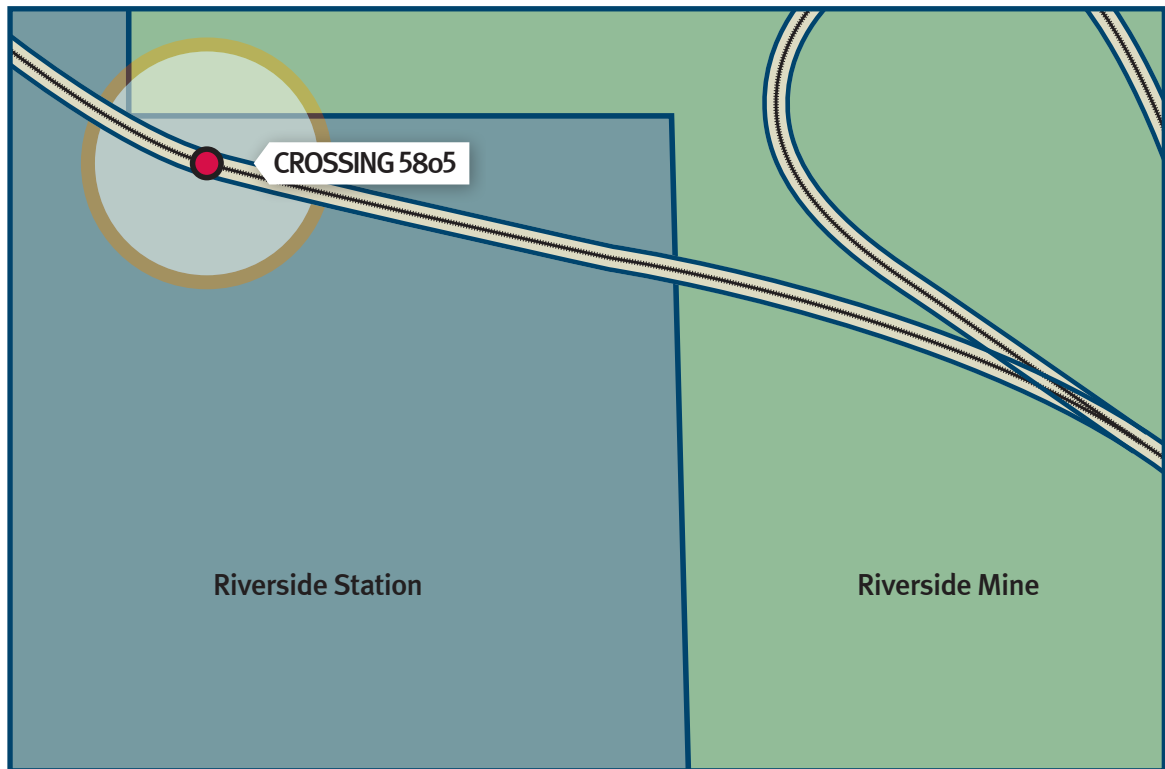
Figure 4: Land boundaries 1993

In 1992 the Queensland Government acquired land from the owners of Riverside Station to establish the rail corridor between the Goonyella and Riverside Mines and North Goonyella Mine (refer Figure 4). The rail corridor was opened to rail traffic in August 1993.

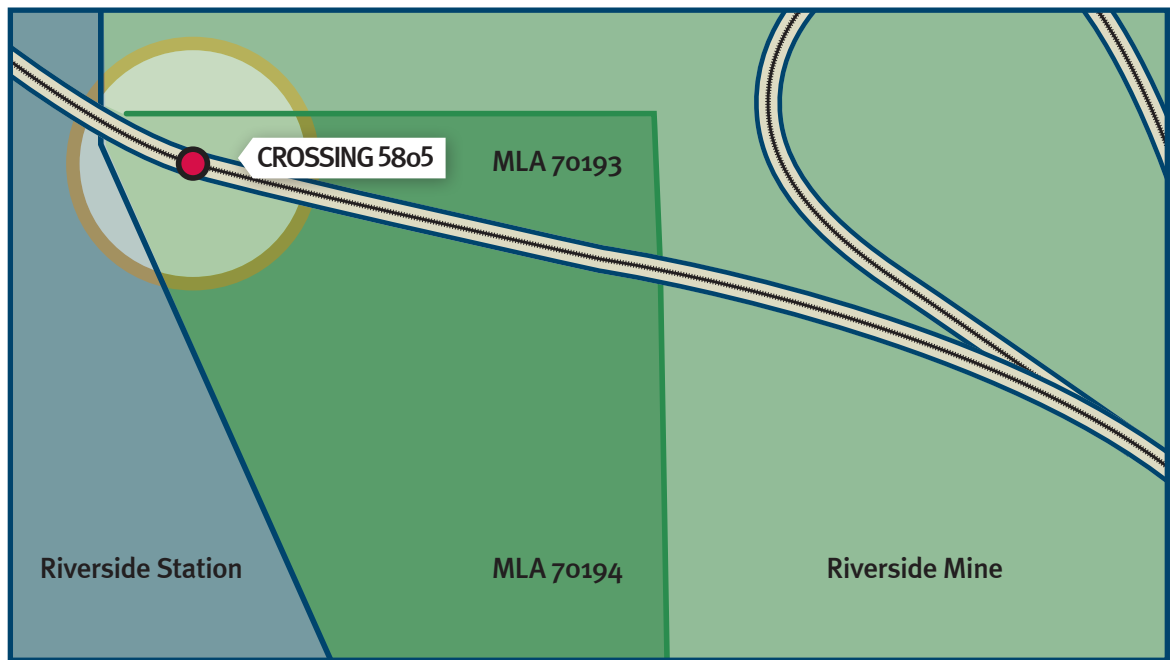
Figure 5: Land boundaries 2005

In 1994 land was leased from the owners of Riverside Station by the mine operator. Land acquired on the northern side of the rail corridor forms Mining Lease 70193 and land to the south of the corridor forms Mining Lease 70194. As a result of the grant of the lease, Occupational Crossing 5805 was now located between two parcels of land utilised for mining activities rather than pastoral use (refer Figure 5).

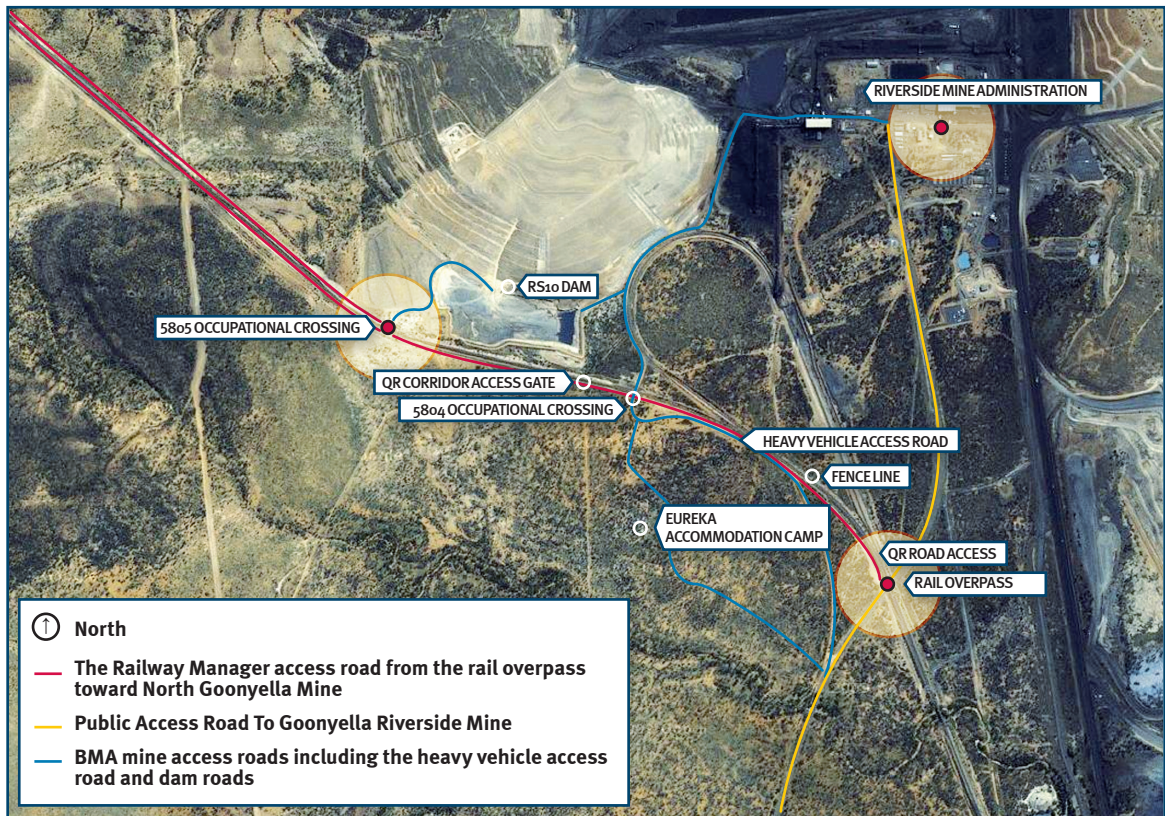
Figure 6: Goonyella roads

With the expansion of the mine in 2005 and particularly when construction of the Eureka Creek accommodation camp commenced in 2008, the crossings began to be used frequently for mining activities. Over time, roads have been developed within the mine lease that interact with the rail corridor. Figure 6 depicts the roads surrounding the rail line at the time of the incident.

The railway manager had installed a gate on the rail corridor to prevent access to unauthorised persons to the corridor in 1993. Beside the gate a sign was installed by the railway manager to provide advice the area was a prohibited area. The location of the gate is depicted in Figure 6: Goonyella Roads.

Dam RS10 is located near the rail corridor on the mining lease (refer Figure 6). The dam had been formed from a mining pit and had sheer walls. The dam water level prior to late 2010 had been at least 20 metres below the height of the access road exposing the walls of the dam. The walls were not able to be climbed down to access the pumping station below.
