TECHNICAL REPORT

Subject: Analysis of Blakefield South Mine (BSM)
Explosion

Date: First Draft 16 Feb 2012
Revised 20 Feb 2012; 29 Feb 2012

Report Prepared By: Drs Hsin Wei Wu and Stewart Gillies

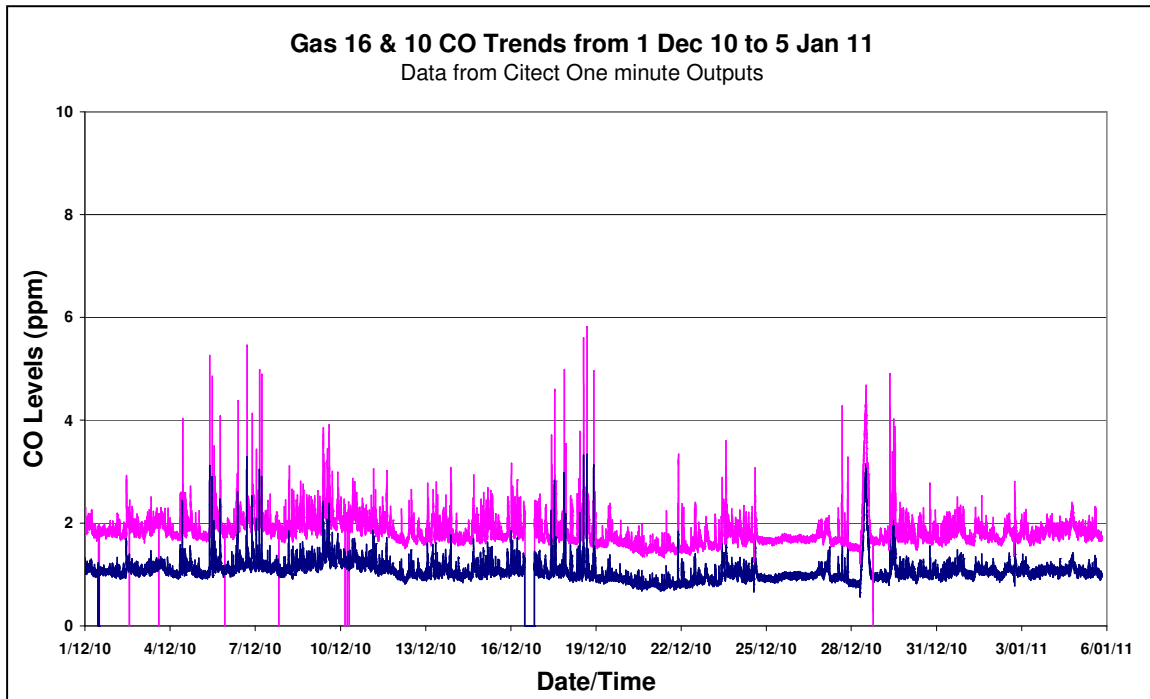
Figure 3.1 CO gas trend recorded at Gas 16 & 10 Stations (1/12/10 – 05/01/11).

CO gas levels in a mine atmosphere are of interest as they may indicate the onset of a fire or spontaneous combustion heating (or may show an indication of exhaust fumes from a diesel powered vehicle). In the various figures above both Gas 16 & 10 Stations' data indicate that CO levels are below 4.0ppm almost all the time and never record greater than 6ppm and then only for a very short period. Furthermore readings are very stable with no indication of a long term rising trend that may indicate onset of a heating.

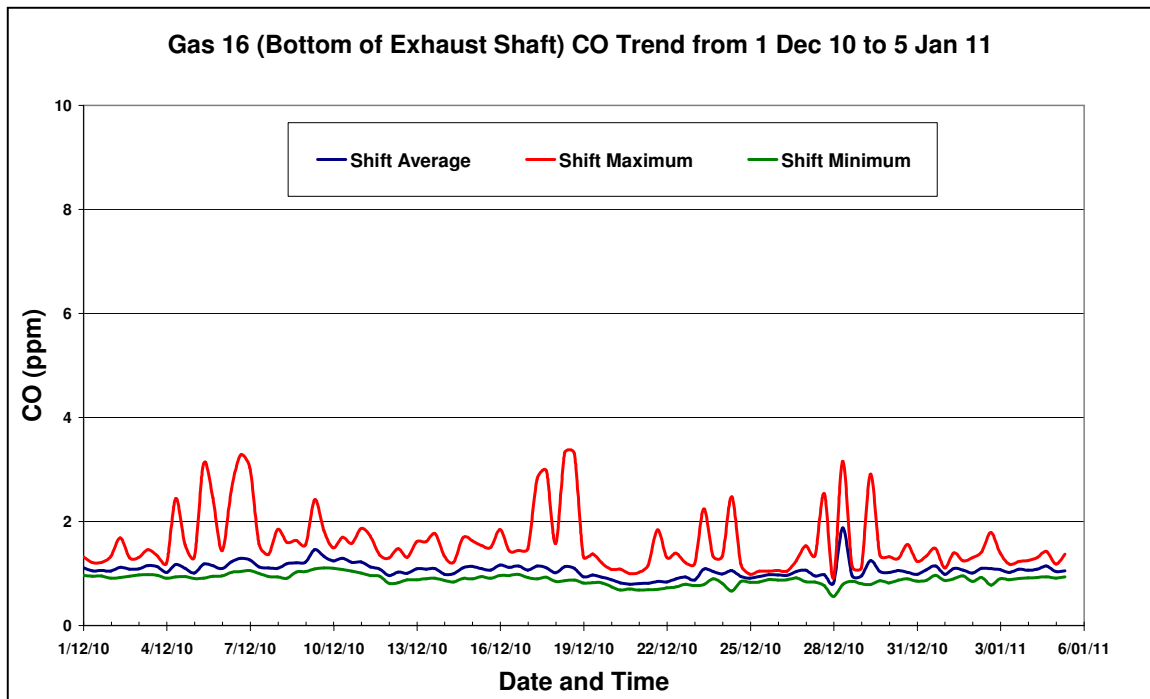
Figure 3.2 CO gas trends of shift average, maximum and minimum at Gas 16 Station – Bottom of Exhaust Shaft (1/12/10 – 05/01/11).

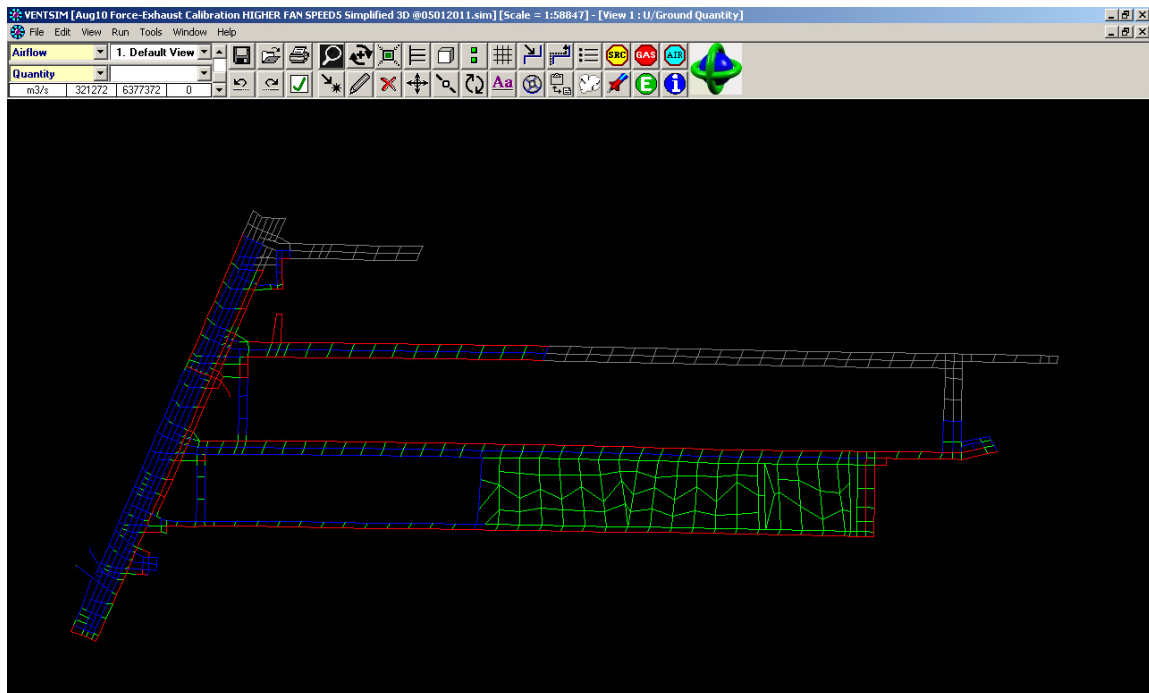
To be able to undertake proper Ventgraph model and simulation for the January 2011 incident, the 3D Ventsim model is to be updated to the status of the ventilation network just prior to the incident using the relevant information available from monthly ventilation reports and plans. This task is currently being undertaken and the following figure shows a screen snapshot of the updated 3D Ventsim model at 5 January 2011 prior to the incident.

Figure 6.2 Screen snapshots of the updated 3D Ventsim model as at 5 January 2011.
