Learnings from Middlemount Mine Highwall Fatality 26 June 2019

Presented by:
Dave Champion
Operations Manager / SSE

Incident Overview

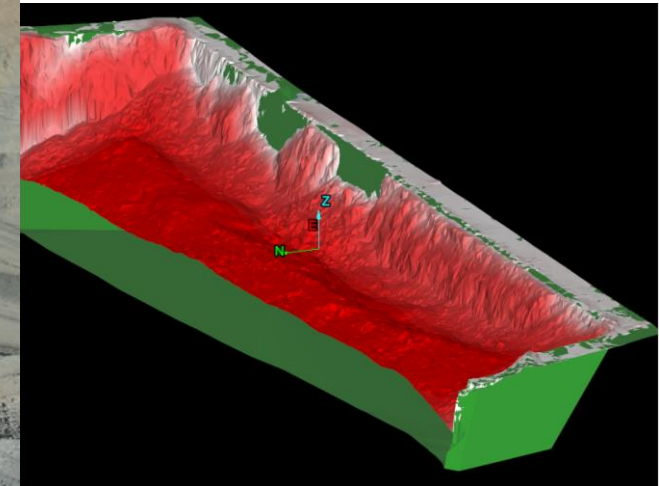
Significant hang-up material evident on southern highwall post blast.

Mining to commence West to East.

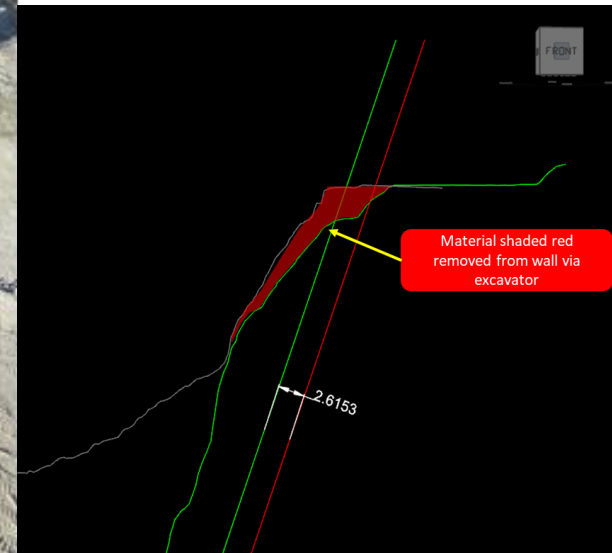
EX65 finished cleaning highwall back to pre-split on upper level.

EX46 was digging back to hard on highwall west to east.
