Mines Inspectorate Report

Stephen Cave Fatality & Serious Injury to

Dawson Mine - 16 February 2015

File GCAN-9TT7GF

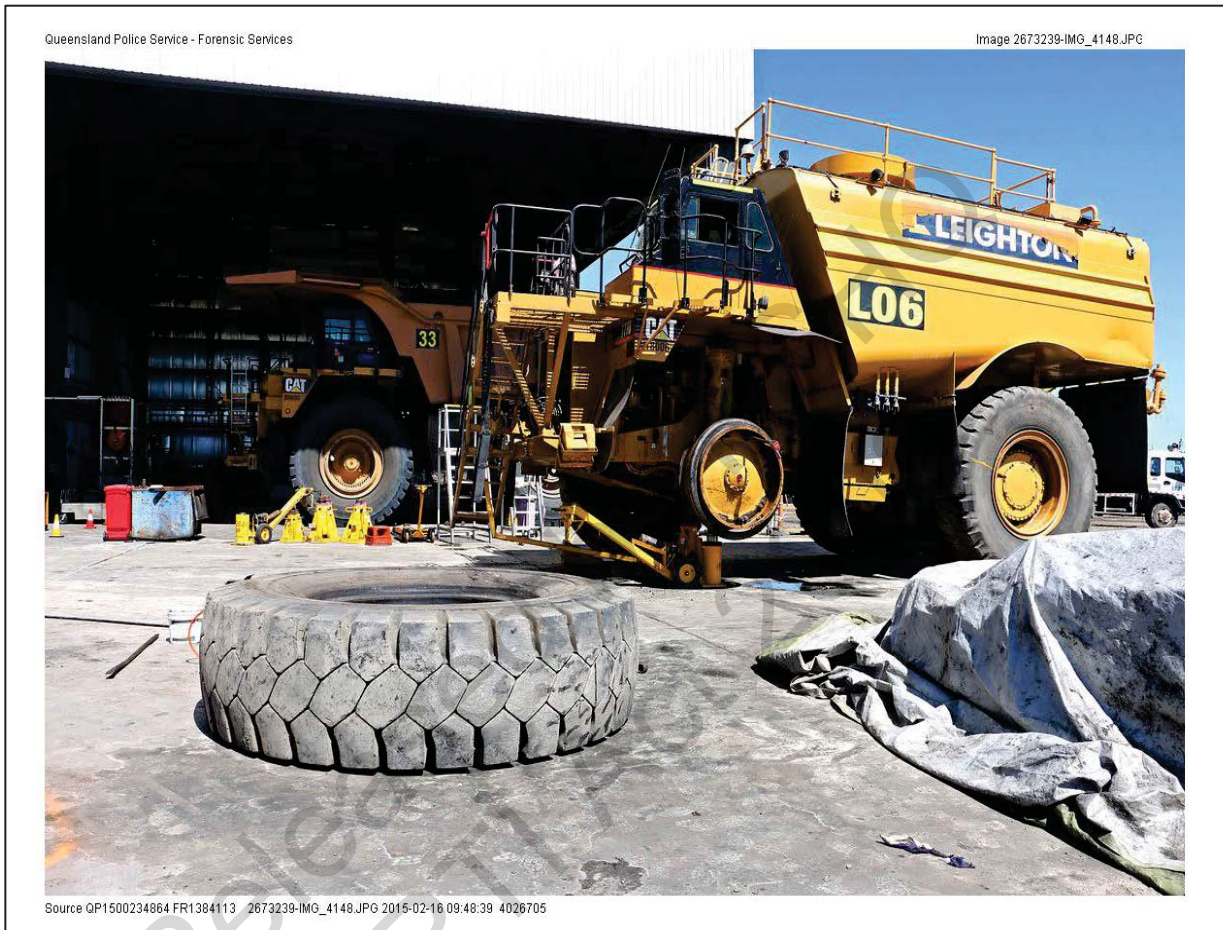
7.2.1 Water Truck WT8006

Figure 3: CAT 777D Water Truck WT8006 post incident (taken by QPS prior to site release).

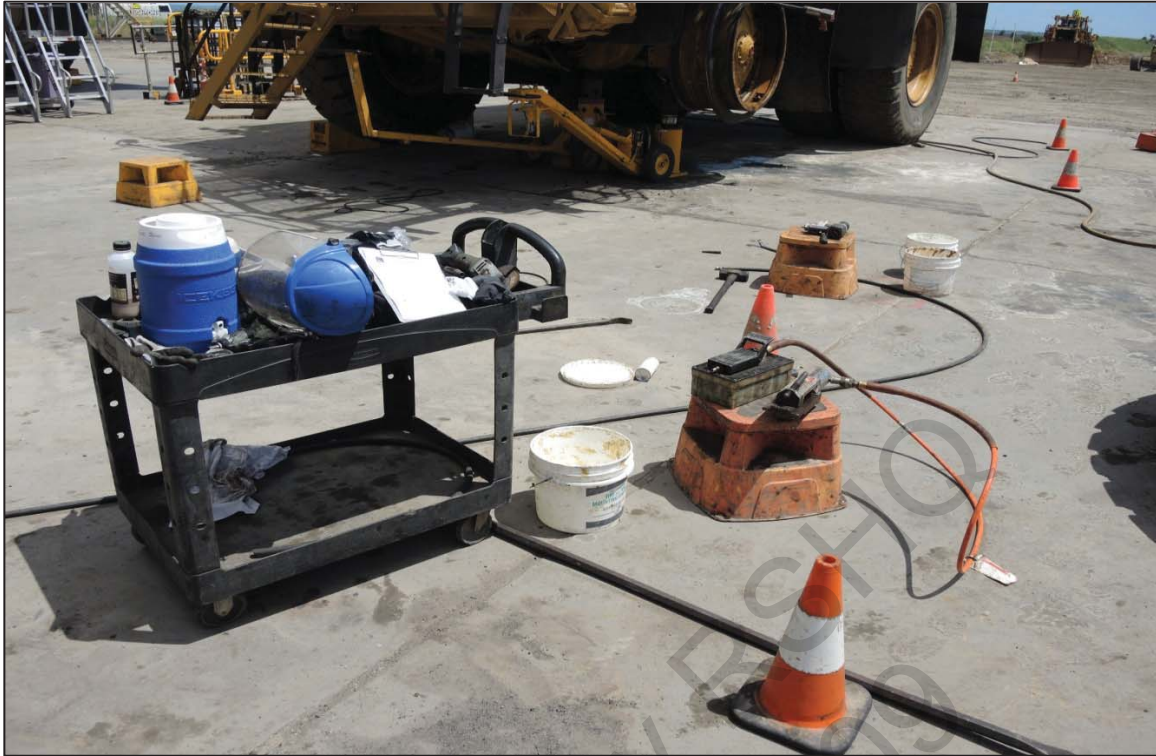
sch4p4(6) Personal information *Figure 5 shows the bead seat breaker on the orange step (foreground)*

Figure 5: Bead Seat Breaker on the Orange Step (DNRM photos taken at the incident scene).

Once it was observed that the tyre bead had been pushed away from the bead seat band, sch4p4(6) Personal i held the Tyre Handler arms in this position, keeping downward pressure on the tyre.

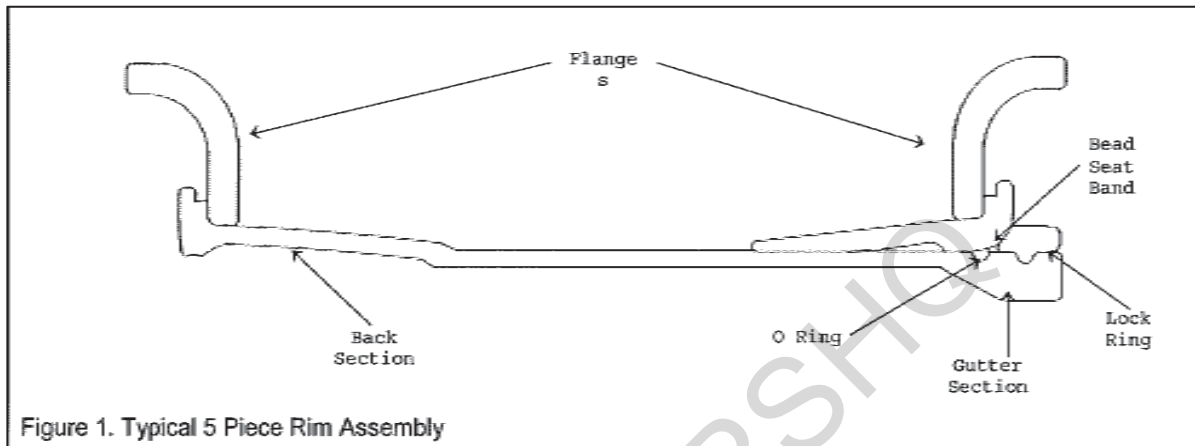
Figure 8: AS 4457.1 - Figure 1 - Earth moving machinery - Off-the-road wheels, rims and tyres – Maintenance & Repair

Figure 8 is a typical 5 piece rim assembly comprising of a rim base, flanges, bead seat band, 'O' ring and lock ring. The above assembly is similar to the construction of wheel that was involved in the incident.

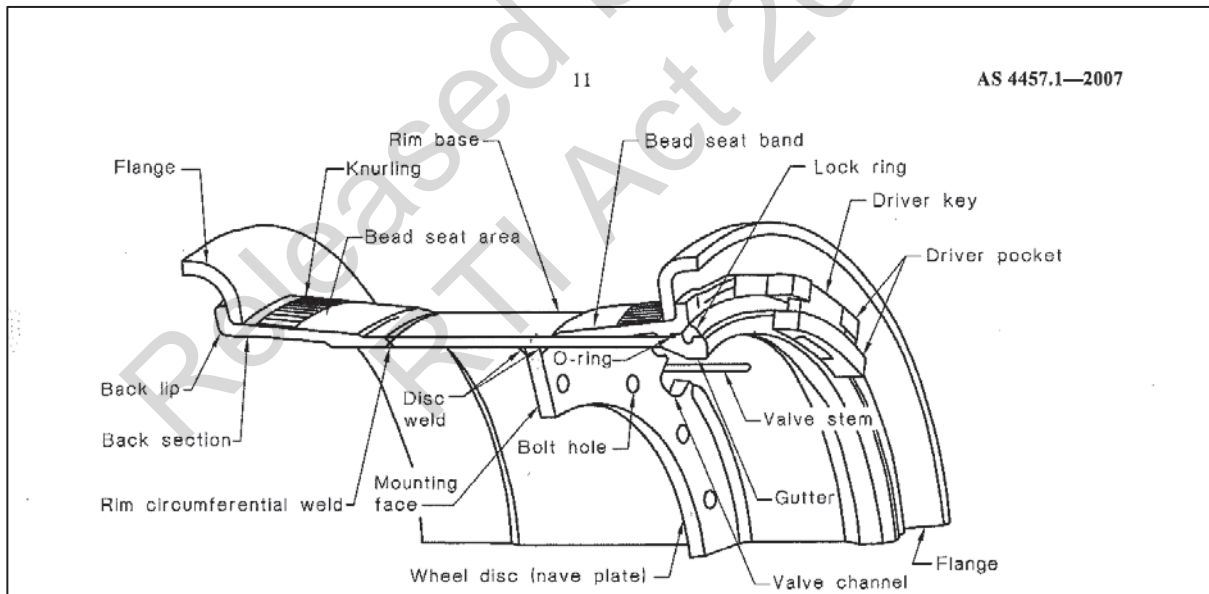
Figure 9: AS 4457.1 - Figure 2 - Earth moving machinery - Off-the-road wheels, rims and tyres – Maintenance & Repair

Figure 9 shows the nave plate mounted asymmetrically on the rim base. The offset from the nave plate to the edge of the rim, is greater on one side than the other. When in operation mode, the large offset protrudes over the drive hub. When in transport mode, the wheel is bolted to the rim 'back to front', which makes the wheel base wider so that the truck can be set down onto a low loader for relocation to another site.

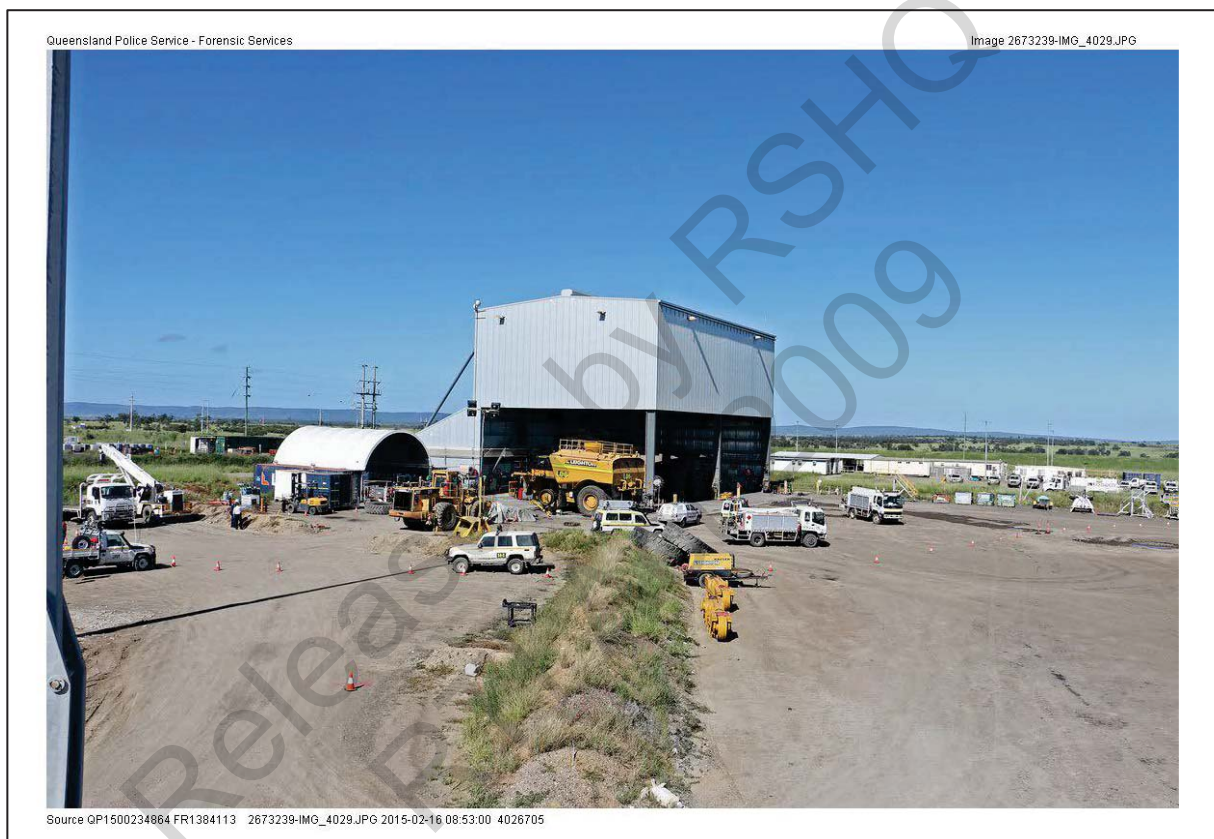
Figure 22 shows Water Truck WT8006 on a concrete pad in the foreground of the photo. The Leighton Contractors administration building can be seen in the background of the workshop.

Figure 22: Shows Water Truck WT8006 in the foreground; the Dawson South Workshop with the administration buildings in the background (taken by QPS prior to site release).

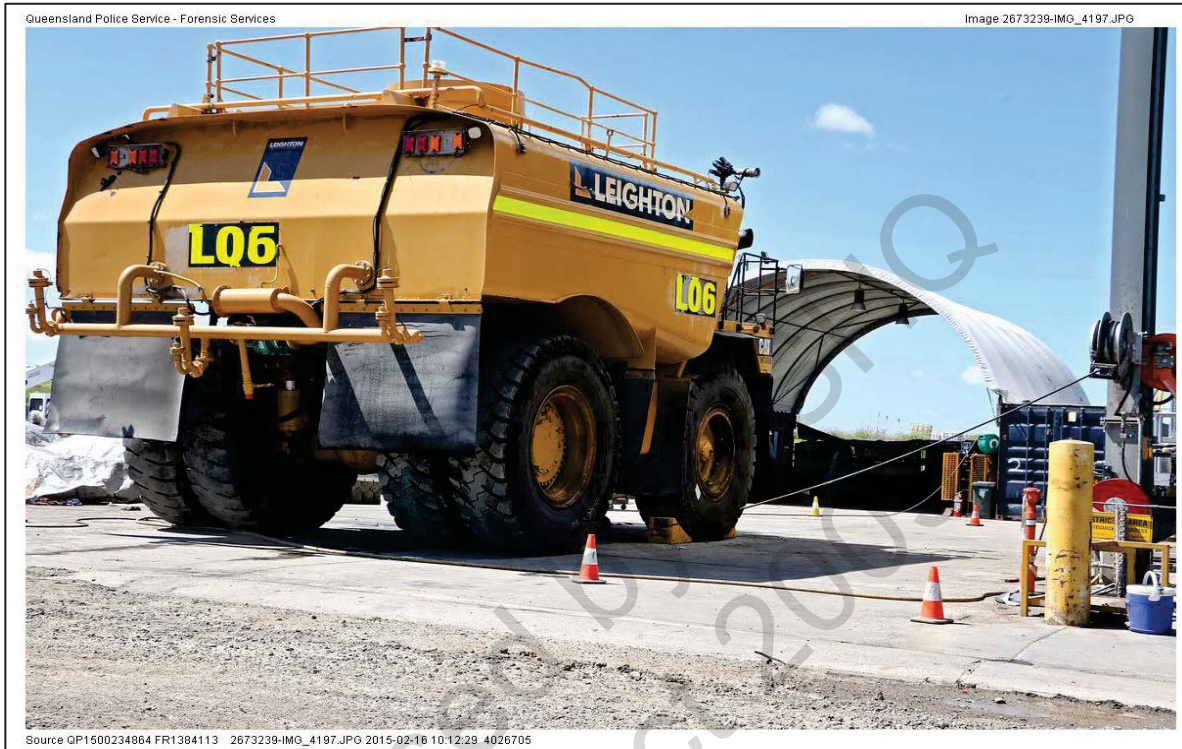
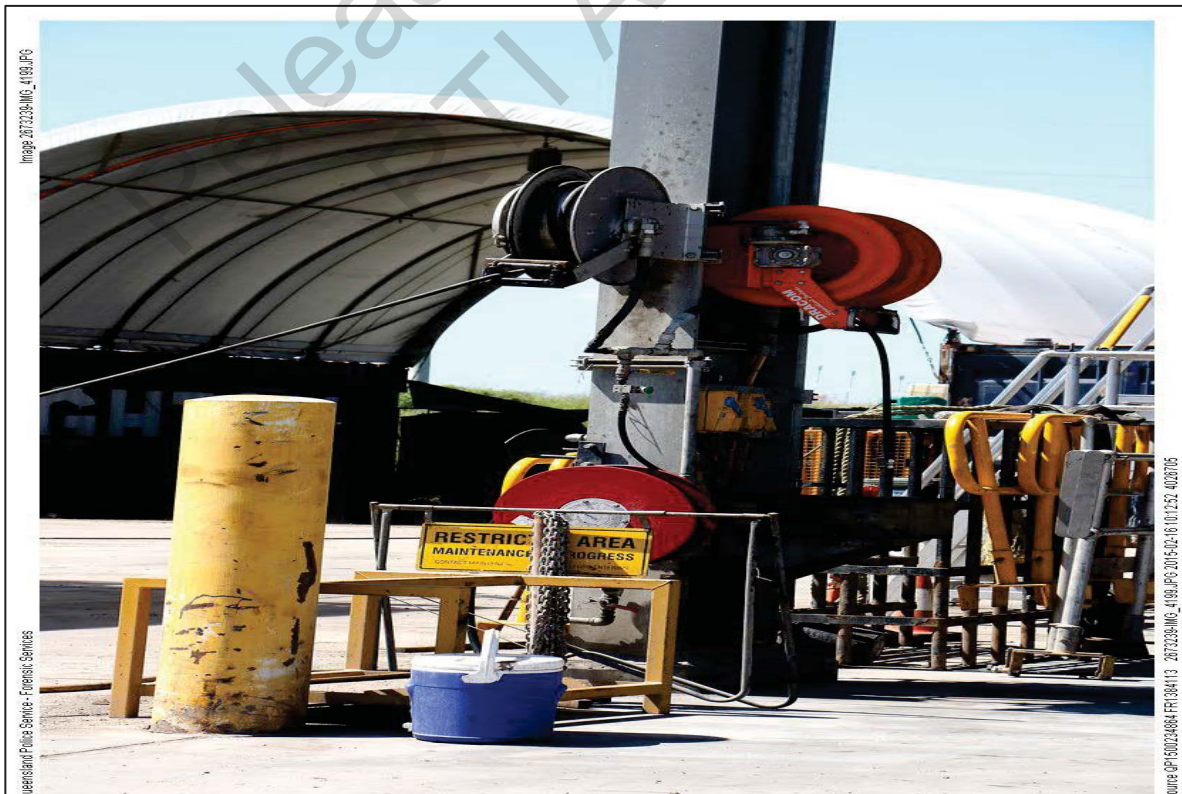
This system is reticulated around the workshop and is supplied from a Compair compressor with a Delcos 3100 control system that is set to an air pressure discharge of 126 psi. The air supply reticulation supply point that was used is shown in figures 23 and 24.

Figure 23: Air supply reticulation supply point (taken by QPS prior to site release).

Figure 24: Air supply reticulation supply point (taken by QPS prior to site release).

The two airlines are used for tyre inflation, as well as air supply for the pneumatic tools. There is a hose reel for pneumatic tools, and a one inch outlet for large bore tyre inflation, which is just out of shot in Figure 24. The one inch outlet has a 'T' section fitting which is connected to an isolation valve and a 'silencer'. This allows the tyre to be deflated through to the atmosphere in a controlled manner with adequate noise reduction.

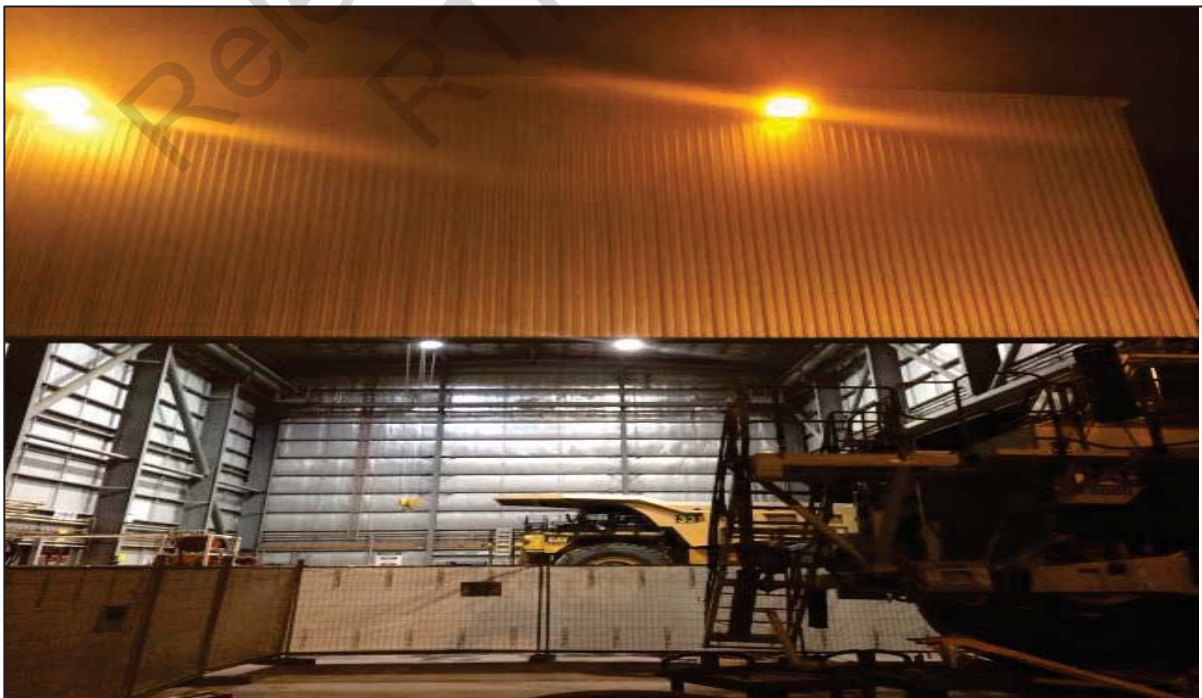
The tyre bay area where tyre fitting activities were taking place is on an external concrete pad approximately 10 metres x 15 metres located on the eastern side (reference direction only) of the workshop. The general area lighting of this pad is provided by two fixed sodium vapour lights mounted on the eastern side of the building (refer Figure 27). It should be noted that the illumination from this lighting is significantly reduced to the area of the Position 1 wheel hub on the eastern side of the water truck, as the body of the water truck shadows this area.

Figure 27: Fixed sodium vapour lights mounted on eastern side of building (taken from Simtars Occupational Lighting Survey) (Thiess)

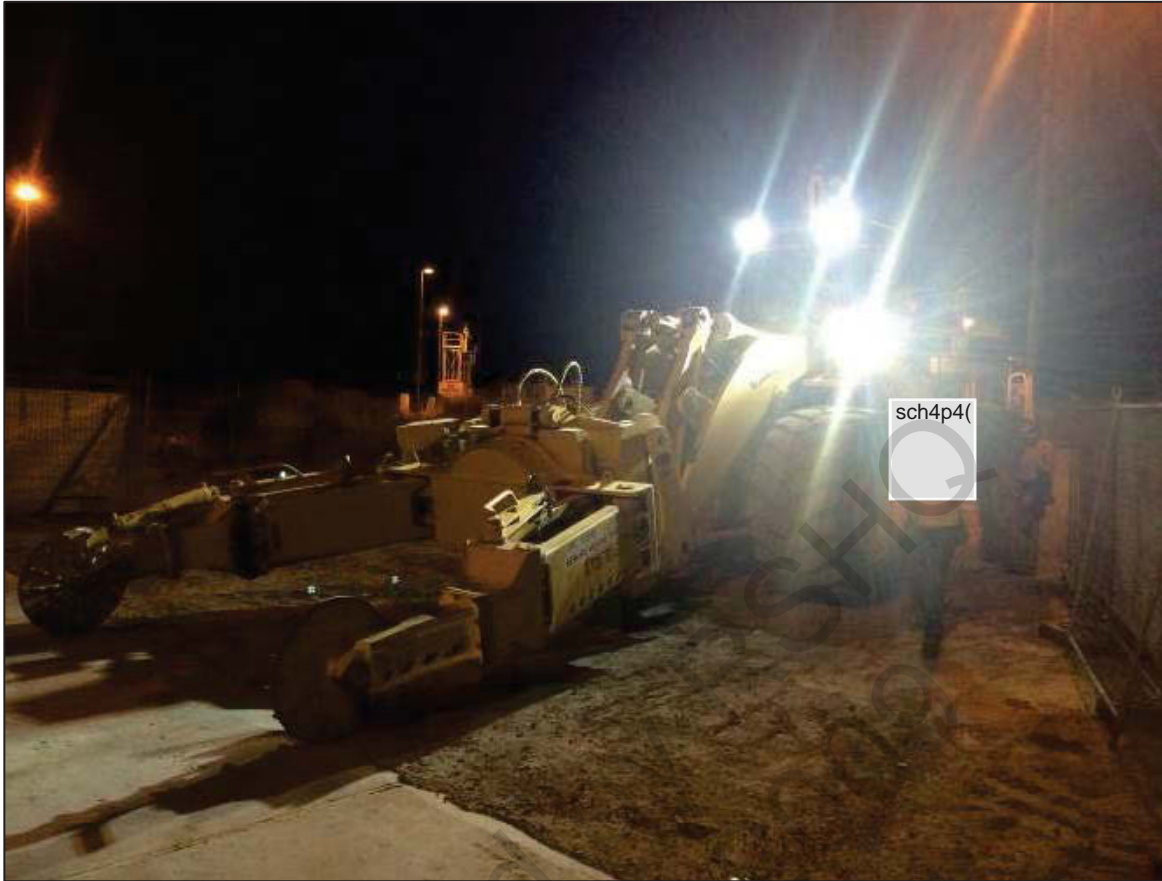
Figure 29: Lighting from Tyre Handler (taken from *Simtars Occupational Lighting Survey*) (Thiess)

On the shift in which the incident occurred, the transportable lighting plant was not working after 1910 hours, and with the water truck in position at the tyre bay, the only lighting sources would have been from the Tyre Handler and personal cap lamps.

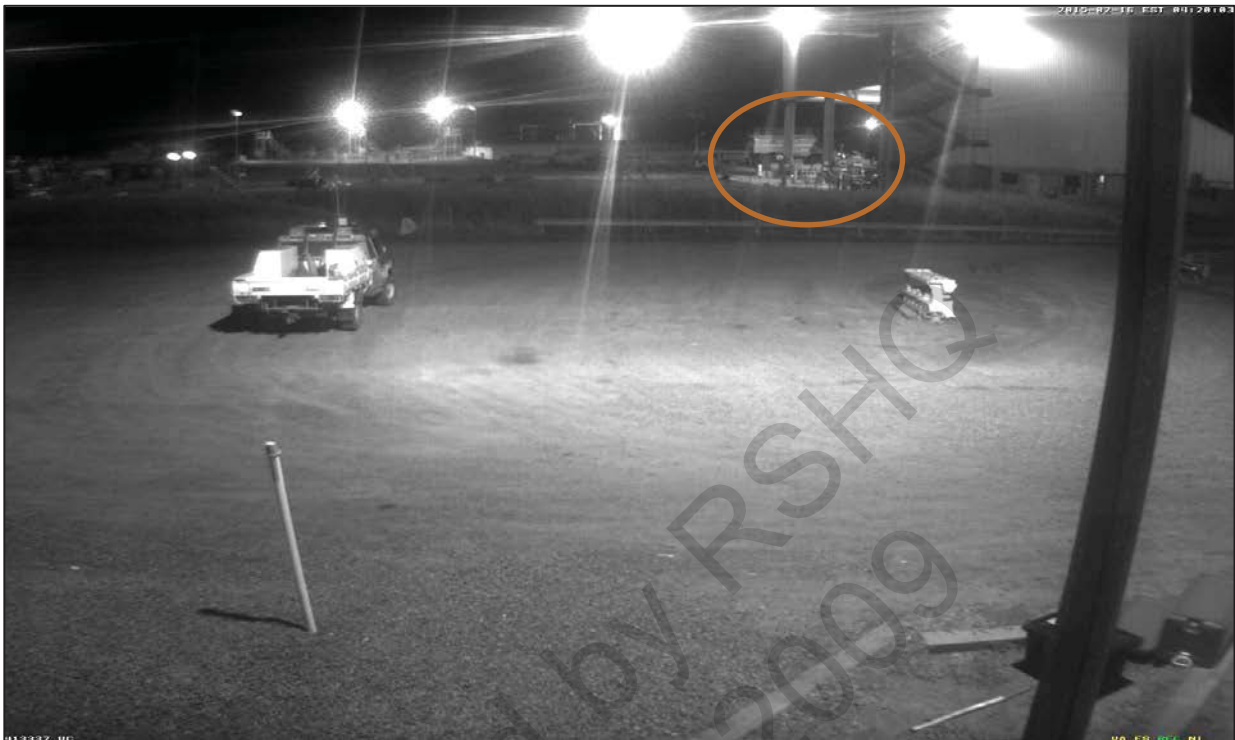
done on Position 1 wheel was determined. Figure 30 shows a still shot from this camera. The water truck (circled) involved in the incident can be seen in the background on the north east corner of the building.

Figure 30: Dawson South Carpark Camera 1 still shot (taken from CCTV footage).

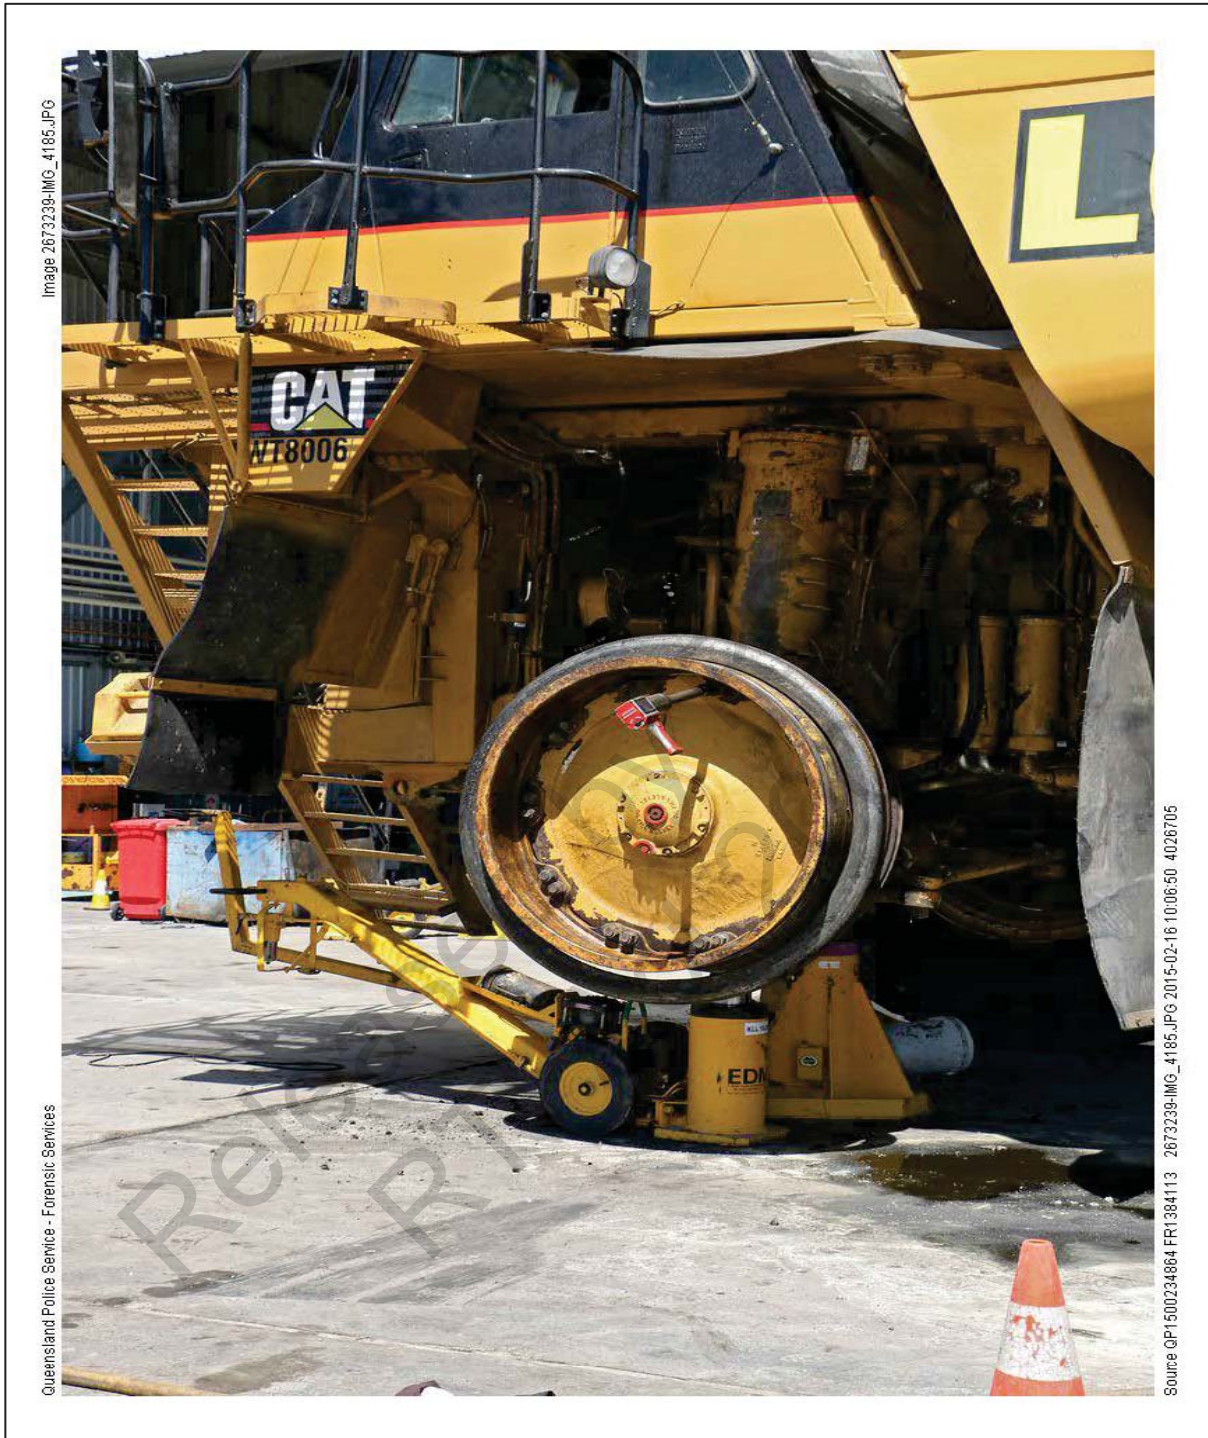
At the time of the incident, sch4p4(6) Personal was in the process of tightening the wheel nuts to a tension of 900N/m. This was done by using a pneumatic torque multiplier, 'Norbar' model number 18033 (Appendix 39). Figure 31 shows the Norbar still in the position where it was being used when the incident occurred.

Figure 31: Norbar in position being used when incident occurred (taken by QPS prior to site release).

The airline was attached to the Norbar at the time of the incident, but has suffered subsequent damage as a result of the incident. As rim components, or tyre, have been ejected from the truck, the airline fitting in the Norbar was broken.
