Royal Commission on the Pike River Coal Mine Tragedy

Volume 2

Date of Publication: October 2012

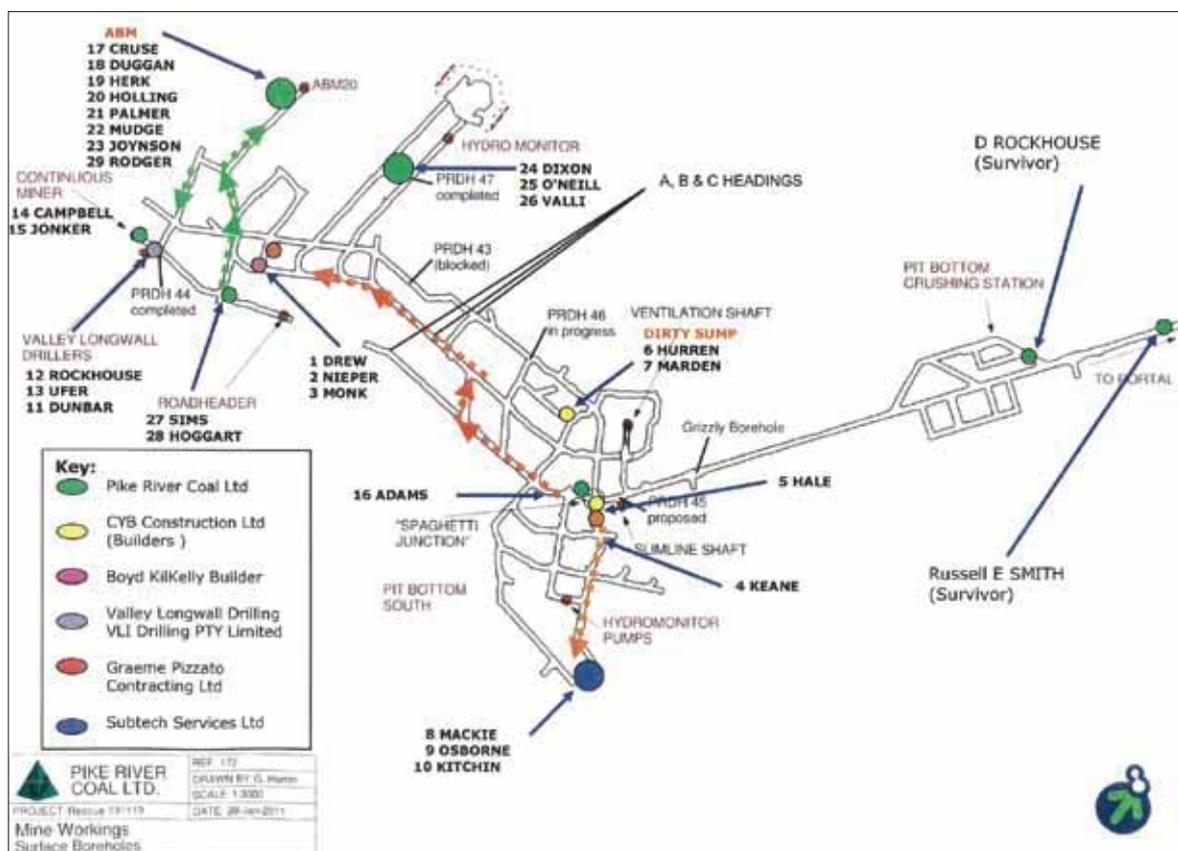
Figure 1.1: Last known position of the 29 deceased and two survivors²

6. The positions can only be indicative. They were fixed from the last sightings of the men by people who were also underground but left before the explosion, and also by reference to the work the men were to undertake that day.

37. To escape the effects, Daniel Rockhouse went inbye towards the crushing station (see Figure 1.1). It was clearer, but there was no place of refuge. He donned and activated his self-rescuer and moved back out to the main drift. The self-rescuer did not seem to be working properly so he discarded it. In the drift, next to his loader, he was overcome and fell to the ground again. He shouted for help, but there was no response. His eyes watered, his body tingled and he thought he was 'shutting down'.¹⁵ He lapsed into unconsciousness.

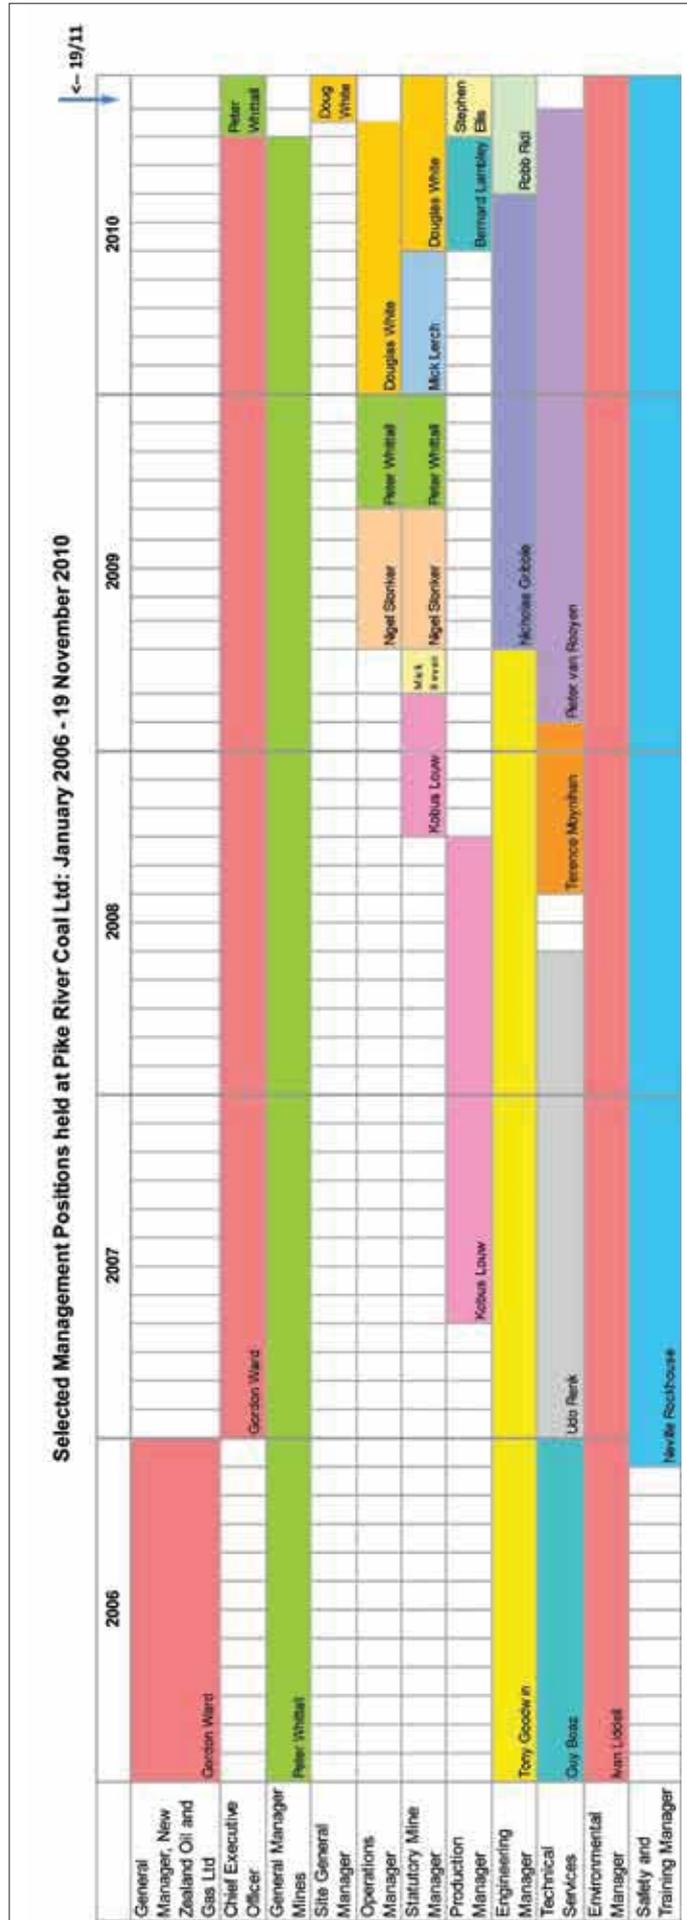
Figure 6.1: Selected management positions held at Pike River Coal Ltd, January 2006–19 November 2010⁹

5. Pike had a high turnover of miners underground,² and was unable to retain personnel in many key operational management roles.
6. As shown in Figure 6.1, from the time the mine was classified as a gassy coal mine in November 2008, Pike had six mine managers, two technical services managers and three engineering managers. In 2010 the mine had two production managers.
7. The high management turnover 'compromised [Pike's] functioning and continuity',³ owing to inefficiencies, loss of institutional knowledge and the need for employees to adjust to differing management styles. There was no systematic handover process when staff changed; the exception was Pieter van Rooyen's handover when he left Pike in November 2010.⁴

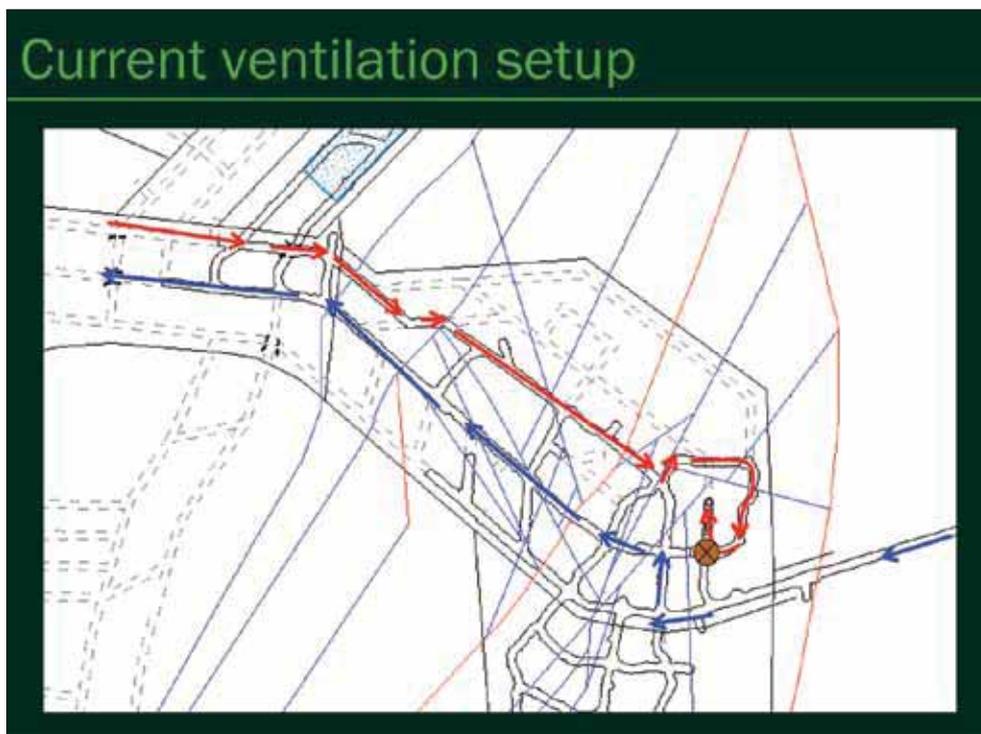
Figure 8.4 : Current ventilation setup⁶¹

46. Pike's early planning contemplated multiple intakes beyond the first year of development.⁶⁰ In November 2010 the Pike River ventilation system was still a one intake and one return system, as shown in the following diagram:

47. The blue arrows depict fresh air entering through the intake (main drift), circulating through the workings and exiting through the return, shown in red. The main underground fan is depicted as a circled X towards the bottom right of the diagram, at the base of the ventilation shaft. Mr van Rooyen presented this simplified diagram of the Pike ventilation system to the Pike board in August 2010.

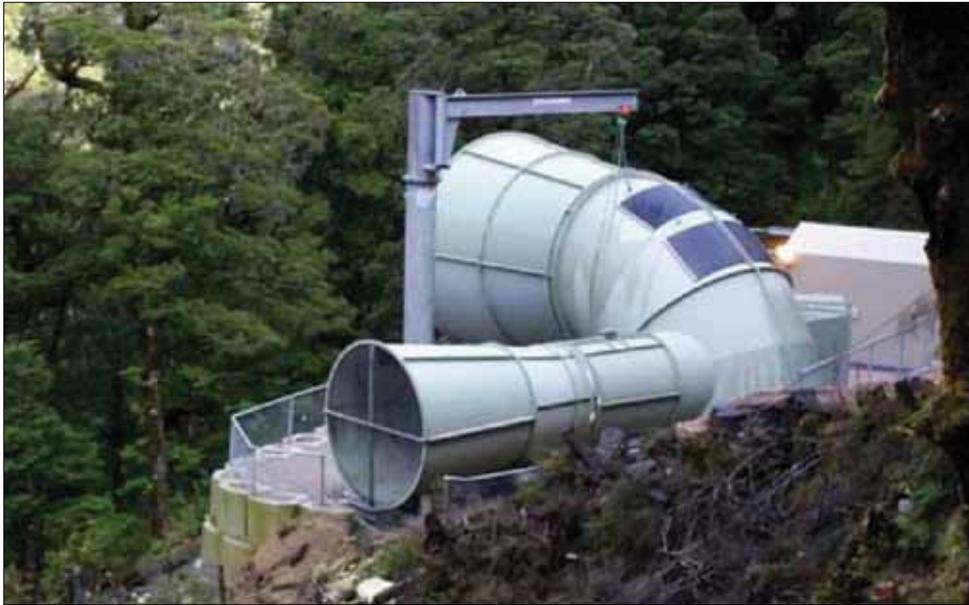
Figure 8.5: The surface back-up fan

50. Pike installed the surface back-up fan at the top of the ventilation shaft in June 2009. The exhaust structure (evasé) for the surface fan is on the left in the photograph, and the larger evasé is for the main underground fan.

51. Fläkt Woods designed, built and installed the surface fan. It was powered by a 132kW electric motor with a capacity of 90m³/s air flow at 0.4kPa (kilopascals) pressure.⁶⁶ The fan acted as the primary fan until the first main fan was commissioned underground.
52. The diagram below shows a bird's-eye view of the surface fan as installed. In the centre was the main underground fan evasé, designed to direct the air flow horizontally and prevent rain or snow entering the ventilation shaft.⁶⁷ The surface fan impeller (blades) and motor were to the right. To the left was an airlock entrance allowing access to the fan housing. Anyone climbing the ladder in the ventilation shaft would also exit through the airlock.

53. On the top of the housing were four explosion panels, designed to allow a pressure wave of air and debris following an explosion to go straight through the top of the housing and minimise damage to the fan. The explosion panels are seen in black in Figure 8.5.
54. Because both the surface fan and main underground fan were connected to the same ventilation shaft, a system was needed to block off air flow through one or other easé, depending which was in use. Initially Fläkt Woods designed a butterfly damper for that purpose, but this was damaged and not repaired for 12 months or more.⁶⁹ During commissioning of the underground fan a few weeks before the explosion, Pike installed a set of louvres at the end of the main fan easé as shown below. These were designed to close if the main fan stopped and the surface fan started up to ventilate the mine.

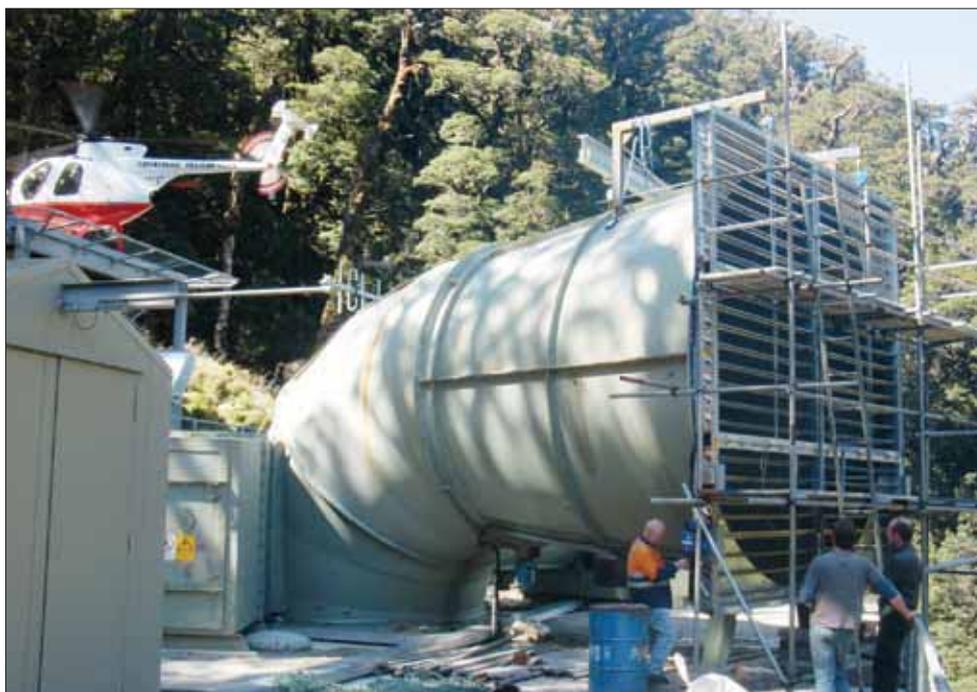
Figure 8.7: Easé showing louvres being installed

55. The surface fan was powered by electrical cabling that ran from the portal substation up the main drift and then to the surface via the shaft. This was unusual. It meant that if power was tripped to the main fan at the portal, for example because of methane in excess of 0.25% in the vicinity of the fan motor, power would also be unavailable to the surface fan. Accordingly, diesel generators were installed to start automatically if the main fan stopped, enabling the surface fan to operate.⁷⁰

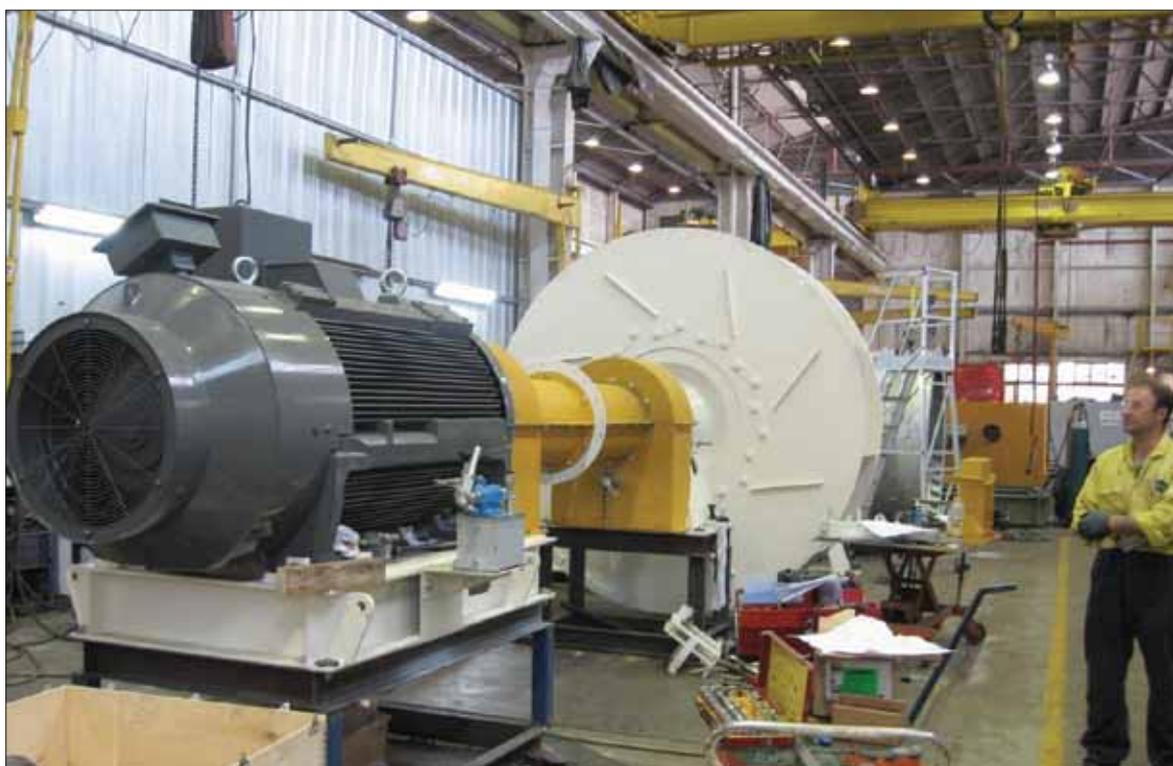
Figure 8.8: Underground fan being assembled in factory

60. Pike's first main underground fan was installed in August and September 2010. Its size and configuration are shown in the photograph below. The fan motor (grey) is in the foreground, with the drive shaft (orange) connecting to the fan impeller (white).

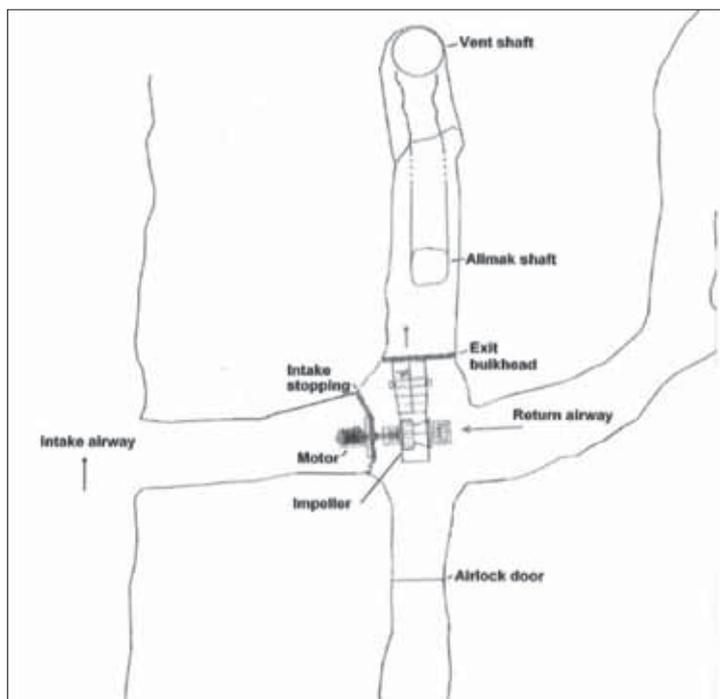
Figure 8.9: Orientation and operation of underground fan

62. Air entered from the return airway to the right of the diagram, then passed through the impeller and up the Alimak shaft. The non-flameproof motor was in fresh air on the intake side and sealed off from the fan impeller by a stopping, through which the drive shaft passed. The exit bulkhead was partly fitted with louvres, which were closed when the fan was working, but opened when it tripped. This enabled the surface fan to draw air more easily up the ventilation shaft to maintain mine ventilation. The airlock doors prevented return air from entering the mine intake system.

65. The main fan was first operated on 4 October 2010, but sparks came from the fan shaft at the junction with the intake stopping through which it passed.⁸⁵ To resolve the problem Pike removed a brass bush, which formed a seal between the drive shaft and the stopping.⁸⁶ This left a gap which Mr Sanders estimated was at least 20mm.⁸⁷ Mr White accepted there was potential for methane-contaminated air to leak through the gap if the fan was not operating.⁸⁸

73. This was described as 'somewhat deficient' by the joint investigation expert panel, who noted protection was a standard requirement in underground booster fan installations 'albeit in the form of a bypass mechanism'. Installation of explosion protection by means of a bypass in the underground workings near the fan 'may have contributed to reducing the extent or even the level of damage to the mine; as well as providing potential survivability of the ventilation system for later operation'.¹⁰⁵

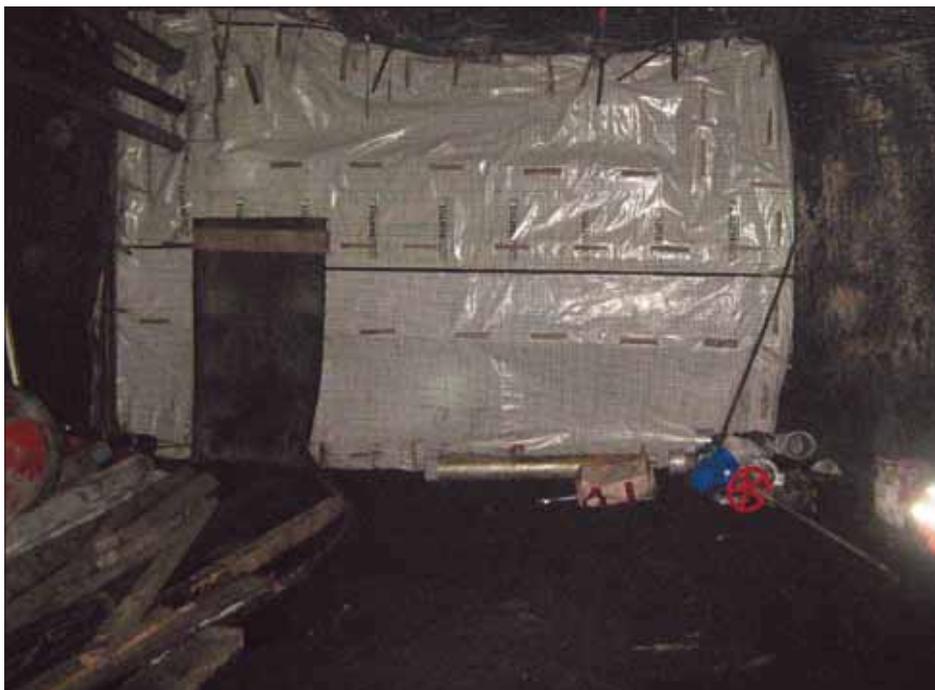
Figure 8.12: Board and brattice stopping¹⁴⁸

104. Stoppings must be constructed to a suitable standard to avoid leakage, which can compromise the performance of the ventilation system. Stoppings should also be built to withstand the pressures that may follow a roof fall or windblast within the mine.¹⁴⁹

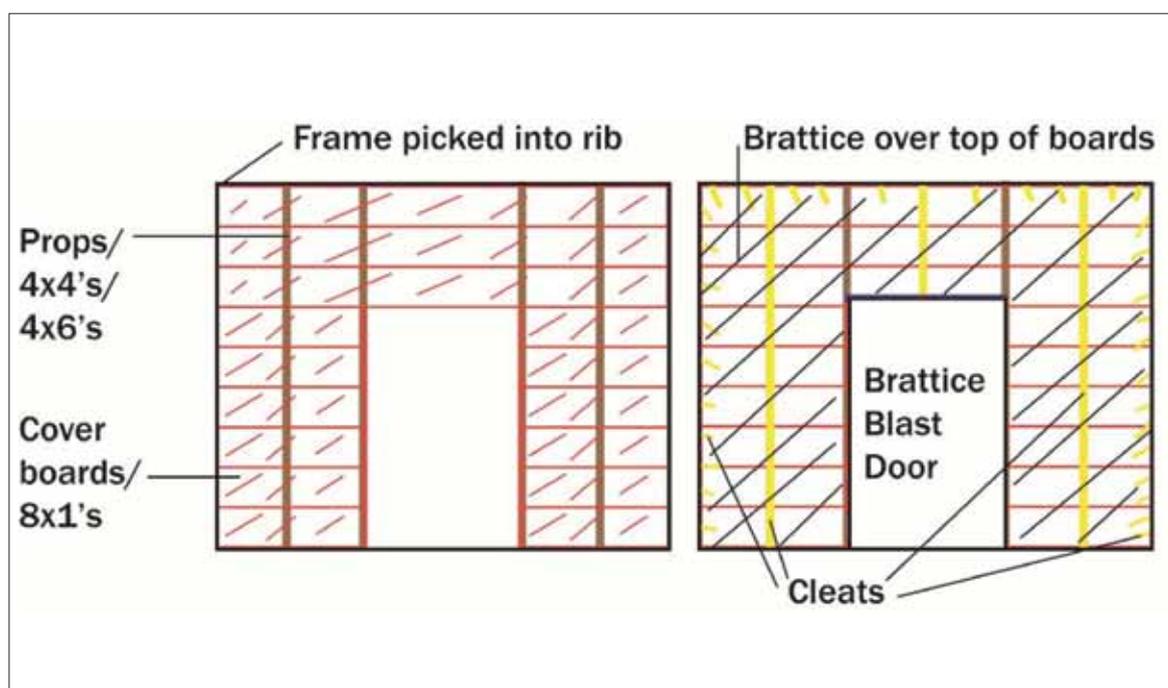
Figure 8.13: Board and brattice construction method¹⁶²

113. In May 2010 Pike issued a standard operating procedure document entitled 'Underground Standards', which set out the standard for both temporary and permanent stoppings.¹⁶¹ The basic construction method was the same for both, namely board and brattice construction, as depicted in the diagram below and in Figure 8.12.

114. The construction method was essentially to use standard timber covered by brattice. The main difference with permanent stoppings was that these were covered in mesh and sprayed with shotcrete (this is concrete or mortar

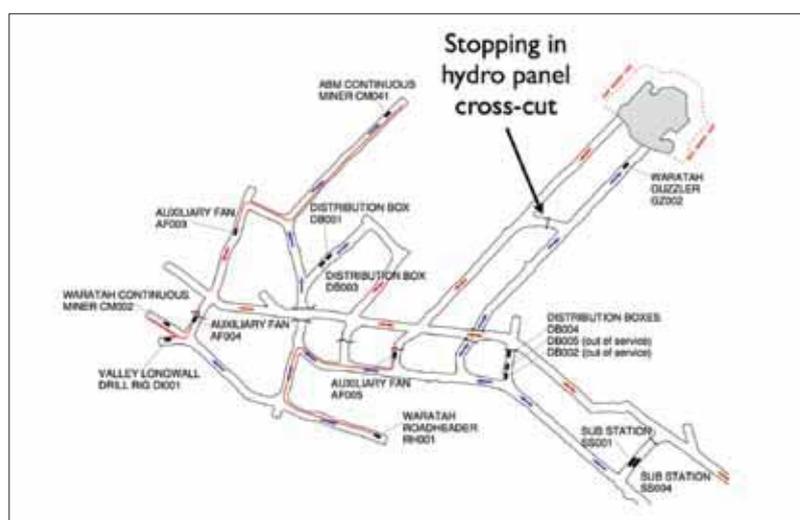
Figure 8.14: Stopping in hydro panel cross-cut¹⁶⁵

116. On 30 October 2010 there was a large roof fall in the goaf in the hydro panel. The roof fall generated a pressure wave that knocked over the stopping at cross-cut one in the hydro panel, marked in the diagram below.

117. The incident occurred around 4:00am on 30 October 2010. Steve Wylie was the deputy on duty. Just before the roof fall the crew had been cutting to the left of a stump of coal in the goaf. Slabs of coal had been falling from the side of the stump, most likely as a result of downward pressure from the roof of the goaf. Mr Wylie heard the roof collapse and saw that it had fallen in, covering the front of the monitor.¹⁶⁶

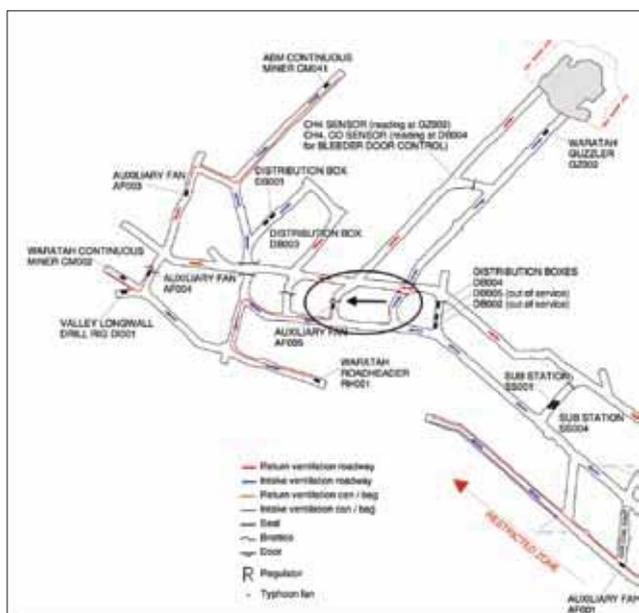
Figure 8.16: Hydro panel and cross-cut 3¹⁸⁴

125. The DOL investigation team carried out a detailed analysis of the ventilation control devices at Pike River, and concluded their quality was 'extremely variable'.¹⁸⁰ The stoppings near the main ventilation fan were made of steel and concrete, and rated to 35kPa. A number of stoppings were constructed using 'pogo sticks', expandable poles with an internal spring often used to hold up cables within the mine. Mr Reece described pogo sticks as 'very temporary arrangements',¹⁸¹ not intended for any type of permanent construction. The mine was attempting to achieve a number of permanent stoppings in the months leading up to November 2010, although these would not necessarily be rated.¹⁸² The stoppings in November 2010 would not have complied with Queensland standards.¹⁸³
126. The DOL investigation stressed the significance of the stopping at cross-cut 3, marked with an arrow below.

127. That stopping was directly in line with the return from the hydro-monitor panel. Any significant roof fall in the hydro goaf would create an overpressure down the return, and the stopping would need to withstand that pressure.
128. Despite that risk, the stoppings at cross-cuts 3 and 4 remained in a temporary state on 19 November 2010. The collapse of the stopping at cross-cut 1 in the hydro panel on 30 October 2010 had served as a warning of this vulnerability, but Mr White said it was 'not likely' any consideration was given to the matter, even following the 30 October incident.¹⁸⁵
129. Mr van Rooyen agreed with the criticism of the stopping at cross-cut 3, and said it 'should have been made permanent preferably before or certainly early on in the excavation of the hydro panel'.¹⁸⁶ He agreed that the

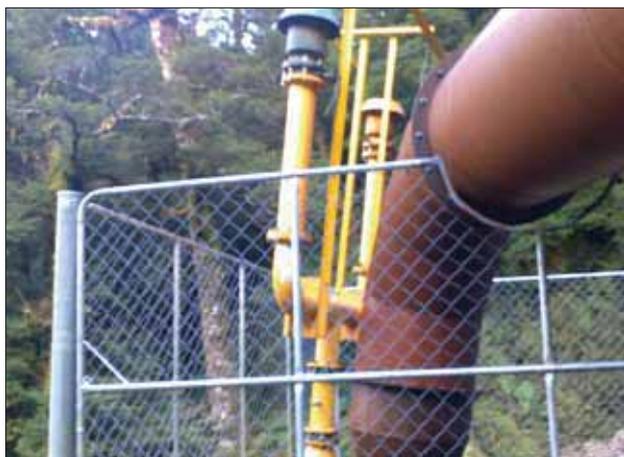
Figure 9.4: Gas riser and slimline shaft⁴⁵

53. The collapse of the ventilation shaft on 2 February 2009 severely limited mine ventilation. To recover air capacity, Pike drilled the slimline shaft from the same surface drill pad location it had recently used to install the gas drainage system. Figure 9.4 below shows the gas riser (yellow) with flame arrestors, and the brown pipe is connected to the top of the slimline fresh air shaft.

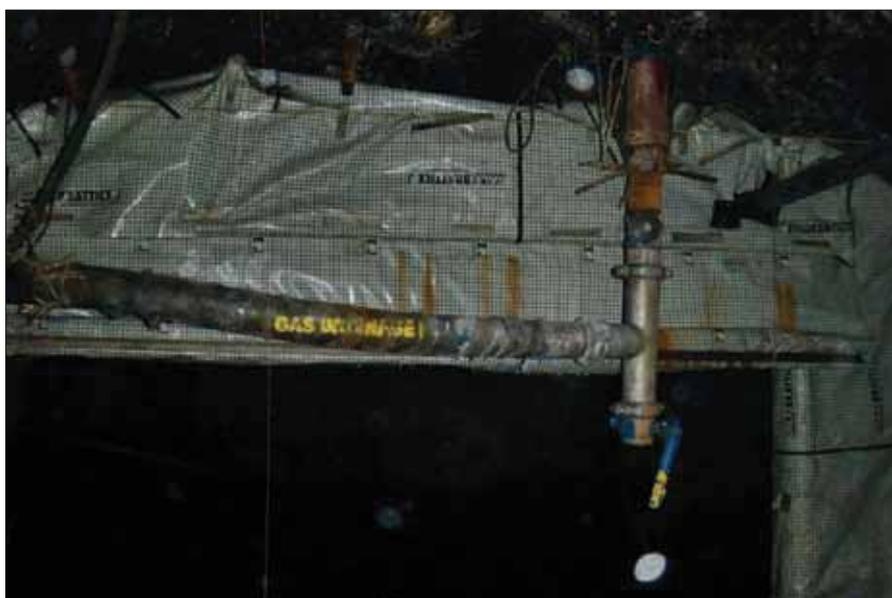
Figure 9.5: Bottom of gas riser at entrance to the FAB

54. The bottom of the 6" riser is shown below connected to the 4" gas drainage line labelled in yellow, at the entrance to what became the fresh air base (FAB) in mid-2010.⁴⁶

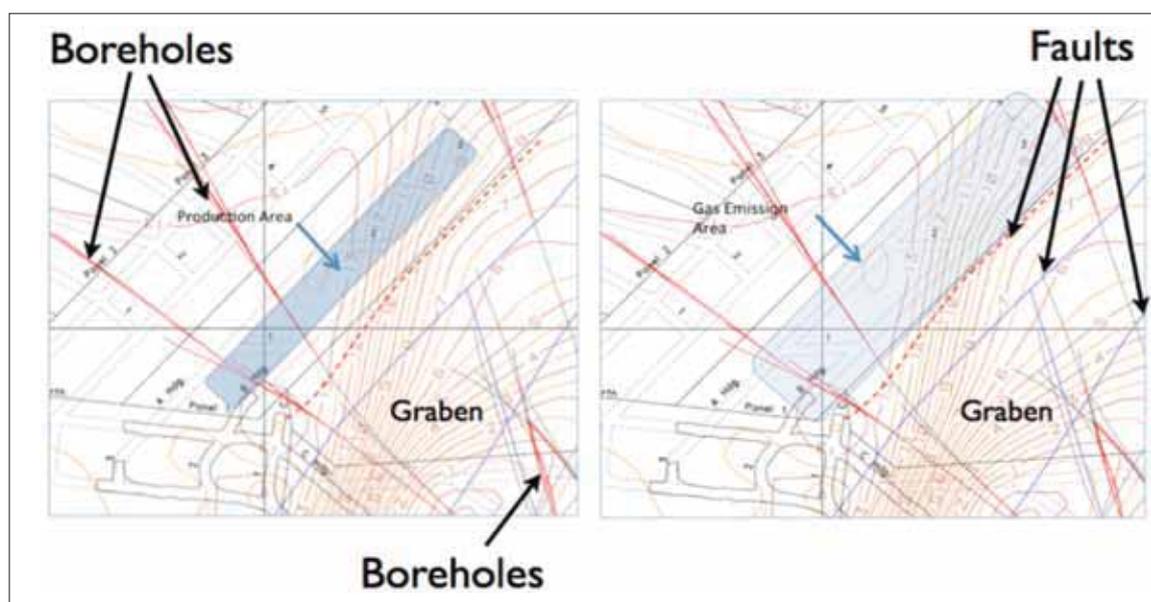
Figure 9.8: Panel 1 production area and panel 1 area of interest for gas emissions¹²⁹

109. The following diagrams show the proposed production area of the hydro panel, and the expected gas emission area for gas flows from the surrounding strata.¹²⁷ Long in-seam boreholes intersect the panel,¹²⁸ and faulting to the east of the panel is shown.

110. Borehole GBH016 was subsequently drilled 'flanking' the eastern boundary of panel 1, but no drainage holes were drilled within or to the west of the panel. GBH016 and the intersected boreholes were designed primarily for exploration of the seam, not for systematic pre-drainage of methane from the panel before mining.¹³⁰
111. The gas content core sample result of 8.29m³/t from GBH016 underlined the need for further drainage of the area, particularly given the use of an untried hydro-extraction method in a thick seam with the likelihood of high methane release. However, coal extraction from panel 1 began without pre-draining the seam down to safer gas levels.

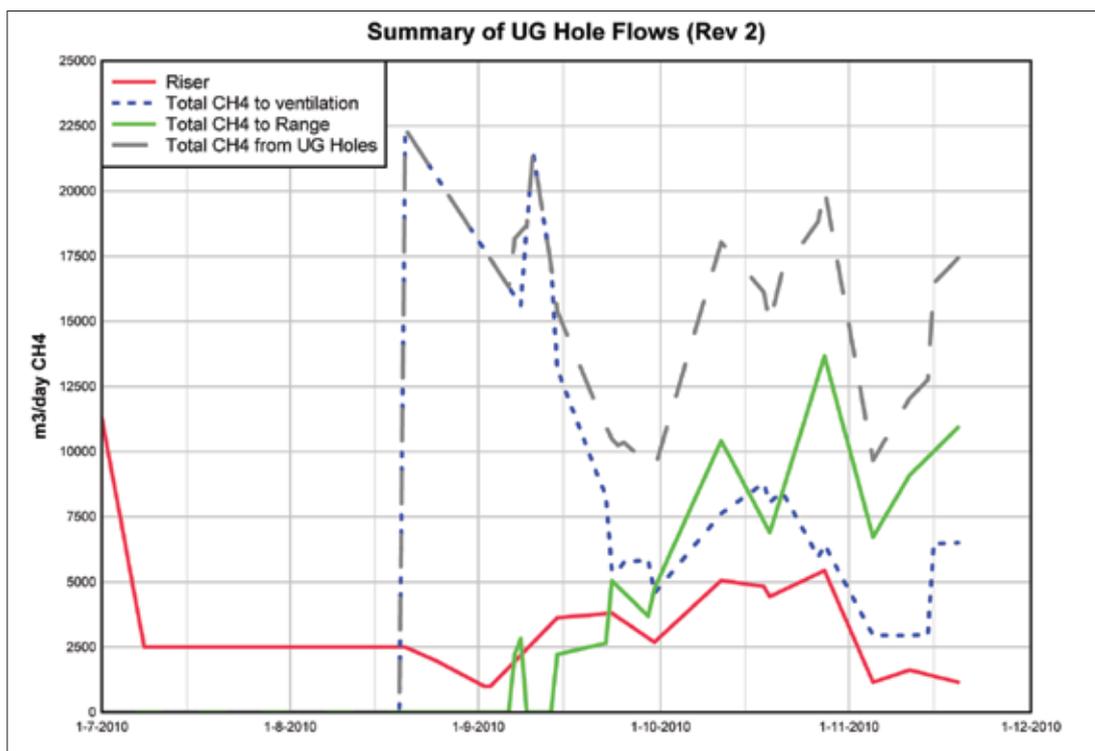
Figure 9.9: Graph summarising total daily drainage system gas flow measurements¹⁵⁰

126. The following graph prepared by the joint investigation expert panel¹⁴⁹ summarises the total daily methane volumes (m^3/day) for the drainage system gas from July 2010 until the explosion. The red line depicts the volume of methane measured at the bottom of the gas riser, which decreases from the beginning of July when the practice of free venting began with GBH012 disconnected from the range. The blue line shows the volume of methane free vented to the mine's atmosphere for dilution by ventilation; and the grey line shows the total methane flow from all boreholes. These measurements began on 20 August 2010, the start of gas flow measurement from individual boreholes. The green line shows the total methane volume flowing into the range from September 2010 when weekly gas drainage measurements commenced.

127. The noteworthy features are the high volume of methane free vented when compared to the volume of gas entering the range, and the difference between the volumes entering the range and reaching the bottom of the riser. For example, on the day of the explosion the measured gas flow into the range was 126.4l/s but only 13.3 l/s was measured at the gas riser. Such discrepancies dated back to the beginning of October. Various explanations for the difference have been suggested including leakage, methane back-feeding into other areas, a blockage in the range or incorrect measurements at the gas riser.¹⁵¹
128. As late as 27 October 2010, there was no accurate recording of methane emissions and no comprehensive system in place to capture, record and store all data permanently.¹⁵²
129. The expert panel criticised Pike's gas management approach:

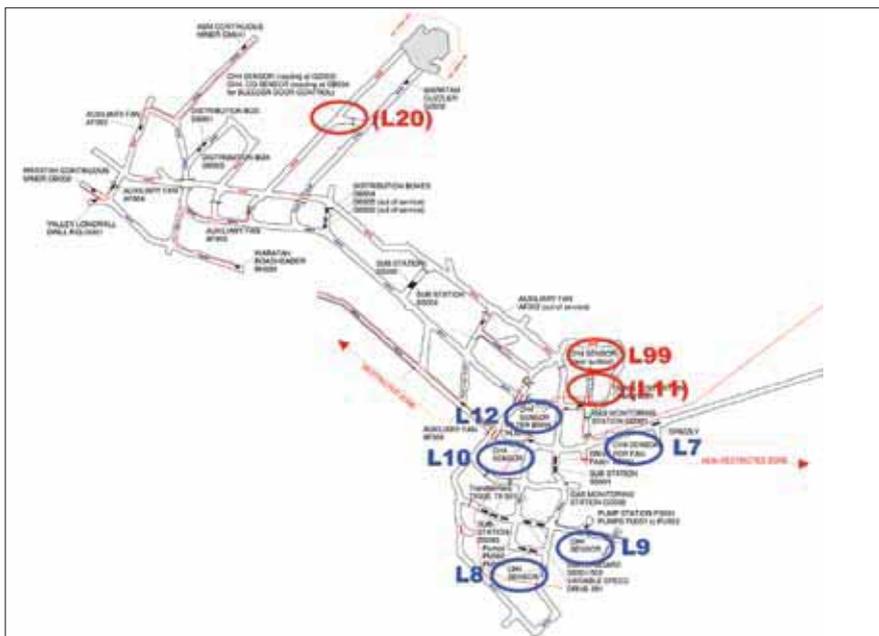
Figure 10.1: Location of fixed methane sensors²²

11. As at 19 November 2010 there were eight fixed methane sensors connected to the surface control room,²¹ shown in Figure 10.1.

12. The five sensors circled in blue were all located within the intake roadways, in areas expected to be ventilated by fresh air. These sensors were located at or near electrical equipment in an area Pike designated as the 'non-restricted zone'. Regulations require the non-restricted zone to contain no more than 0.25% flammable gas. The sensors in this area at Pike River were set to trip power at 0.25% methane.

14. The sensor at L11 stopped working on 4 September 2010,²⁴ and the sensor at L20 stopped working on 13 October 2010,²⁵ leaving Pike with no gas sensors reporting to the surface from further into the return than the ventilation shaft. This did not give the mine adequate information about the location, source and quantities of flammable gas within the mine. Surface controller Barry McIntosh said the controllers had raised the issue of the location of gas sensors, and in his view the gas sensors 'weren't up far enough' in the mine.²⁶

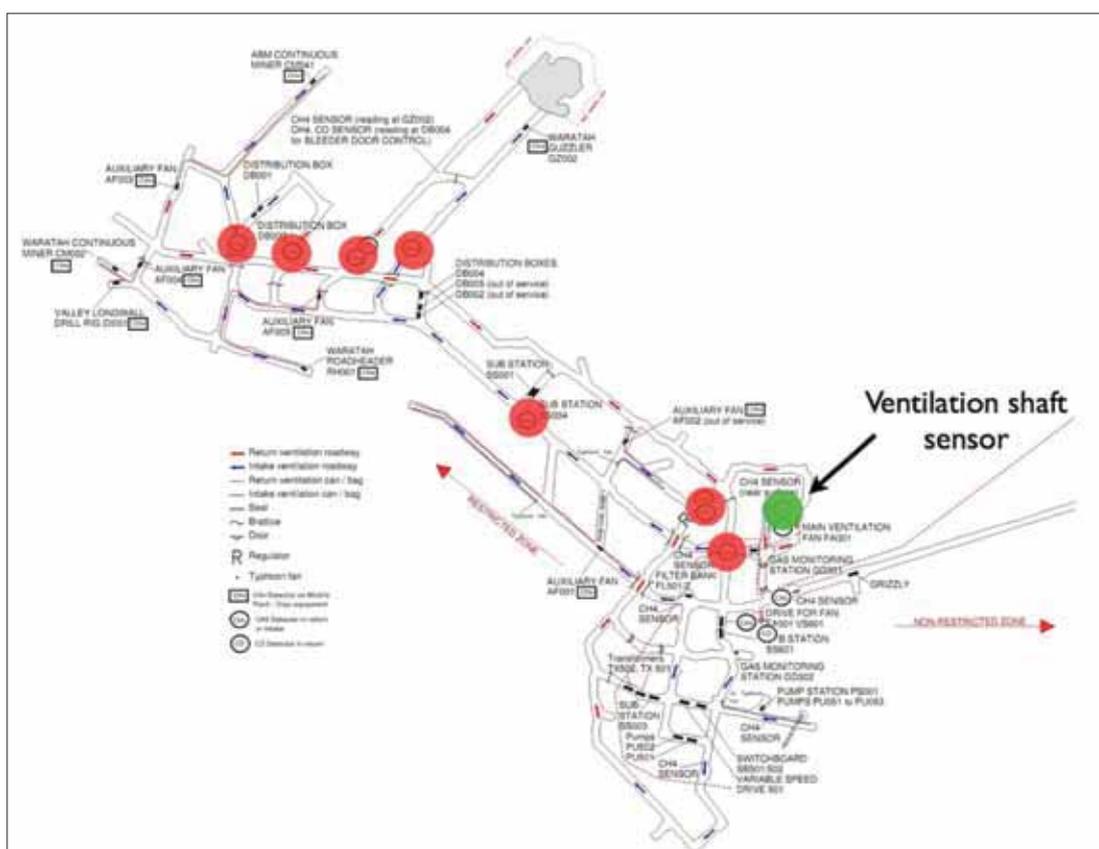
Figure 10.2: Plan of required gas sensors at Pike River under Queensland legislation²⁷

15. By way of comparison, consultant David Reece provided on request a plan showing where Pike would have typically required gas sensors under Queensland legislation. His plan was not absolute and was subject to a number of technical qualifications including the proximity of other detectors, but on the basis of the plan, Pike would probably have required seven fixed sensors (marked in red) reporting to the surface from inbye of the ventilation shaft. As at 19 November Pike did not have any fixed gas sensors reporting to the surface in these areas. The only functioning sensor reporting to the surface from the return was at the position marked in green on the plan.

16. The joint investigation expert panel said that the mine 'should not have operated' without at least two sensors in the return, connected to an alarm and set to trip the power supply for the underground fan.²⁸

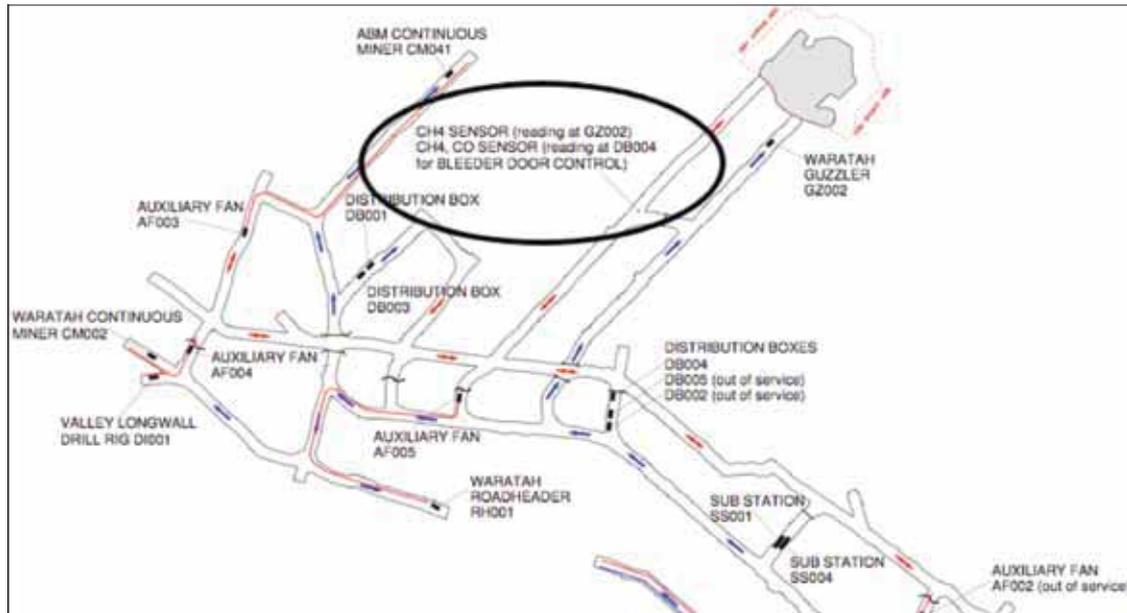
Figure 10.3: Location of hydro-panel sensors²⁹

17. There were two methane sensors located in the return from the hydro panel, circled in black on the diagram below.

18. One provided a reading at the guzzler near the hydro monitor, but did not report to the surface or result in any permanent record of gas levels. The other sensor had been exposed to methane concentrations above 5%, and did not work after 13 October 2010.³⁰

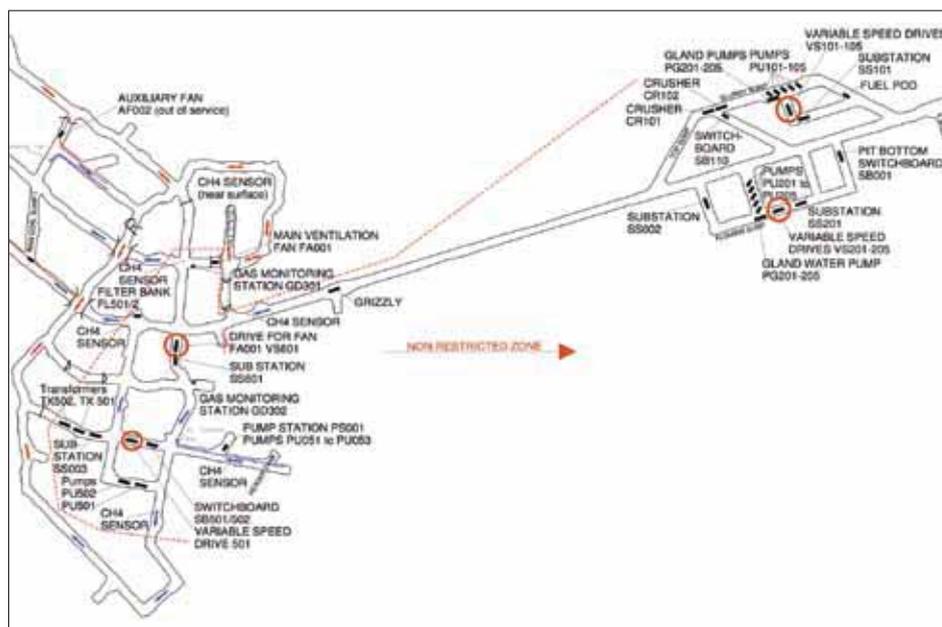
Figure 11.3: Plan showing VSDs underground at Pike River²²

28. Pike used VSDs to allow the fixed speed motors for the main fan and underground pumps to operate at variable speeds. The VSDs do this by varying the frequency of the power supply to the motors.²⁰ This enables a softer start-up process and also allows the operating speeds of a motor to match its output demand, resulting in cost savings and improved performance.
29. Pike had 12 VSDs underground, at the locations circled in red in Figure 11.3. There were five VSDs in each of the locations to the top right of the plan and one at each of the locations to the bottom left of the plan.
30. There were concerns about the use of VSDs. Mr Reczek was aware of the use of VSDs underground elsewhere, but they were 'explosion protected. They're in flameproof enclosures and they're confined to the body of machinery'.²¹

He had never seen a configuration such as that at Pike River, which was essentially a significant number of fixed VSDs underground.

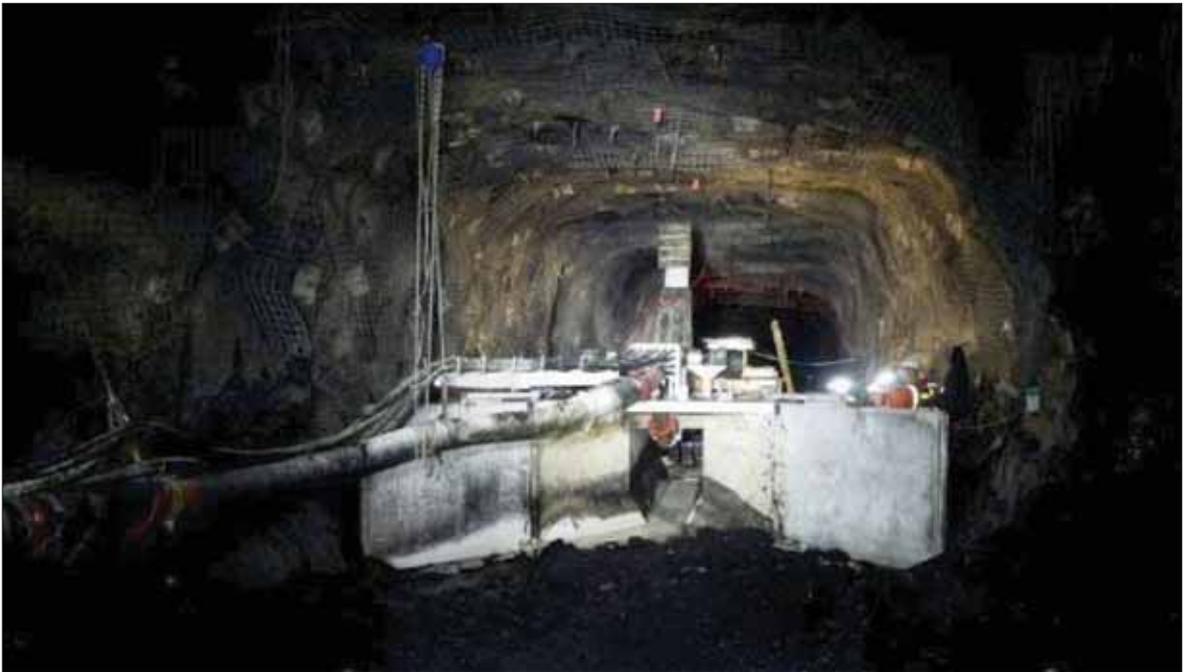
Figure 12.4: Guzzler ready to gather and direct water/coal mixture⁶

5. At Pike River a machine called a guzzler was located 18m behind the hydro monitor, and directed the mixture of coal and water into the roadway flume system. The guzzler also crushed any large lumps of coal.⁵ It is shown in the photograph with its 'wings' open ready to gather and direct the coal/water mixture.

54. Mr Nishioka's work record during the monitor's first week of operation noted that:
- the guzzler was too large and complicated;
 - it was hard for the operator to see the direction of the monitor nozzle, because vision was blocked by the housing;

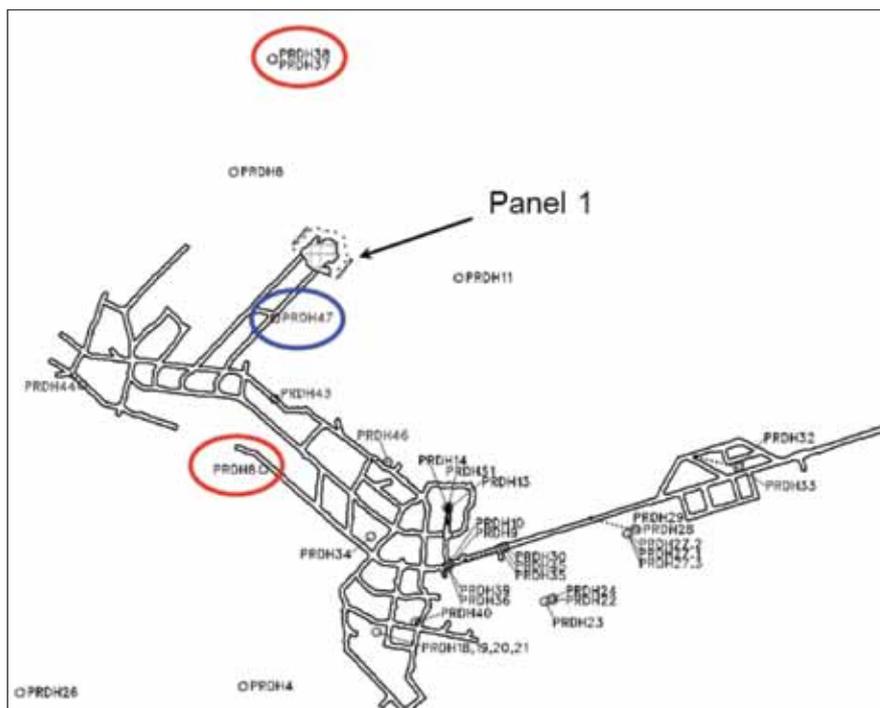
Figure 12.12: Drillholes in the vicinity of Panel 1⁷⁷

63. In July 2010, as part of its annual insurance risk assessment, Hawcroft Consulting 'strongly recommended' Pike undertake a thorough risk assessment into the potential for windblast before coal extraction began in panel 1.⁷⁶
64. On approximately 3 September 2010 Pike carried out the 'panel 1' risk assessment, which dealt with many aspects of windblast. However, Pike had inadequate information to assess the likelihood of windblast occurring and, as noted above, many of the 'existing controls' relied on in the risk assessment did not exist or were ineffective.
65. There was no vertical borehole in the area of the hydro panel, so the only geotechnical data available was from vertical drillholes PRDH8 and PRDH37. These were some distance apart to the south and north of panel 1, as shown below circled in red. PRDH47 (shown below circled in blue) was not drilled until after the explosion.

66. Consultants Strata Engineering used information from drillholes PRDH8 and PRDH37 to provide Pike with windblast advice on 29 August 2010, and Pike relied on this advice repeatedly in the risk assessment. The advice noted that Pike River's bridging panels were planned to be 31m wide in the first instance, but might increase to 50m in the future, with an extraction height in the 10–13m range.⁷⁸ Pike generally took Strata Engineering's advice, based on modelling, as encouraging about the windblast hazard. The island sandstone was considered likely to bridge over panel widths of up to 30m, and although it might fail over larger distances, this was likely to be progressively in smaller blocks rather than a large plate-like fall associated with windblast.⁷⁹

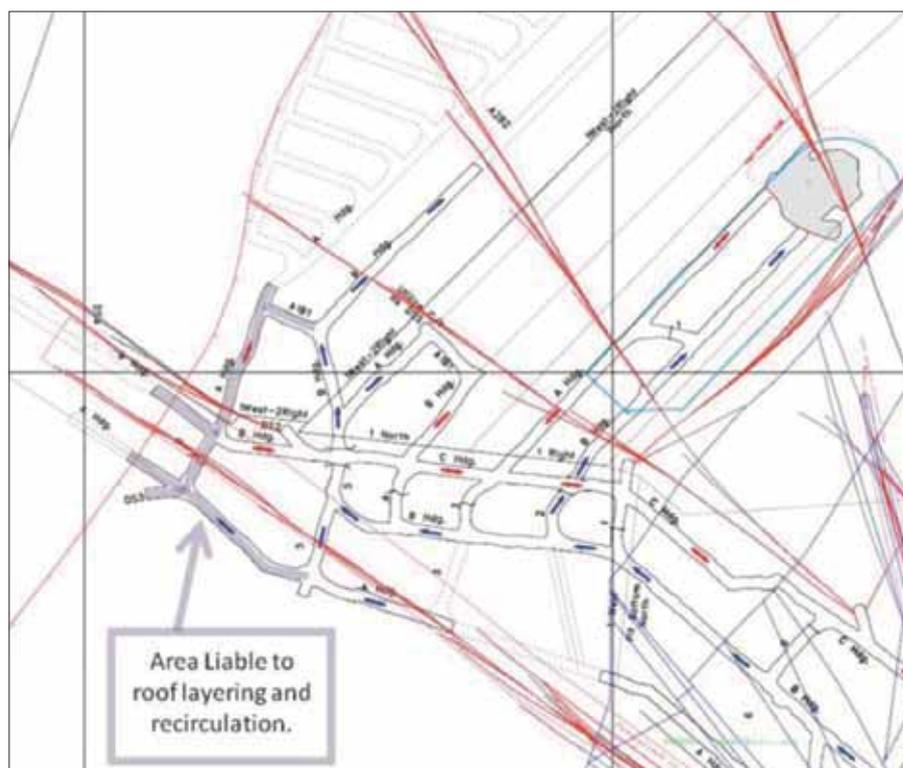
Figure 14.2: The area of the goaf and the intersecting borehole¹⁵

33. The expert panel concluded that there were few potential locations within the mine capable of producing the required volume of methane. One possible location was the hydro panel goaf.
34. Hydro mining at Pike River had created an irregular goaf approximately 30m wide, 40m deep and up to 9m high. The void volume was approximately 6000m³. The goaf was not ventilated. Methane would have continued to bleed from the coal seam into the goaf.¹³ It also contained an in-seam borehole drilled to explore the limits of the seam and also pre-drain methane. The borehole had been intersected during hydro mining, and therefore provided an additional potential source of methane.¹⁴ The diagram below illustrates the area of the goaf (top right corner) and the intersecting borehole. The gas drainage lines are marked in red.

There was also a rider seam above the goaf which, after disturbance of the roof strata during mining activity, could leach further methane into the goaf.

42. The third, and 'less likely,' scenario was a gas accumulation centred in the most inbye and western area of the mine, where the two continuous miners, the roadheader and the in-seam drilling rig were located. This area is depicted in Figure 14.2 and labelled 'area liable to roof layering and recirculation'. There had previously been ventilation and gas management problems in this area, which triggered the shutdown of machinery and the initiation of various methane control measures. In giving evidence, Mr Reece said scenario three was considered less likely because of the significant volume of methane required, which experienced workers, and statutory officials, should have detected and reacted to.²²

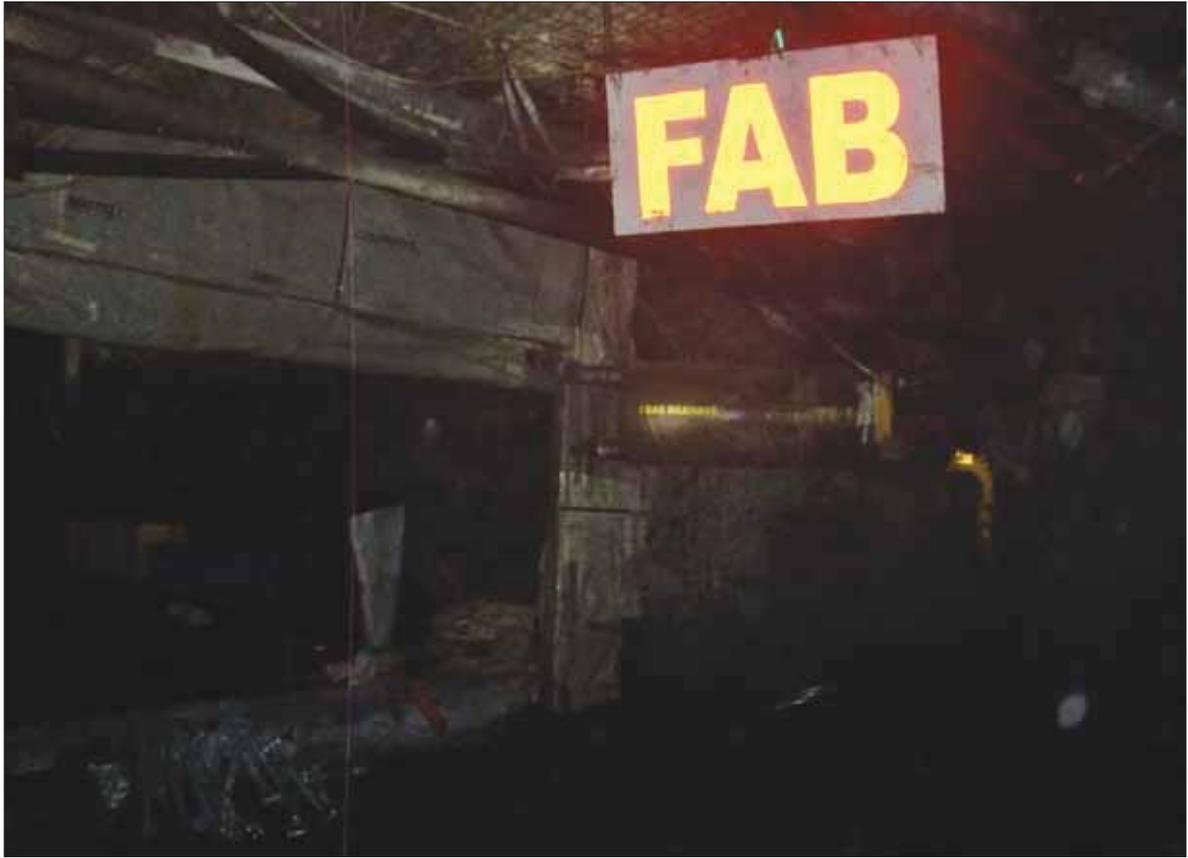
Figure 16.2: View of the upper FAB from outside⁷⁸

132. The upper FAB was developed in March 2010 following a risk assessment which found that the main vent shaft was not suitable as a second means of exit from the mine. The slimline stub was 15m deep, 5m wide and 5m high. The methane drainage line passed through the stub and vented through a gas riser to the surface. A roll-down brattice door was installed so the stub could be isolated in an emergency. Fresh air was available from the surface through the 600mm diameter slimline shaft. The stub contained a cache of 108 self-rescuers (60 of 30 minutes' duration and 48 of 60 minutes' duration), first aid equipment, fire-fighting equipment, a digital access carrier (DAC) and three telephones, one of which was connected to the surface. Pike had planned improvements to the slimline stub, such as increasing its size, installing concrete walls and double doors incorporating an air lock system. The improvements were meant to have been completed by June 2010 but had not been done by the time of the explosion.

133. The roll-down brattice screen would not have prevented the FAB being polluted with the toxic atmosphere. Following the explosion, the failure of the underground fan resulted in a reversal of the air circuit, meaning the slimline shaft became a chimney through which noxious explosion products were drawn into the stub and up to the surface. The upper FAB was not a place of safety and was not functional as an FAB at 19 November 2010. It was not even fit as a changeover station.
