Royal Commission on the Pike River Coal Mine Tragedy

Volume 2

Date of Publication: October 2012

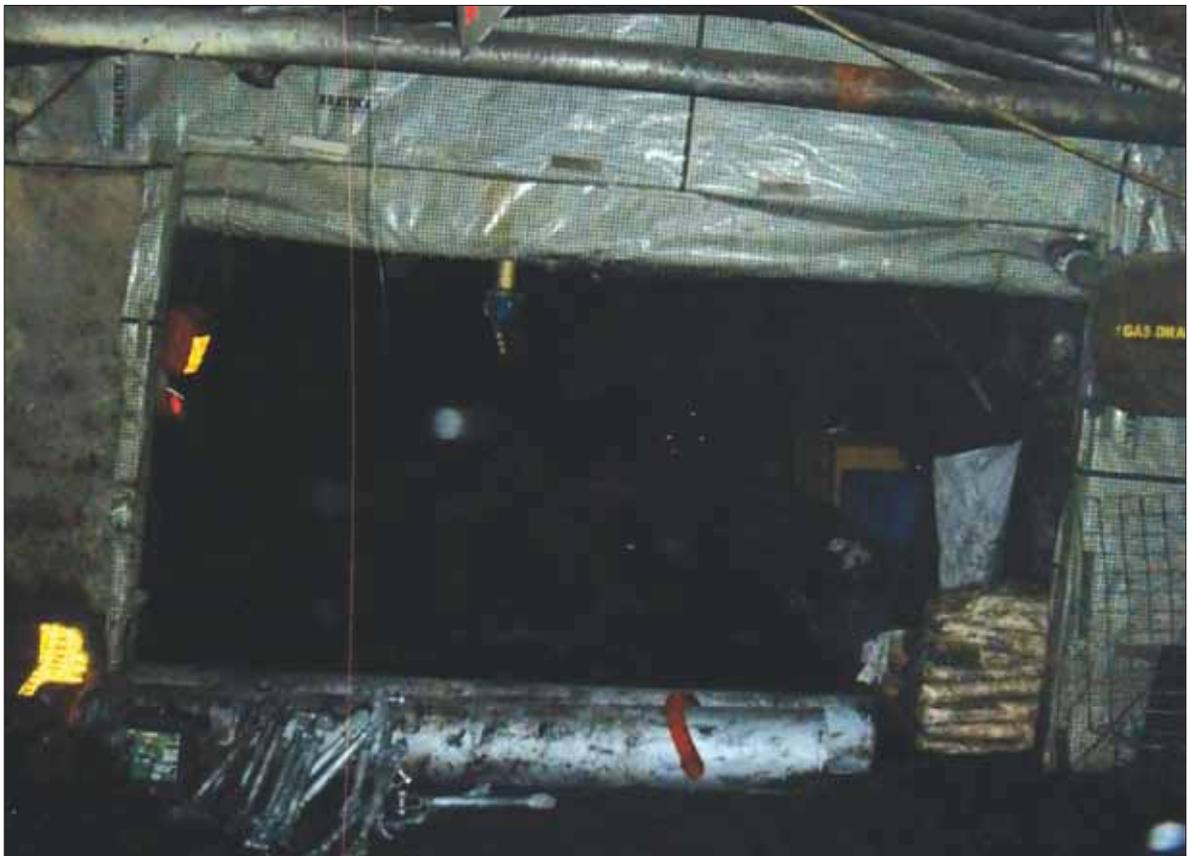
Figure 16.3: View of the upper FAB looking inside⁷⁹

133. The roll-down brattice screen would not have prevented the FAB being polluted with the toxic atmosphere. Following the explosion, the failure of the underground fan resulted in a reversal of the air circuit, meaning the slimline shaft became a chimney through which noxious explosion products were drawn into the stub and up to the surface. The upper FAB was not a place of safety and was not functional as an FAB at 19 November 2010. It was not even fit as a changeover station.
