Section 89. Coal Mines Regulation Act, 1982.

Report of an investigation into the Notification of a Dangerous Occurrence.

A Fire Occurred on Longwall 7 Coalface at 12-45 a.m. on 13th December, 1986, when a block of polyurethane foam being used to fill a roof cavity self ignited.

WEST CLIFF MINE -

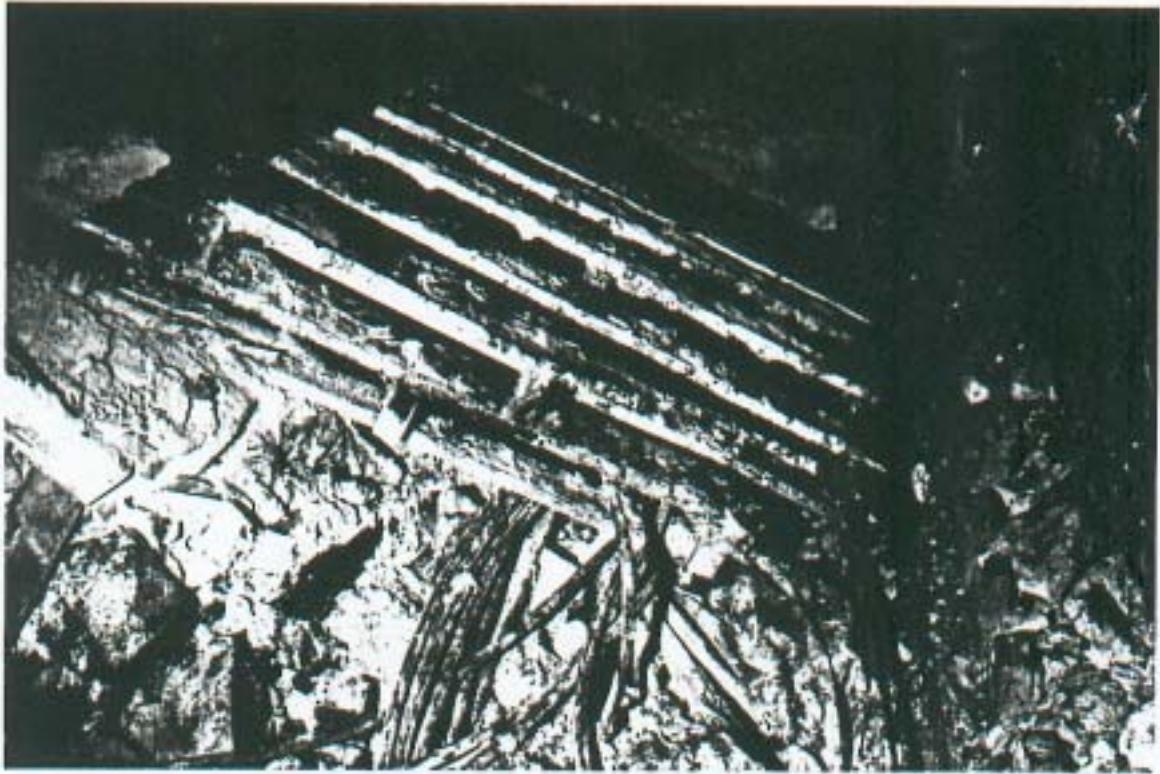
3

Laying across the face conveyor were three wood pallets which had been dug out from the stone dust wall opposite 87-88 chocks. There was evidence of all three pallets having been on fire. (Photographs 3, 4, 5, 6).

SHOWS EXTENT OF BURNING OF WOOD PALLETS

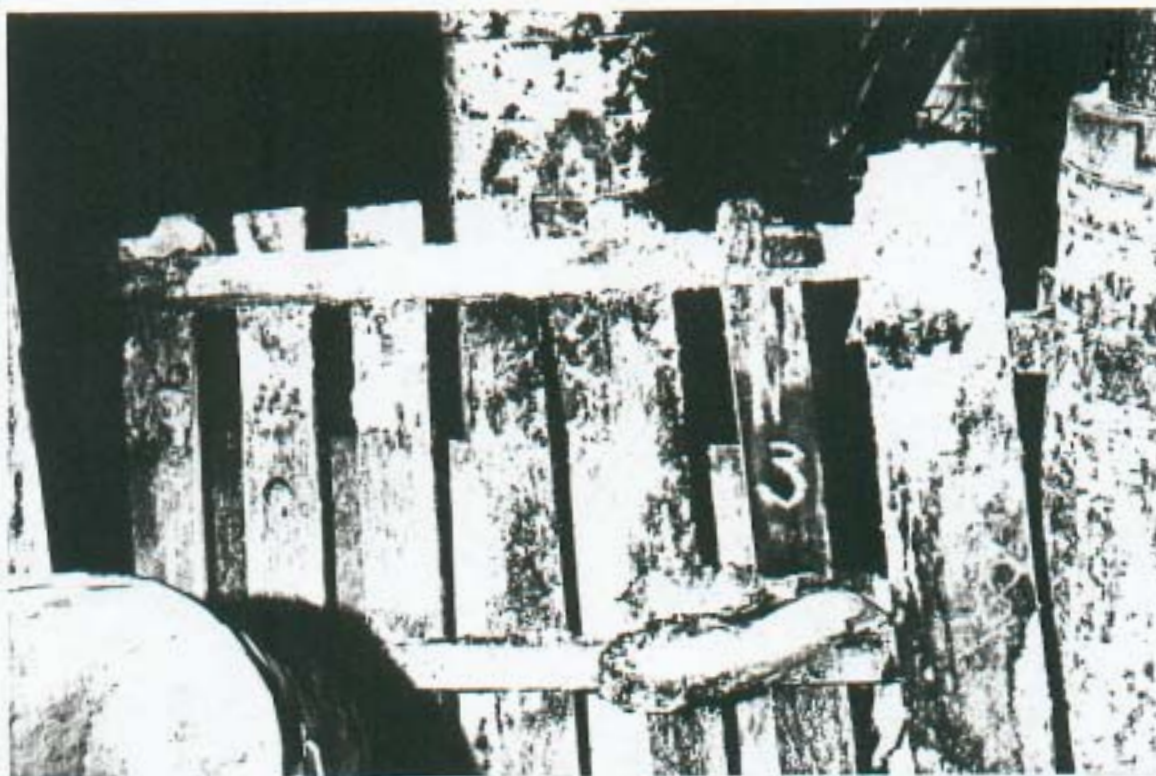
4

SHOWS BURNT WOOD PALLET AND STONEDUST
BAG PAPER

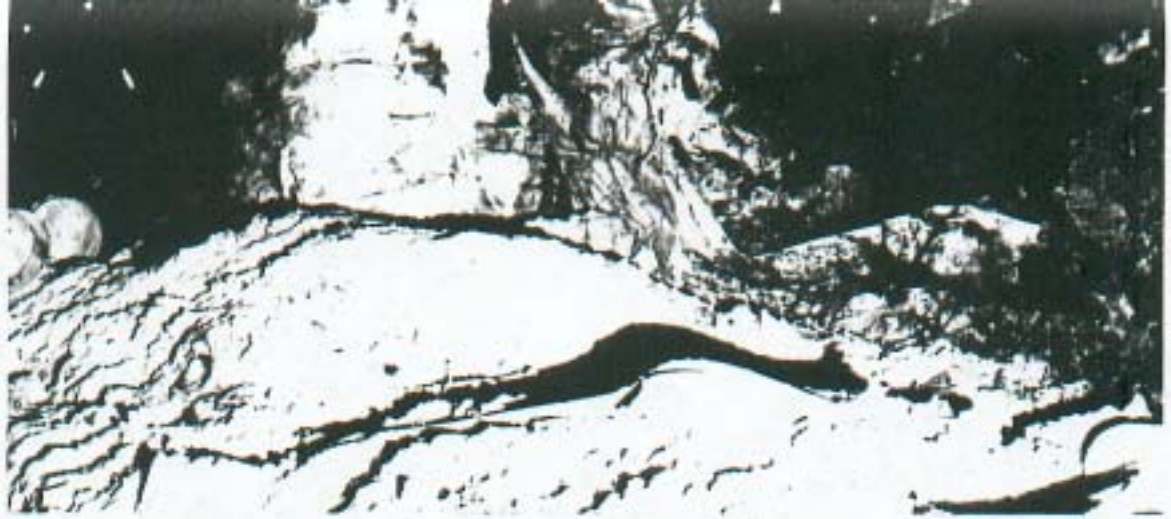
7

VIEW LOOKING TOWARDS MAIN GATE END OF STONE DUST WALL

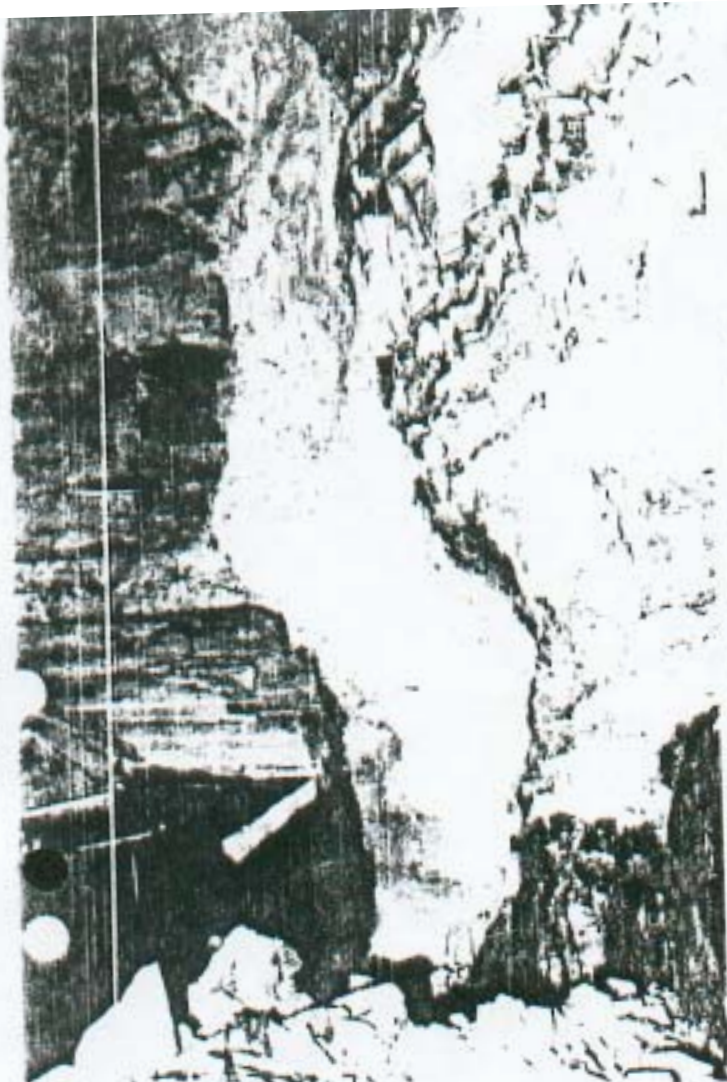
SKETCH SHOWING FALL IN L.W.7 FACE.

LONGWALL 7 COAL FACE

VIEW LOOKING TOWARDS TAIL GATE SHOWING
SKEW INTRODUCTION INTO COAL SEAM AND ROOF
STRUCTURE

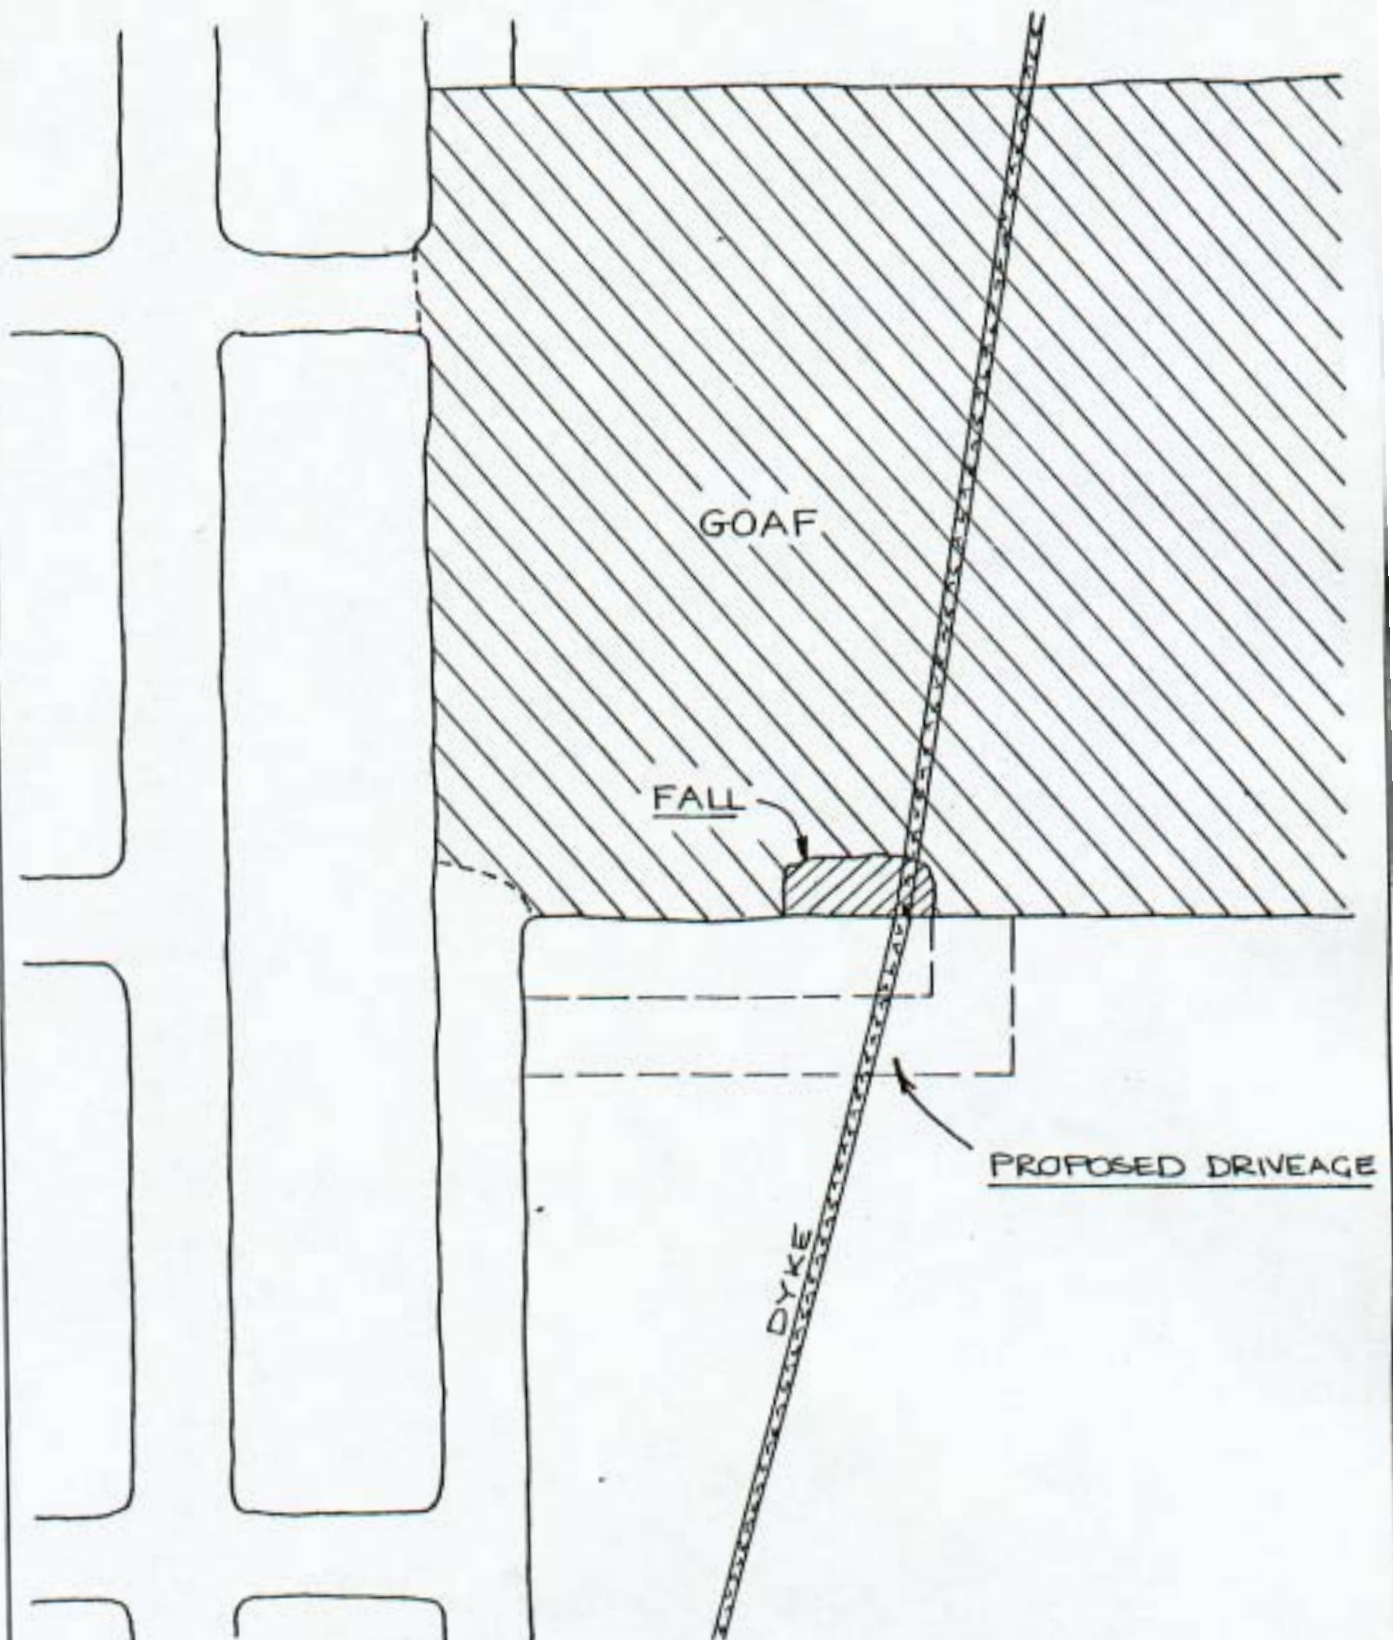
FIGURE 4.

PROPOSED DRIVEAGE TO SHORTEN THE LONGWALL.
PLAN VIEW.

Consideration was also given to shortening the longwall face by driving a heading using a continuous miner on the main gate side of the dyke, as shown in Figure 3. An analysis of this alternative revealed that the face conveyor could be shortened and the drivage could be achieved, however the chocks could not be removed with safety and it would be likely that one or more chocks would need to be abandoned.

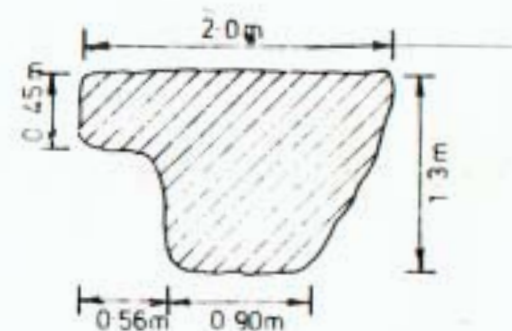
DIMENSIONS OF SECTION DUG OUT
DURING INITIAL FIRE.
